National Register of Historic Places
Inventory—Nomination Form

historic Old Bloomfield

Old Bloomfield
 Talbot County
 Maryland

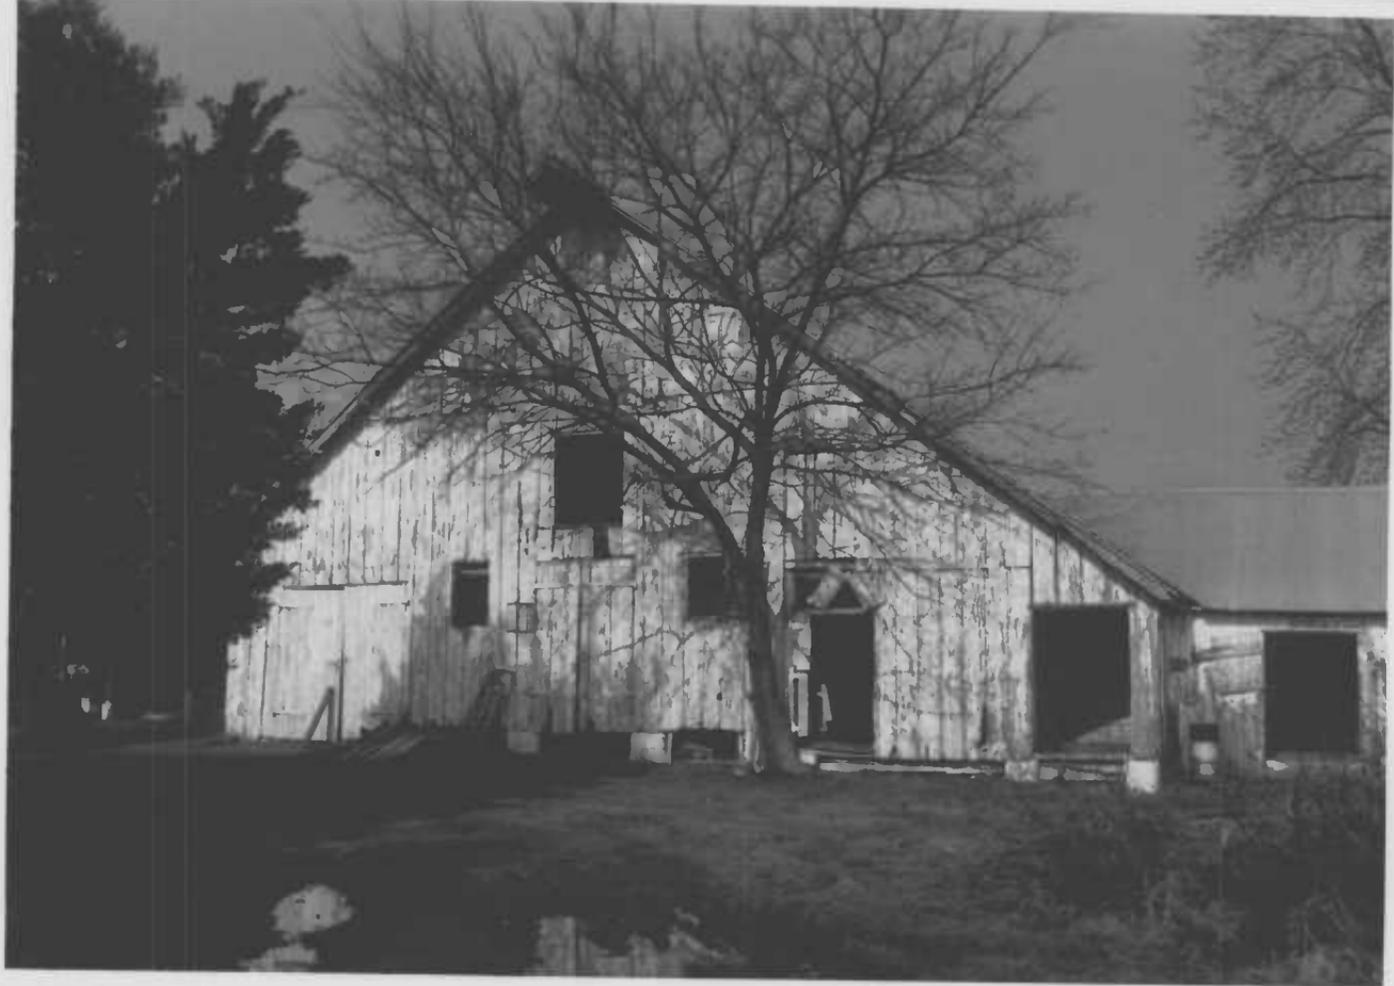
OLD BLOOMFIELD, Corn Crib

Northwest elevation.

Several notable farmbuildings have survived. A small frame diary dating to the late 19th century is located to the rear of the house. A row of farmbuildings along the northeast side of the driveway includes a heavy timber frame crib 10 feet by 22 feet and a barn 47 feet wide and 30 feet deep. Both buildings are constructed of circular sawn timber, and probably date to the third quarter of the 19th century, but are similar in form and construction to much earlier buildings. A handsome pale fence enclosed the yard to the northeast and northwest of the house.

Several 19th century outbuildings have survived, as well as a handsome pale fence (possibly 19th century). Of particular note are the heavy timber frame crib and the large barn on the northeast side of the farmyard.
