MARYLAND COMPREHENSIVE HISTORIC PRESERVATION PLAN DATA - HISTORIC CONTEXT

WA-I-264

Shafer Farm

Maryland Historical Trust State Historic Sites Inventory Form

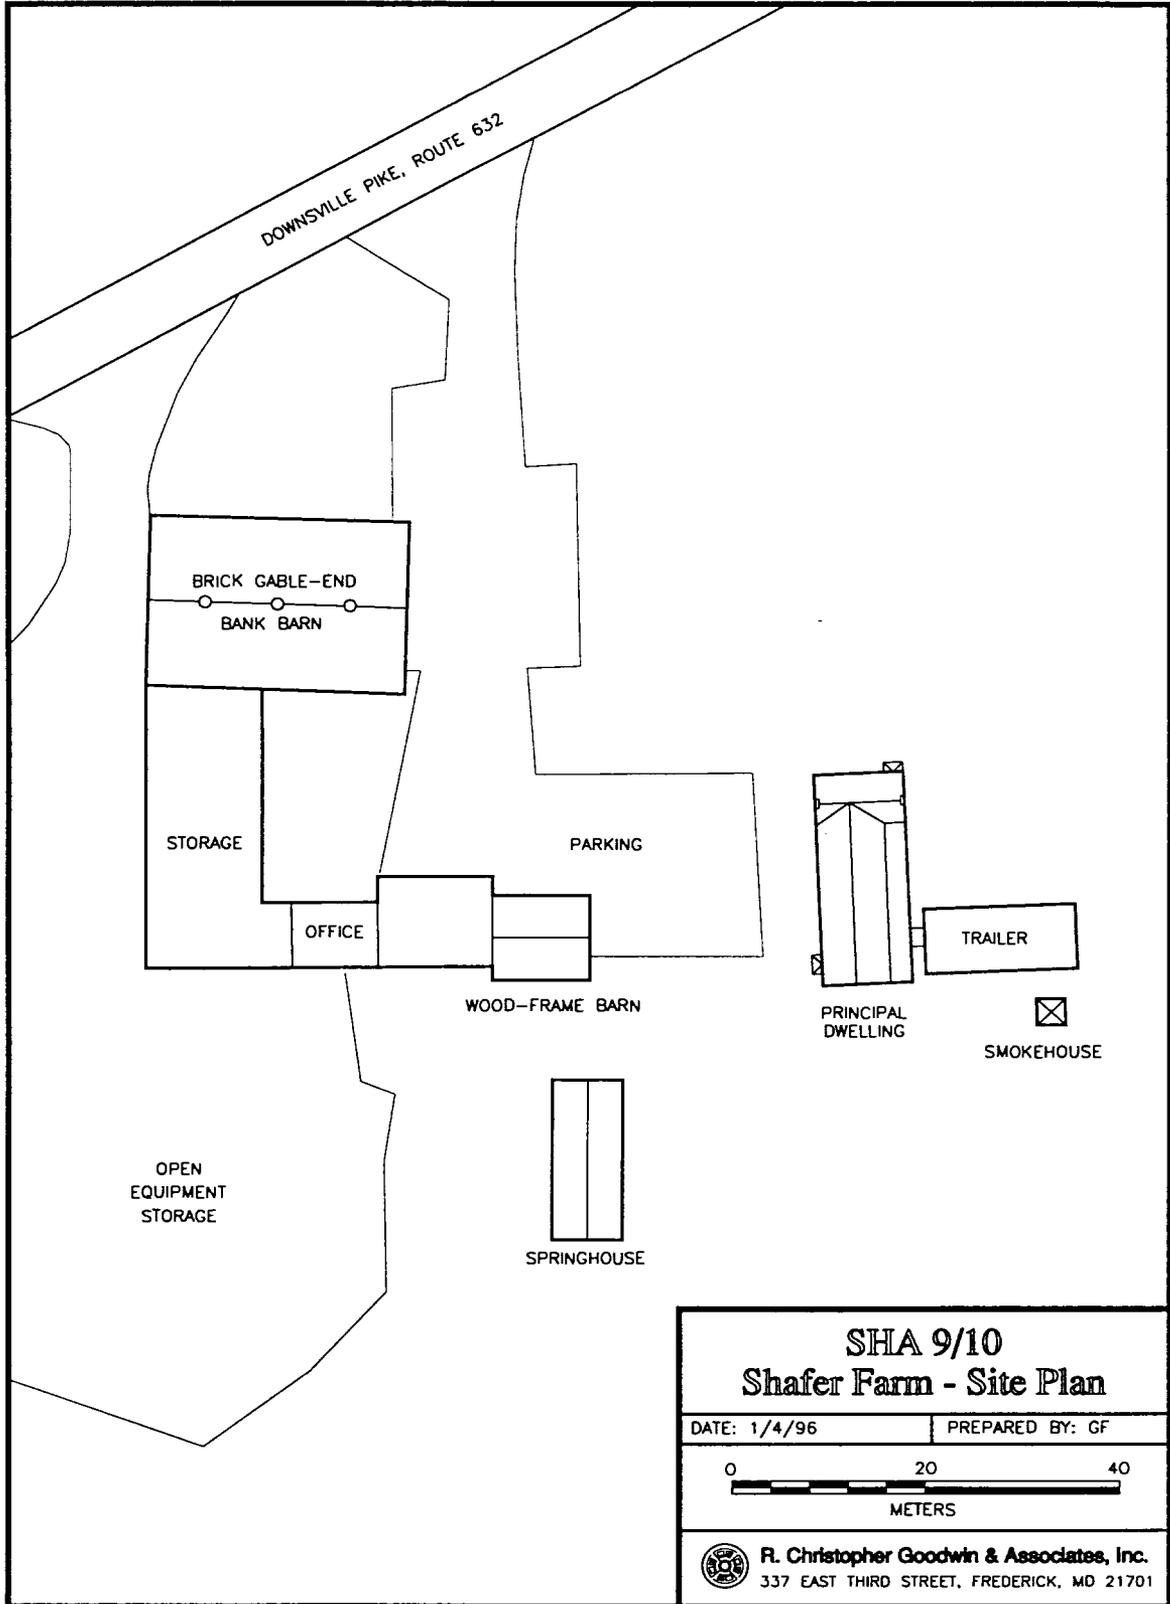
Sketch Plan of Shafer Farm.

The farm complex is comprised of five buildings: a brick dwelling, a brick-end bank barn, a stone springhouse, a wood frame barn, and a wood frame smokehouse. The former farm complex occupies a site on the east side of Downsville Pike (Route 632). The complex buildings are oriented towards the west overlooking agricultural fields that historically were part of the Shafer Farm. The brick dwelling and bank barn dominate a low rise that slopes toward the tributaries of Marsh Run; outbuildings are sited east of the barn and south of the dwelling. A paved driveway provides access to the complex from the Downsville Pike. A parking area and storage yard is located between the main dwelling and bank barn.

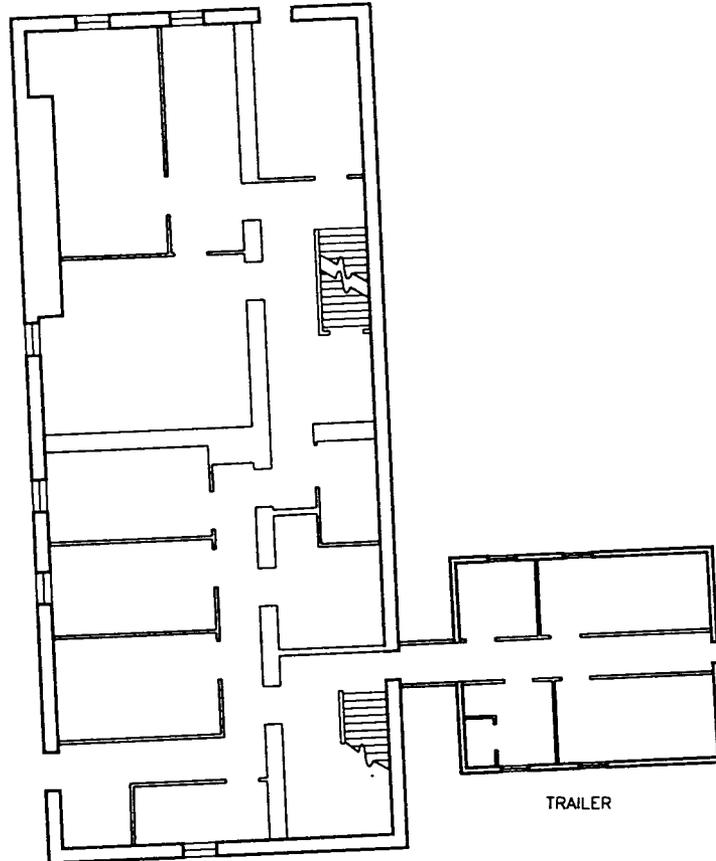
First Floor Plan of Principal Dwelling

Principal Dwelling (ca. 1850). The principal dwelling of the Shafer Farm is a mid-nineteenth century example of a side-hall plan, Piedmont farmhouse. The original design of the dwelling was substantially modified ca. 1980 when the building was adapted to office use.

The principal block of the house is three bays wide and two bays deep. An ell extends east from the principal block. The ell is three bays wide and one room deep.

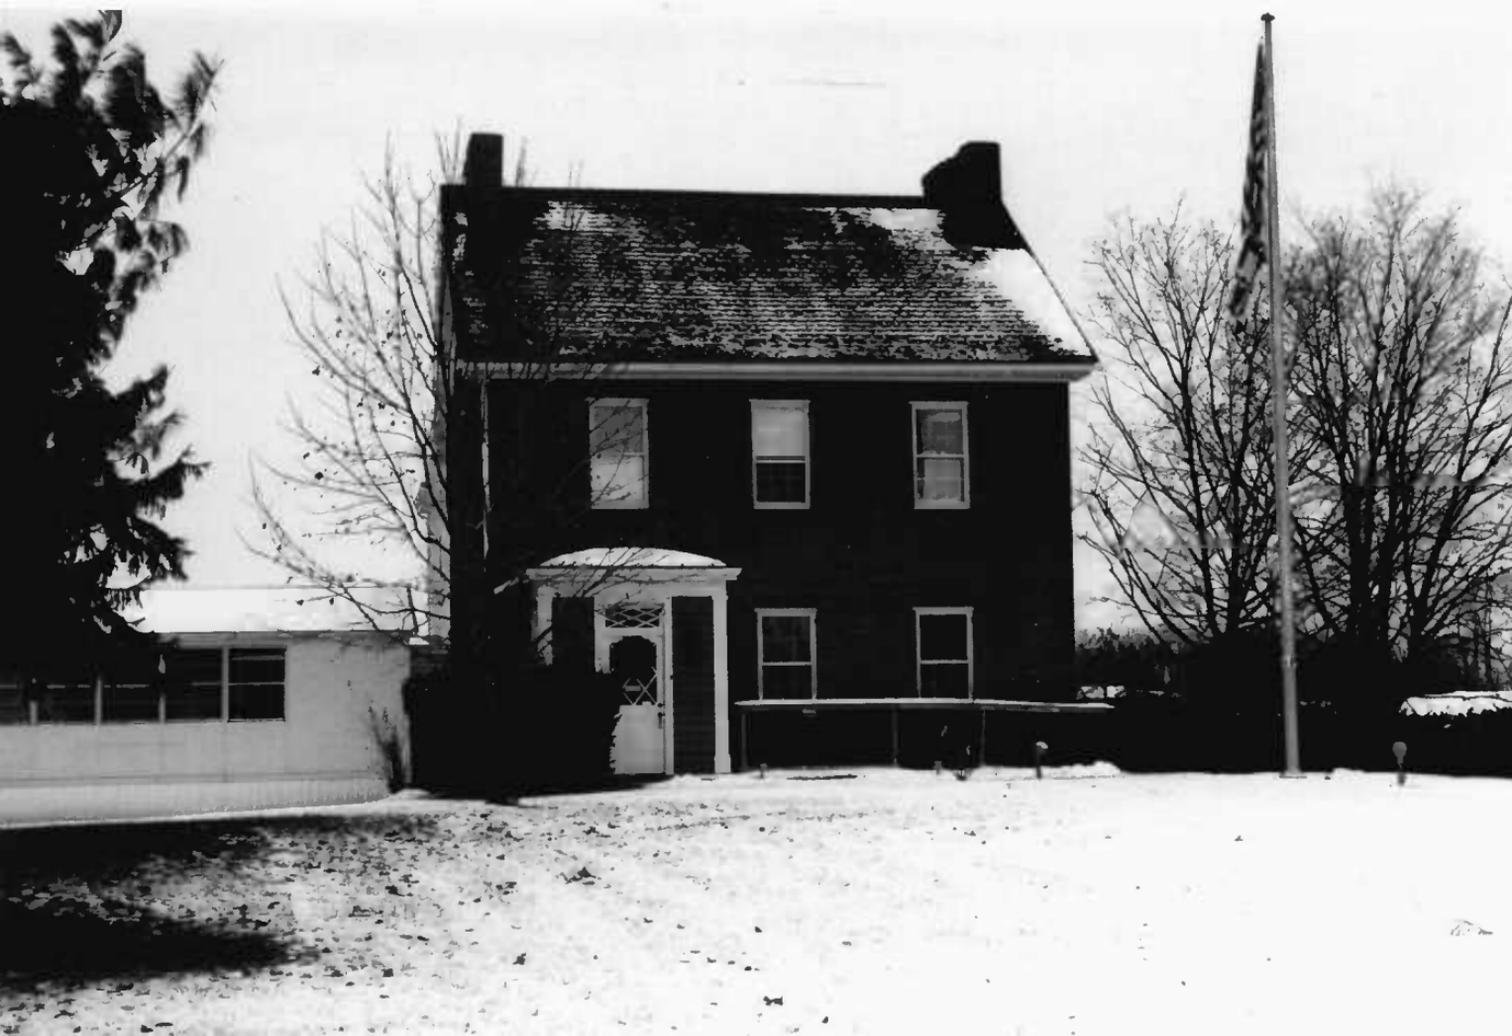
1 of 9

The symmetrical, three-bay, brick building comprises a two-story principal block and two-story ell. The primary (west) elevation is laid in stretcher bond while the remaining elevations employ common bond brick work. The structure is supported by a coursed rubble foundation and terminates in an intersecting gable roof, sheathed in asphalt shingles. The gable-end elevations of the principal block include paired brick, interior-end chimneys. A simple, molded, wood cornice and gable returns embellish the eave line.

The primary entrance to the principal block is marked by an enclosed hipped porch that spans the north bay of the west elevation. The porch, a contemporary addition, features a single-light, paneled, wooden door with diamond muntins. The diamond pattern is repeated in the transom. The porch is clad in wood siding; pilasters define the corners of the element. The hipped roof is sheathed in composition shingles. The one-bay element replaced an open, one-story, shed porch that extended the length of the front elevation. The earlier porch was ornamented with turned posts, scrolled brackets and bargeboards.

The windows of the principal block are replacement one-over-one light, double-hung, wooden sash windows with removable six-over-six light muntins. Jack arches mark the window openings. The windows are flanked by paneled wood shutters. The gable-end elevations retain the original nine light attic windows.

View West, West Principal Elevation, Principal Drawing

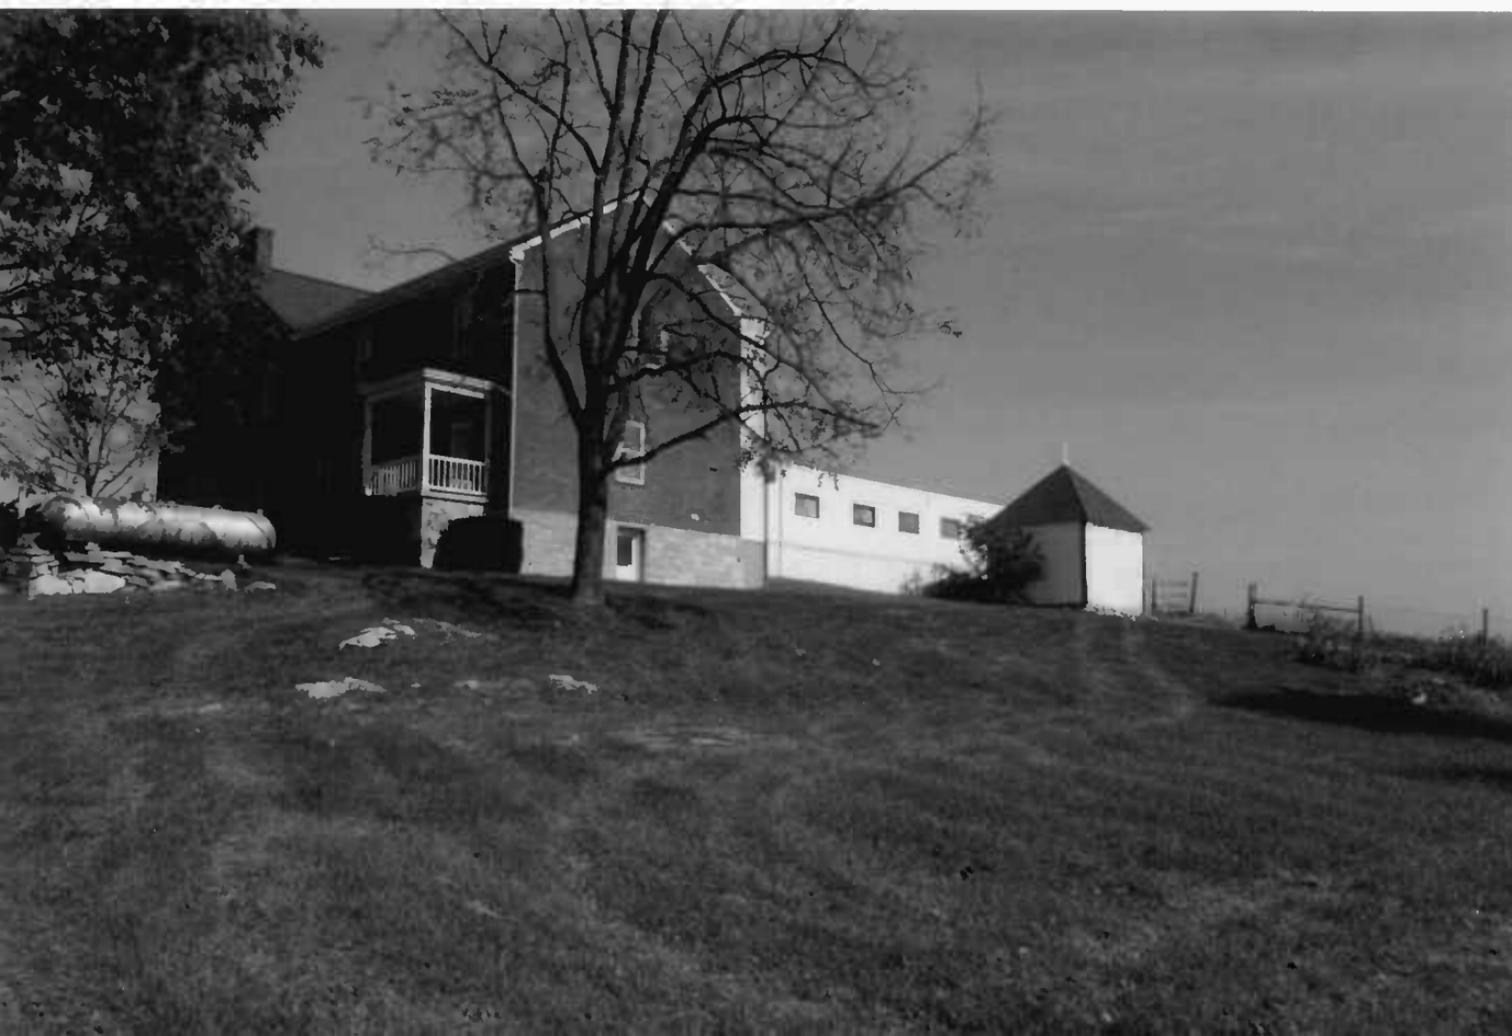
3 of 9

Smokehouse (ca. 1850). The smokehouse is located northeast of the principal dwelling. The rectangular, one-story, wood frame structure rests on a raised stone foundation. The walls are clad with vertical board and batten siding. A single wooden door located on the south elevation provides access to the building. The door is secured by original hardware and metal hinges. The north elevation incorporates small wooden ventilators near the eave line. The building is sheltered by a pyramidal roof sheathed with asphalt shingles. A replacement wooden finial is located in the center of the roof. The interior of the smokehouse features a poured concrete floor, the exposed wood beams are blackened by smoke.

View Northwest, Southwest Rear Ell, Principal Dwelling, including Smokehouse

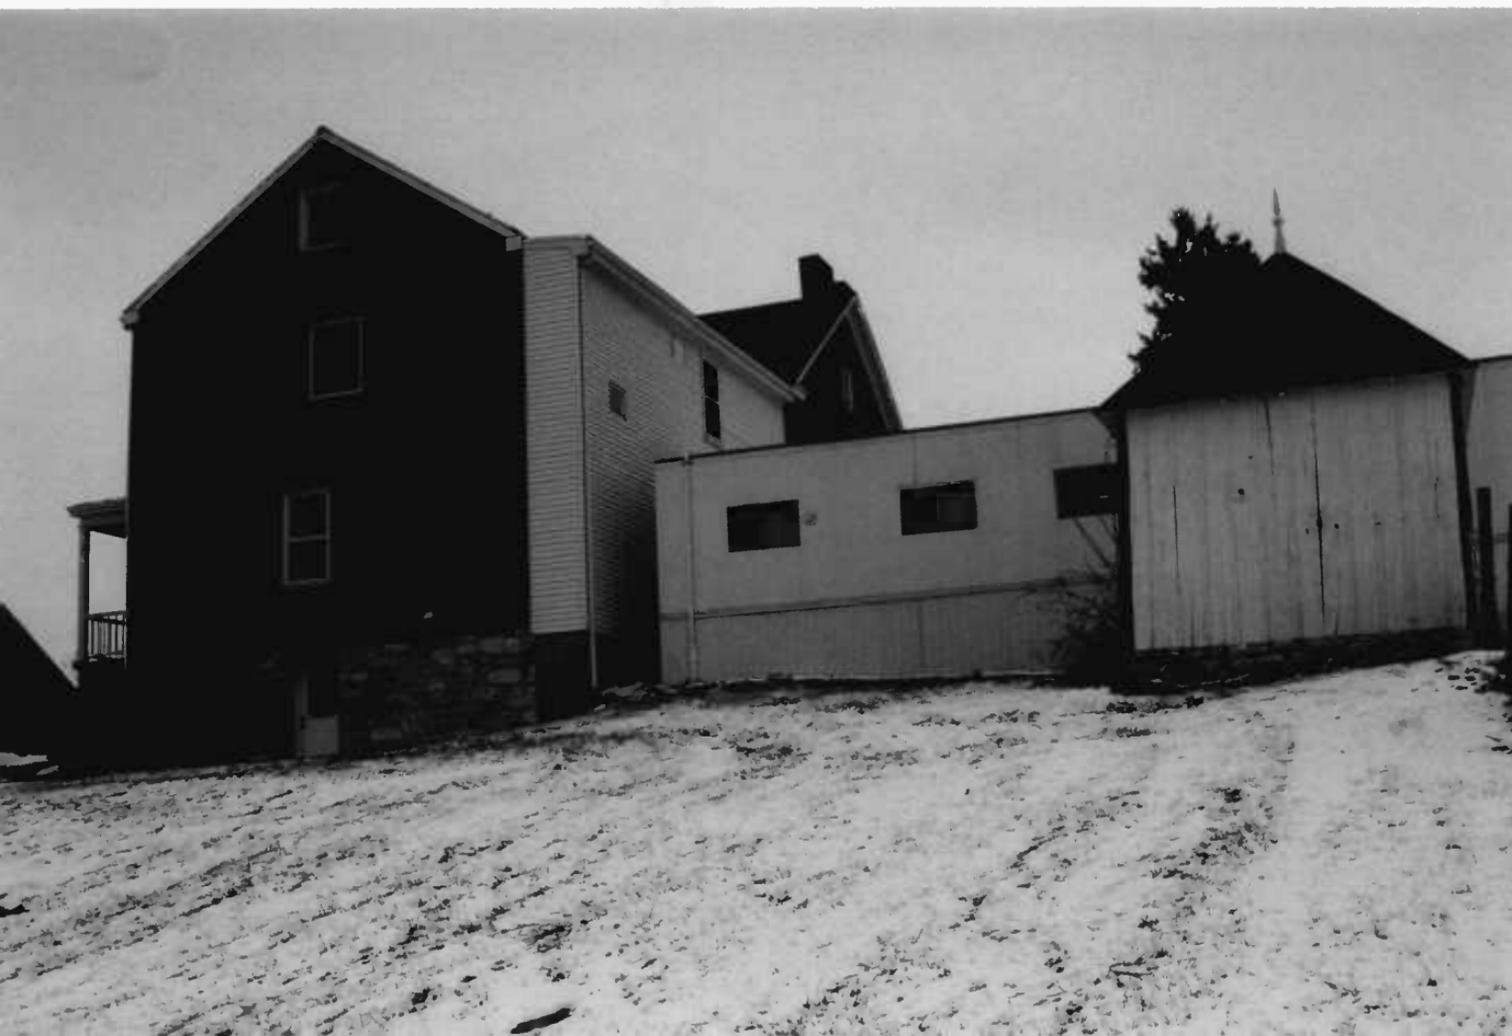
4 of 9

A narrow, two-story, shed-roof addition extends from the north elevation of the ell. The addition is supported by a concrete block foundation and is sheathed in aluminum siding. Two, one-story, office trailers are connected to the addition.

View Southwest, Rear Ell, Principal Dwelling, including trailer

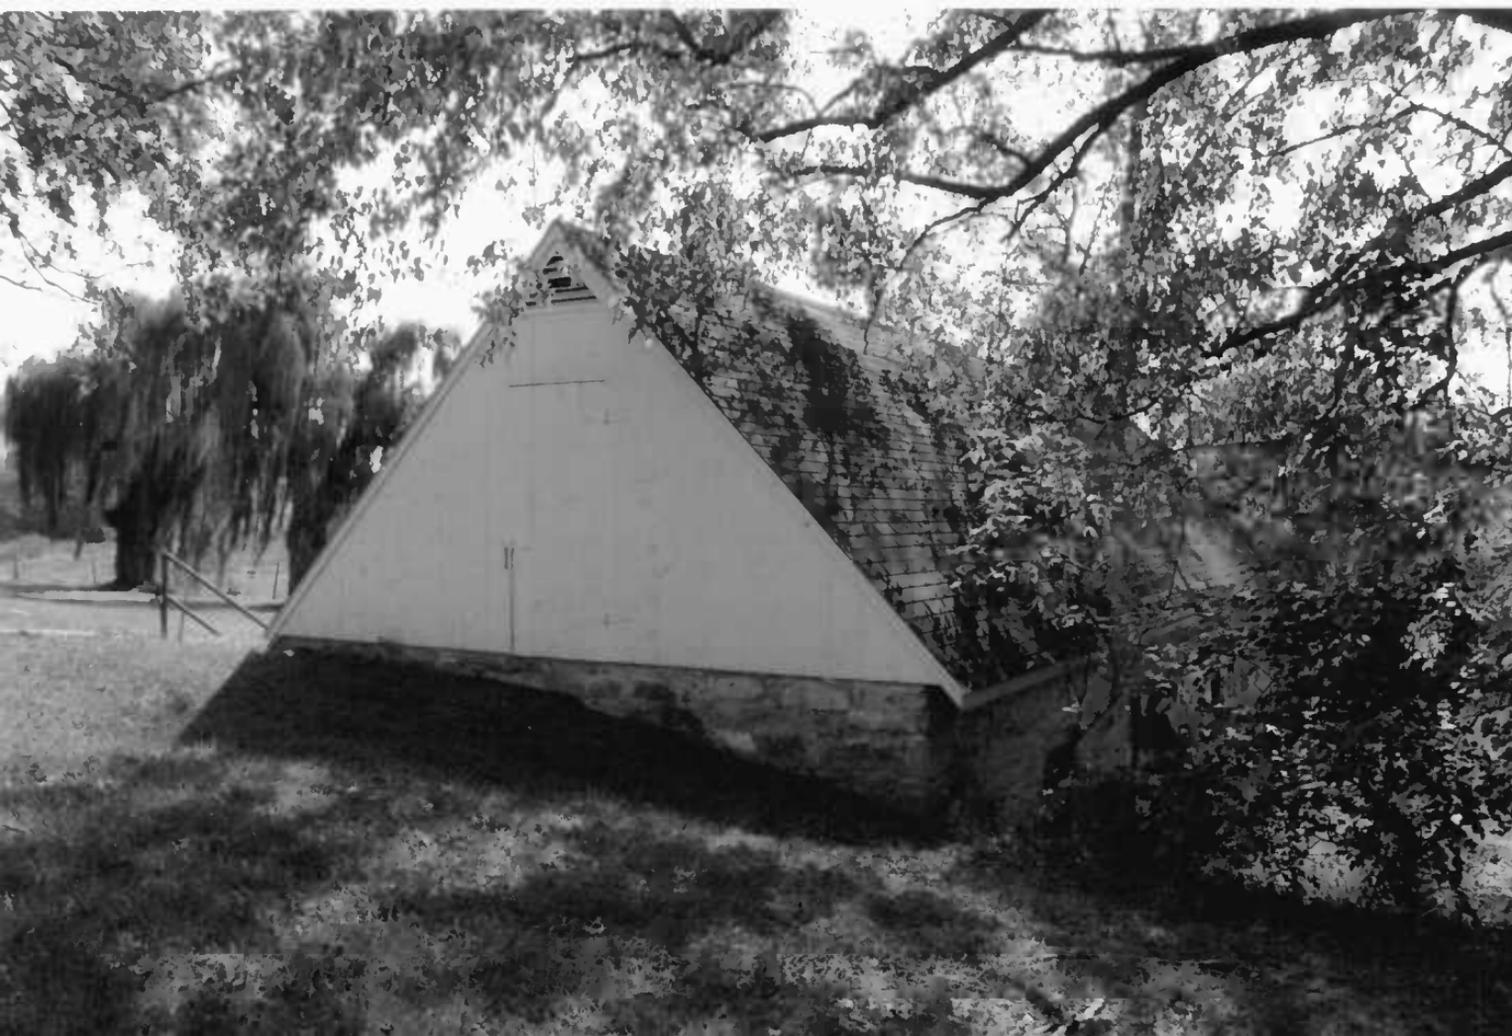
6 of 9

Springhouse (ca. 1800). A stone springhouse is located approximately thirty feet southeast of the principal dwelling. The springhouse is constructed of rough-cut, random course stone; larger stones supporting the building corners. The exterior walls are painted white. The spring house is a rectangular, one-and-one-half story structure consisting of two rooms connected by a central breezeway. This dog trot ground plan is an unusual configuration for a springhouse (Dickey:1976). The opening created by the central breezeway is supported by two large wooden beams. The building is banked into the slope of the hill creating a partially exposed ground floor. Each room of the building is accessed by doors located in the breezeway. The doors to each room are located off center; both retain their original pegged framing. The building terminates in a replacement steep side-gable roof clad with asphalt shingles. An earlier roof was slate. Simple wood boards mark the eave the gable ends. The south elevation features a two window openings that are centered in each room. The east elevation includes a stone chimney with a brick stack. The east, gable-end elevation features vertical board siding. The west elevation is bermed into the hillside providing grade-level access to the attic level through a wooden vertical board door.

View Northeast, West Elevation, Springhouse

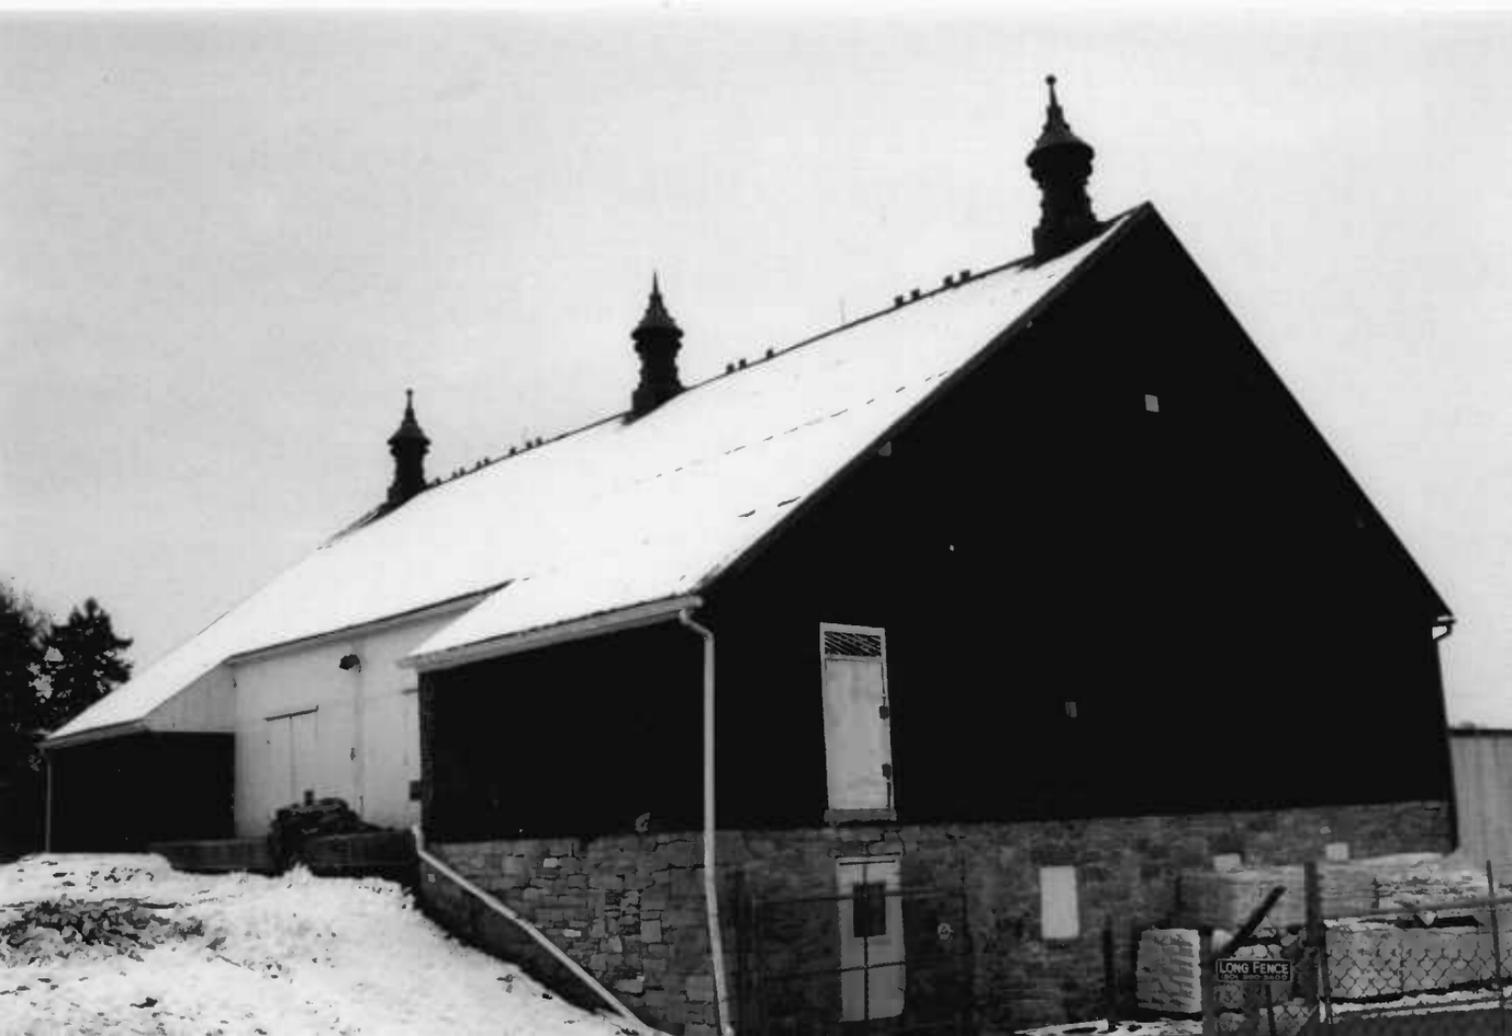
7 of 9

Brick Gable-End Bank Barn (1851). A two-and-one-half story, rectangular plan, brick bank barn is located southwest of the dwelling and is oriented towards the Downsville Pike (Route 632). The barn rest on a raised, random course limestone foundation. The west, north, and south upper story walls are constructed in brick and incorporate elaborate geometric diaper work that serves to ventilate the building's interior. The east elevation forebay is sheathed in vertical board siding. The building terminates in a side gable roof sheathed with metal standing-seam panels. Three metal ventilators project from the roof ridge.

The primary (west) elevation is defined by projecting brick bays that flank the banked earth entrance ramp. The two bay entrance is sheathed in plywood and houses two sets of hinged double doors. The hinged double doors are plywood units supported by wood frames. A concrete loading dock occupies the central recess created by the projecting brick bays.

The building's decorative gable-end brickwork consists of a series of four rows of repeating motifs: diamond, sheaf, hour glass, and diamond. The upper gable includes an elaborate design of triangles that create a stylized lily.

View Northeast, West Elevation, Brick Gable-End Bank Barn
