WA-I-506 Brick Bungalow

Early 20th century

Hagerstown Vicinity

Maryland Historical Trust State Historic Sites Inventory Form

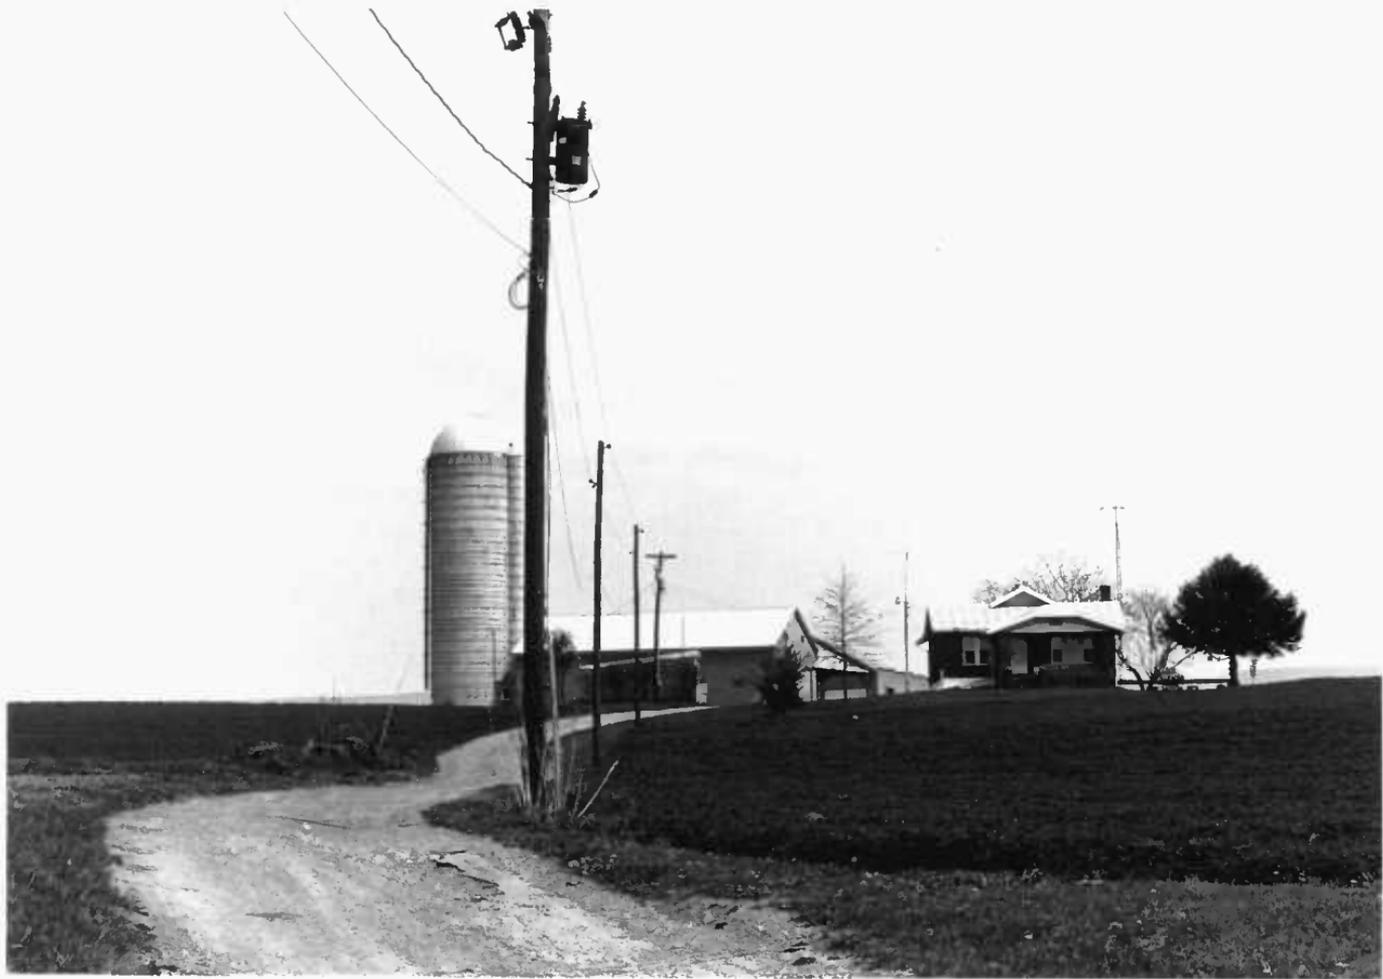
1. Brick Bungalow WA-I-506
2. Washington County, Maryland
3. Joe Getty
4. May 1983
5. Maryland Hist. Trust, Annapolis, Md.
6. West Elevation; camera facing east
7. 1/1
