WA-I- 519 Brick Bungalow

Hagerstown Vicinity

Maryland Historical Trust State Historic Sites Inventory Form

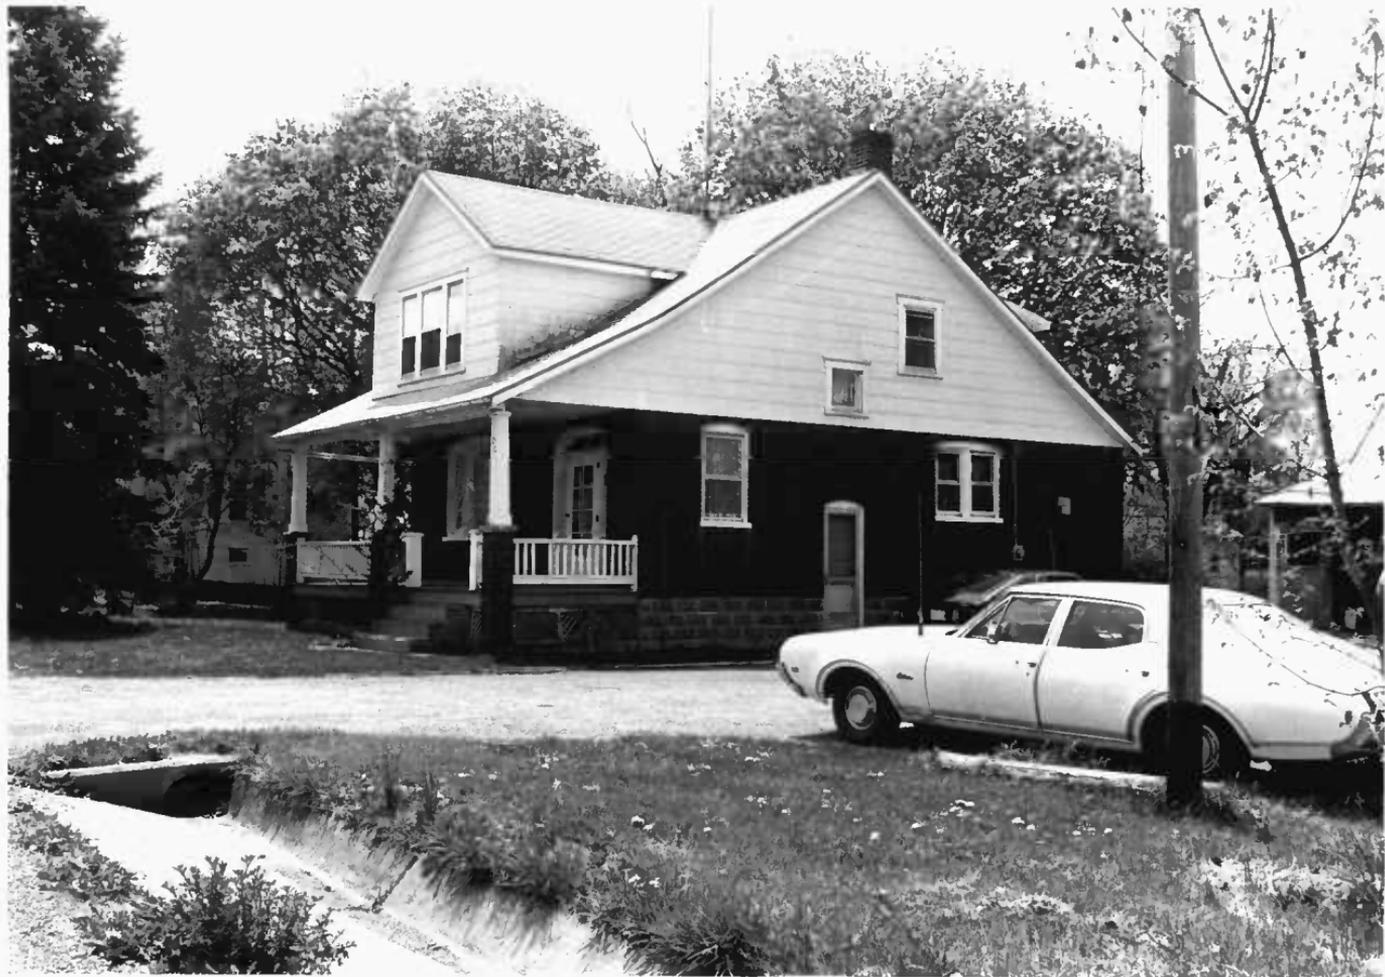
The bungalow is a brick structure on a concrete block foundation. It has an asphalt shingle covered roof and a brick flue at the north gable end. The main facade has a porch with a stick railing and boxed posts. Within the porch is a doorway with a fanlight. On the roof is a large gabled dormer with a three-section window.

1. Brick Bungalow WA-I-499 519
2. Washington County, Maryland
3. Joe Getty
4. May 1983
5. Maryland Hist. Trust, Annapolis, Md.
6. East Elevation; camera facing west
7. 1/1
