WA-II-482      Brick Farmhouse

# Maryland Historical Trust State Historic Sites Inventory Form

Survey No. WA-II-482

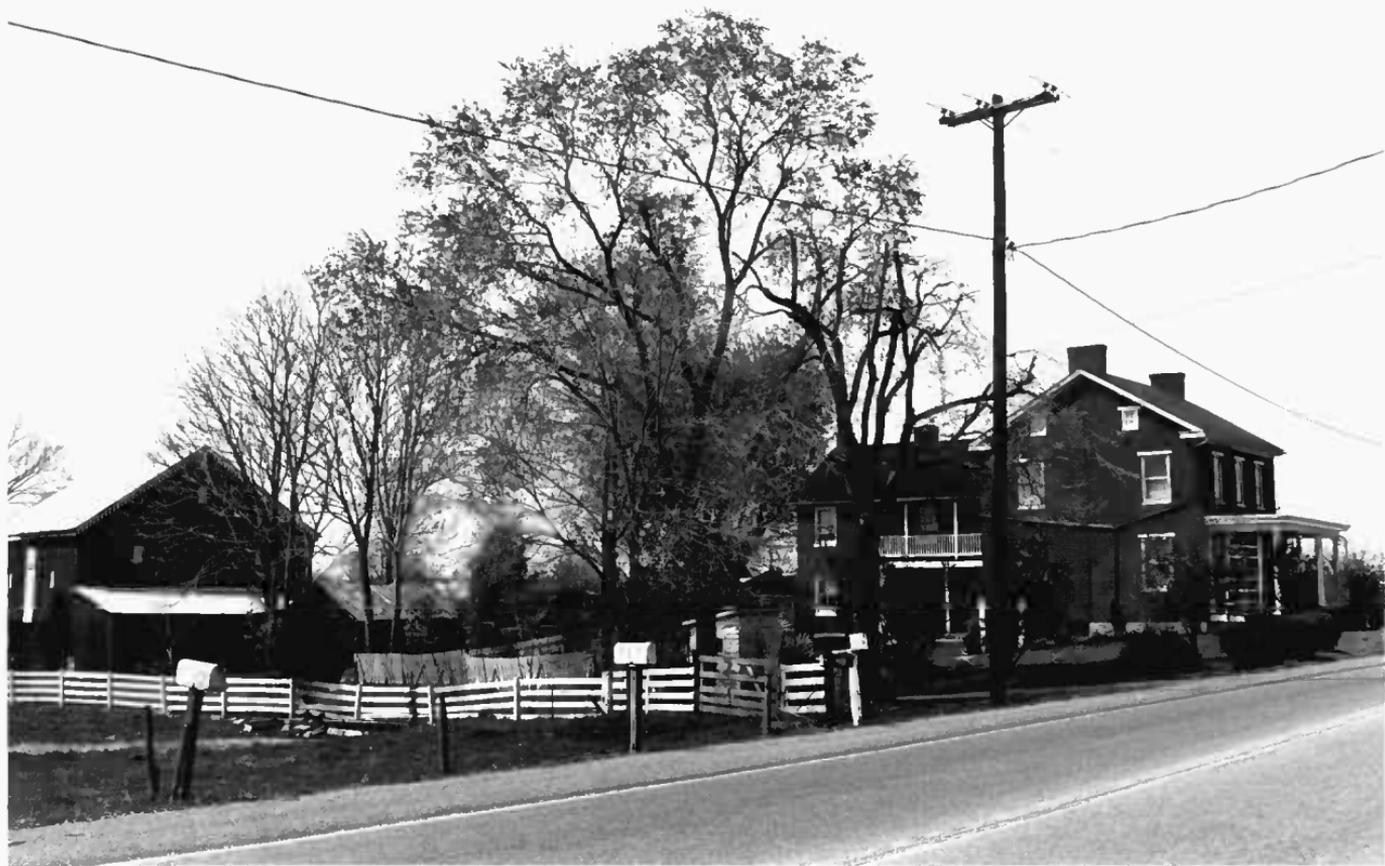
1. Brick Farmhouse           WA-II-482
2. Washington County, Maryland
3. Joe Getty
4. May 1983
5. Maryland Hist. Trust, Annapolis, Md.
6. Farm overview; camera facing northwest
7. 1/3

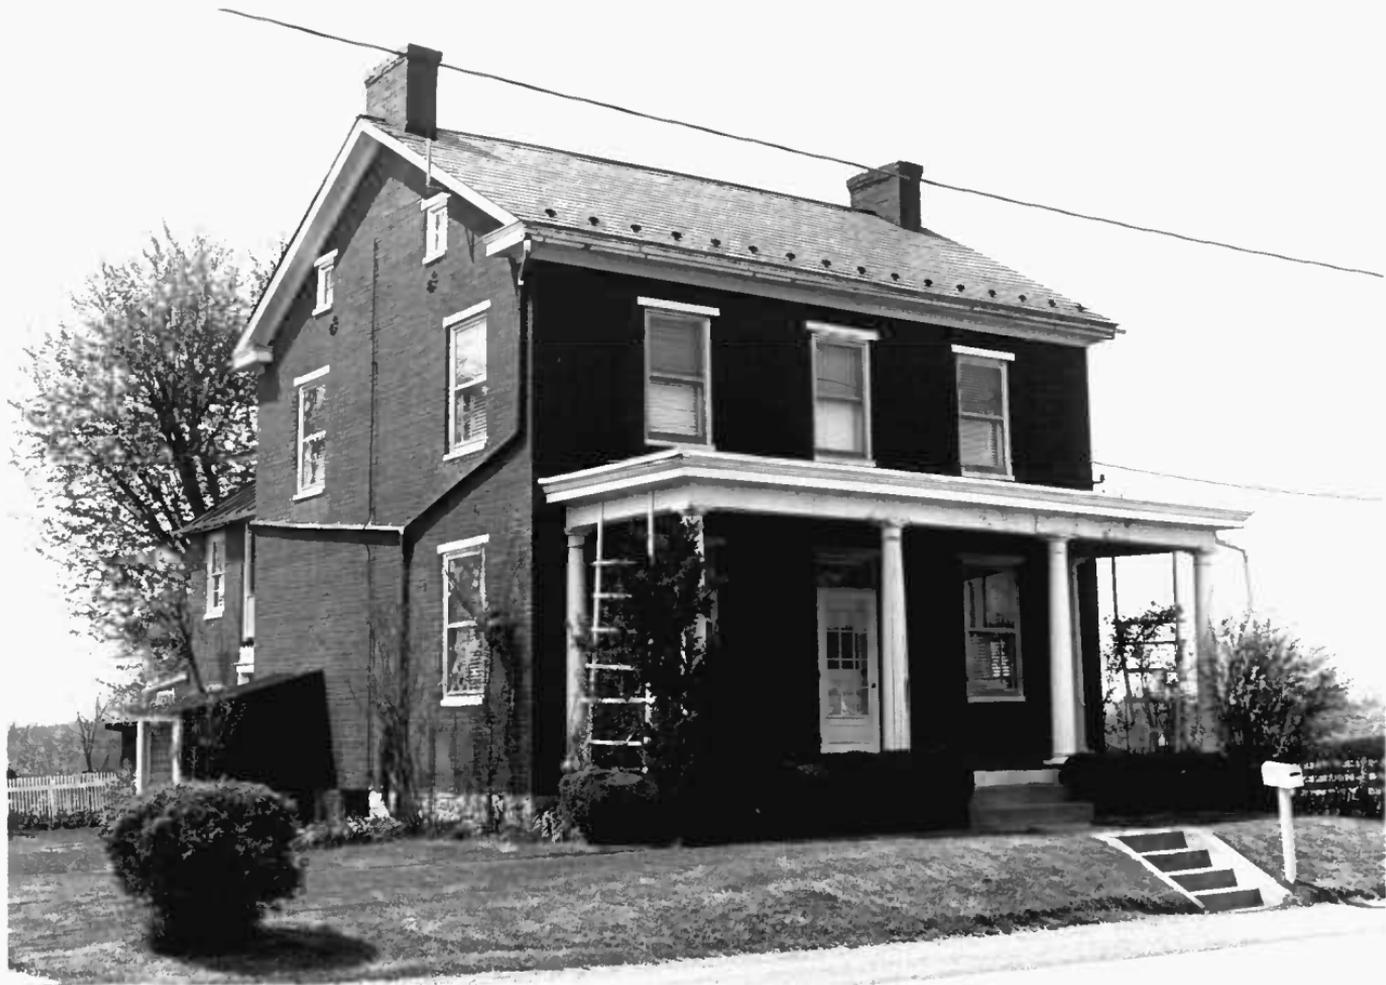
The house is on a Stone foundation. The brick is laid in stretcher bond. The windows have plain white wood sills and lintels. The roof cornice is boxed with a serpentine molding and returns at the gable ends. The ell has a large chimney mid-way back from the main house at the peak of the gable and a chimney at the gable end. There is also a small shed addition at the rear of the ell.

1. Brick Farmhouse           WA-II-482
2. Washington County, Maryland
3. Joe Getty
4. May 1983
5. Maryland Hist. Trust, Annapolis, Md.
6. South & east elevations; camera facing  
northwest
7. 2/3

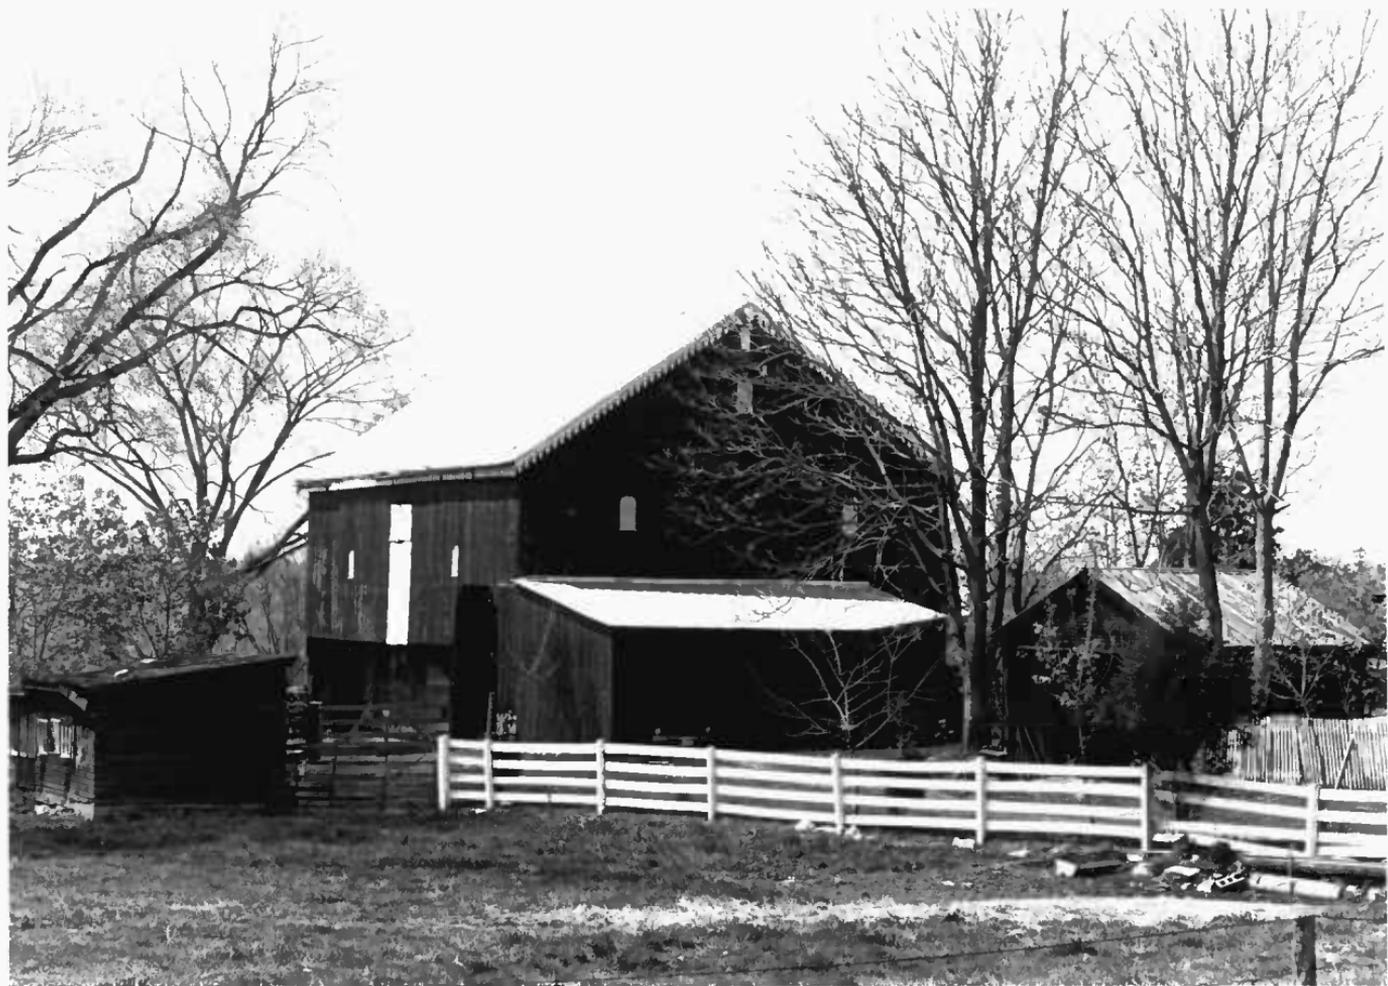
1. Brick Farmhouse           WA-II-482
2. Washington County, Maryland
3. Joe Getty
4. May 1983
5. Maryland Hist. Trust, Annapolis, Md.
6. Barn--south & East elevations; camera  
facing northwest
7. 3/3
