WA-II-488 Brick Farmhouse

Late 19th century

Benevola

Maryland Historical Trust State Historic Sites Inventory Form

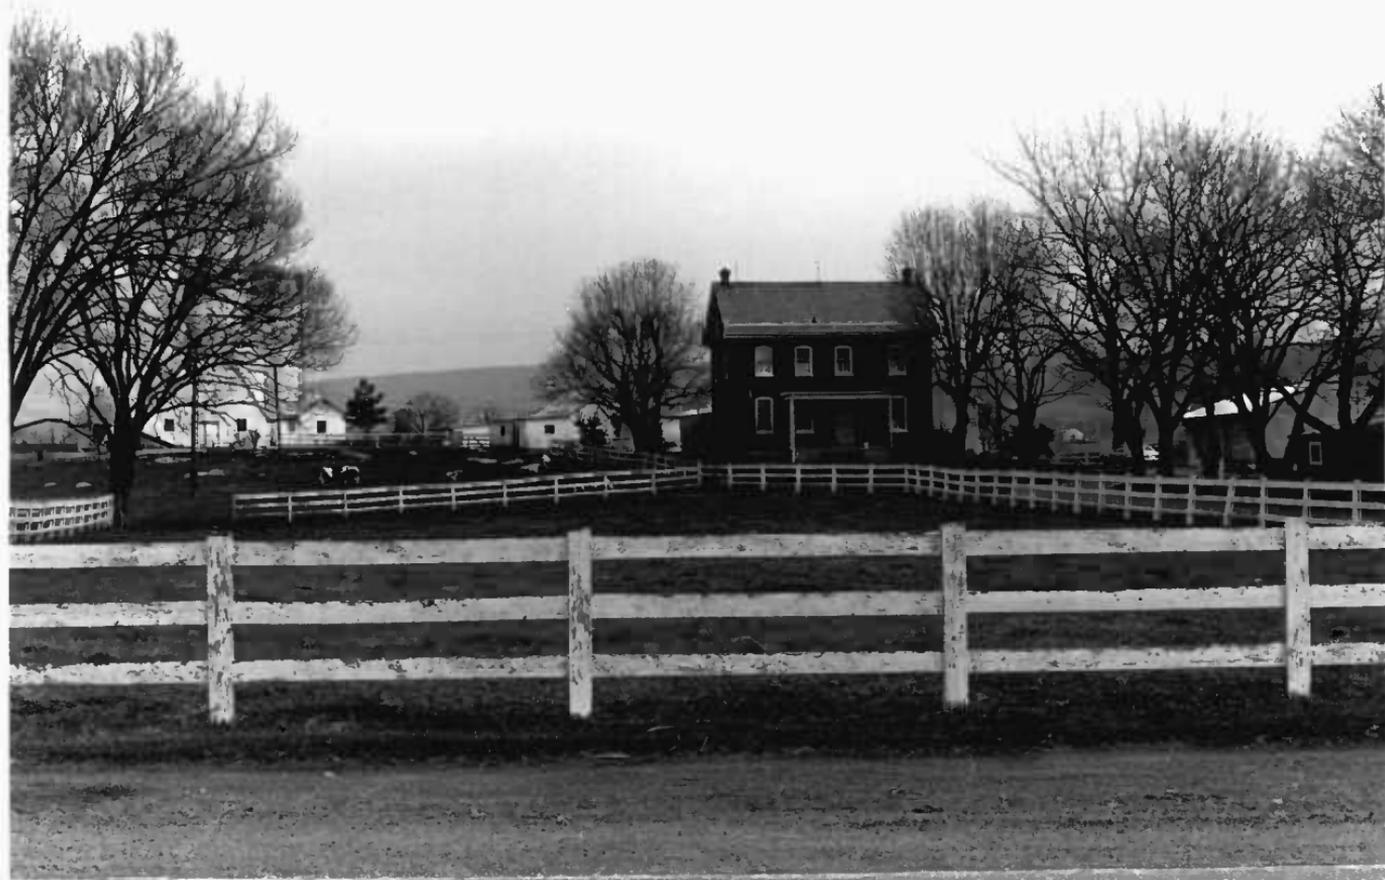
1. Brick Farmhouse WA-II-488
2. Washington County, Maryland
3. Joe Getty
4. May 1983
5. Maryland Hist. Trust, Annapolis, Md.
6. West elevation; camera facing east
7. 1/1
