**MARYLAND HISTORICAL TRUST  
NR-ELIGIBILITY REVIEW FORM**

Property Name: 1 South Main Street Inventory Number: WA-II-769

Project: Boonsboro Streetscape - WA960A21 Agency: Maryland State Highway Administration

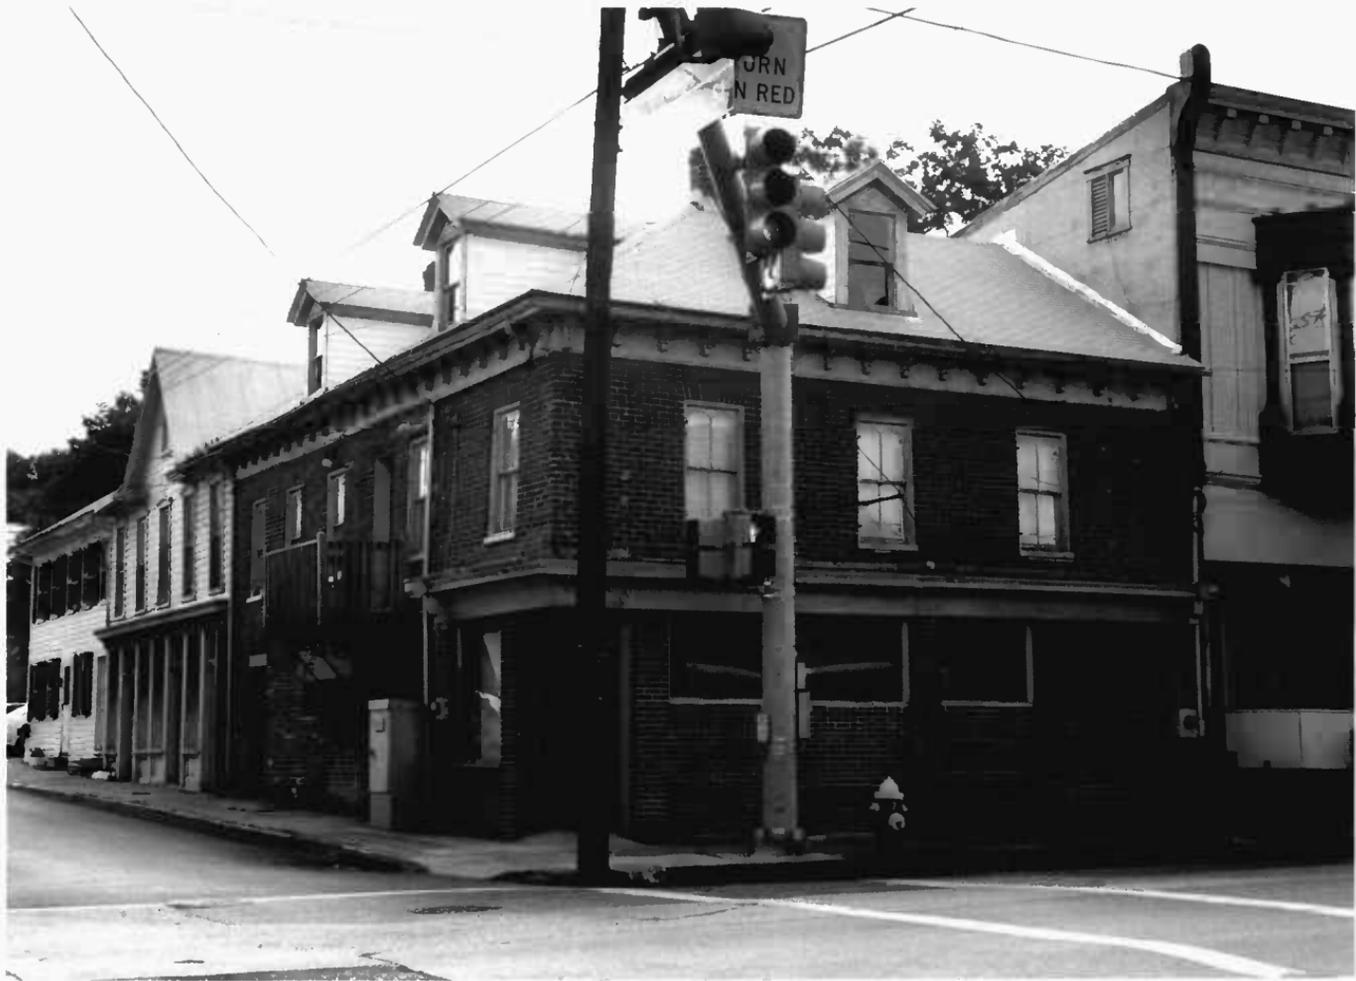
WA-11-769

looking SE, main building

No. 1 South Main Street is a two-and-one-half-story, three-bay-wide by six-bay-deep, attached, brick, corner commercial building. The brickwork is laid in a six-course American bond. The first floor has been remodeled with modern brickwork, small plate glass windows and a corner entrance. The hip roofline includes gable dormers on the north and west elevations and an interior chimney. The cornice features brackets; there is also a cornice above the first floor. The second floor has 2/2 wood sash windows surmounted by brick jack arches. The upper panes are segmentally arched. As an example of the late-nineteenth-century commercial style of architecture in Boonsboro, this building is a contributing resource to the Town of Boonsboro Historic District.

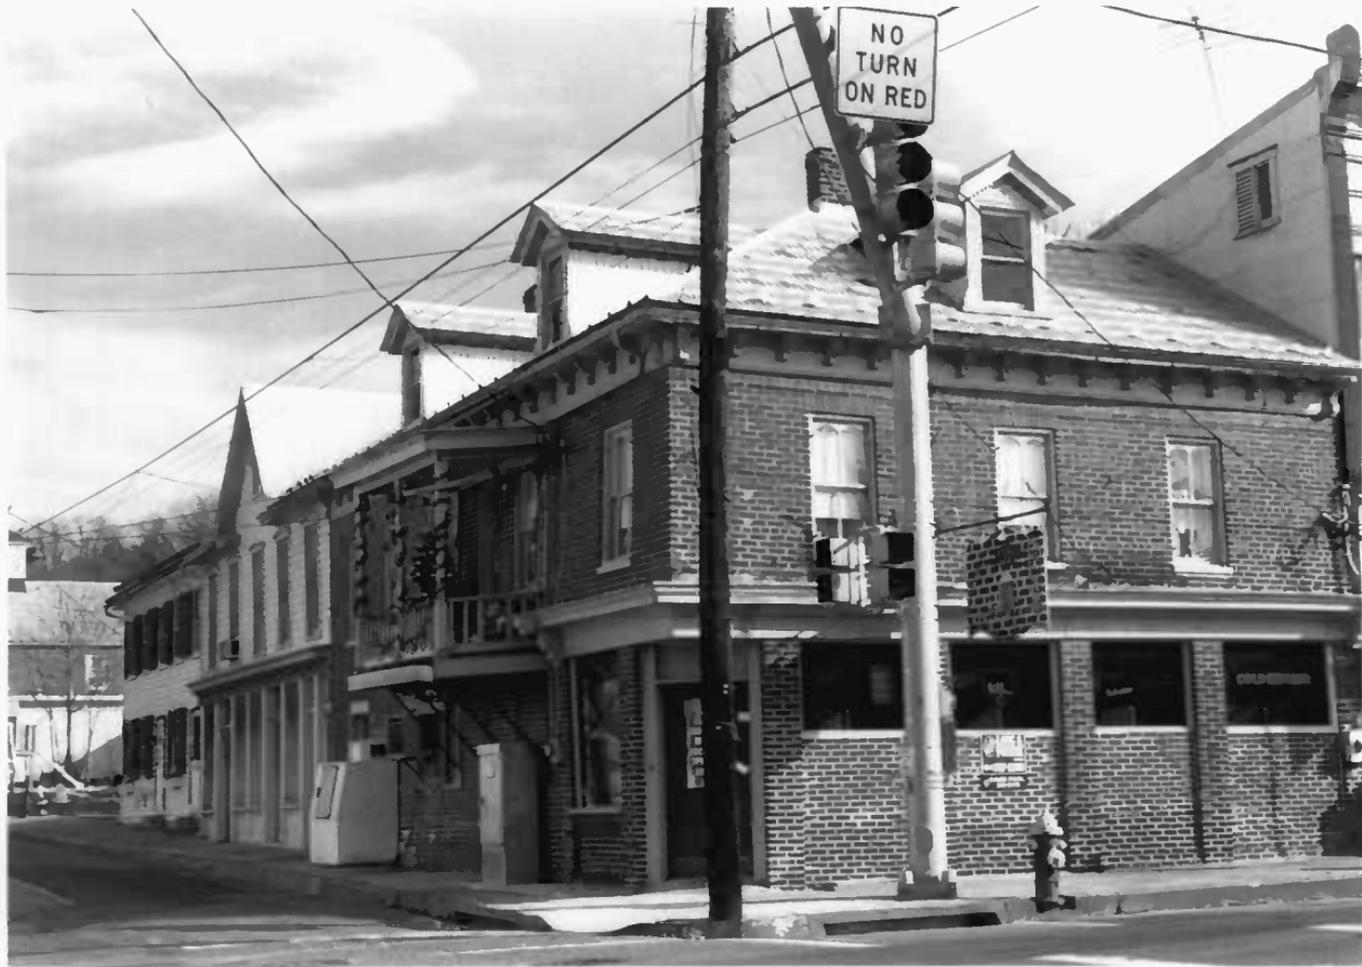
WA II-169

LOOKING SE

1 South Main Street is a west-facing, horizontally massed, two-and-a-half-story, three-bay, brick, attached, residential and commercial structure. The building is set directly at the public-right-of-way at the southeast corner of Main and St. Paul Streets. The brick is laid in a common bond and has been sandblasted. The roof is hipped and is sheathed with tin. There are two dormers facing St. Paul Street and one chimney. The projecting eaves are supported by brackets. The building has undergone extensive alterations on the first floor: all of the storefront windows have been partially bricked in such that there is no view into the building. A door has been cut into the corner of the structure. Windows consist of double-hung, two-over-two sash on the second floor and one-over-one sash in the dormers. The upper panes of the second floor windows are arched. There is an open balcony on the second floor of the building, facing St. Paul Street.
