**MARYLAND HISTORICAL TRUST
DETERMINATION OF ELIGIBILITY FORM**

Property Name: Kretsinger Farm Inventory Number: WA-IV-049
 Address: 13654 Kretsinger Road City: Smithsburg Zip Code: 21783-1214
 County: Washington USGS Topographic Map: Smithsburg, MD-PA
 Owner: Lewis W. Persons, et al. Is the property being evaluated a district? ___yes
 Tax Parcel Number: 77 Tax Map Number: 27 Tax Account ID Number: 14-005404
 Project: Ringgold Wireless Facility Agency: FCC
 Site visit by MHT Staff: X no ___yes Name: _____ Date: _____
 Is the property located within a historic district? ___yes ___no

Continuation Sheet No. 1

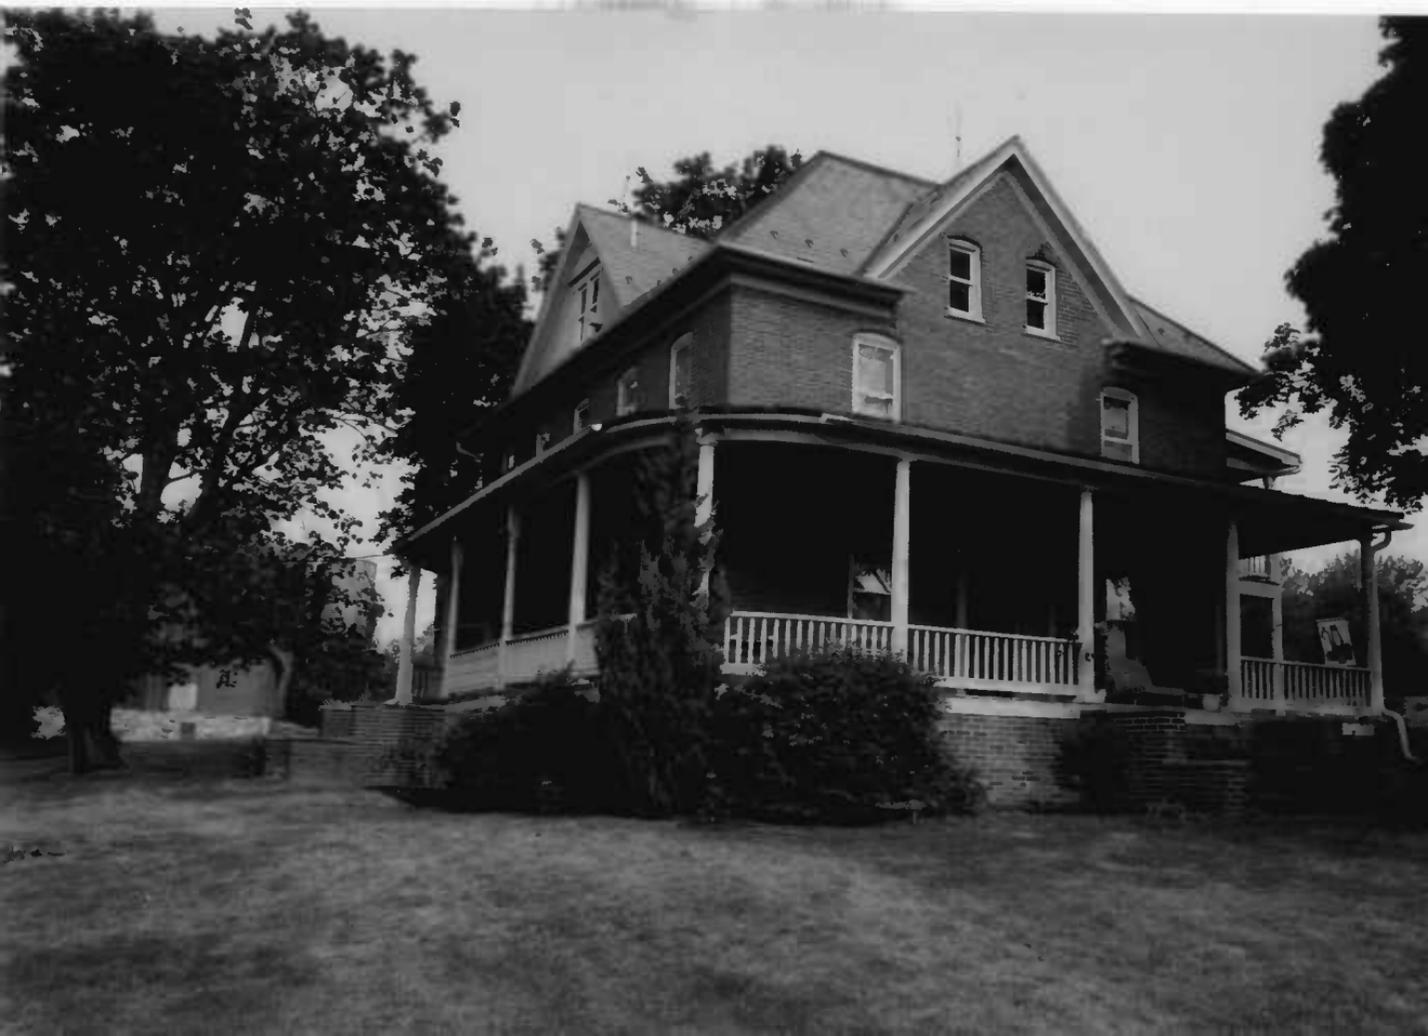
#116

The house at this historic property is a square-plan 2.5-story brick Colonial Revival building constructed on a brick foundation. The house faces the southeast and its main entrance is in the southeast façade. The building measures 3x5 bays and has a wrap-around porch supported by Tuscan columns infilled by a wood balustrade. There is a 2-story side (north) addition and porch. There is one interior brick chimney in the rear (west). The building's exterior is brick laid in a common bond. The front door has a fanlight and sidelights. Windows are 1/1 double-hung sash (metal) in segmental arch surrounds with wood sills. The building is capped by a slate hipped roof with cross gables and lightning rods.

House : view to NW

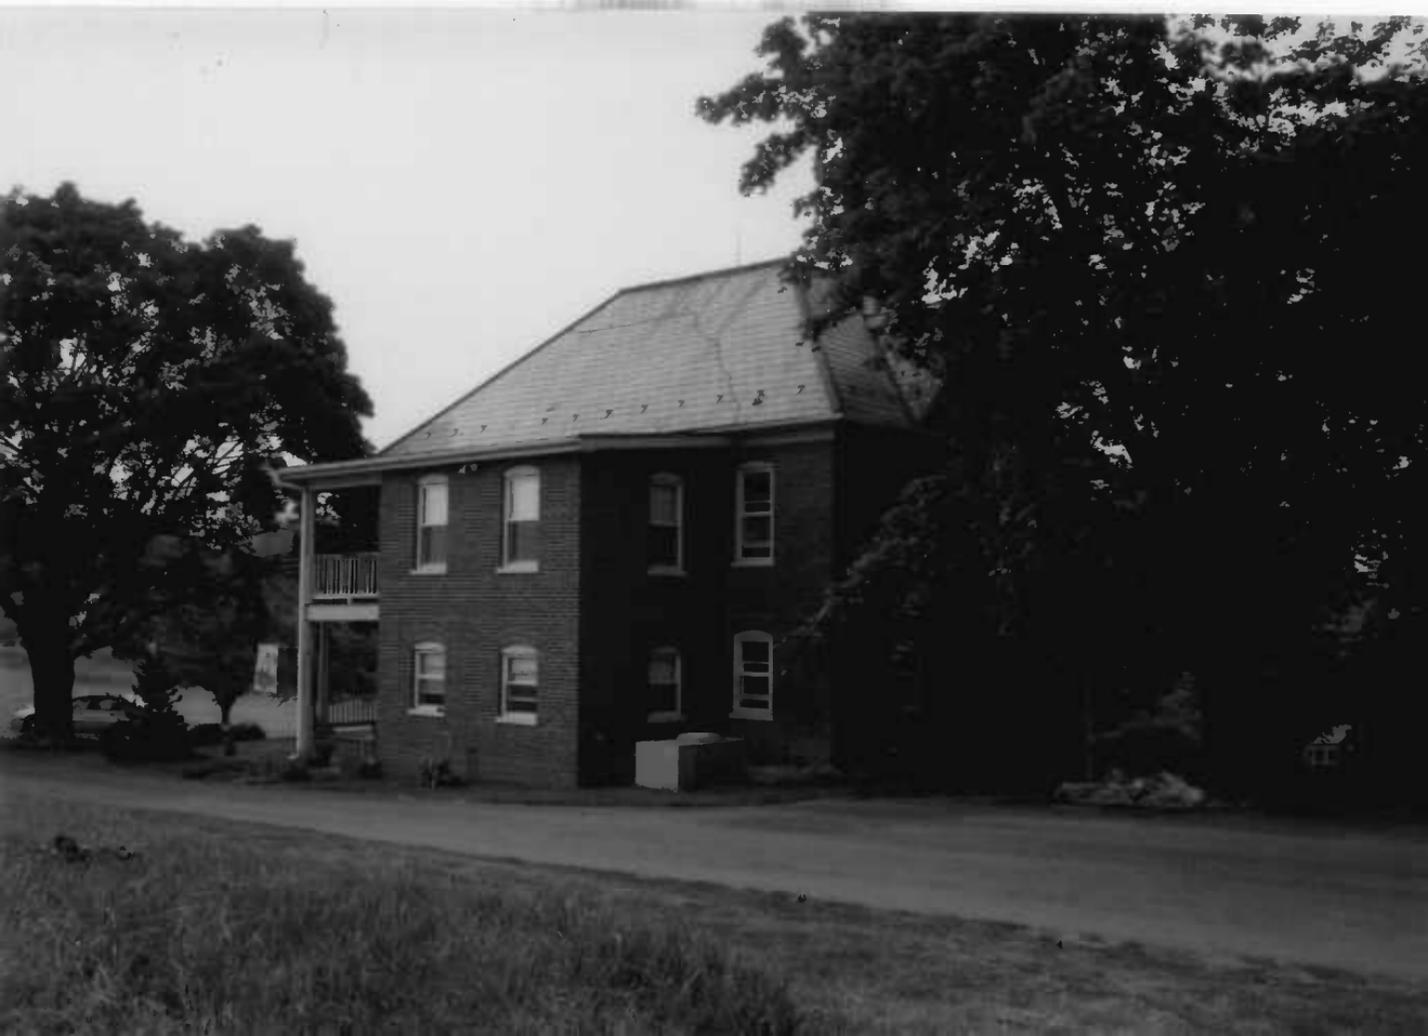
2/6

House (rear) North
facade. View to
South

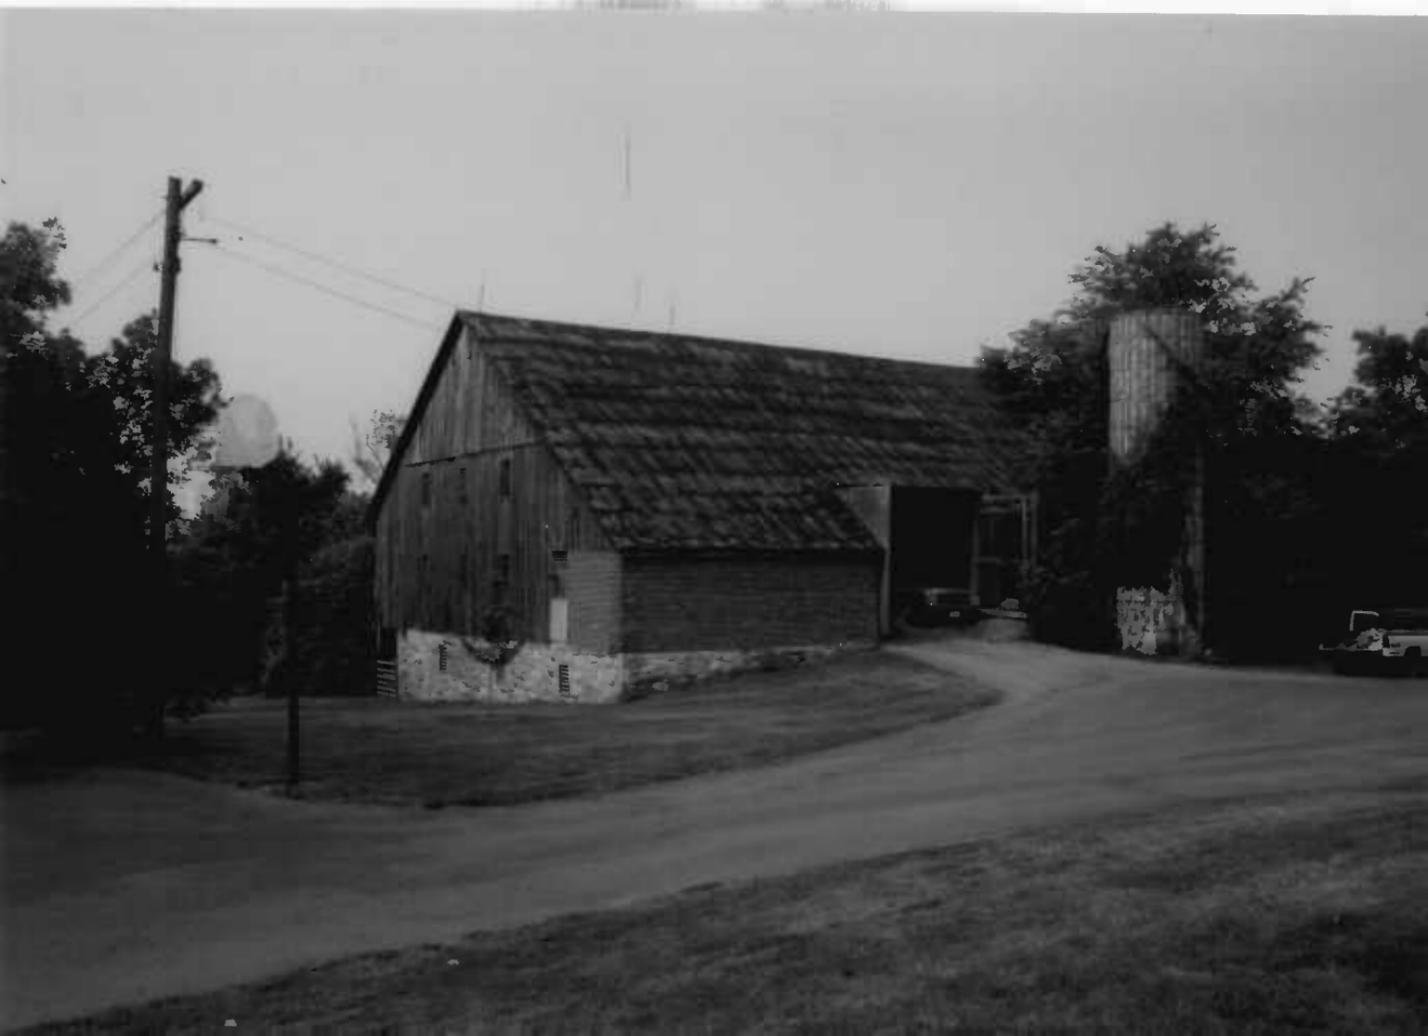
#314

The barn is located west of the house and is a posted forebay standard banked barn with a detached silo. The barn is constructed on a stone rubble foundation and is clad by vertical wood siding; the roof is clad by standing seam metal. There are louvered vents in the gable end walls.

Barn view to

South

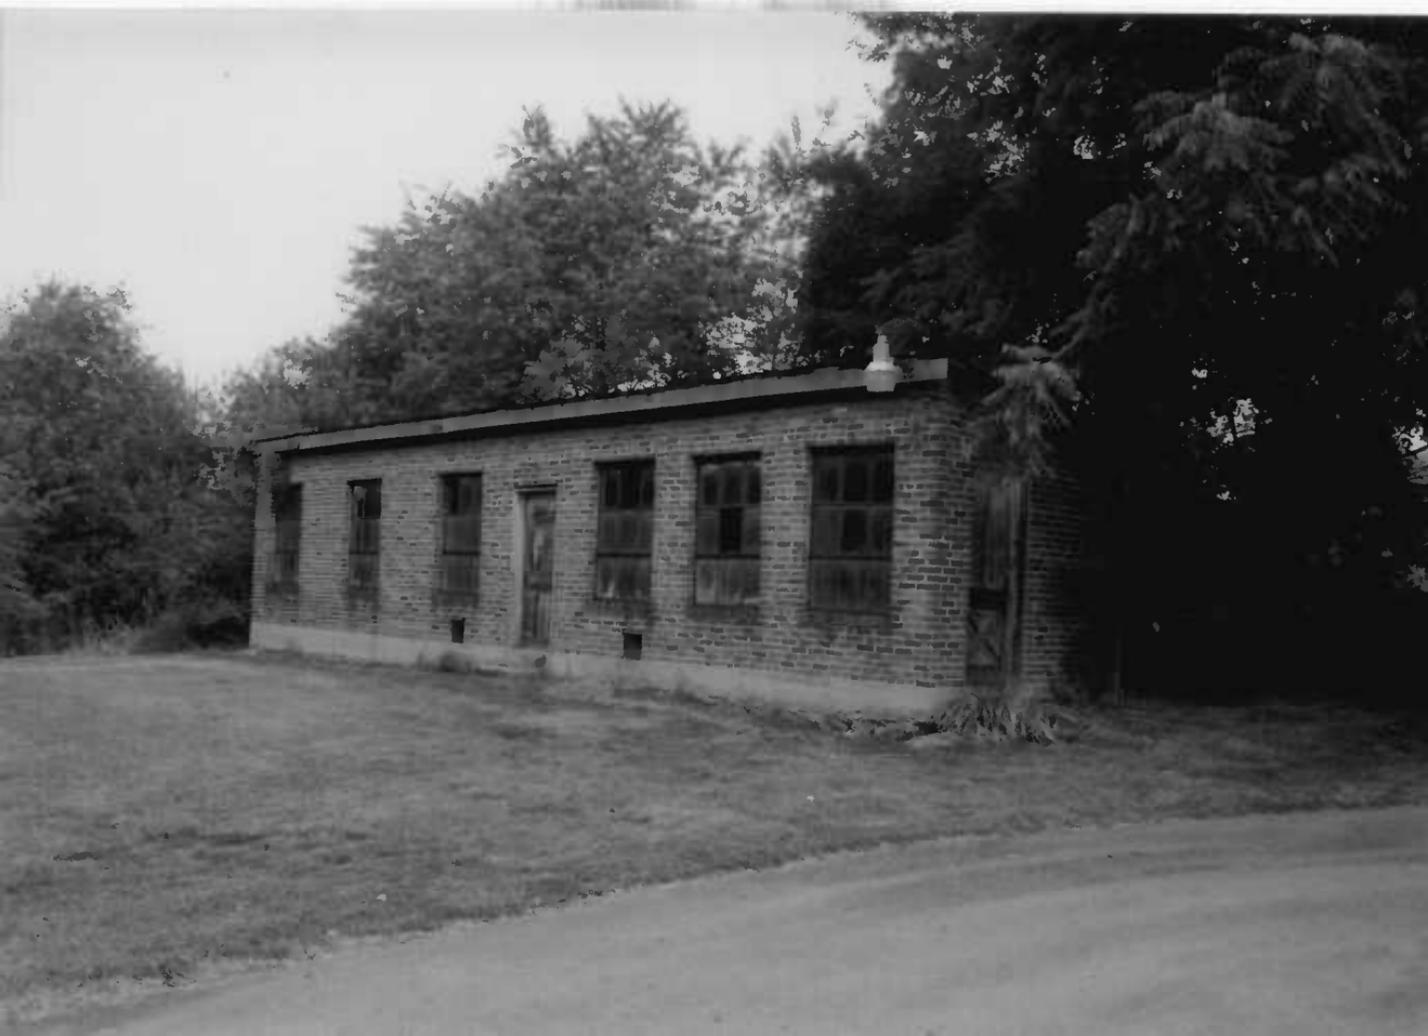
116

This rectangular brick building, constructed on concrete foundation has a symmetrical five-bay façade (west), a shed roof, and fixed nine-light windows.

Agricultural Outbuildings

Views to NW

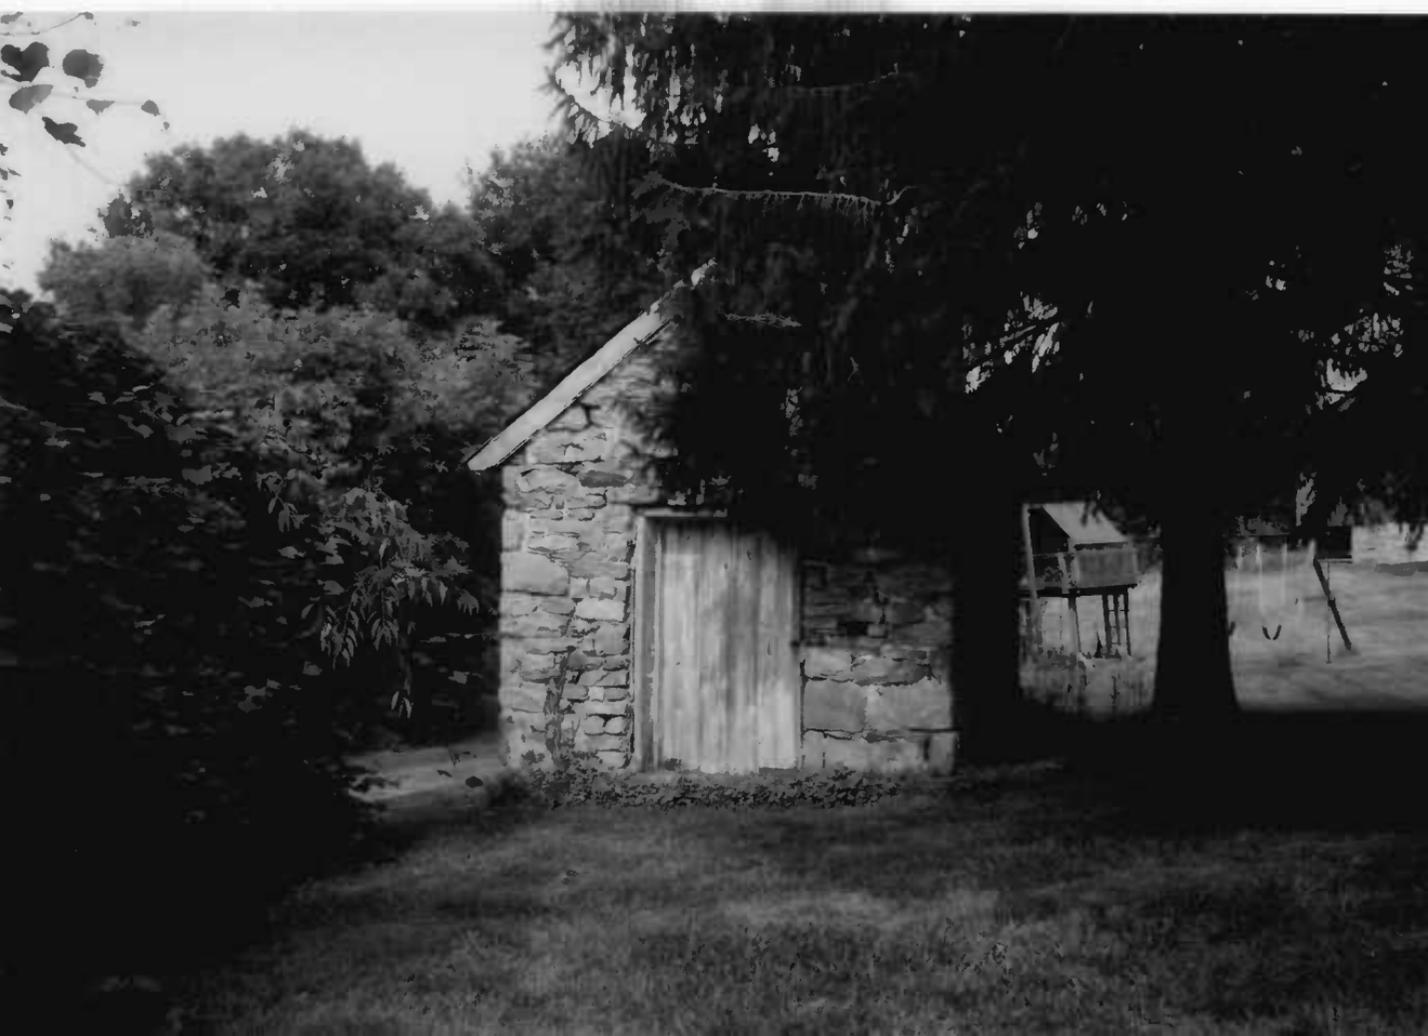
#5/6

The spring house is located south of the house. It is a rectangular building constructed of squared and coursed rubble. The gable front building is oriented east-west and there is a single door in the east façade.

Springhouse,
view to West

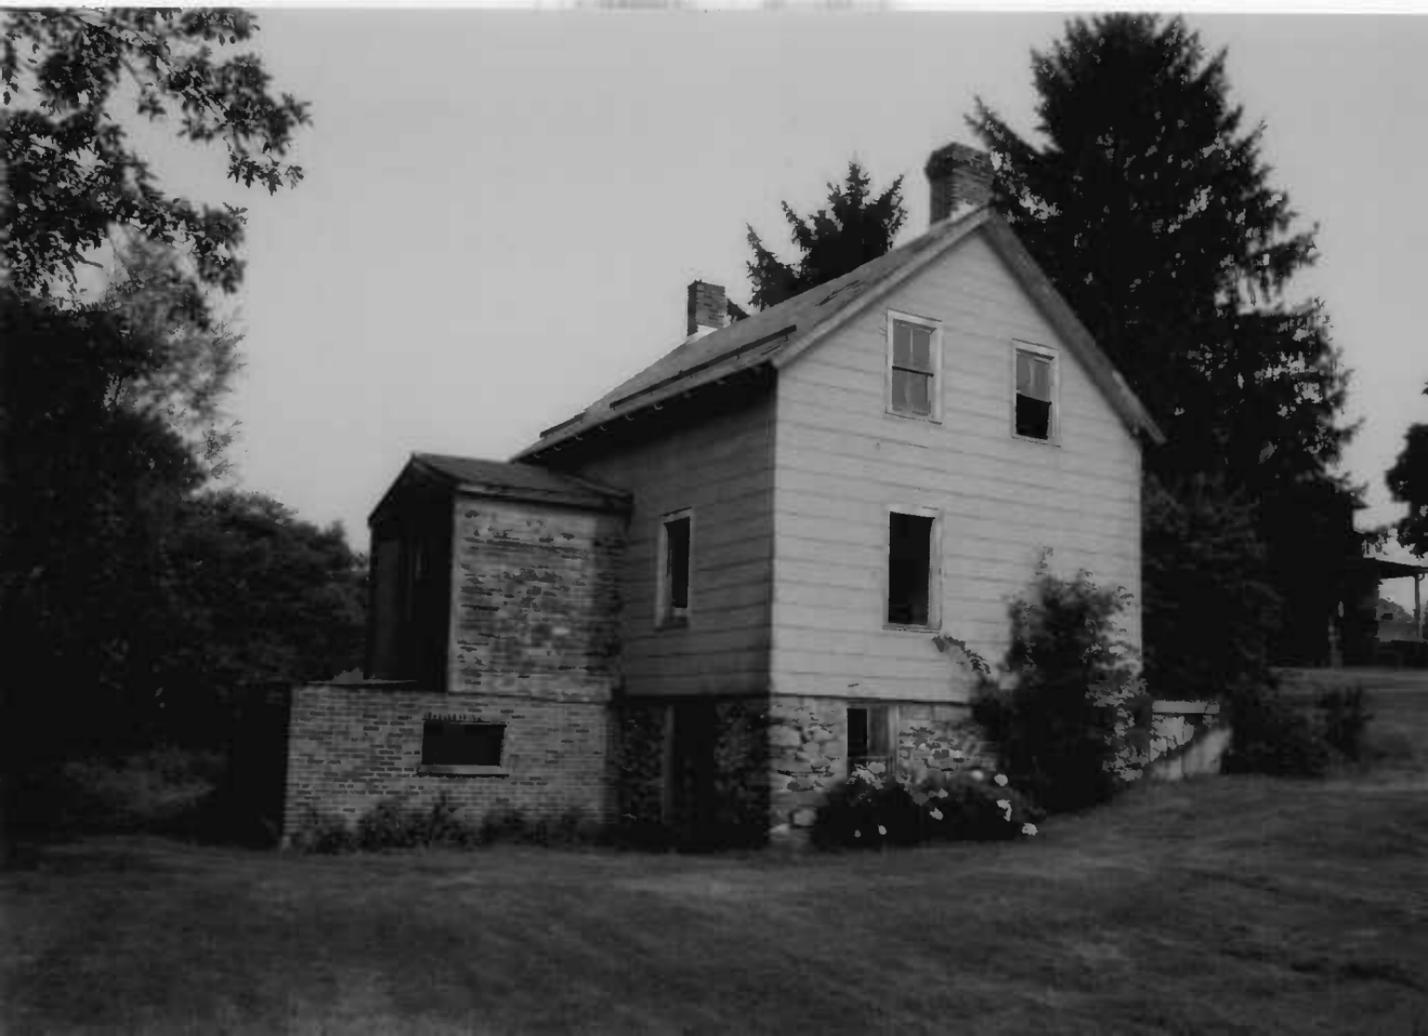
#6/b

This house is located southeast of the spring house and main house. It is a rectangular building constructed on a squared and coursed rubble foundation over what appears to be a continuation of the spring to the west. The original block of this building rises to 2.5 stories and there are several additions to the north and south façades. The original block appears to be a frame building clad first by clapboard siding and later by asbestos shingles. The remaining windows in this deteriorated building are 2/2 double-hung wood sash windows. There are two gable end interior brick chimneys. The roof is clad by composition shingles and there are wood snow guards at the base of the roof slope.

Abandoned house,
view to NW

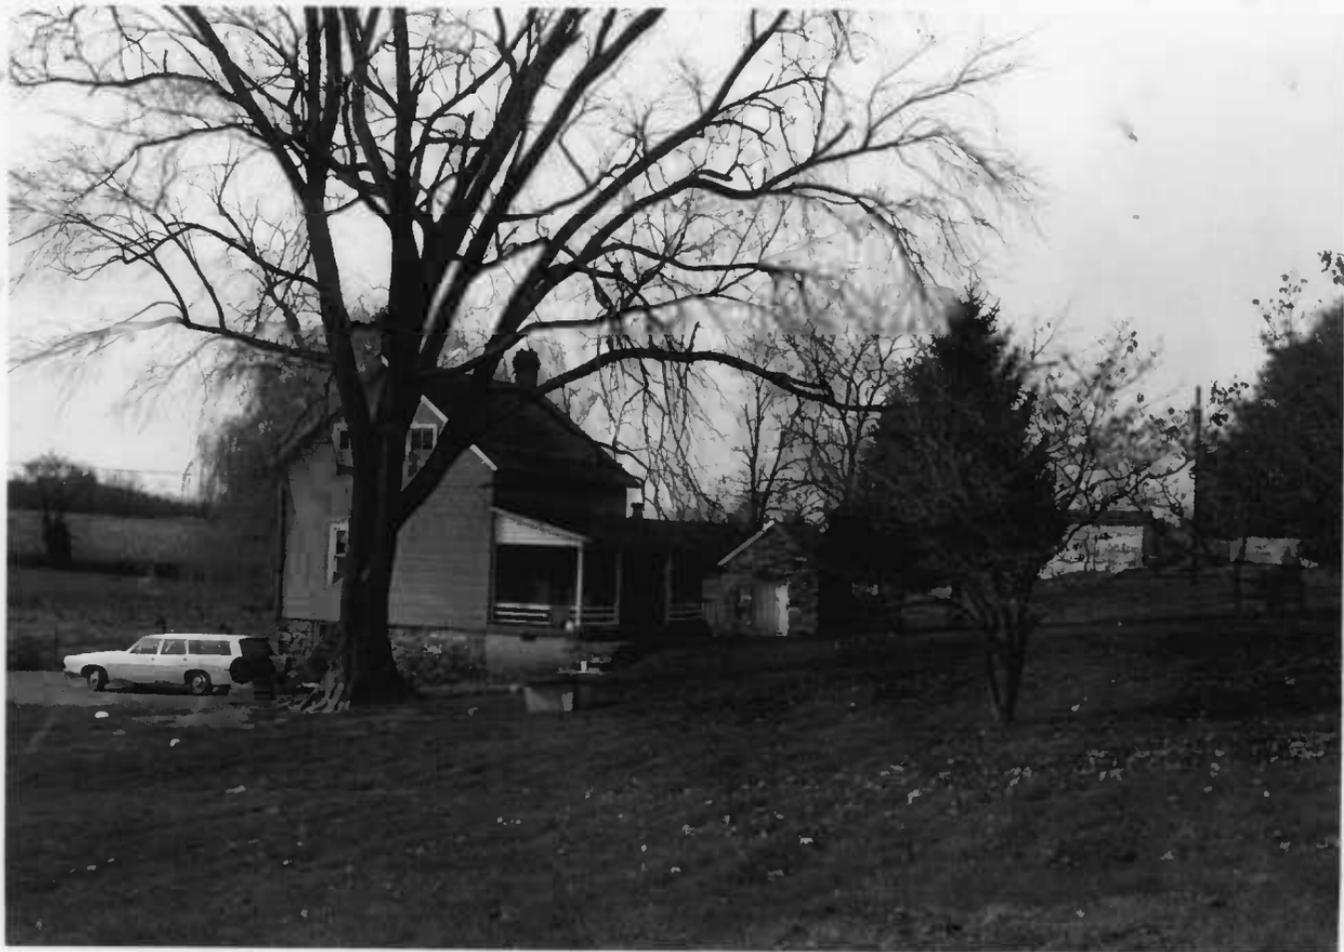
WA-TV-0449

This small farm includes an early 20th century brick house with a hipped roof interrupted by cross gables. All windows and doors have segmentally arched heads. Near the house is a secondary dwelling, a small one and a half story, two bay structure built over a spring. Sheathed with asbestos shingles, it may be either of log or timber frame construction. A frame bank barn is also present.

N.E.

Kretsinger Farm

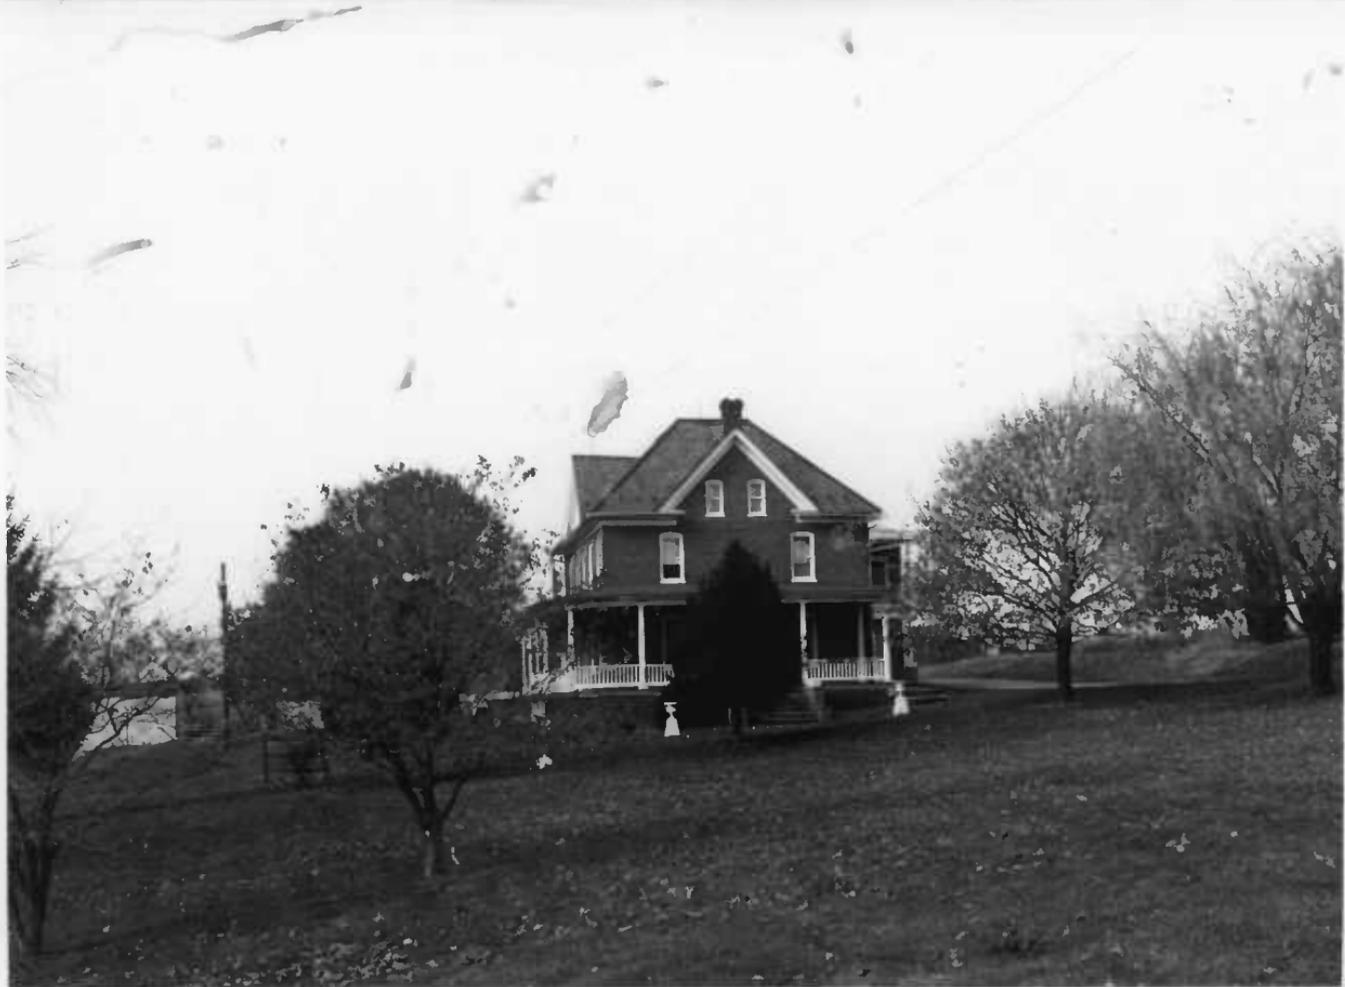
WA-TV-049

E.

Kretsinger Farm
