NOMINATION FORM
for the
NATIONAL REGISTER OF HISTORIC PLACES, NATIONAL PARKS SERVICE

1. NAME				
COMMON:				
AND/OR HISTORIC:				
2. LOCATION				
STREET AND NUMBER: one mile south of Clear Spring, 1/4 mile west of Clear Route 1, Spring-Big Spring Road				
CITY OR TOWN: Clear Spring				
STATE Maryland		COUNTY: Washington

WA-II-036

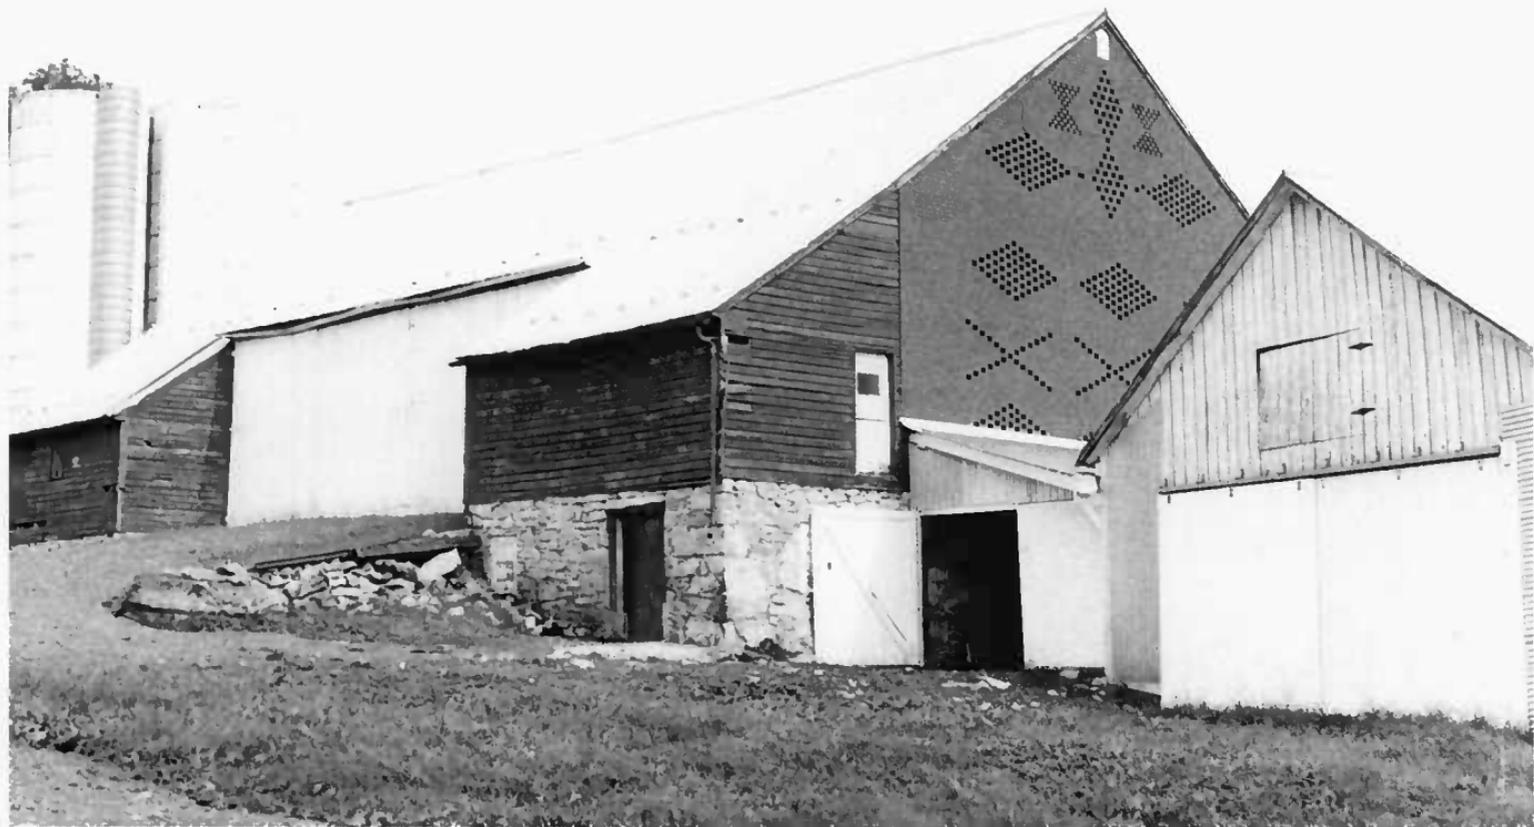
The barn on this property is also significant as an example of the famous brick end structures with lattice work ventilators which are found chiefly in the small geographic area of western Maryland and south central Pennsylvania. They are not only unusual, but are an attractive combination of artistry and function.

BARN, W.
