WA-V-210
Indian Springs Wildlife
Management Area

INVENTORY FORM FOR STATE HISTORIC SITES SURVEY

and/or common GREENVILLE LOG HOUSE

Greenville Log House

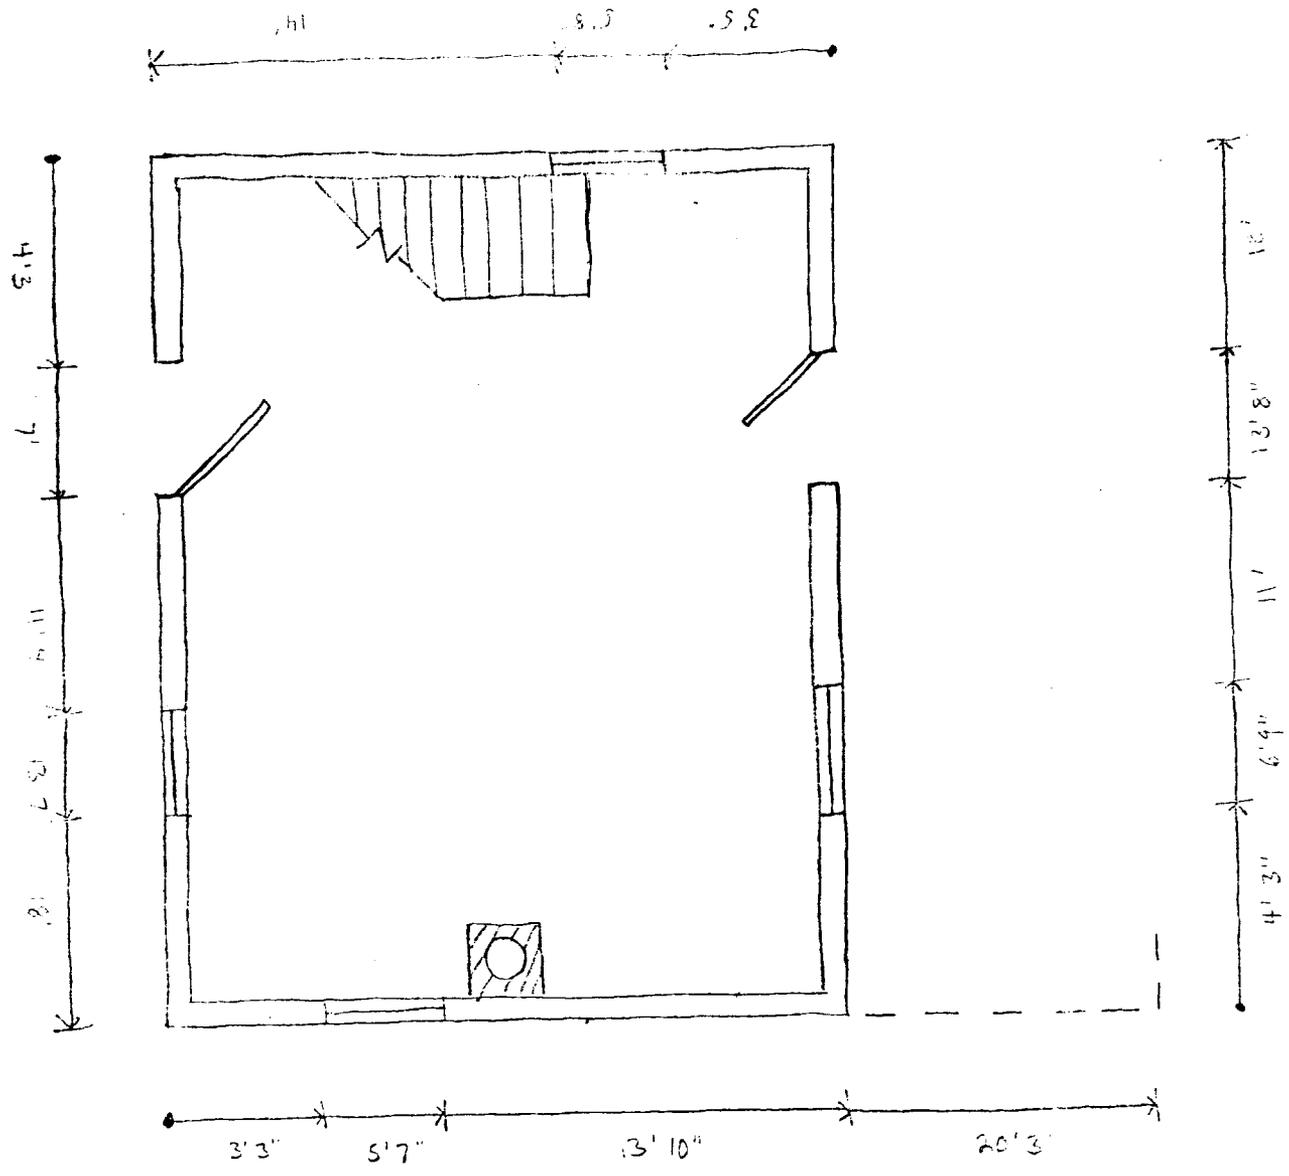
FIRST STORY

The interior plan has one room on each story with a stairway running along the east gable wall and the stove flue chimney at the west gable wall. There is little ornamentation in the structure. The only retained ornamentation is the board frames of the windows which have a bead on the top edge of the frame in a framing of four-inch boards. The structure has a common rafter roof with the rafters projecting out past the plate forming the roof overhang. It also appears that the handrail on the front porch which has an unusual high position ^{and} ~~is~~ in the chamfered posts are original porch trim.

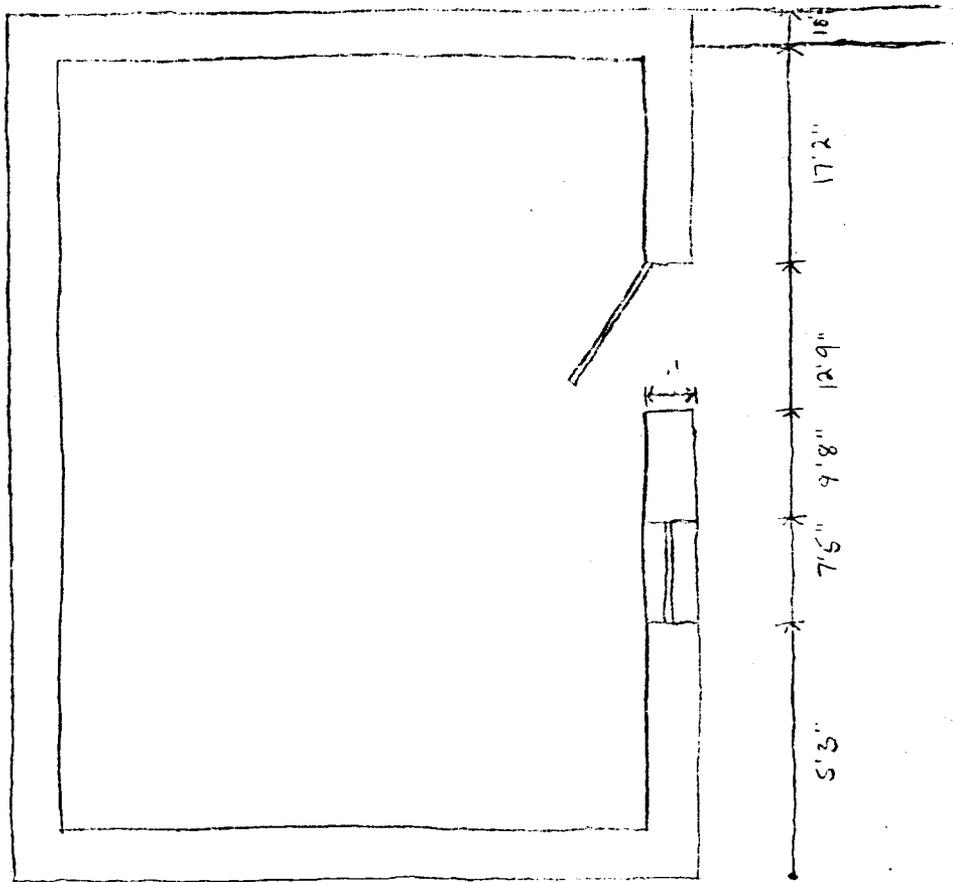
GROUND FLOOR

The main facade has a full ground level story with an entrance in the northernmost bay and a window in the southernmost bay. This entrance includes the bottom tier of a double-tiered porch. The foundation level is whitewashed. Also, there was no interior access between the ground floor and the first story. The first story has a entrance in the northernmost bay and a window in the southernmost bay. The second story has a window in both bays. The doors and windows have plain wood frames and wood sills. All of the doors and windows have been boarded up to prevent vandalism to the structure. The doors are batten tongue-and-groove board construction. The front porch is supported at the foundation level by round logs which support framing for the floor joists. The porch on the first story has squared posts. At the north end of the porch, a stone wall projects out from the foundation to support the first story and the porch. It appears that there were steps up to the porch on this side. The porch is covered with a shed roof covered in corrugated sheet metal. The main roof is also covered in corrugated sheet metal.

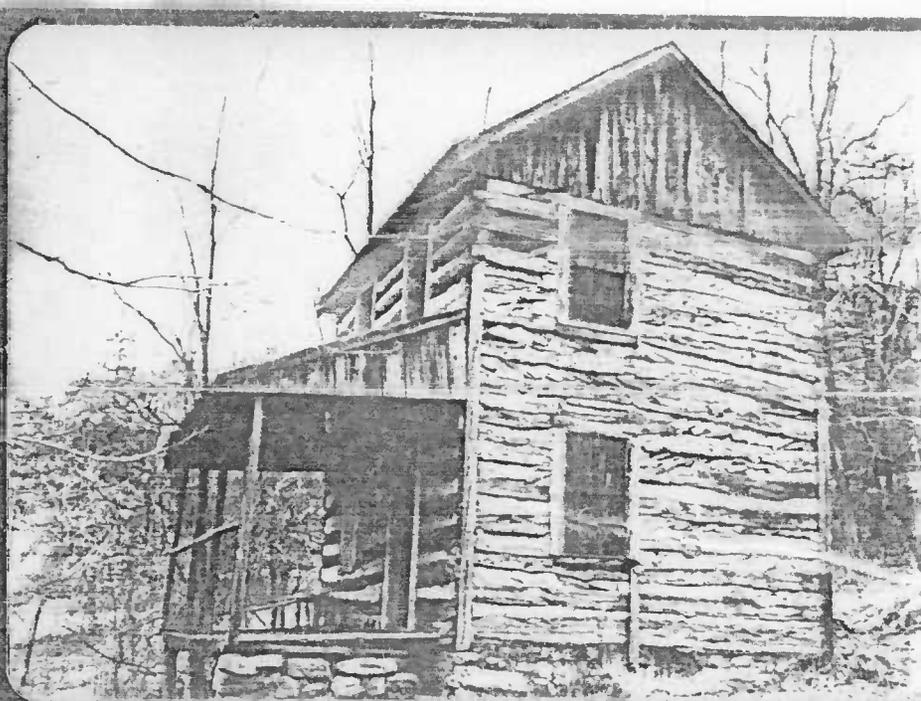
top - east & north facades

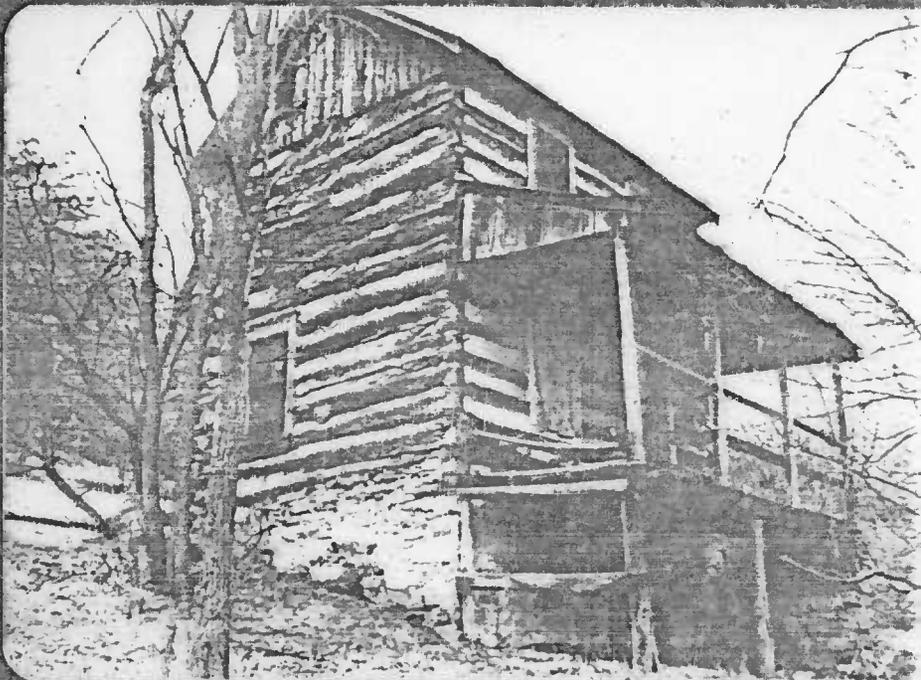
center - east & south facades

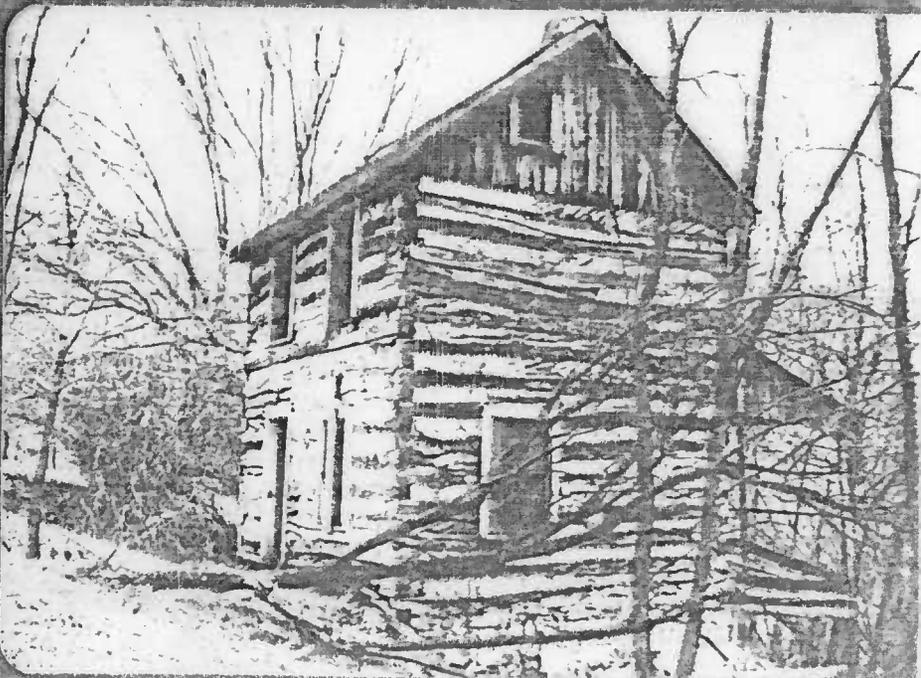
bottom - west & south facades

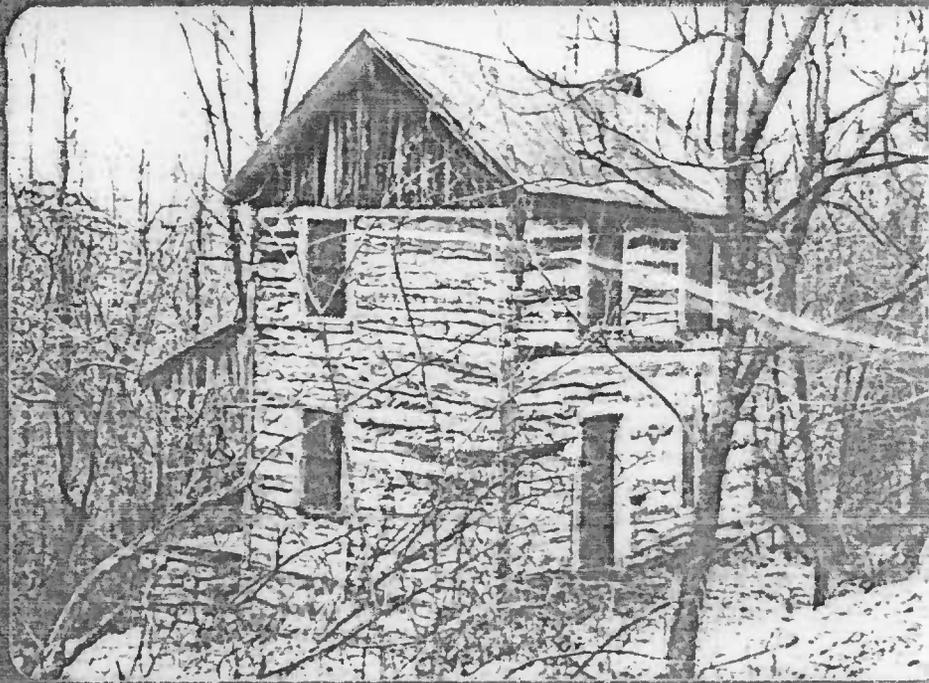
top - north & west facades

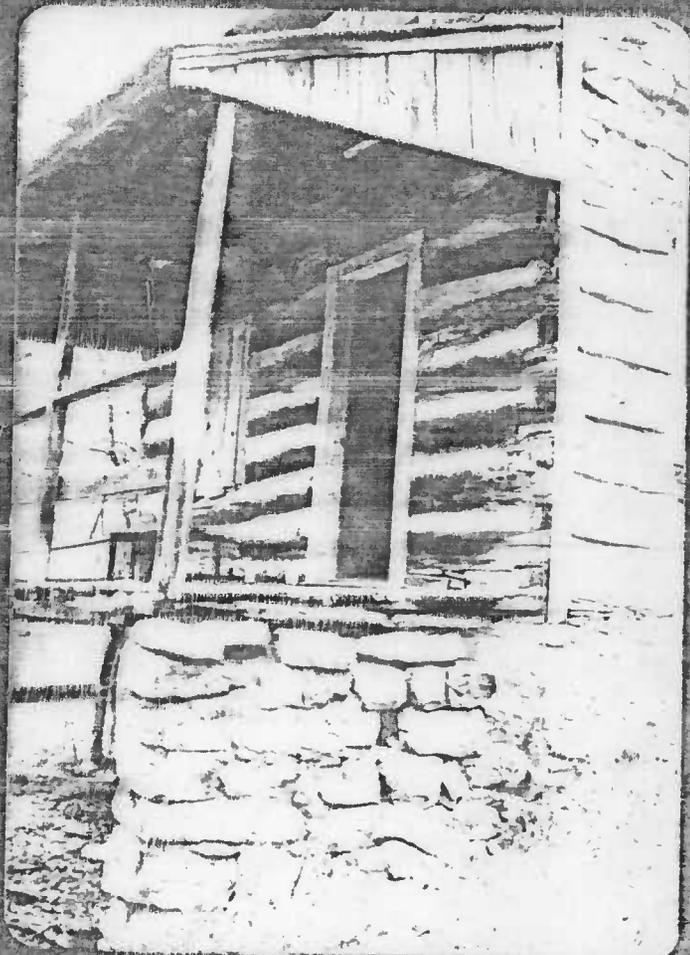
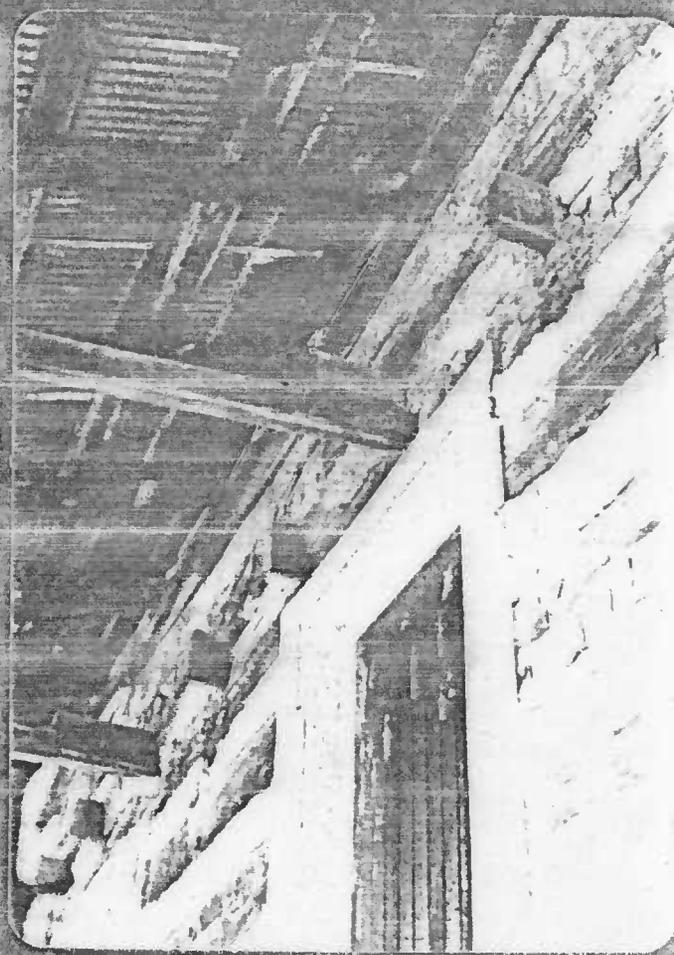
Extending across the front elevation is a one and a half story shed roofed porch supported by chamfered square posts on round wooden posts or pilings. A handrail remains in place along the front of the porch.

WA-V-210 Greeno. He Log House
PORCH DETAILS
top - east side
bot. left - north side
bot. right - roof

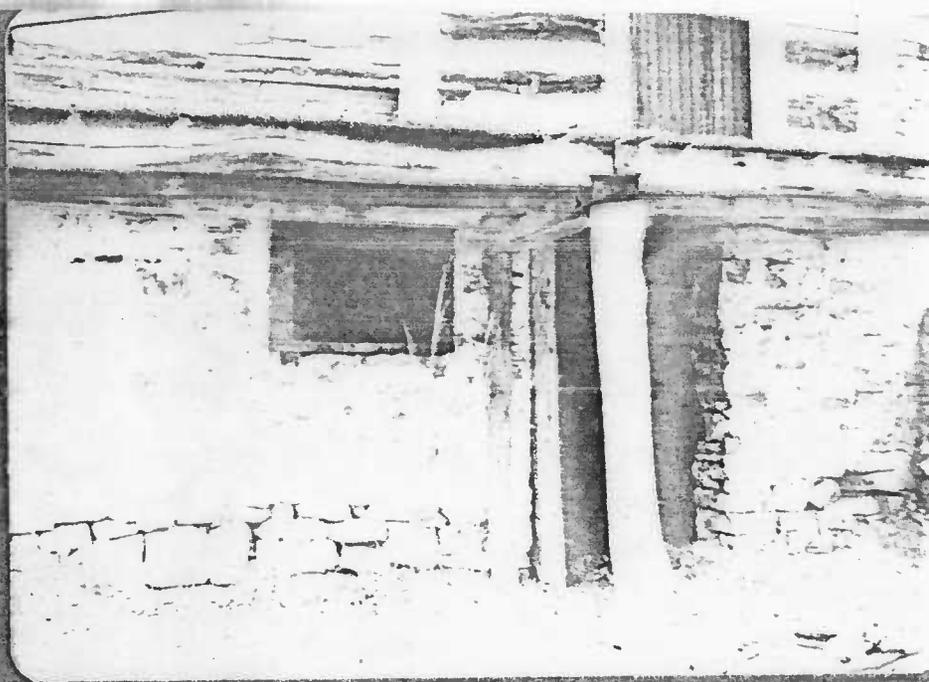
Top - East Facade - Foundation level

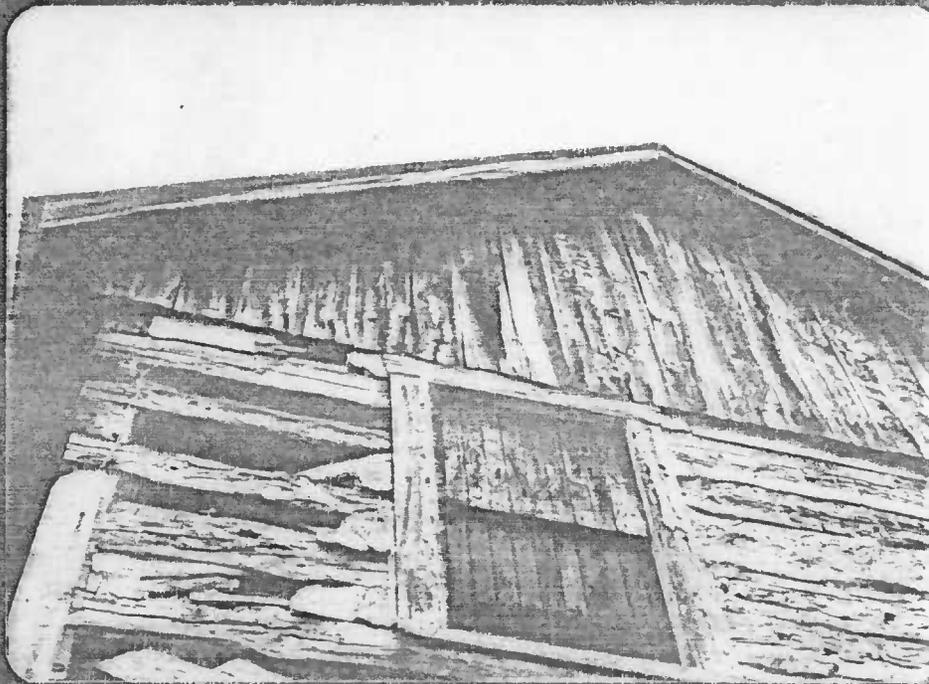
The north gable end has a single window on each story. The south gable end has a window on the first story and a square window in the gable. The gables at both ends are covered in vertical board siding.

Center - North gable

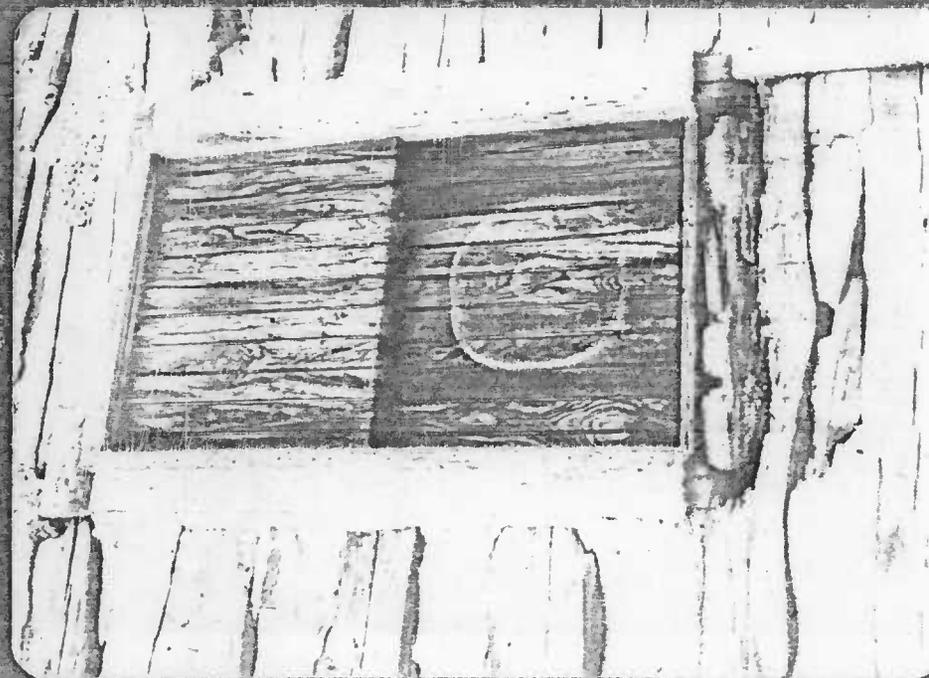
Most windows have been boarded shut and those remaining open retain no sashes. Plain flat architraves trim the openings.

Bottom - Window detail, North facade
