**INDIVIDUAL PROPERTY/DISTRICT  
MARYLAND HISTORICAL TRUST  
INTERNAL NR-ELIGIBILITY REVIEW FORM**

Property/District Name: Dudderar Farm Survey Number: F-7-135

Project: Villages of Urbana Agency: F/COE

# Maryland Historical Trust State Historic Sites Inventory Form

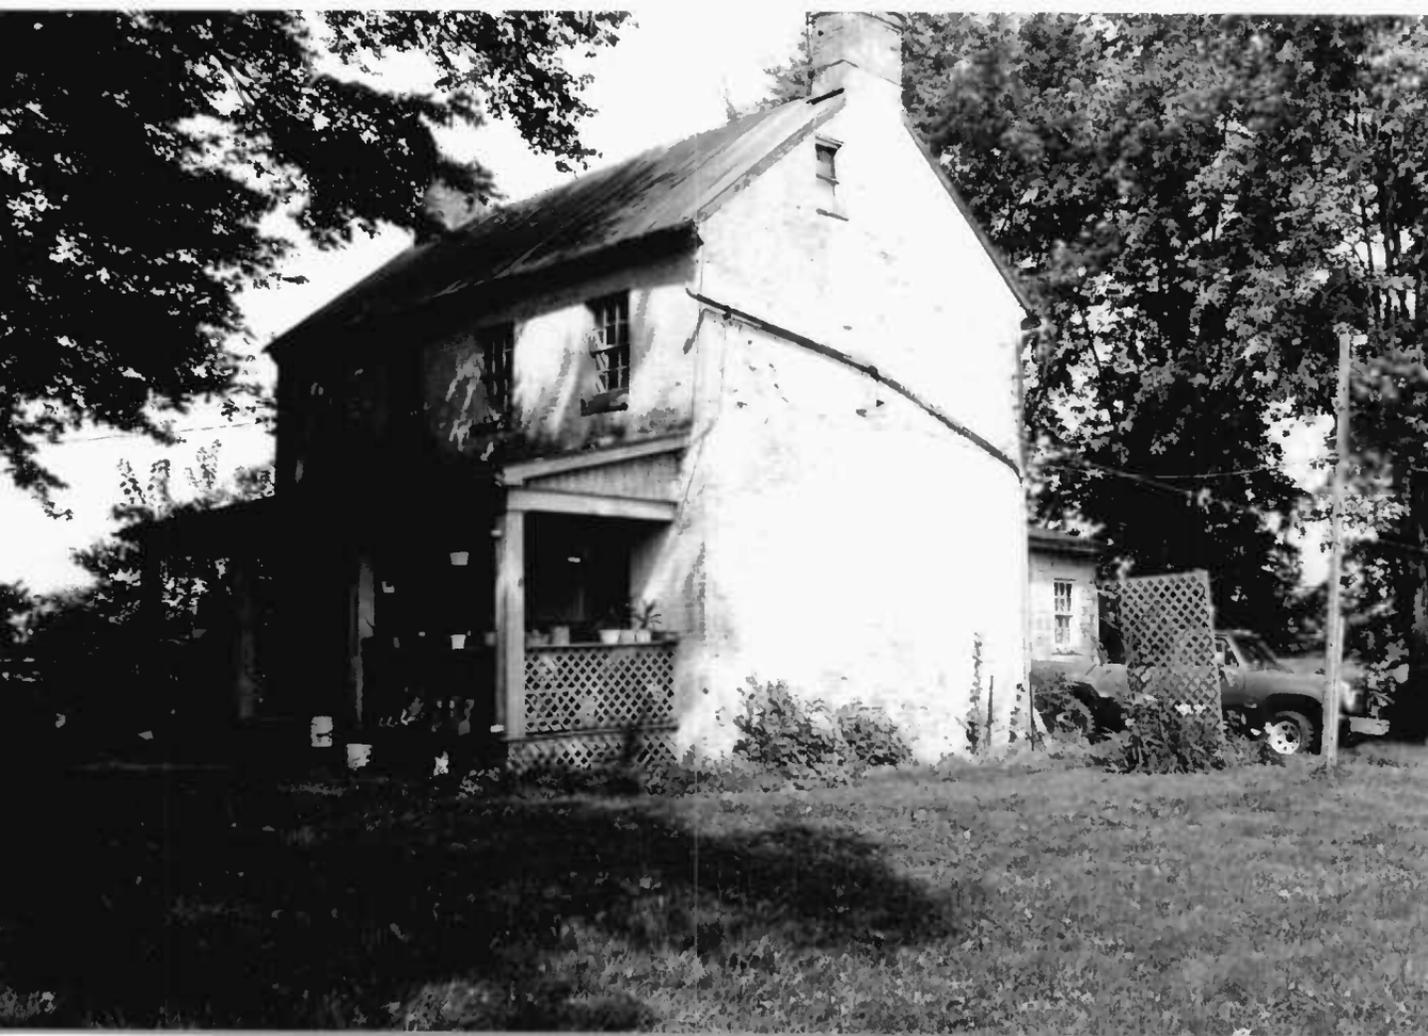
PHOTO 1 OF 11

VIEW NORTHWEST, PRINCIPAL AND SIDE ELEVATIONS  
OF DUDDERLE FARM

The Dudderar Farmhouse is a large, two-story, brick dwelling constructed ca. 1850. The house consists of a main block and rear ell that form an I-shaped footprint. The main block of the house is oriented to the south. The principle block is four bays wide and one room deep. The rear ell, constructed ca. 1875, is connected to the north wall of the main block and extends north. The rear ell is one-bay wide and one room deep. The building incorporates a gable roof over the main block with an intersecting gable roof over the rear ell. A common rafter roofing system was employed for the main block. All rafters are numbered and pinned; the roof does not include a ridge pole. All roof planes are sheathed in standing-seam, metal roofing. The front elevation of the principal block is constructed of brick laid in Flemish bond; side and rear elevations are constructed in five-course common bond. The rear ell is wood-frame sheathed in wood shakes and German siding. The house stands on a coursed, quarried stone foundation. A full basement extends beneath the house.

The principal entrance includes a four paneled door enframed by a simple beaded surround and multi-light transom. The eave line of the front and rear elevations of the main block is marked by a shallow, molded brick cornice. The six-light-over-six-light, double hung, wooden sash windows are original to the structure and are aligned symmetrically. Brick jack arches accent the window bays of the main block. Brick interior-end chimneys with corbelled caps rise from the gable ends of the main block. Small attic windows are located on the south side of each gable end near the roof peak.

A one-story porch spans the primary elevation of the main block. This porch is not original to the building. The shed roof of the porch is clad in standing-seam metal and is supported by four plain boxed columns. The porch floor is constructed of wide wood boards.

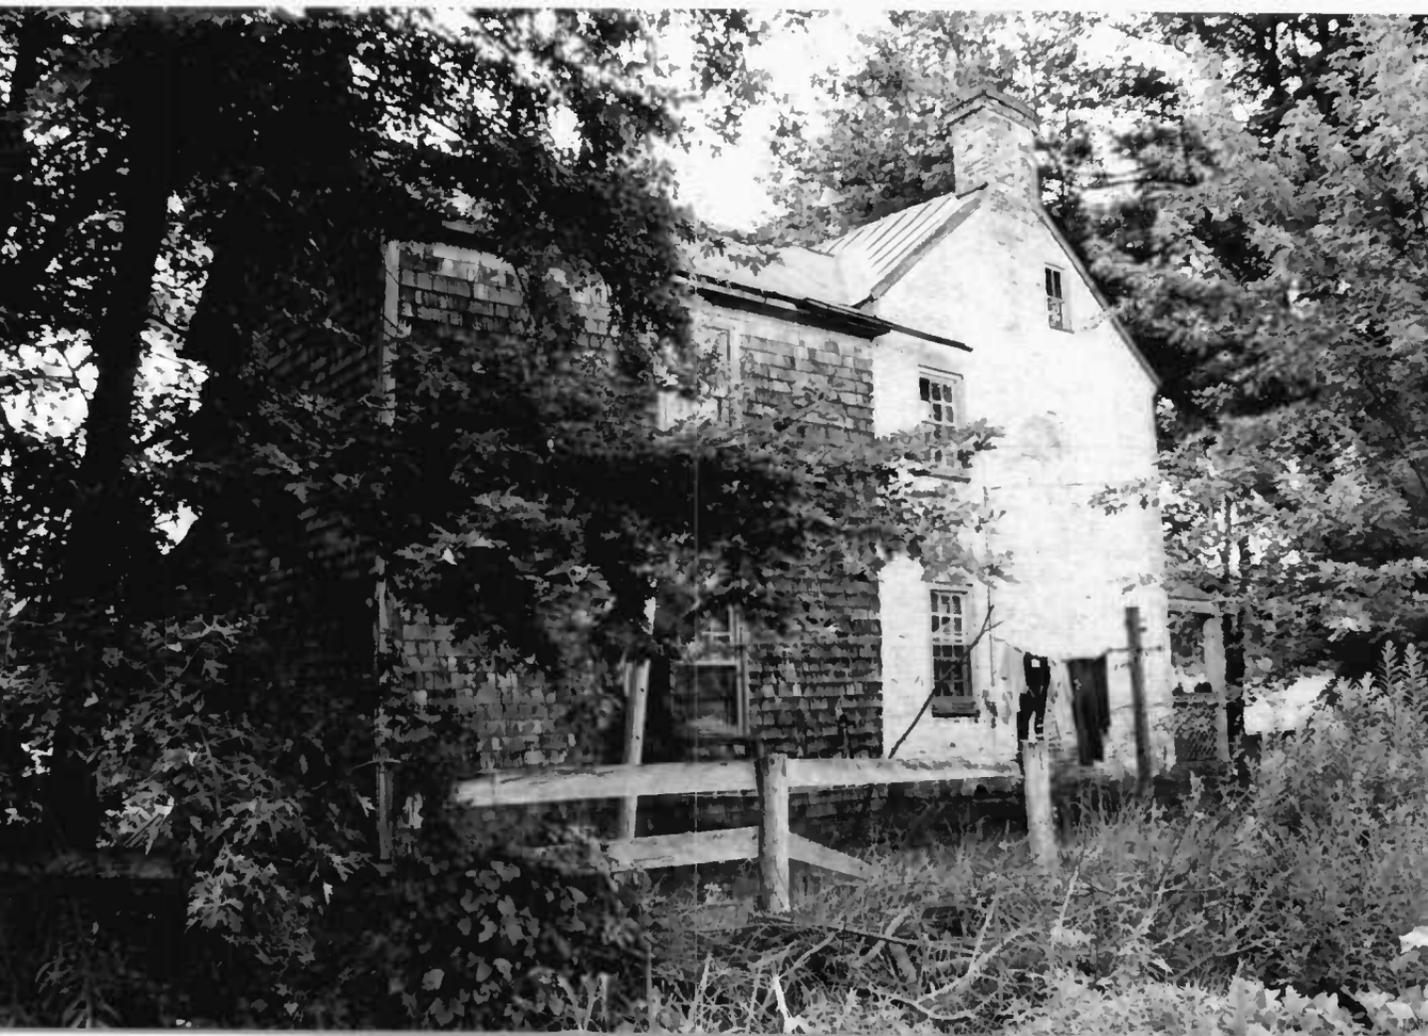
PHOTO 2 OF 11

VIEWS SOUTHEAST, REAR AND SIDE ELEVATIONS OF  
DUDDERAR FARMHOUSE

The two-story, one bay rear ell extends from the west wall of the main block. This addition is wood frame construction sheathed in wood shakes. An interior-end chimney rises from the north elevation. A one-story enclosed porch spans the east elevation of the rear ell. The enclosed porch is four bays wide and is sheathed with German siding.

The first and second levels of the west elevation of the rear ell each exhibit one six-light-over-six light, double-hung, wooden sash windows. The four bay enclosed porch on the east elevation exhibits two, six-light fixed sash windows, a wood-frame screen door, and one six-light-over-six-light, double hung, wooden sash window. The windows of this addition are smaller than the windows of the main block and are not surmounted by jack arches.

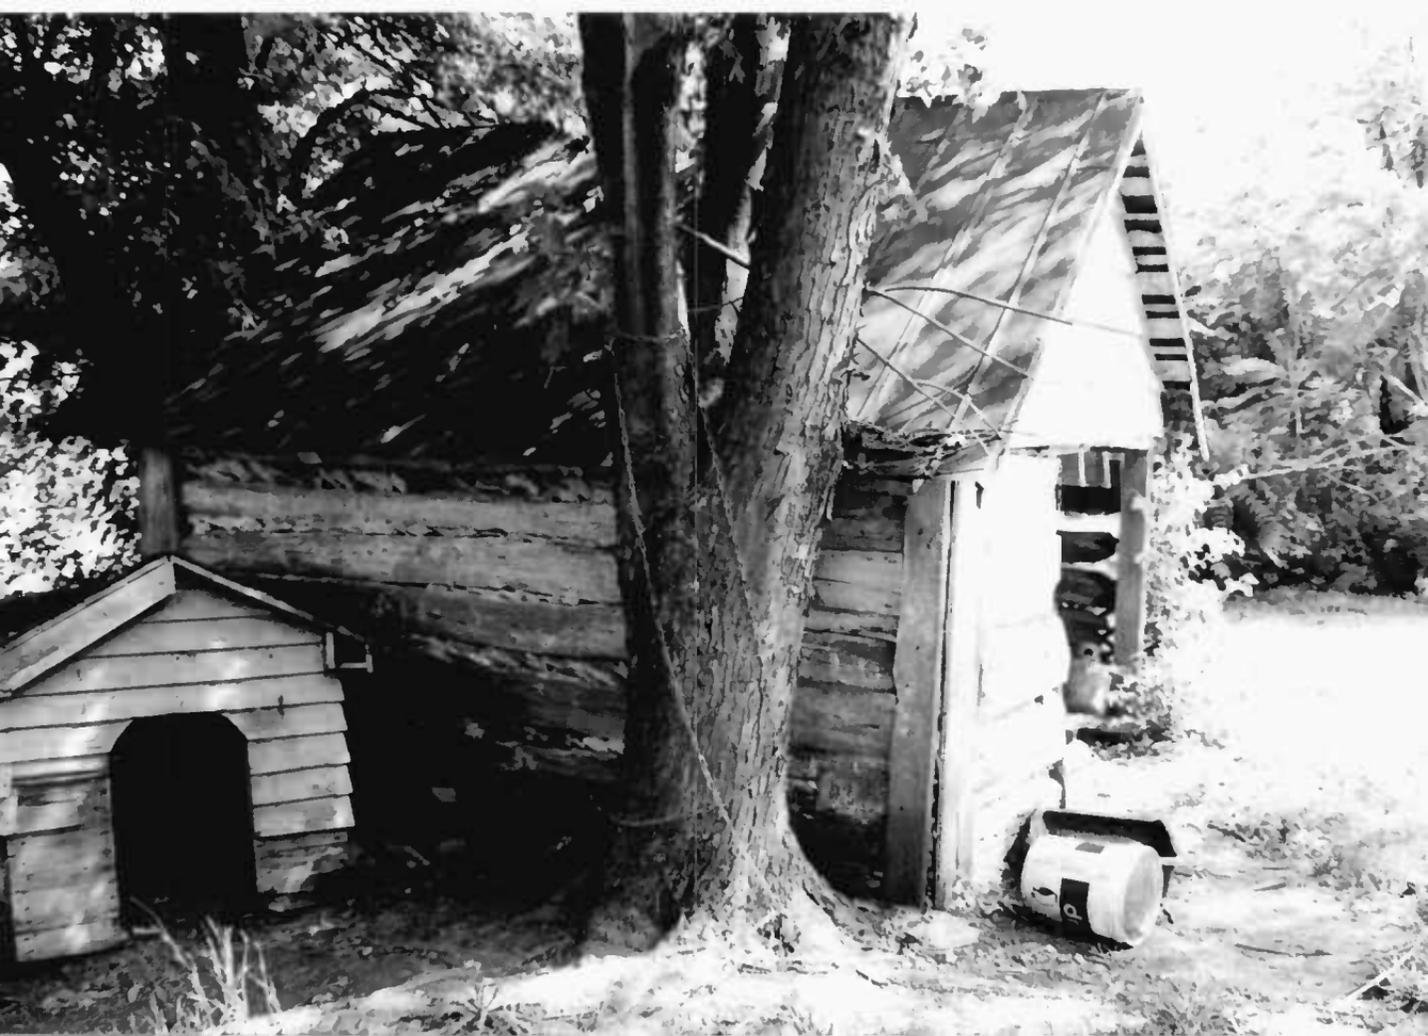
PHOTO 3 OF 11

VIEW NORTHEAST, HAND HEWING LOG SHED (D-2)

A hand-hewn log shed is located approximately fifteen feet northeast of the principal dwelling. The log shed is a rectangular, one-story, one-bay structure. The shed is constructed of rough hewn logs infilled with stone and lime chinking. The front plane of the gable roof is clad with standing seam metal roofing. Circular sawn boards are found in the gable ends. The building rests on a log foundation. The south elevation contains the only opening of the structure: an approximately 4 ft x 4 ft entrance bay.

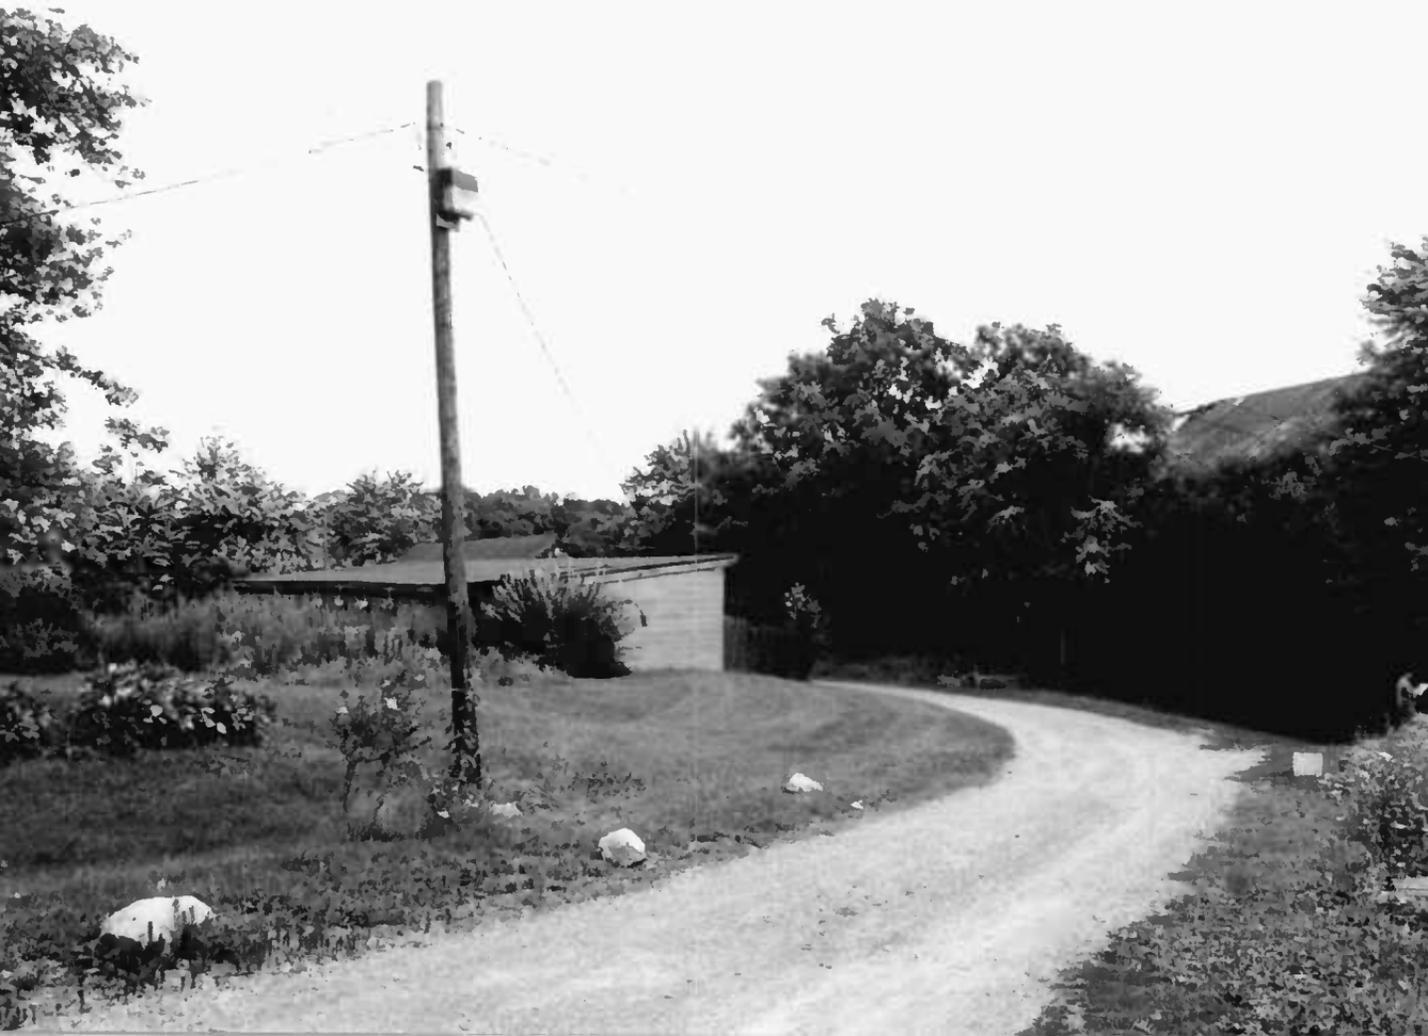
PHOTO 4 OF 11

VIEW NORTHEAST, CONCRETE BLOCK SLIES (D-3)

A concrete-block shed is located to the east of the main house. The shed is a rectangular, one-story, four-bay structure. The building is oriented to the east. Three walls of the building are constructed of concrete-block while the east elevation is open and is supported by three wooden posts. The shed roof is sheathed with corrugated metal. The shed is substantially deteriorated. The roof is missing panels and stress fractures are evident along the rear elevation.

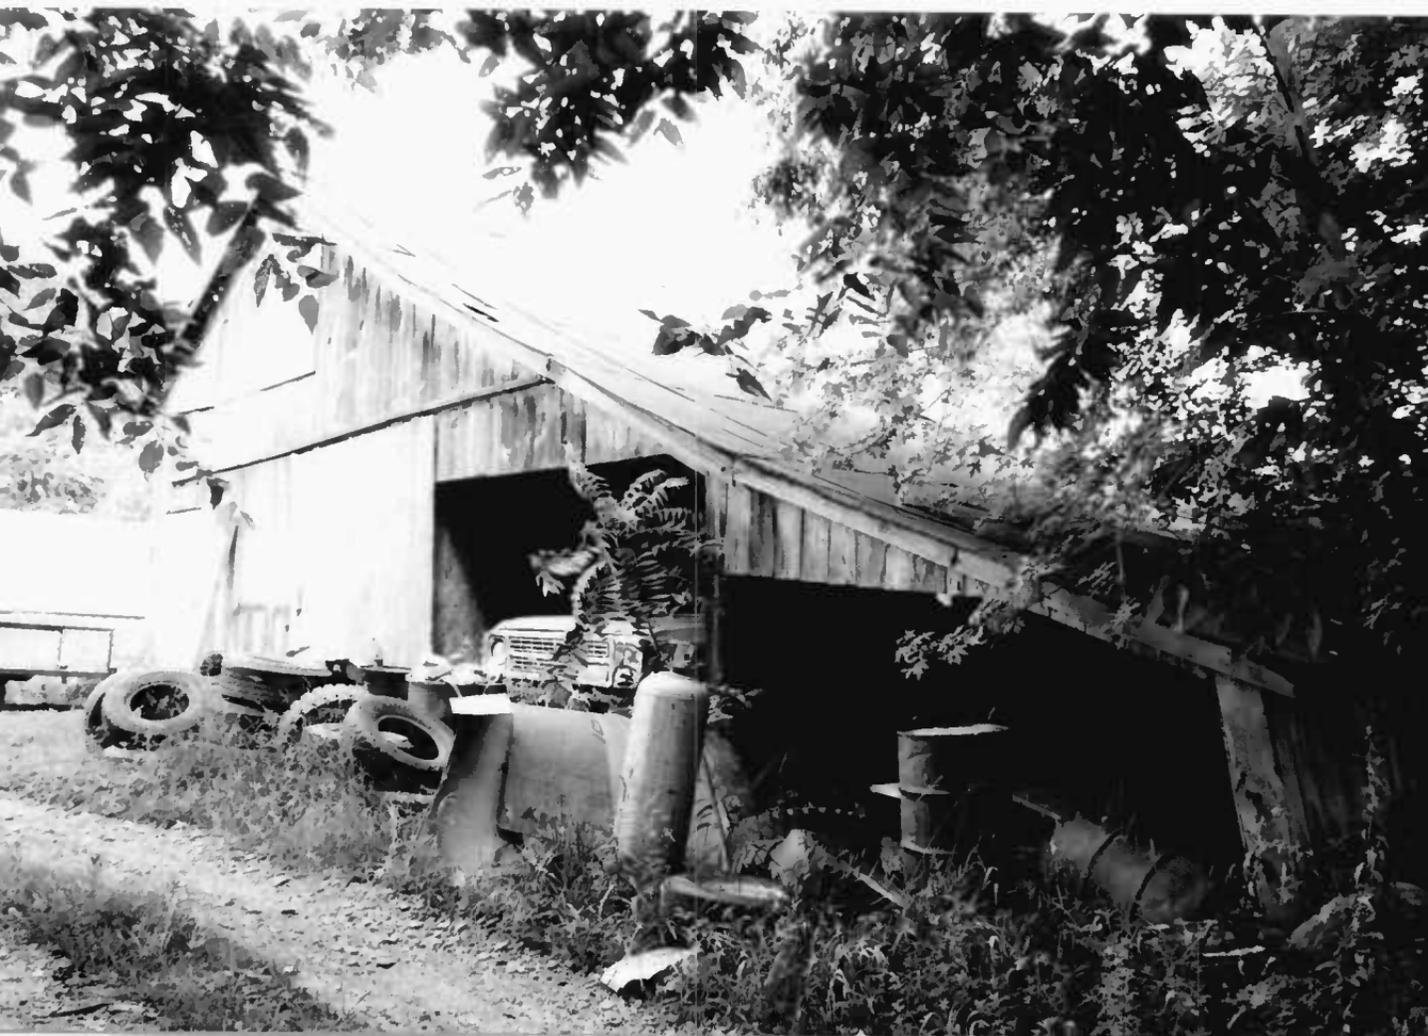
PHOTO 5 OF 11

VIEW NORTHWEST, WOOD FRAME BARN (2-A)

A wood-frame barn is located to the east of the main house and north of the concrete-block shed (D-3). The barn is a rectangular, one-story, three bay structure. The building is oriented to the south. The building is sheathed with vertical board siding. The gable-front roof is clad with corrugated metal. The east plane has been extended to create a saltbox appearance.

The primary elevation of the wood barn includes three entrances: a west bay wood door, a central overhead sliding track door, and an open east bay. The open bay is protected by the extended gable roof. An opening in the gable peak is infilled with plywood. This barn currently is in deteriorated condition.

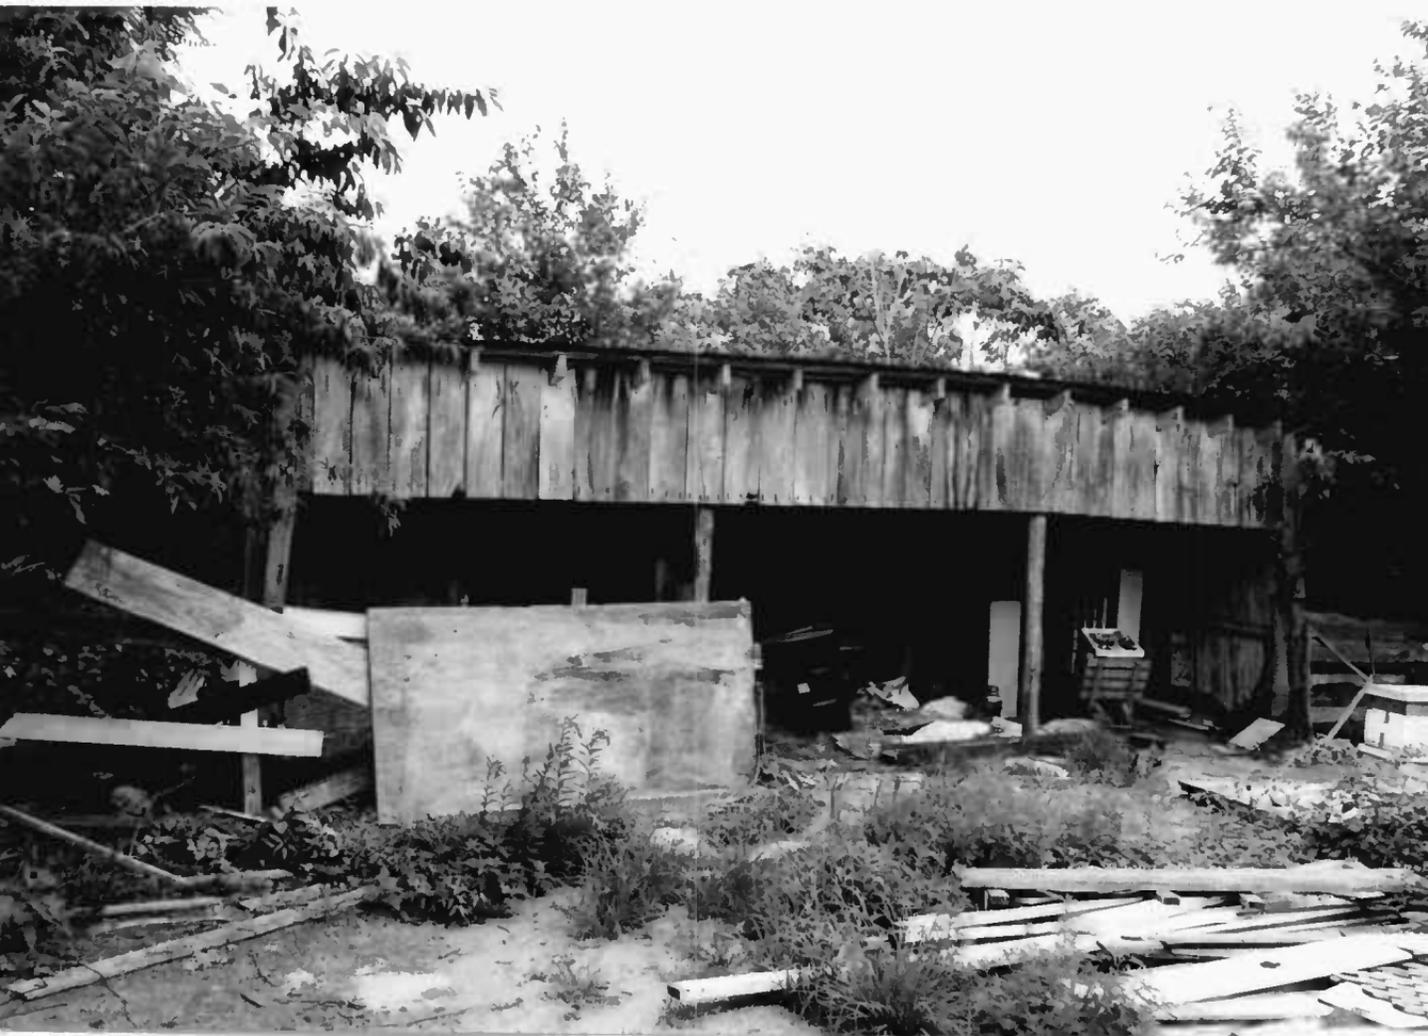
PHOTO 6 OF 11

VIEW NORTHEAST WOOD-FRAME BARN (D-5)

Located east of D-4, D-5 is a rectangular, one-story, three bay wood frame barn. The building rests on a poured concrete foundation. The building is oriented to the south. Three walls are constructed of vertical boards. The south facade is open and two wooden posts define the bays. The shed roof is sheathed with corrugated metal. The shed is deteriorated; the roof is missing panels and sections of wall are missing along the north and west elevations.

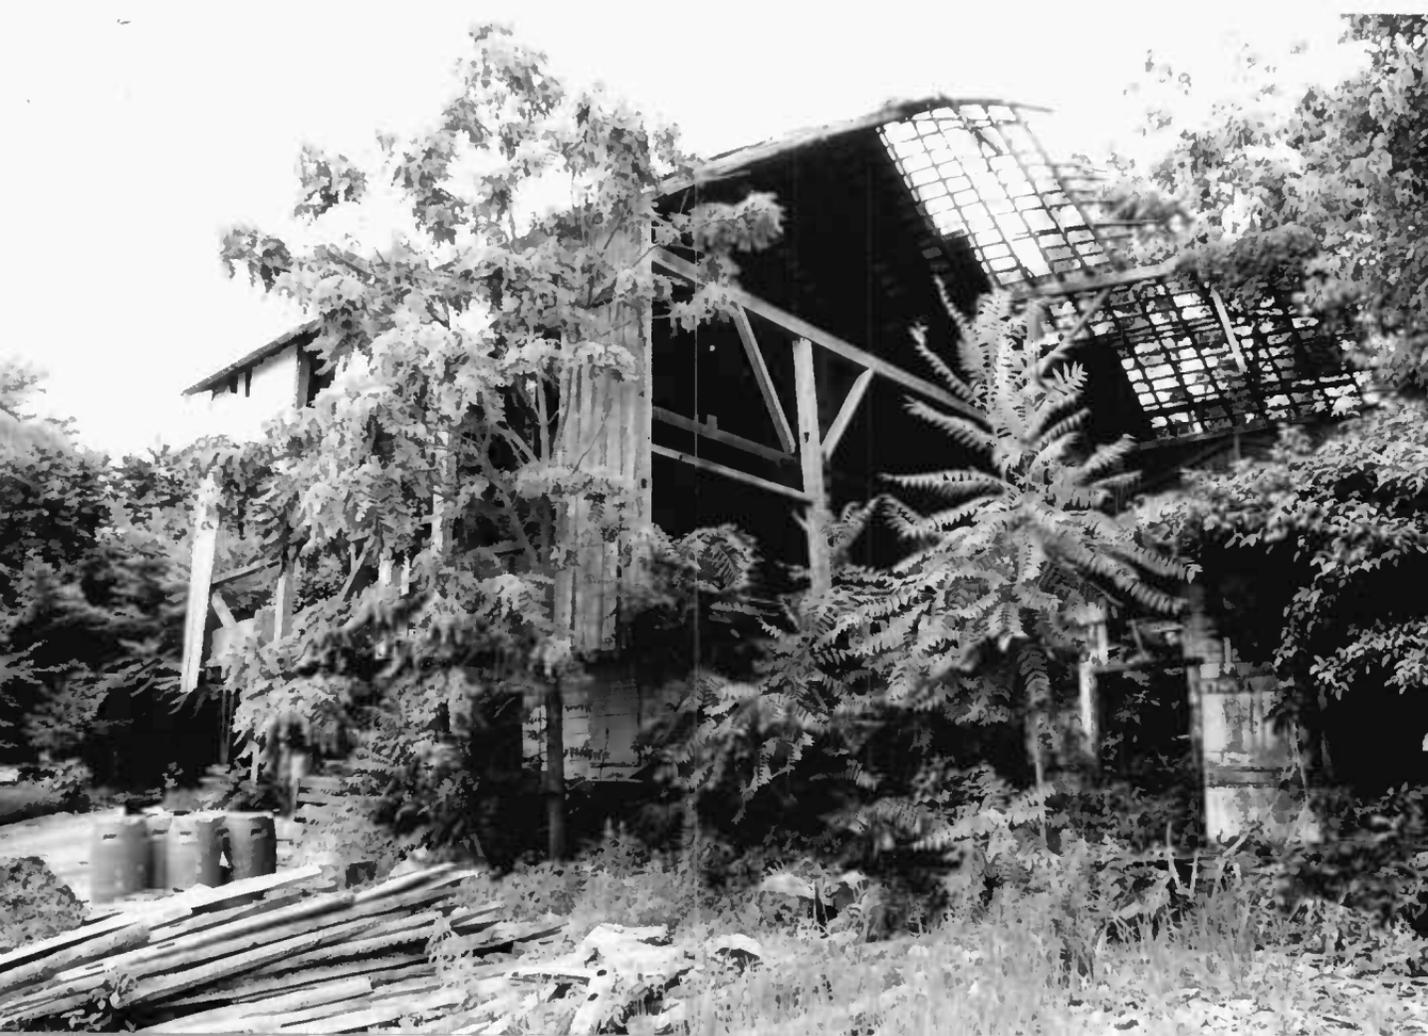
PHOTO 7 OF 11

VIEW SOUTHWEST, WOOD FRONTED BANK BARN (5-7)

A timber-frame barn is located east of the principal dwelling. This structure currently is in deteriorated condition; the immediate building site is overgrown with vegetation. The northern two thirds of the second level loft has collapsed into the ground floor. The structure is supported by a fieldstone foundation, and rises to a gable roof clad in corrugated metal.

The barn plan reflects the spatial divisions common to the barn type. The ground floor is accessible by way of the east elevation. Two livestock stalls are evident in the standing southern section. The mow floor is accessible from the ground level of the west elevation. This level of the barn adopts a plan incorporating a central nave with flanking aisles.

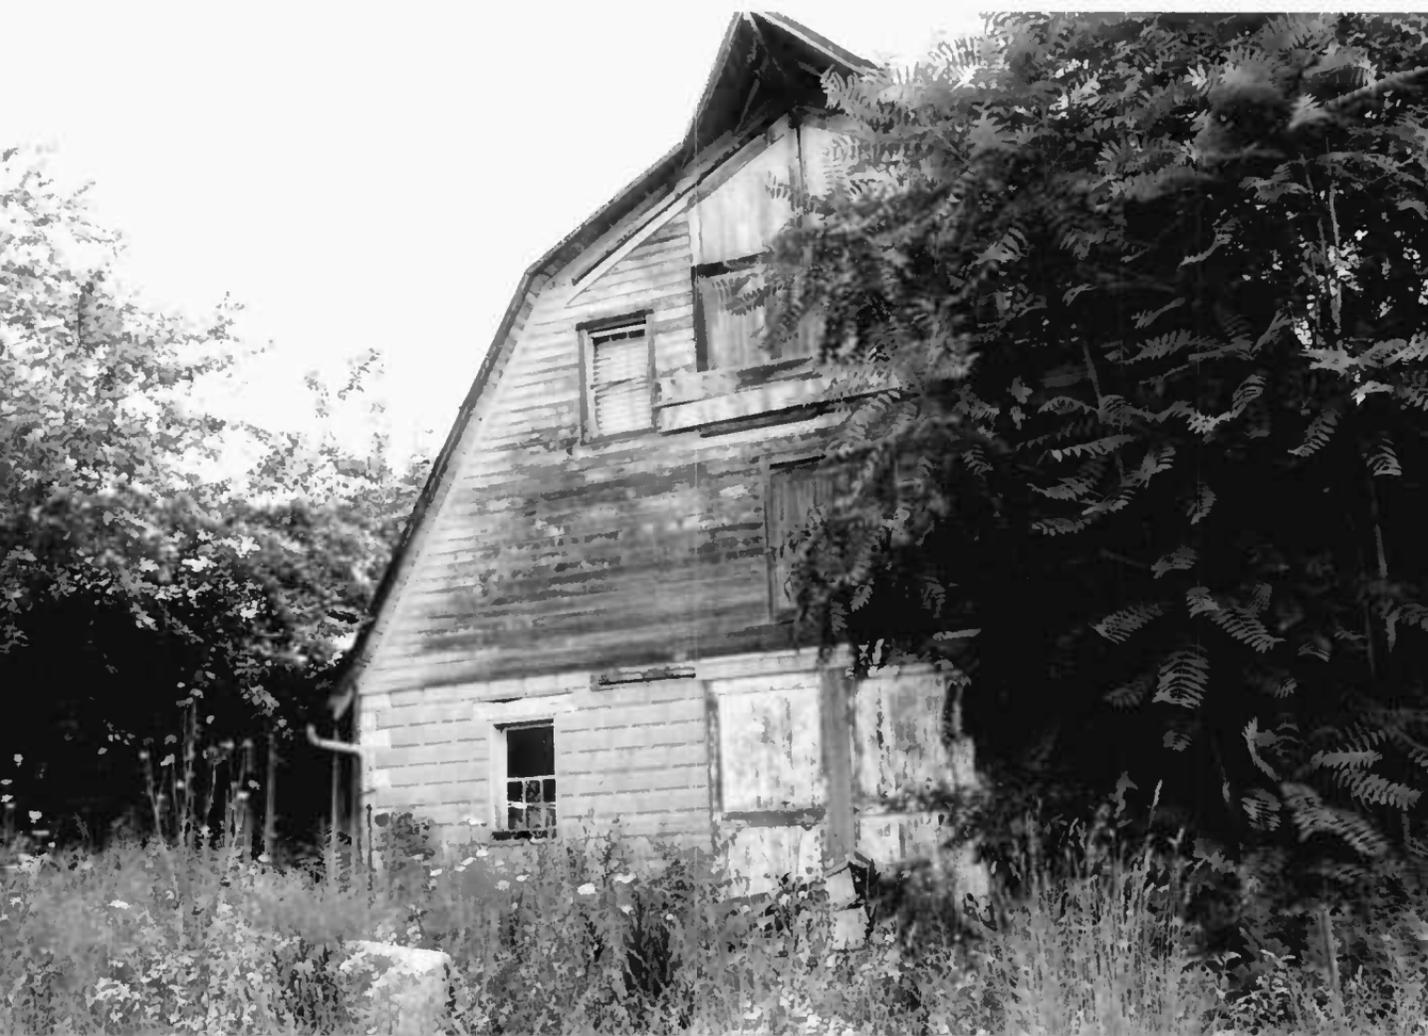
PHOTO 8 OF 11

VIEW SOUTH CONCRETE-BLOCK DAIRY BARN (S-7)

The Dairy Barn is located in the southeast portion of the building complex, and is a two-story building occupying a rectangular plan. The front elevation is symmetrical and divided into three bays; the side elevations include eight bays. The barn is constructed of concrete-block supported by a poured concrete slab foundation. The ground floor exterior walls are concrete-block, while upper levels are clad in wood siding. The gambrel roof is clad in standing seam metal panels. Three sheet metal ventilators punctuate the roof ridge.

The primary entrance incorporates double, wooden track doors. The windows of this structure are six-light-over-six-light, double hung, wood sash. The windows and door bays of the barn exhibit wood lintels and sills. The structure is in good condition although numerous windows have been infilled with corrugated plastic.

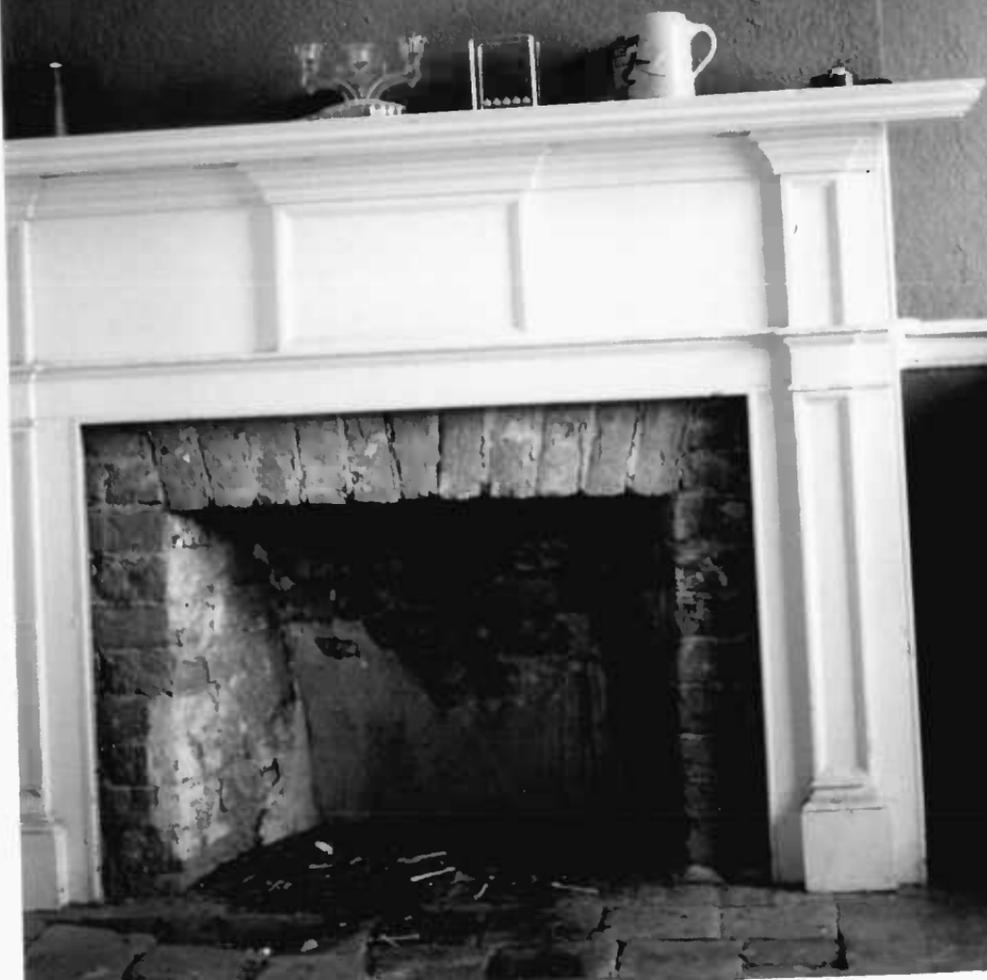
9 of 11

Hall fireplace

The main block of the house is organized in a hall and parlor plan. The principal block retains its original interior finishes, including plaster, flooring, woodwork, and hardware. The primary entrance leads directly into the hall; the parlor is located to the east. Each of the rooms contains a simply detailed fireplace mantel that is centrally located on the gable-end wall. A boxed stair is located in the northeast corner of the hall and leads to the second floor. A door to the basement is located beneath the stairs.
