United States Naval Academy, Dairy Farm
Anne Arundel County

Capsule Summary

MARYLAND INVENTORY OF
HISTORIC PROPERTIES
Maryland Historical Trust
State Historic Sites Inventory Form

Survey No. AA-2177

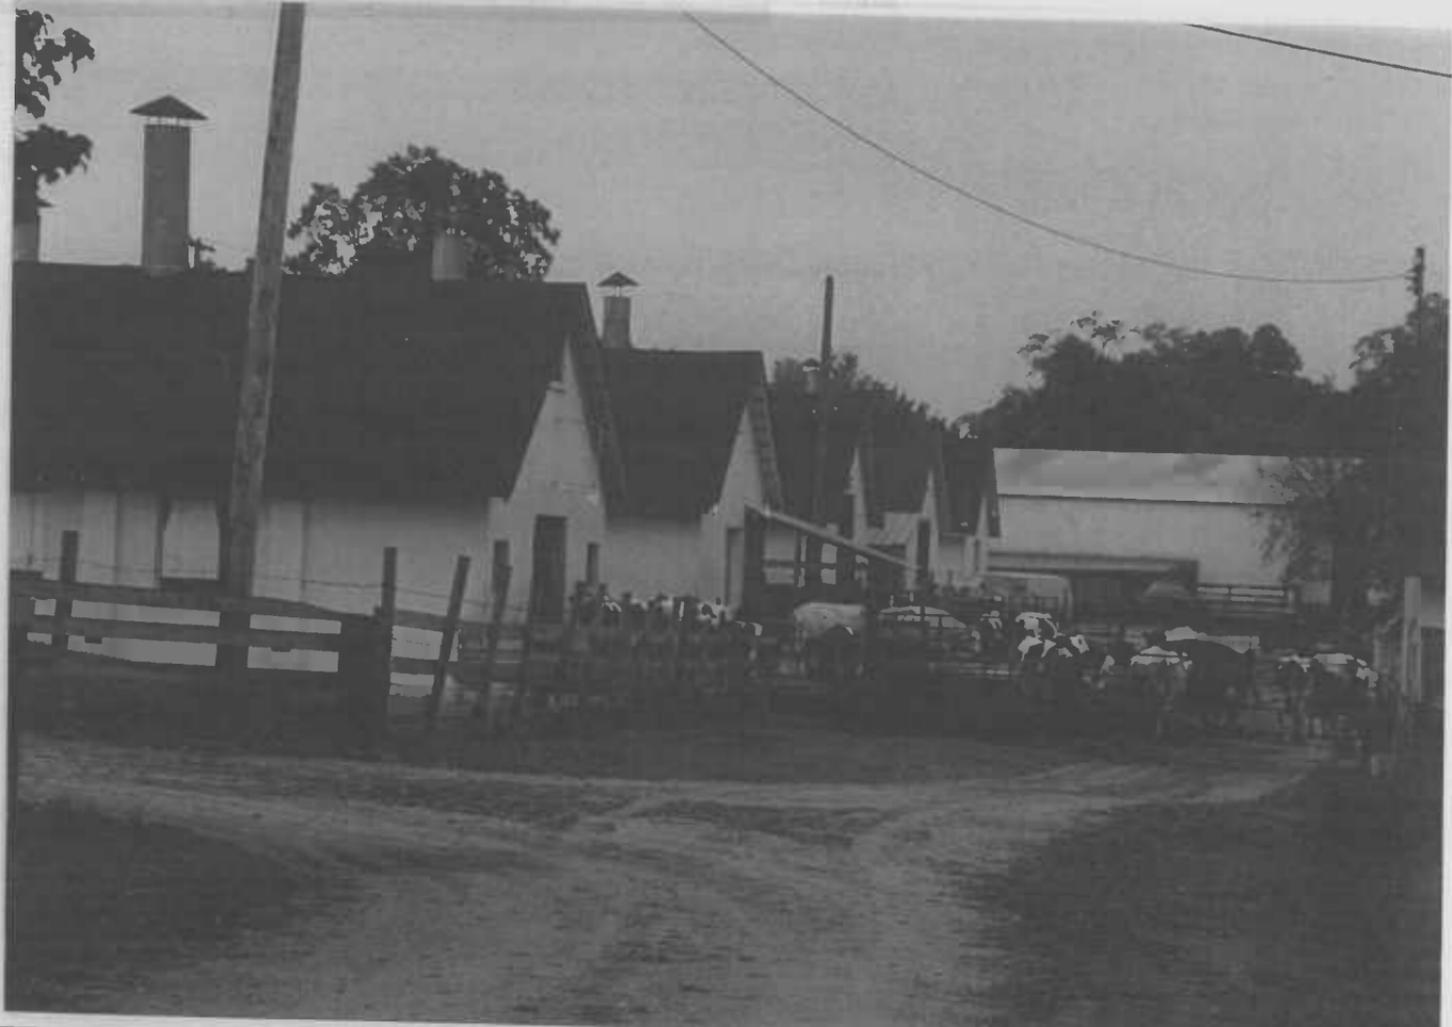
2 of 29

EAST, DAIRY BARN, CONTEXT.

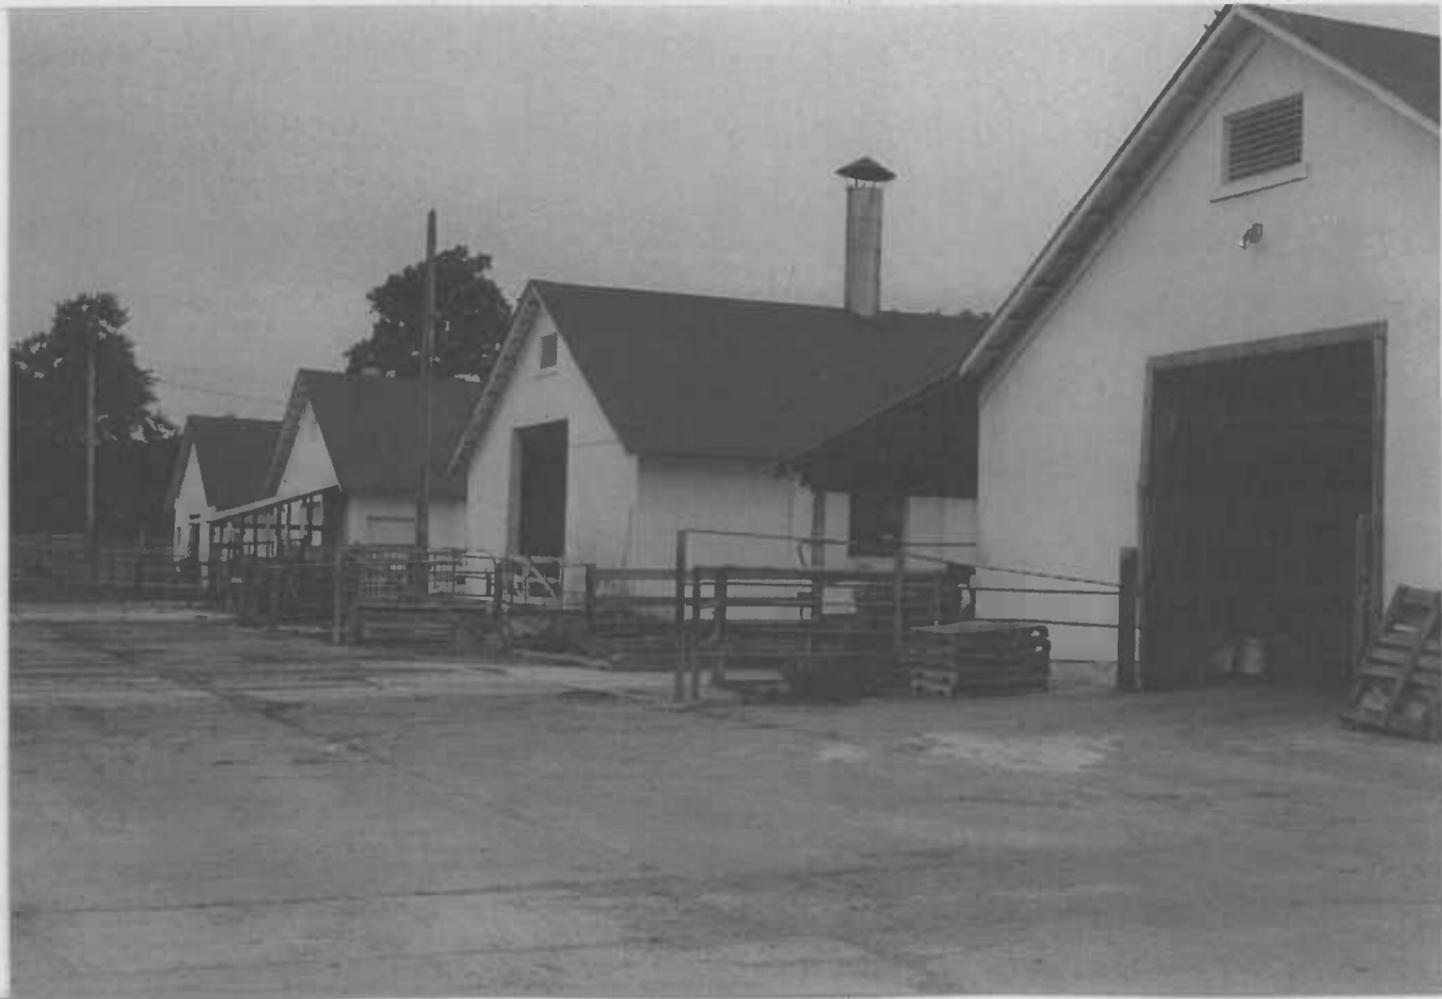
3 of 29

Buildings 28-32. Buildings 28-32 are the five primary cow barns of the complex. Each is one-story, one-bay wide and nine-bays deep, and of concrete construction. Each barn rests on a concrete foundation and terminates in a front-gable roof. The long elevations exhibit nine, one-over-one-light windows with concrete lug sills. Engaged pilasters delineate the bays on the long elevations. The front gable ends incorporate wide double doors, and the rear gable ends display a single overhead track door. The doors open into a wide center aisle extending the length of the barn. On each side of the aisle are 25 stalls.

WEST - BARNS 29-32

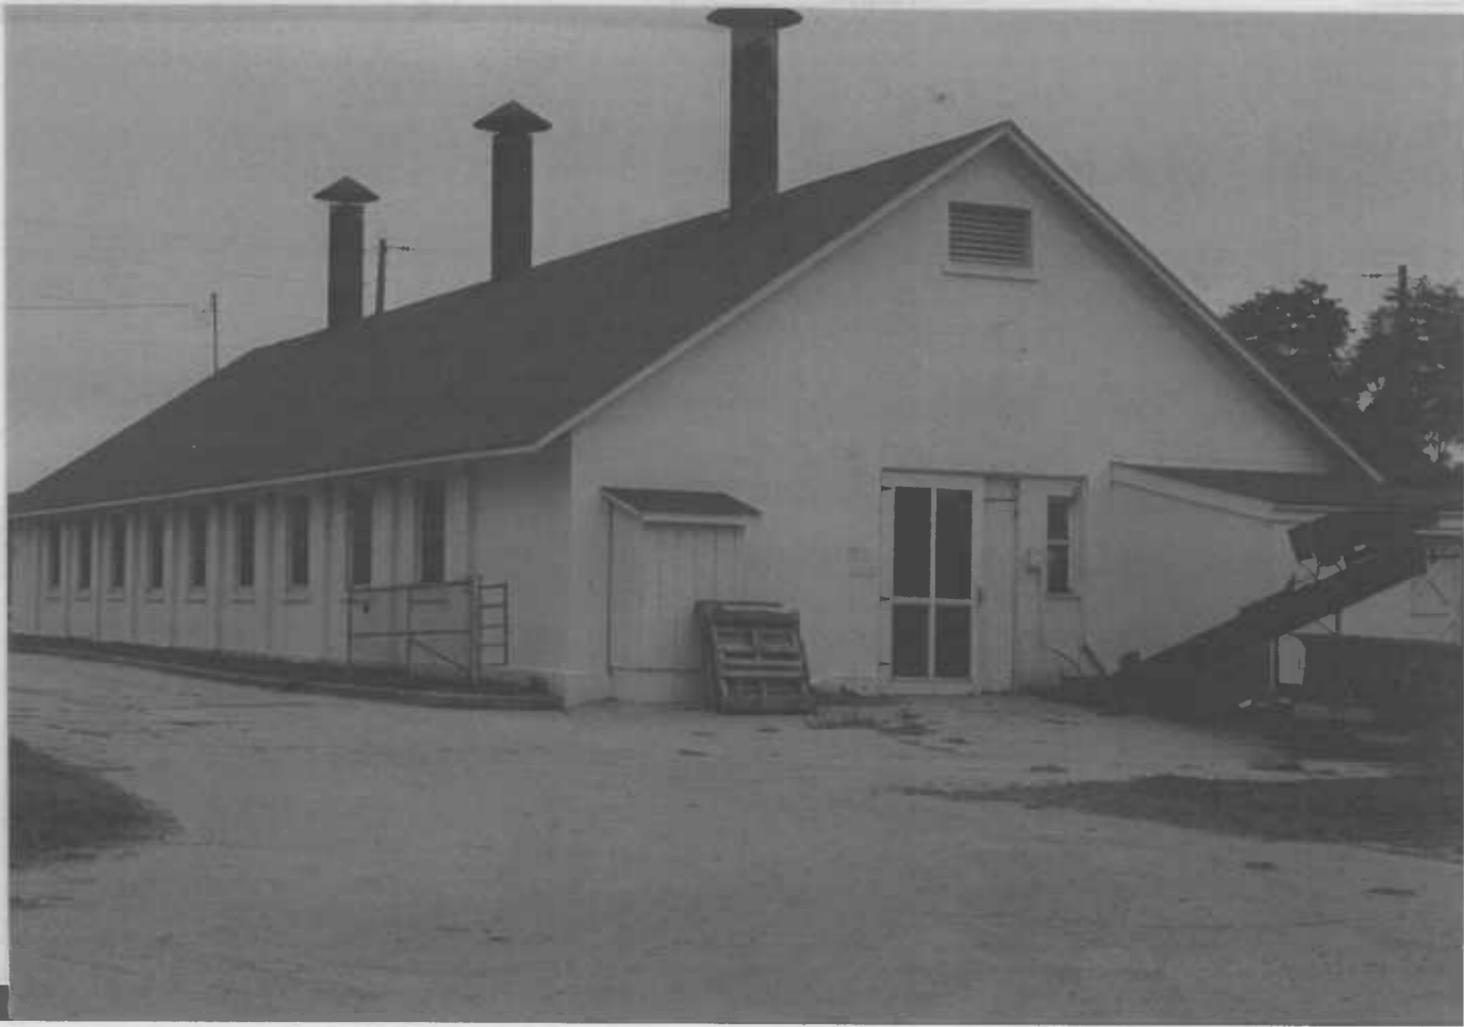
4 of 29

NORTH - BUILDING 28, FRONT + SIDE

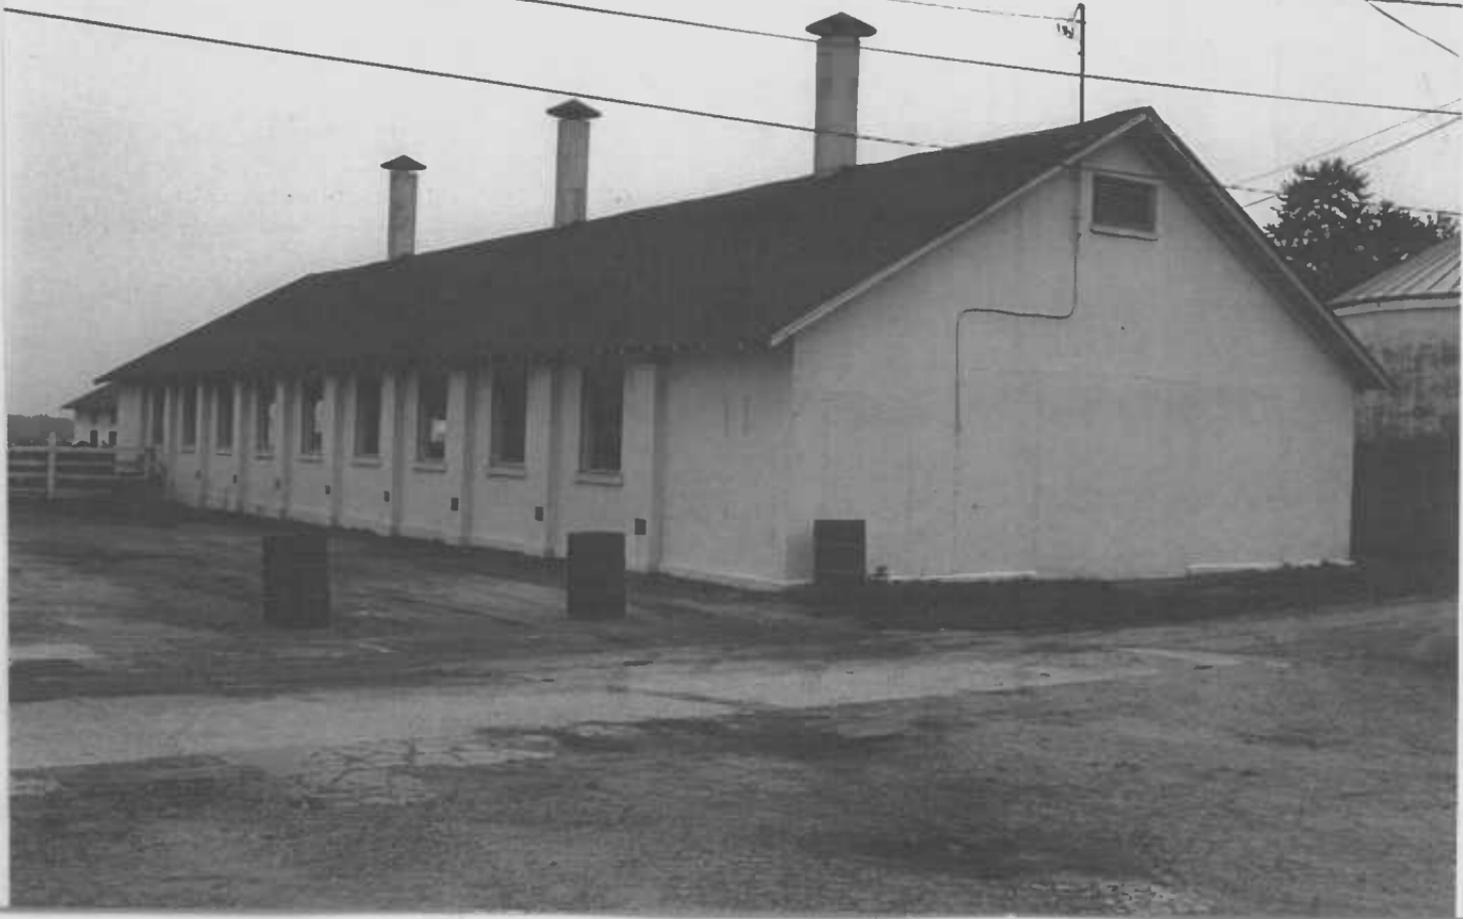
5 of 29

Three tall, metal ventilators are regularly spaced along the ridges. Each of the buildings have been modified slightly by such elements as infilled doors and windows, the addition of shed overhangs, and small lean-to additions. Metal fencing and corrals surround portions of each barn. Barns 28-31 were constructed in 1915 and Barn 32 was built a year later. The rear gable end of Barn 32 exhibits a central overhead track door flanked by single door entries (all are infilled now), unlike the other five barns, which feature only a central track door.

SOUTH, BUILDING 32, REAR + SIDE ELEVATION.

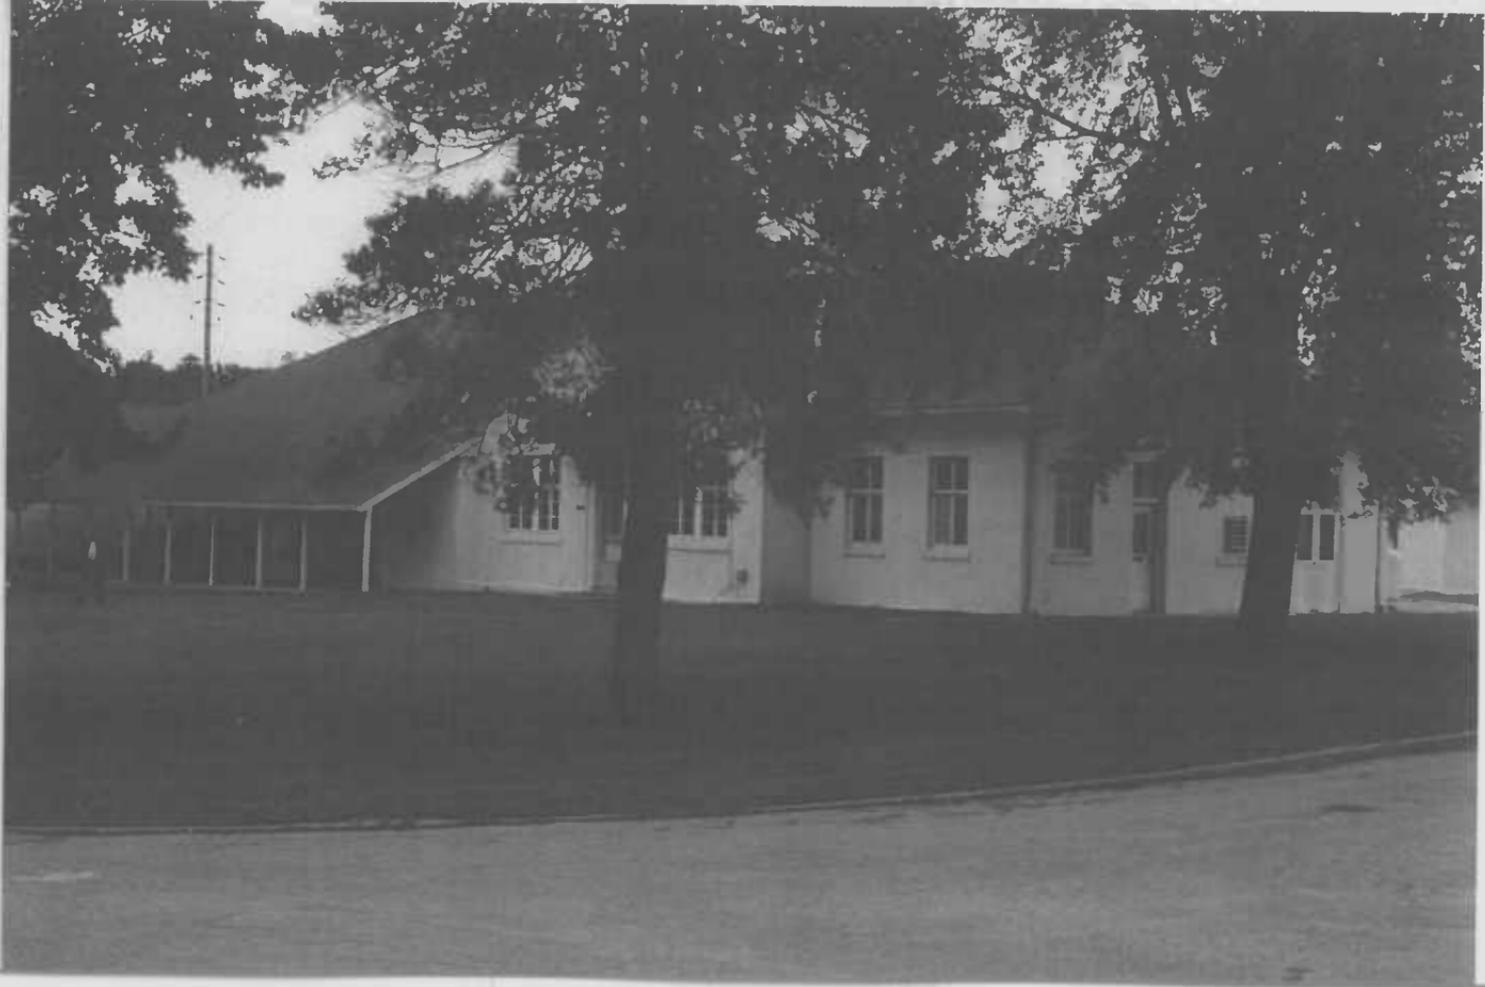
13 of 29

Building 25. Building 25 is a one-story concrete office and cold storage building. It rests on a concrete foundation and terminates in a hipped roof. The north elevation features a cross gable entrance bay which features a bracketed shed hood above the primary entrance, and a small window with diamond-shaped tracery at the peak. All doors are wooden panel and glass units; single doors are surmounted by two-light transoms, and five-light transoms surmount double doors. Each elevation exhibits multi-light casement and pivotal windows with concrete lug sills. The east elevation incorporates a windowless addition to serve as a refrigeration and pasteurization area; the roof at the northeast corner is extended to form a covered loading platform. The west end of the facility houses the offices. A covered walkway at the south elevation leads to Building 172. This building was constructed in 1915 as the Office/Cold Storage Building.

SOUTH, BUILDING 25 PRIMARY ELEVATION

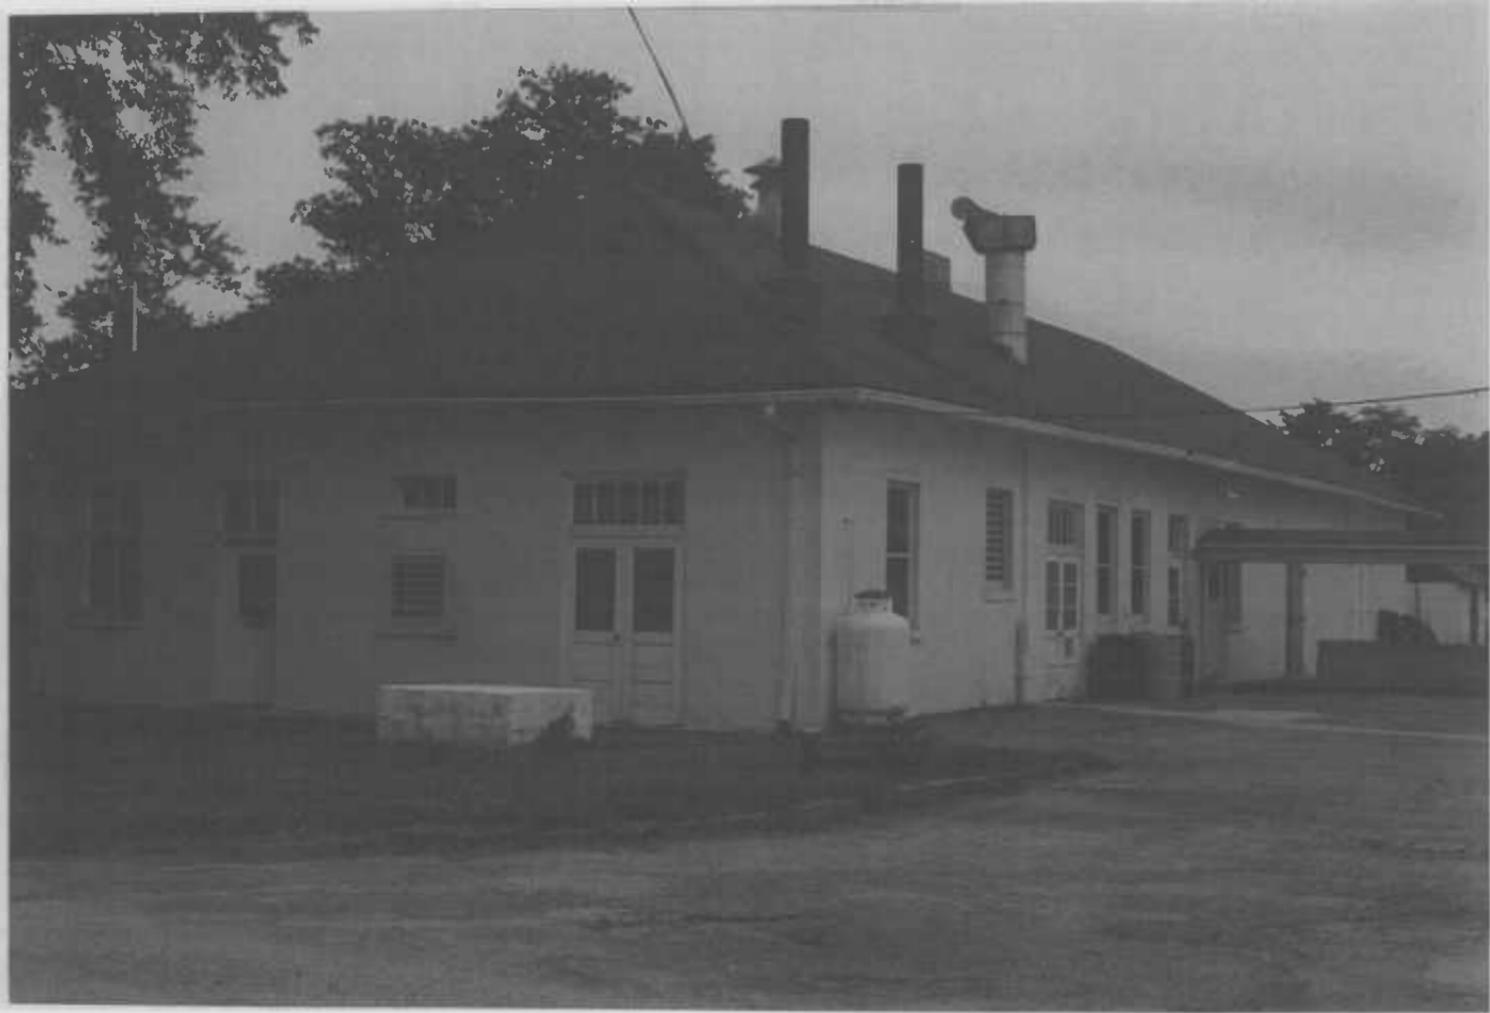
14 of 29

REAR + SIDE ELEVATION

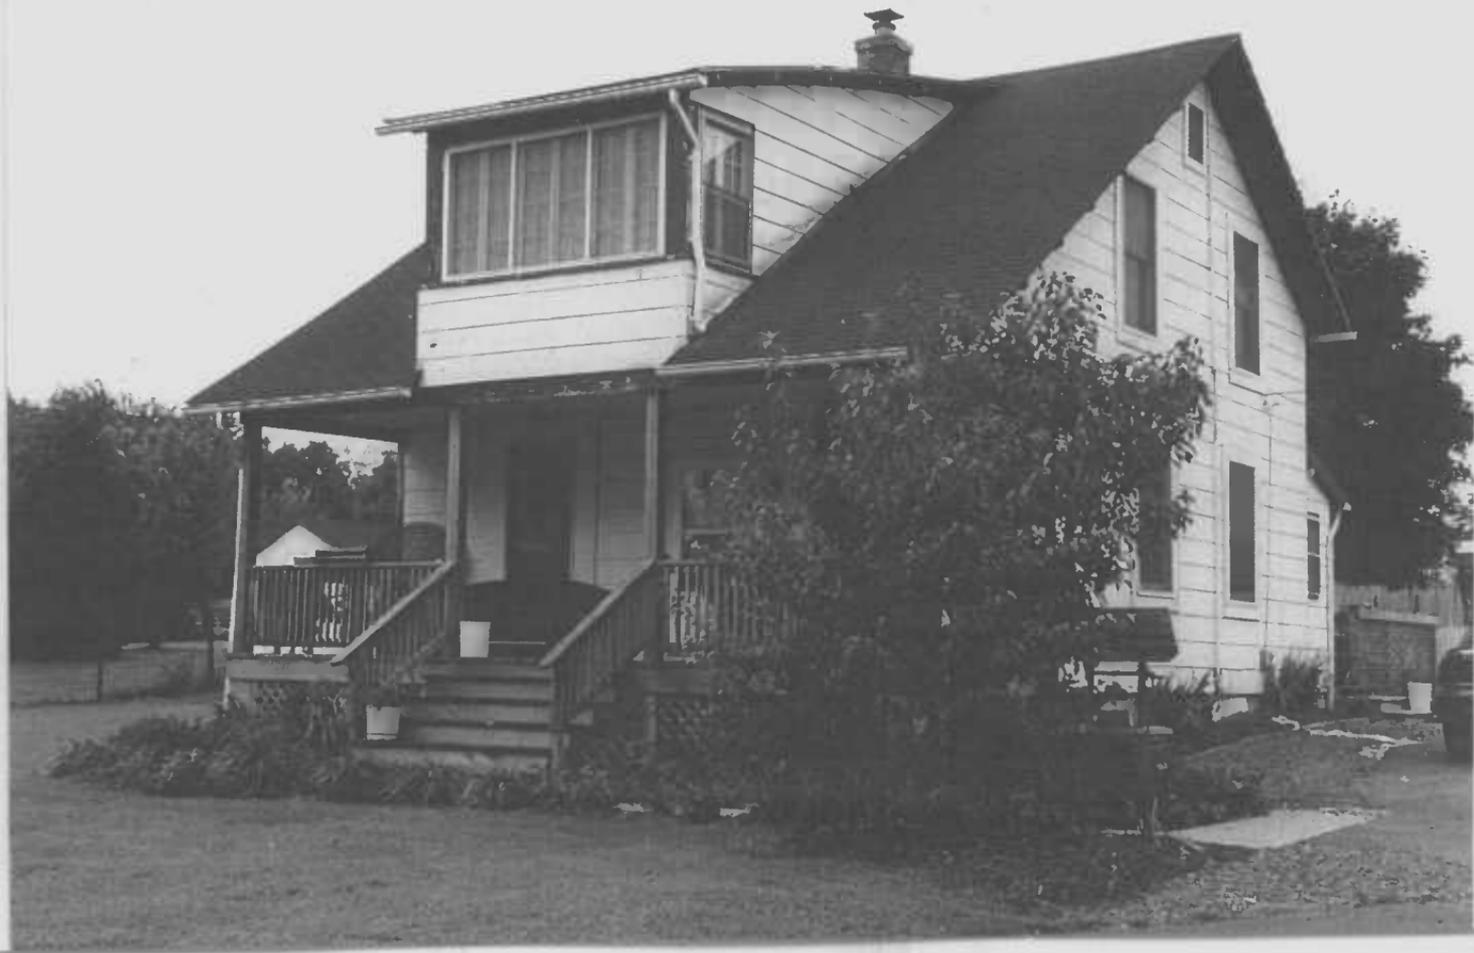
15 of 29

Buildings 128 and 143. Building 128 is a one-and-one-half-story, wood frame cottage resting on a concrete foundation. The dwelling is distinguished by a full-width, inset front porch, and a large, central shed dormer that punctuates the side-gable roof. The front porch is supported with replacement wood posts. The dormer exhibits a band of multi-light windows on the front elevation, and six-over-six-light, wood sash windows on the side elevations. All other windows are double-hung, one-over-one-light, wood sash units, including the two windows on a rear shed dormer. The house is three-bays deep and two-bays wide, and is covered with asbestos siding.

BOOTH BUILDING 128, FRONT ELEVATION

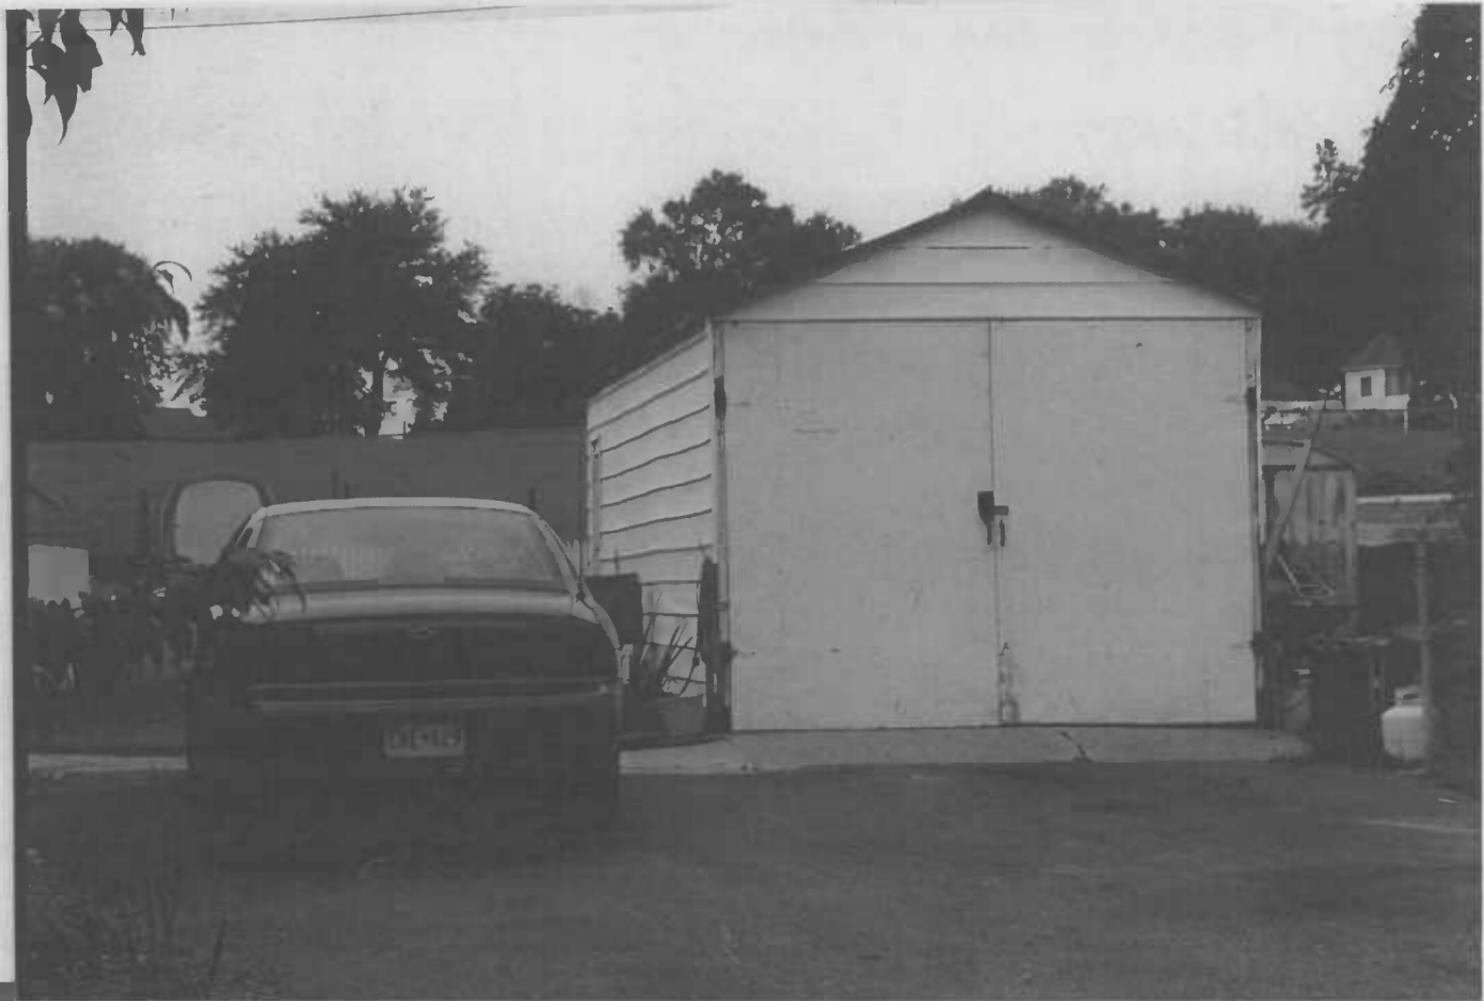
16 of 29

Building 143 is a detached garage located behind Building 128. The garage terminates in a front-gable roof, and, like the house, is covered with asbestos siding. The original garage door has been replaced. The west elevation displays a single door entry. Both the house and the garage were built in 1937. Building 128 was constructed as rental housing, and continues to be utilized as such.

SOOTY, BUILDING 143

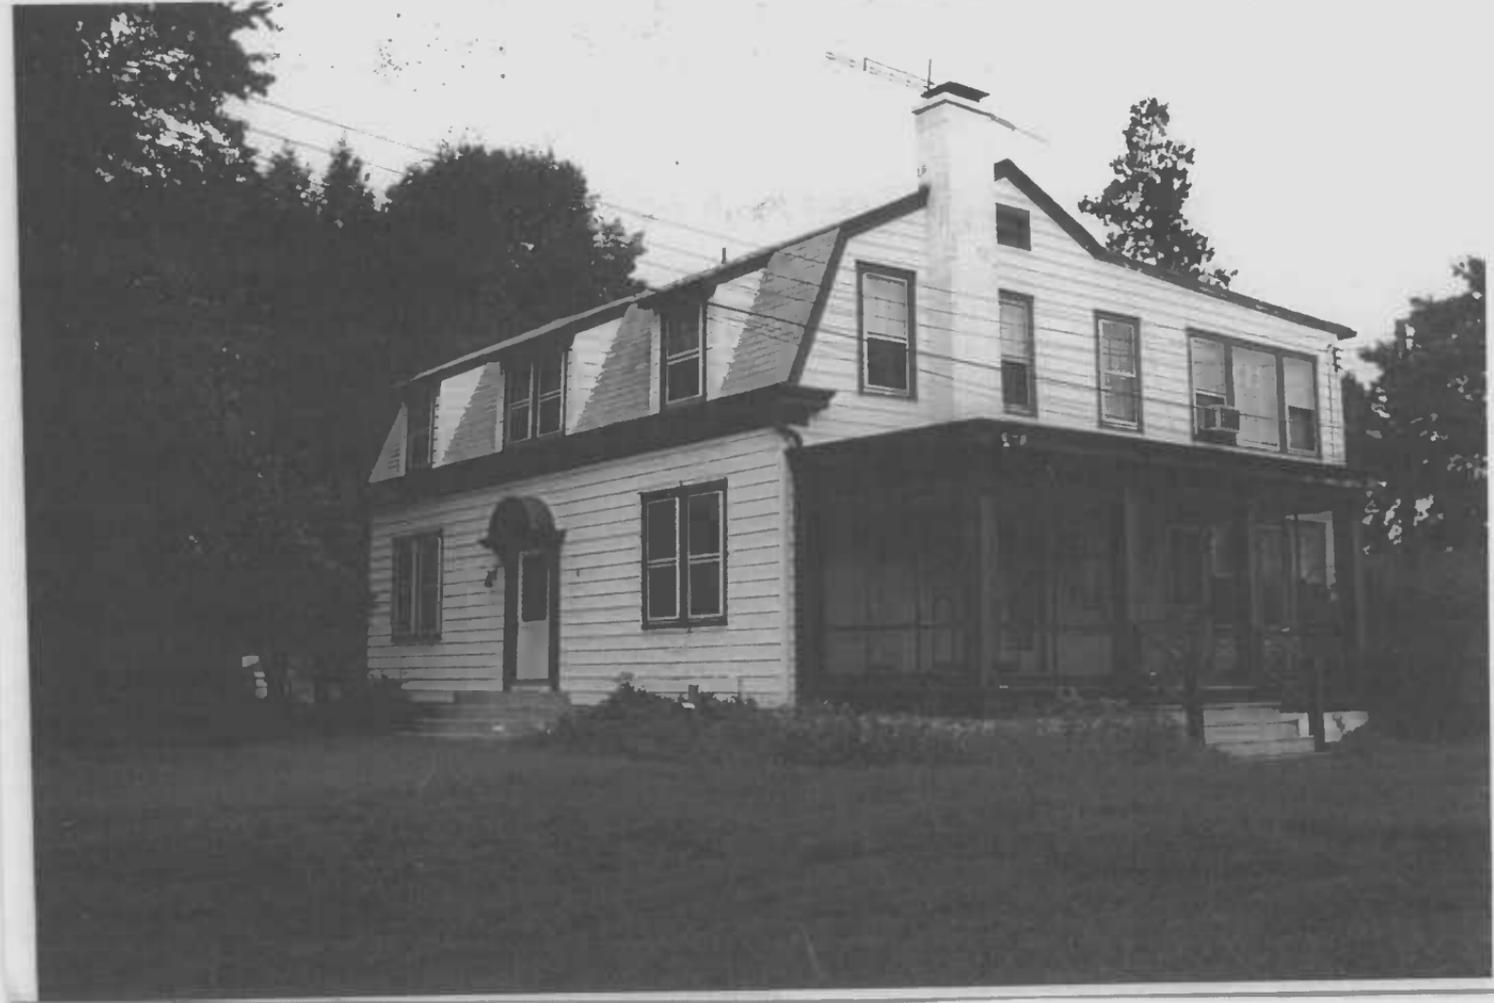
17 of 29

Building 101. Building 101 is a two-story, wood frame house constructed in 1939. The building is clad with aluminum siding, and terminates in a side-gambrel roof characteristic of the Dutch Colonial Revival style. The front roof slope exhibits three shed dormers; the central dormer incorporates paired windows. The symmetrical primary elevation features a central, panelled and glass door surmounted with a semicircular hood. All windows are double-hung, six-over-one-light, wood sash units. The house is three-bays wide and four-bays deep, and rests on a concrete foundation.

A screened-in side porch is found on the east elevation. Four square, wooden columns support the porch's hipped roof. A lean-to on the west elevation incorporates a secondary entrance. The house was modified with a two-story addition appended to the rear of the house. Building 101 originally served as the headquarters house. It is currently a rental house.

NORTH, BUILDING 101 - FRONT + SIDE

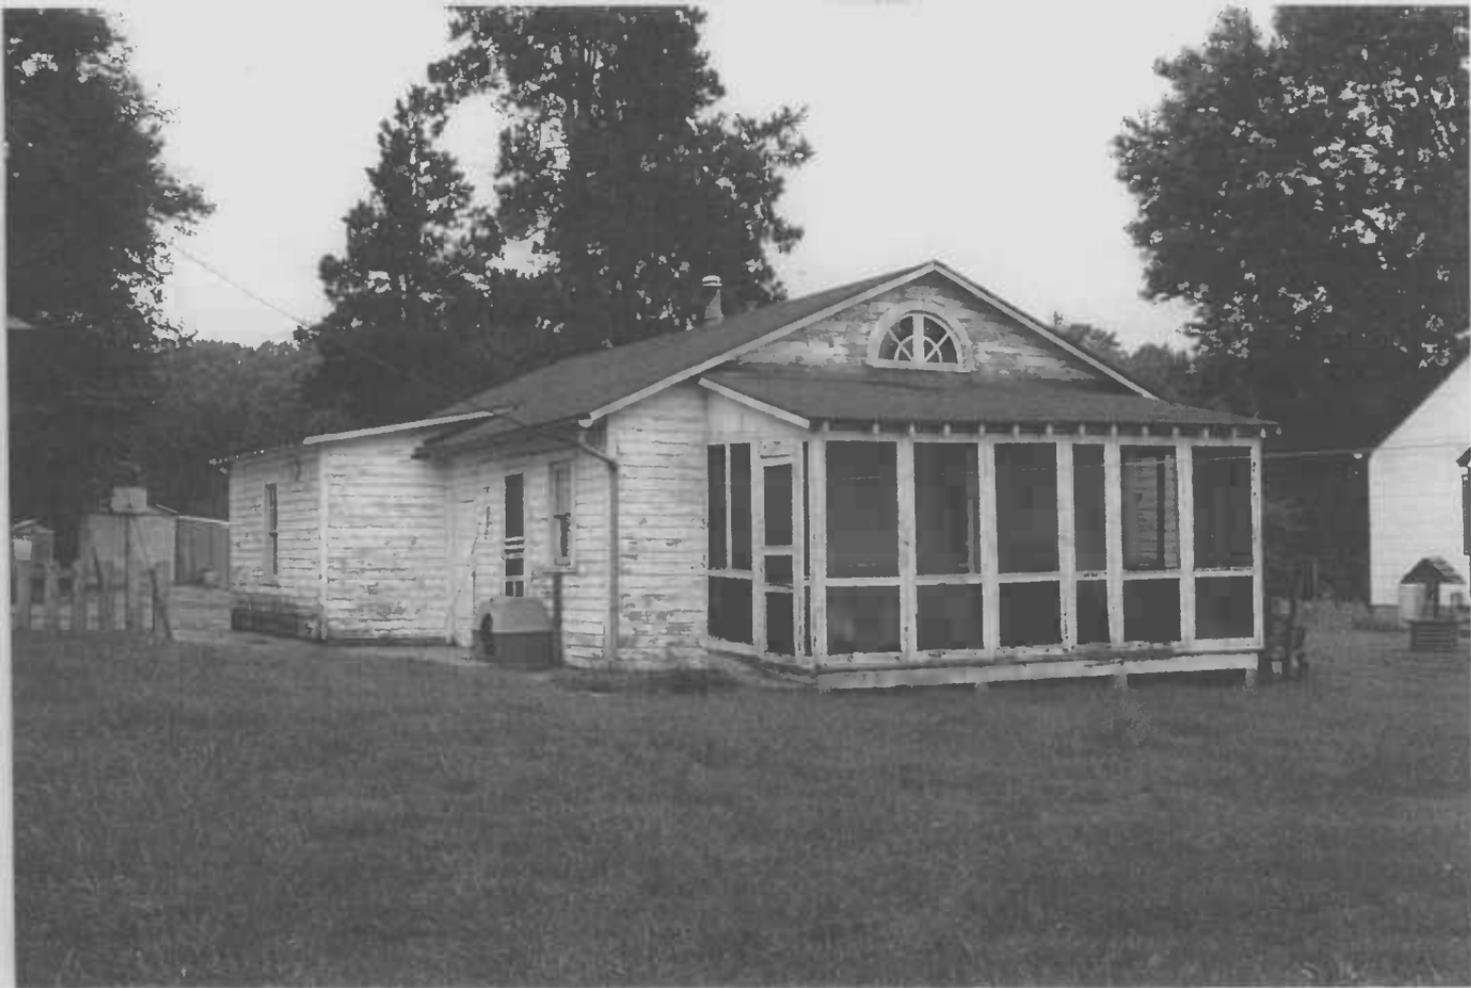
18 of 29

Building 101a. This one-story, wood frame dwelling is raised on a concrete foundation, and terminates in a front-gable roof with exposed rafter ends. A screened-in, shed-roof porch dominates the primary elevation. Above the porch is a multi-light, wood sash lunette. Windows are double-hung, six-over-one-light, wood sash units. The building, which is three-bays wide and six-bays deep, retains the original horizontal wood siding. A shed addition was appended to the south elevation. Built in 1939, this building was a residence for a dairy farm employee. It now serves as rental housing.

WEST, BUILDING 101A FRONT AND SIDE

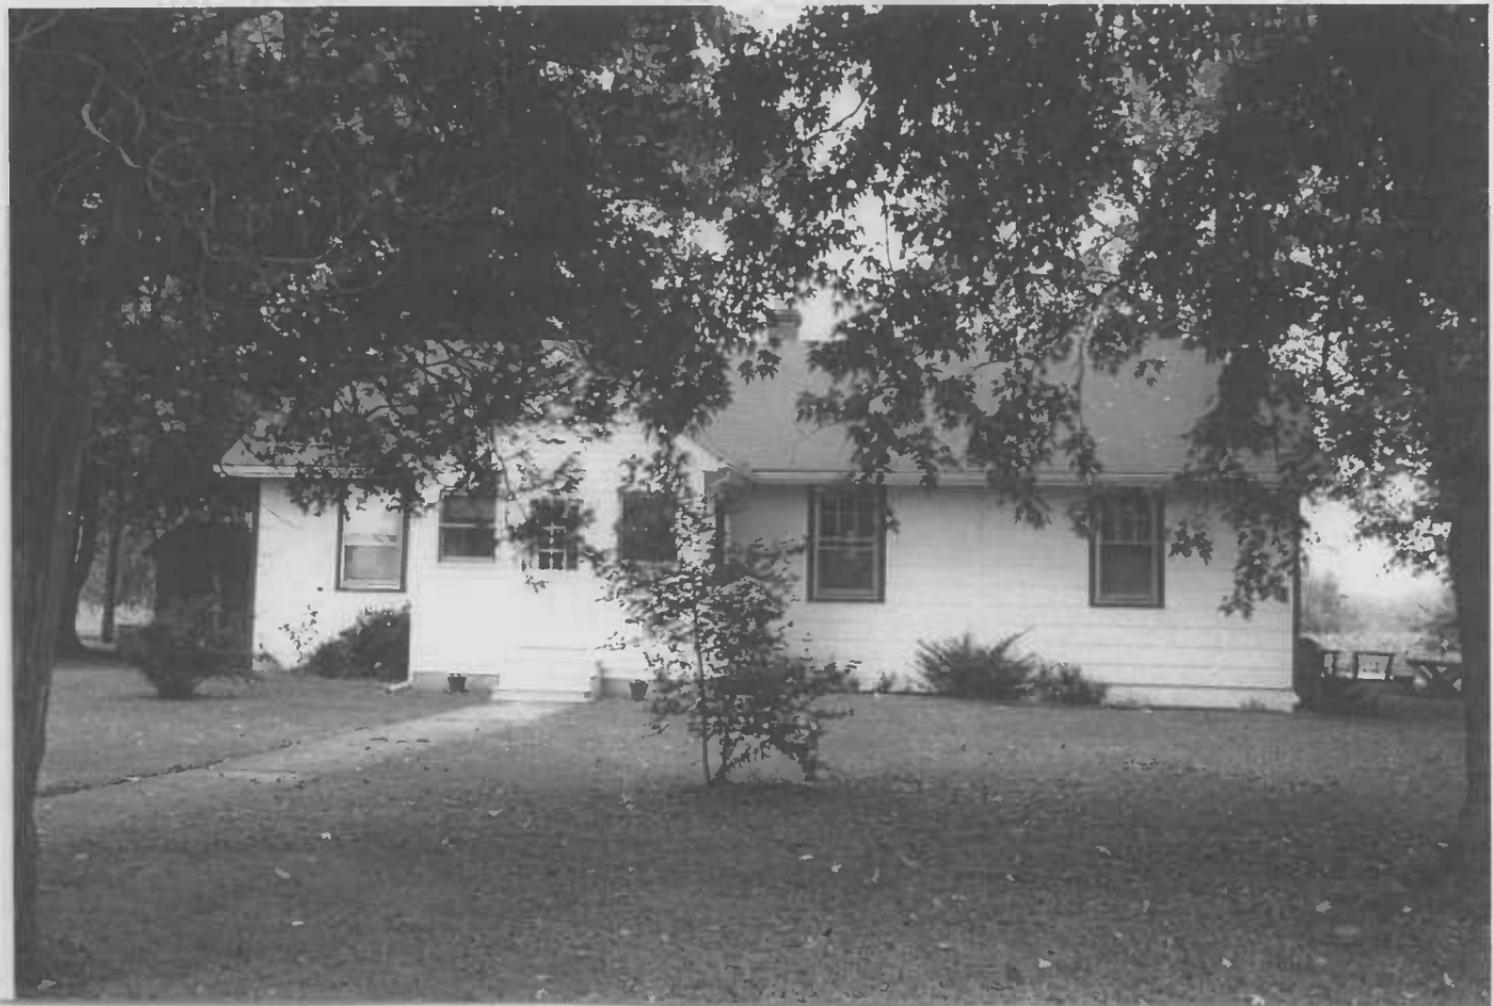
19 of 29

Buildings 103, 105, 107, 146-148. Buildings 103, 105, and 107 are similar one-story, wood frame house designs reflecting the Colonial Revival style. Each house is supported on a concrete foundation, and terminates in a side-gable roof with jerkinhead ends; diamond-shaped ventilators are found below the jerkinhead ends. Building 103 is four-bays wide and two-bays deep, whereas Buildings 105 and 107 are just three-bays wide. The primary elevation of each house is distinguished by a protruding, entrance bay: Building 103 exhibits a front-facing gable bay, and Buildings 105 and 107 have shed roof bays. The houses are sheathed with asbestos shingles, and exhibit double-hung, six-over-one-light, wood sash windows, with exception on the entrance bays, which are covered by aluminum siding and display short, double-hung, one-over-one-light windows flanking a central wood panel and glass door. An interior brick chimney rise from the rear roof plane. Each of these houses, constructed in 1917, originally served as an employee's residence.

NORTH, BUILDING 103, FRONT

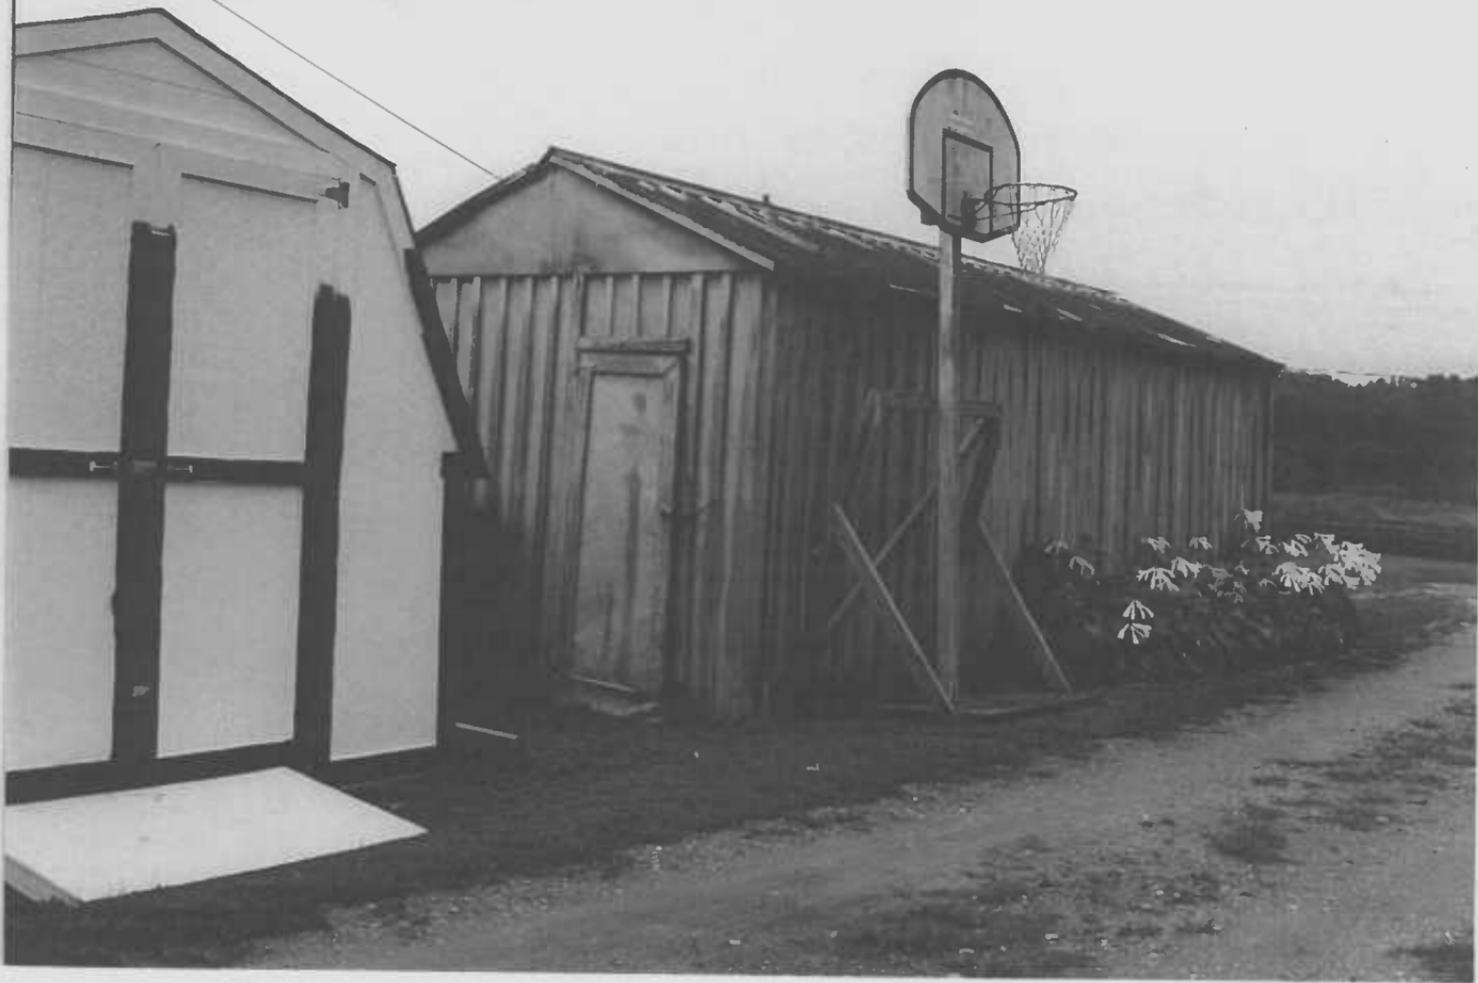
22 of 29

Buildings 108 and 150. Building 108 is a one-story, wood frame house terminating in a hipped roof with exposed rafter ends. It is four-bays wide and deep, illustrating its square plan. The house's concrete foundation supports the asbestos shingle-clad walls. Each elevation exhibits double-hung, six-over-one-light, wood sash windows. The panelled front door is within a corner, screened-in porch addition. The south elevation features a small exterior porch.

WEST, BUILDING 150, FRONT AND SIDE. SIMILAR
TO 151, 148, 147, 146.

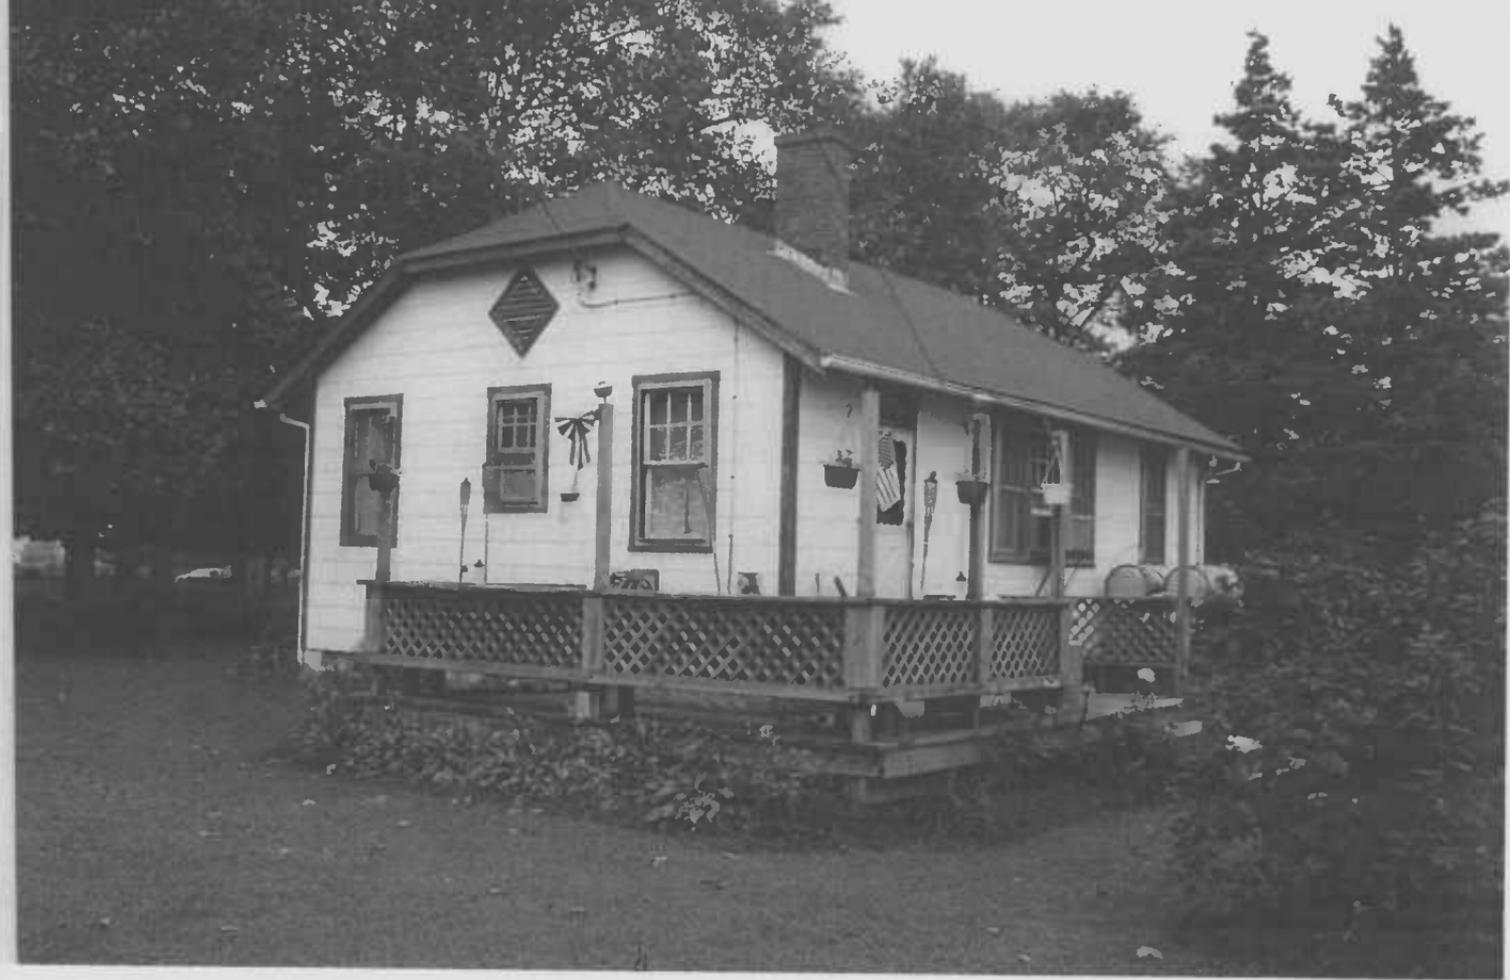
24 of 29

EAST, BUILDING 1071, SIDE A-D REAR

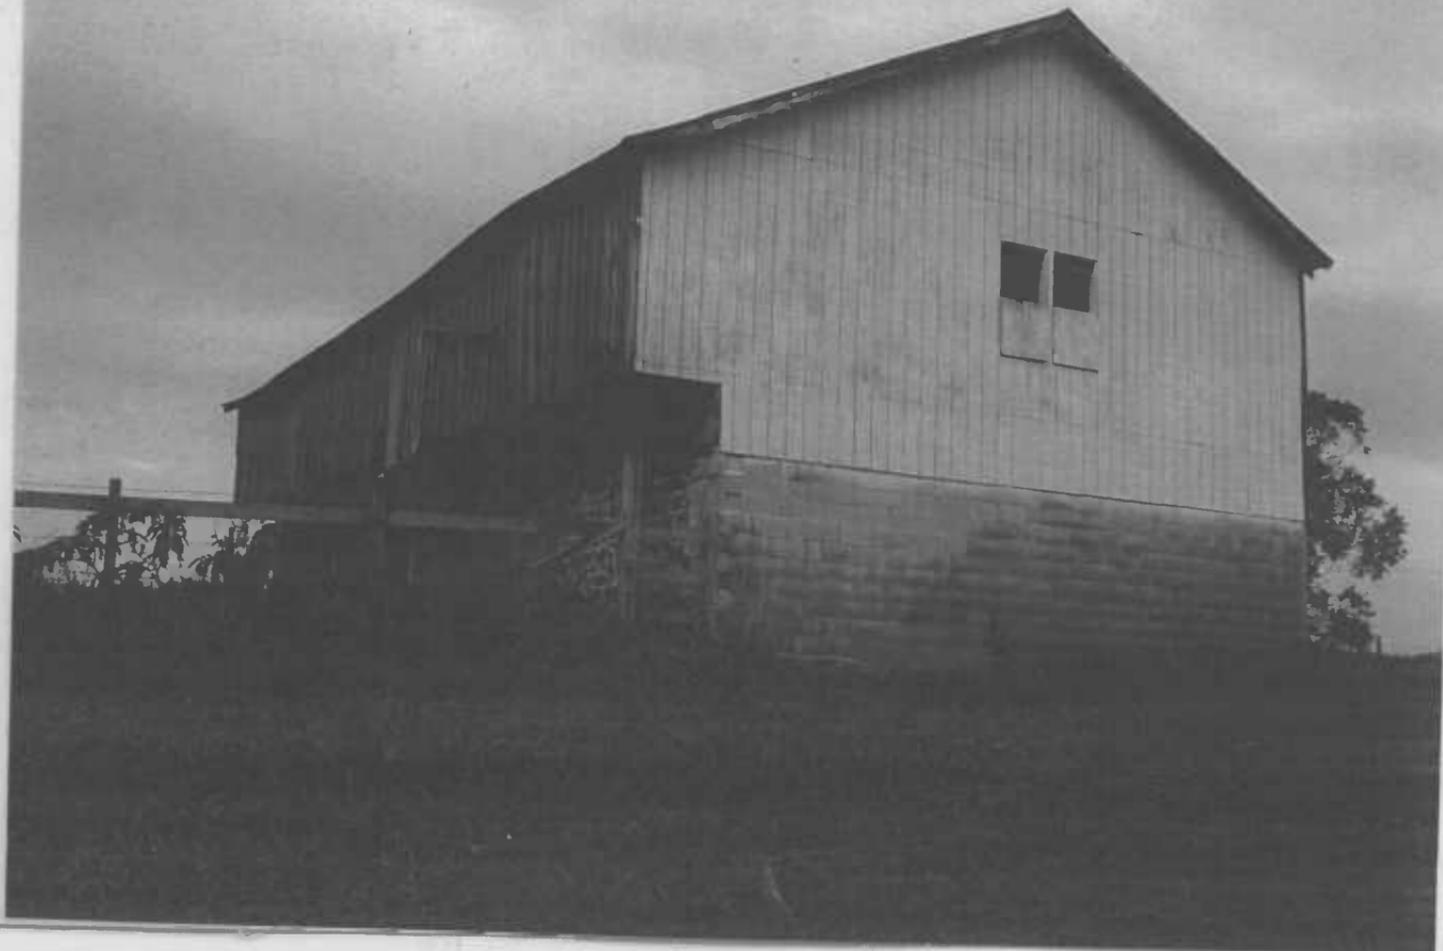
25 of 29

Building 130. Building 130 is a one-and-one-half-story bank barn raised on stone basement walls. The barn terminates in a side-gable roof sheathed with corrugated metal. The forebay, which faces east, cantilevers approximately 5 ft. Reportedly, the upper level was reconstructed in 1942 using portions of the original stone foundation from an unknown date. The first barn was associated with a farmstead established previous to the occupation of the Naval Academy Dairy Farm. Building 130 is isolated in a field distant from the main dairy complex.

SOUTH, BUILDING 130, REAR SIDE ELEVATION
