MARYLAND HISTORICAL TRUST
DETERMINATION OF ELIGIBILITY FORM

Property Name: Bridge B-0391 Mt Zion Rd over Branch of Piney Run Inventory Number: BA-2779

Project: Replacement of Bridges B-0065 and B-0391 Agency: Baltimore County Dept Public Works

MARYLAND INVENTORY OF HISTORIC BRIDGES
HISTORIC BRIDGE INVENTORY
MARYLAND STATE HIGHWAY ADMINISTRATION/
MARYLAND HISTORICAL TRUST

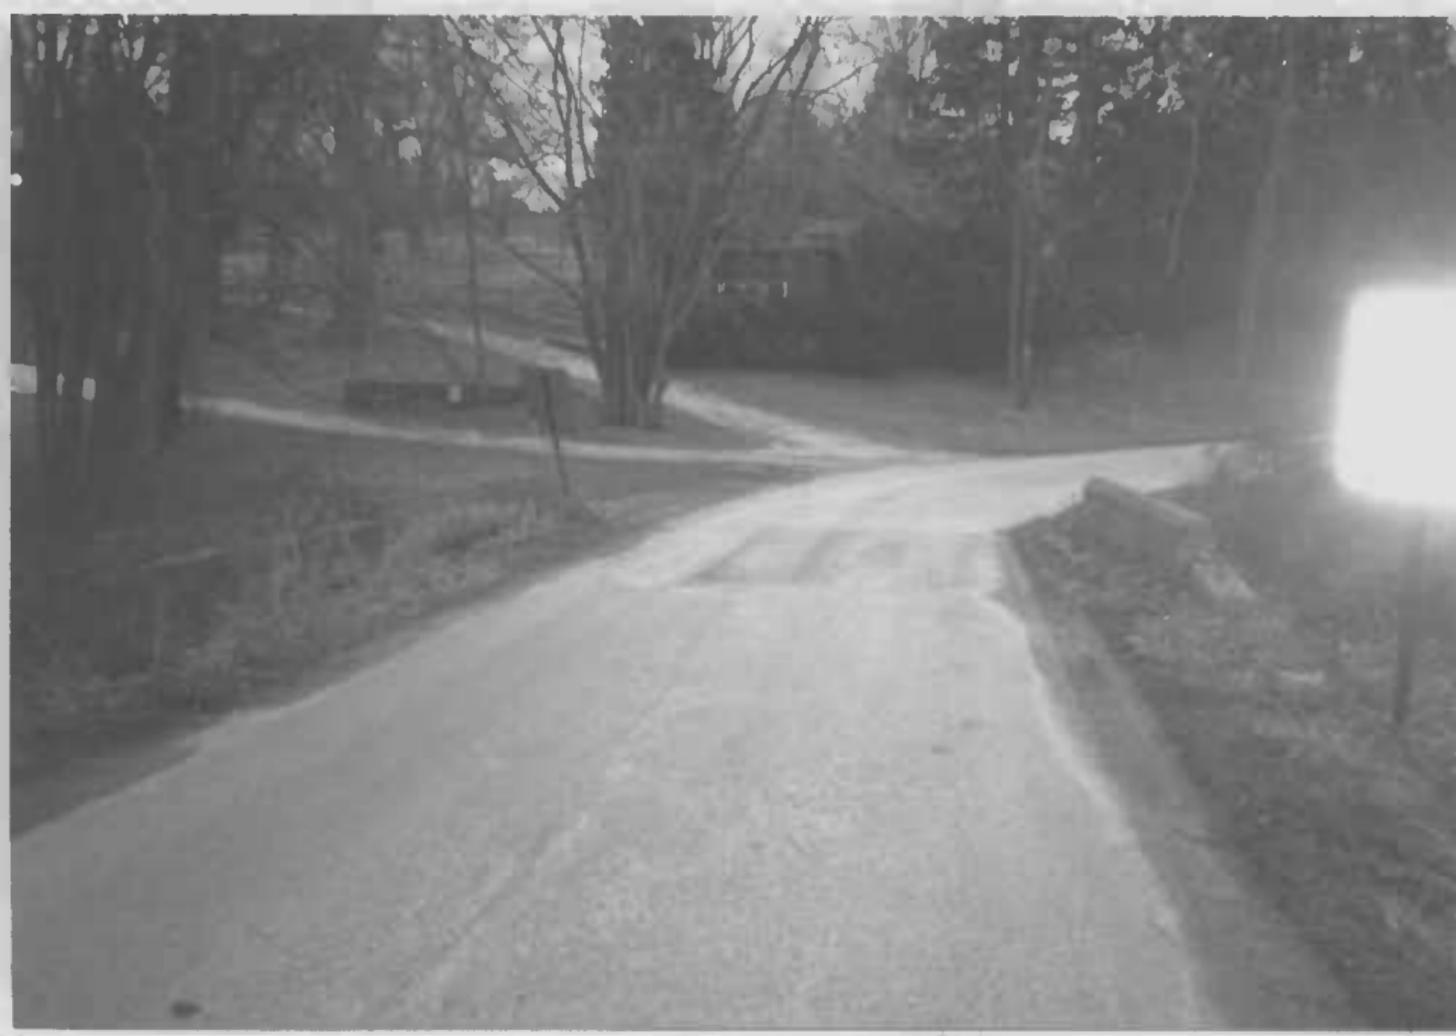
8. 2 of 5

7. north approach

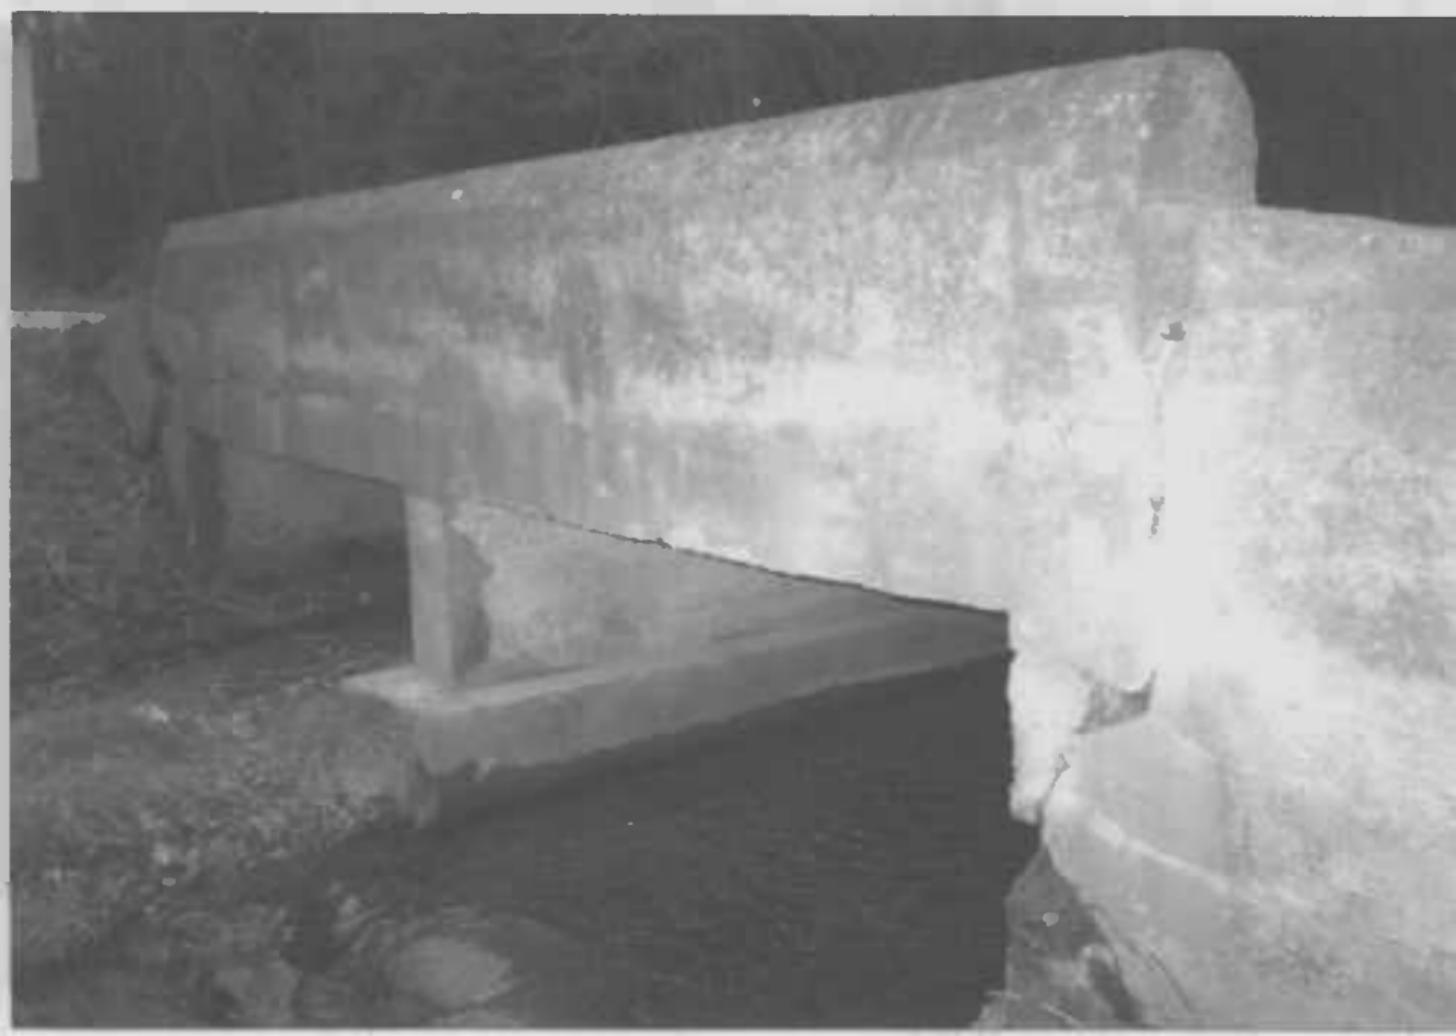
1. BA-2779
2. Mt. Zion Rd over Branch
3. Baltimore County of Piney
4. Eric Guffitts Run
(30391)
5. 3/97
6. MD SHPO
7. detail of abutments
8. 5 of 5

According to the 1995 inspection report, this structure is in satisfactory condition. The south approach is 7/8 inch higher than the bridge. The deck contains diagonal cracks extending from the northwest corner of the bridge into the west parapet. There is also an area of concrete deterioration at the northwest corner of the slab with exposed reinforcing bars. Also, the concrete parapets have some small spalls and scale. The concrete is cracking in the abutments and wing walls. The southeast and northeast wing walls have separated from the abutments and rotated a few inches forward. The south abutment has three (3) spalls, and the north abutment has some cracking.

The bridge retains much of the character-defining elements of its type, including the slab, parapets, abutments, wing walls, and pier. However, the integrity of these elements has been compromised by severe deterioration. The northeast and southeast wing walls have separated from the structure, and the slab and abutments have considerable deterioration.
