Maryland Historical Trust

Maryland Inventory of Historic Properties number: BA-2847

SHA Bridge No. B0065

Bridge name Mt. Zion Road over Piney Run

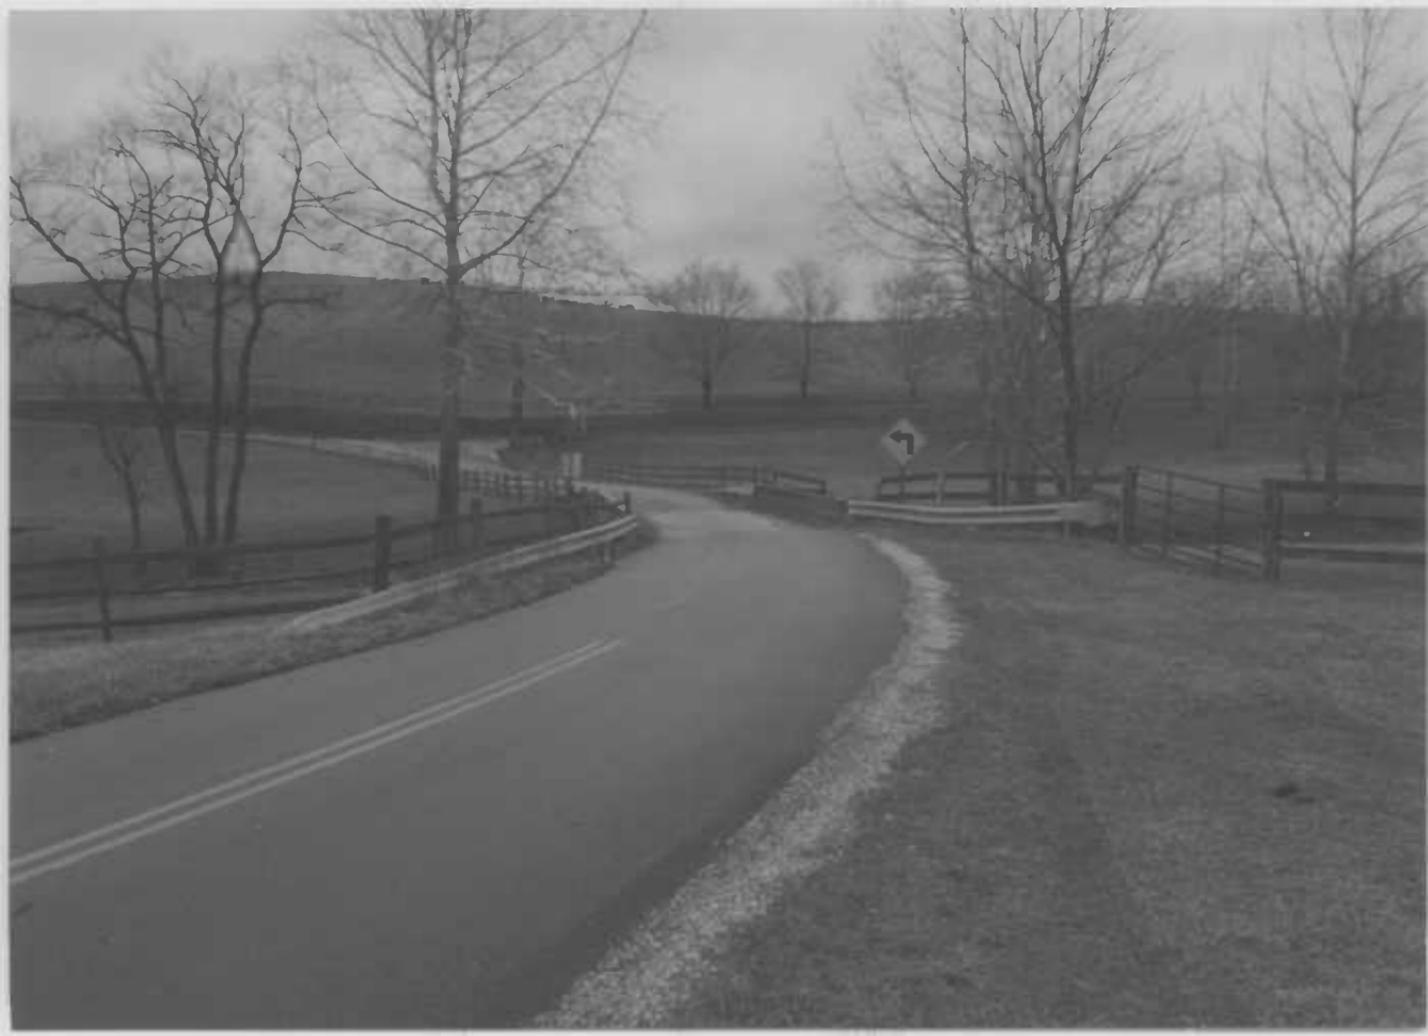
Number 139 of 394

Description SOUTH APPROACH LOOKING NORTH

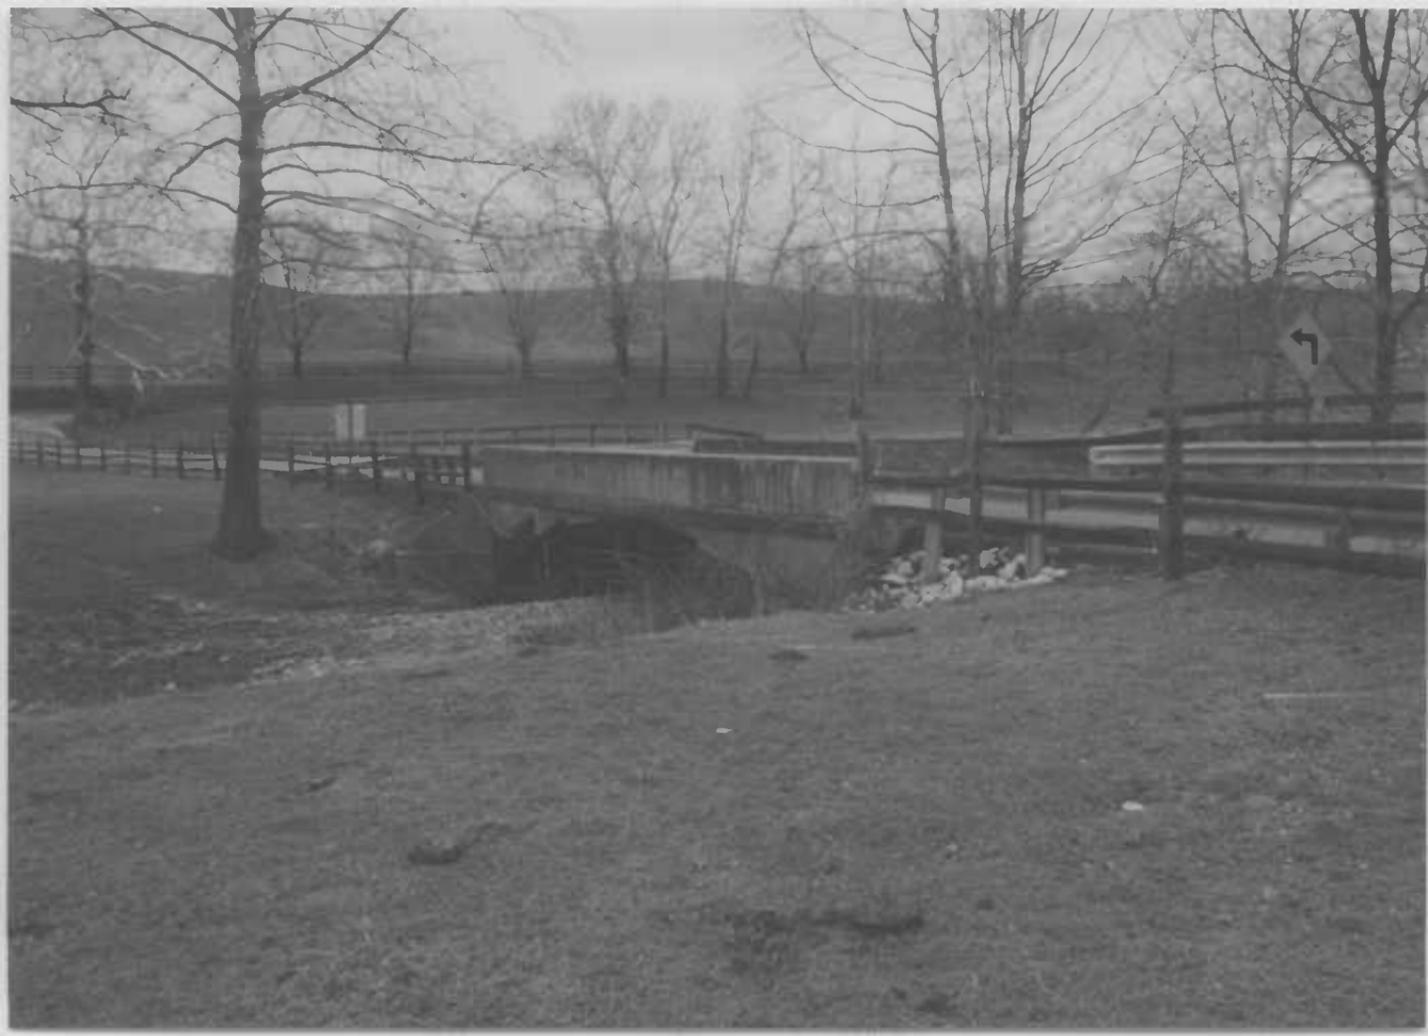
Number 235 of 374

Bridge B0065 is a single span filled concrete arch bridge. The total length of the bridge is 44 feet with the clear span measuring 40 feet. The spandrel walls are approximately 6 feet tall and 20 feet wide. The bridge has a rise of approximately 5 feet 4 inches from springline to crown. There is a clear roadway width of 16 feet 4 inches, with an overall bridge width of 17 feet 8 inches. The arch barrel has extreme deterioration, reinforcement bar exposure, cracking and efflorescence. There are large areas of scale and reinforcement bar exposure at the joint of the parapet and spandrel wall. The spandrel walls have large areas of cracking and patched areas from previous repairs. In addition, the walls have areas of efflorescence. According to a 1995 inspection report, the bridge is in fair condition with a sufficiency rating of 35.2.

Bridge B0065 retains one of its original parapets. There is a single section running the length of the bridge including the wingwalls. This single section has 6 incised panels measuring 5 feet by 1 foot. There is extreme scaling on one of the caps of the parapets and cracking throughout the panels.

Description WEST ELEVATION LOOKING
NORTHEAST

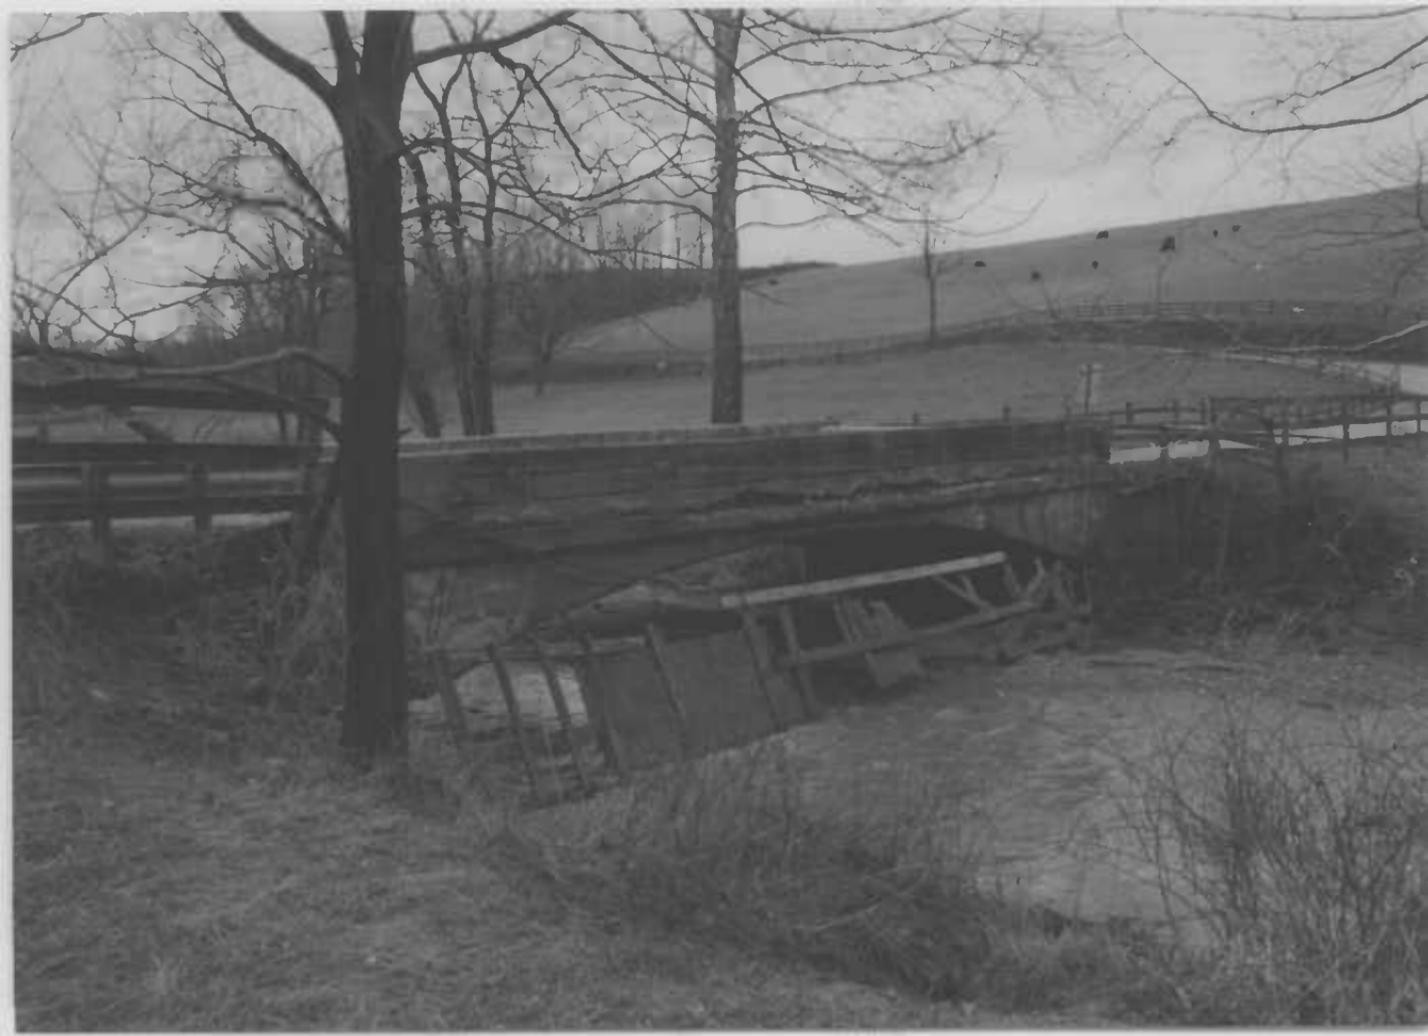
Number 3 of 374

At some unknown date, the eastern parapet was replaced. Though major patching of the bridge has occurred, there have been no major alterations to this structure.

Description EAST ELEVATION LOOKING
NORTHWEST

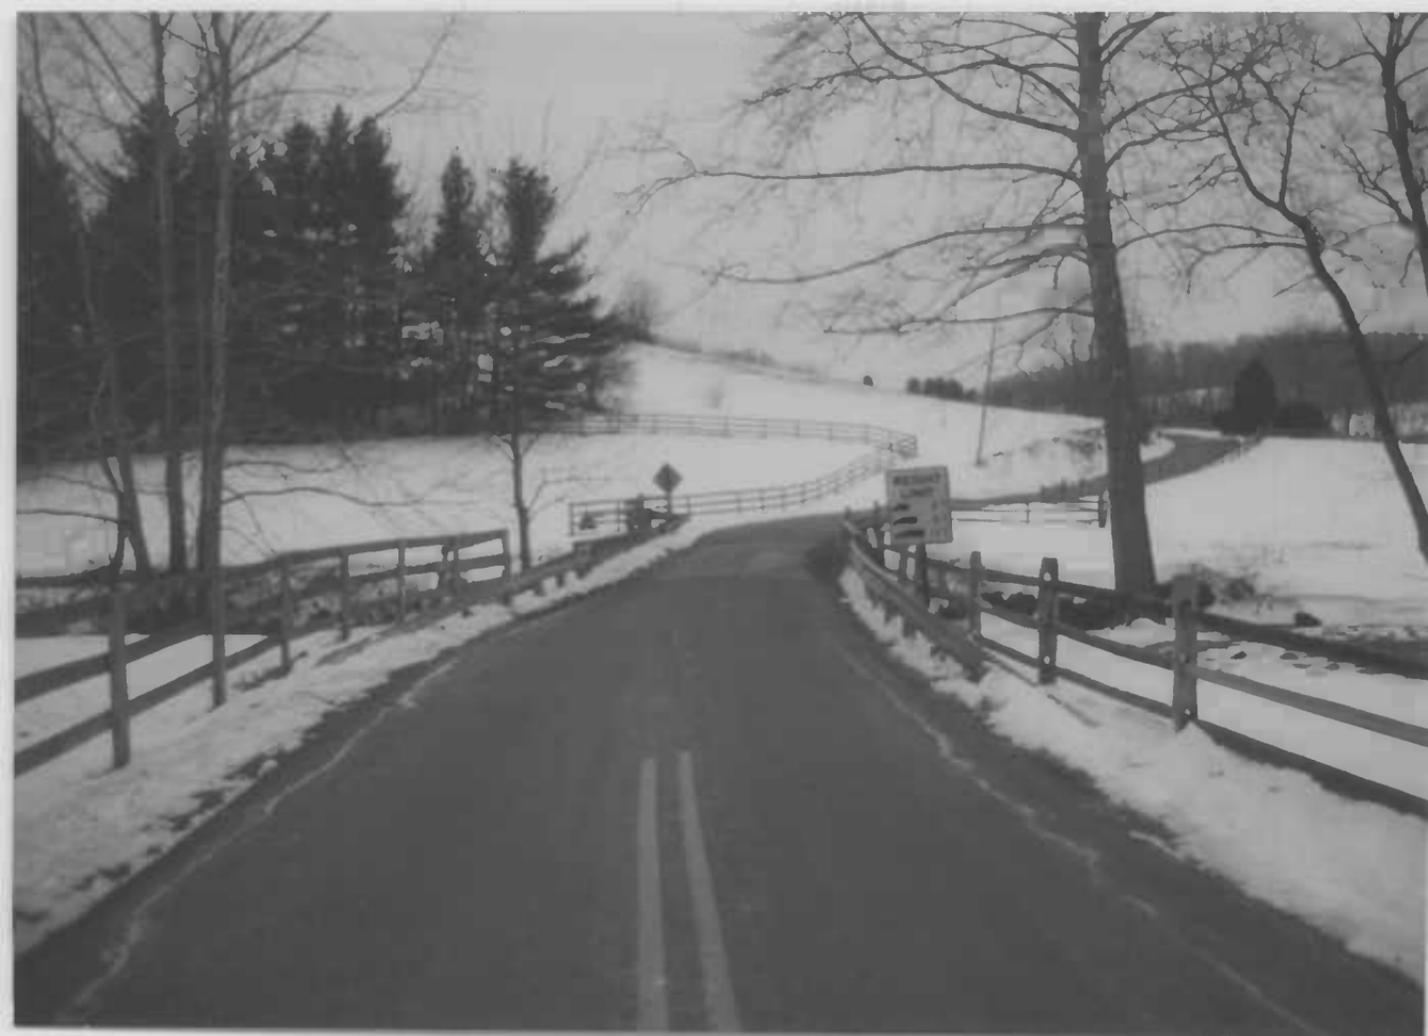
Number 4 of 37

Description SOUTH APPROACH LOOKING
NORTH
