**Maryland Historical Trust**  
**Inventory of Historic Properties Form**  
**Maryland Route 30/Manchester Bypass Project**

historic Rhodes Farm

Survey No. CARR-1500

CARR-1500  
Rhodes Farm  
Melrose vicinity  
Carroll County  
Manchester Quad

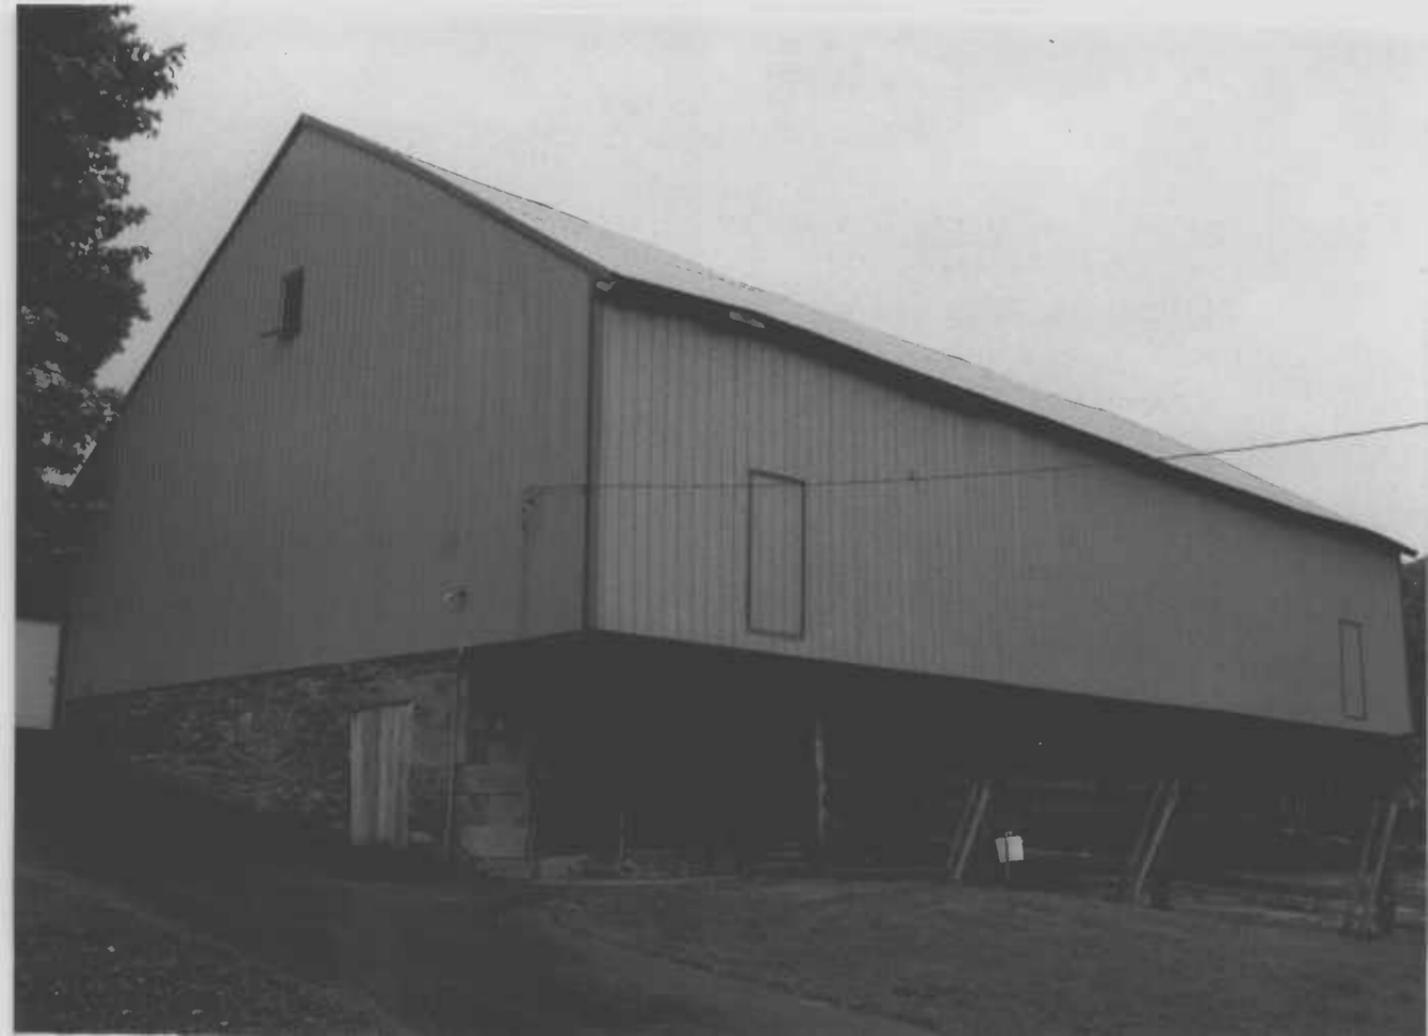
1. CARR: 1500
2. Carroll County
3. Madeleine Scheerer
4. June 1996
5. Maryland SHPO
6. Raver House  
7314 Hanover Pike  
Northeast elevation - barn
7. 1/6

The two-and-a-half story, fieldstone foundation bank barn has been covered in metal sheets on its upper levels, obscuring the original fabric. There are traces of logs in the upper level but evidence points to the structure being a fieldstone barn. The unsupported forebay faces west and the metal gable roof is parallel to the road. The seven bay by four bay structure retains its original form despite alterations. A unique feature of the barn is the side ramp on the south elevation.

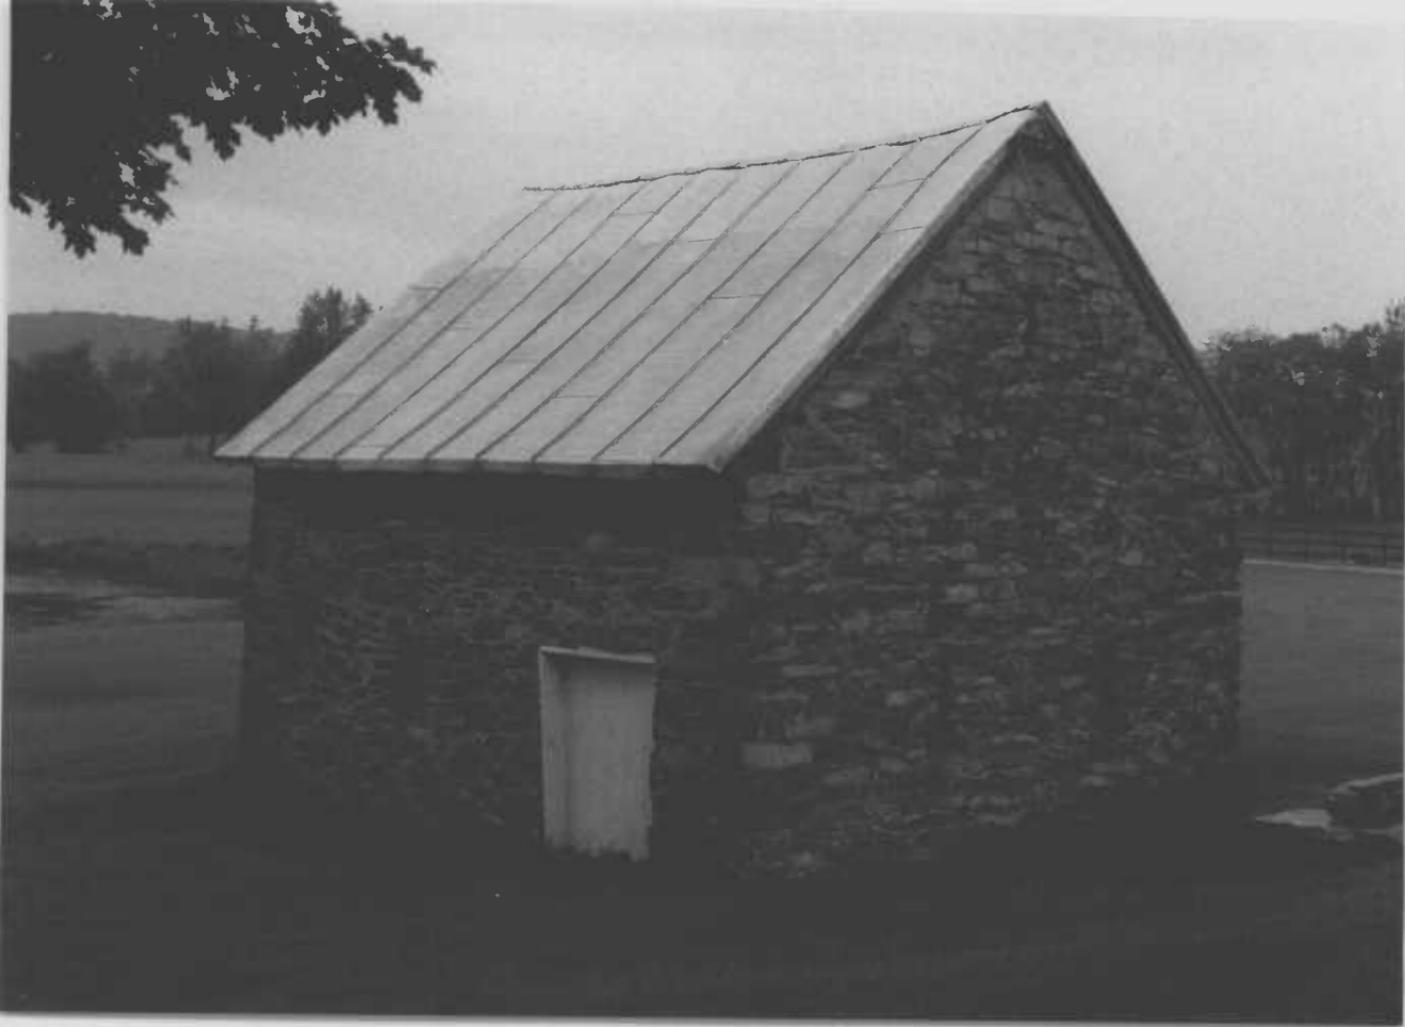
1. CARR 1500
2. Carroll County
3. Madeline Scheerer
4. June 1996
5. Maryland SHPO
6. Raver House  
7314 Hanover Pike  
SW Elevation - Springhouse
7. 216

This 1-1/2-story structure is 2 bays by 2 bays with a metal gable roof parallel to the road. Fenestration consists of two slits cut into the fieldstone walls on north, east and south elevations and one window slit and plank door on the principal [west] facade. There are window slits in the loft area gable ends. Brick remains south of the building could either be a well or bakehouse chimney. This may have been the original house used until the main house was built. There is a spring within the building and a loft on the upper story, according to the owner. The building may have been used as a spring house or summer house after the main house was erected.

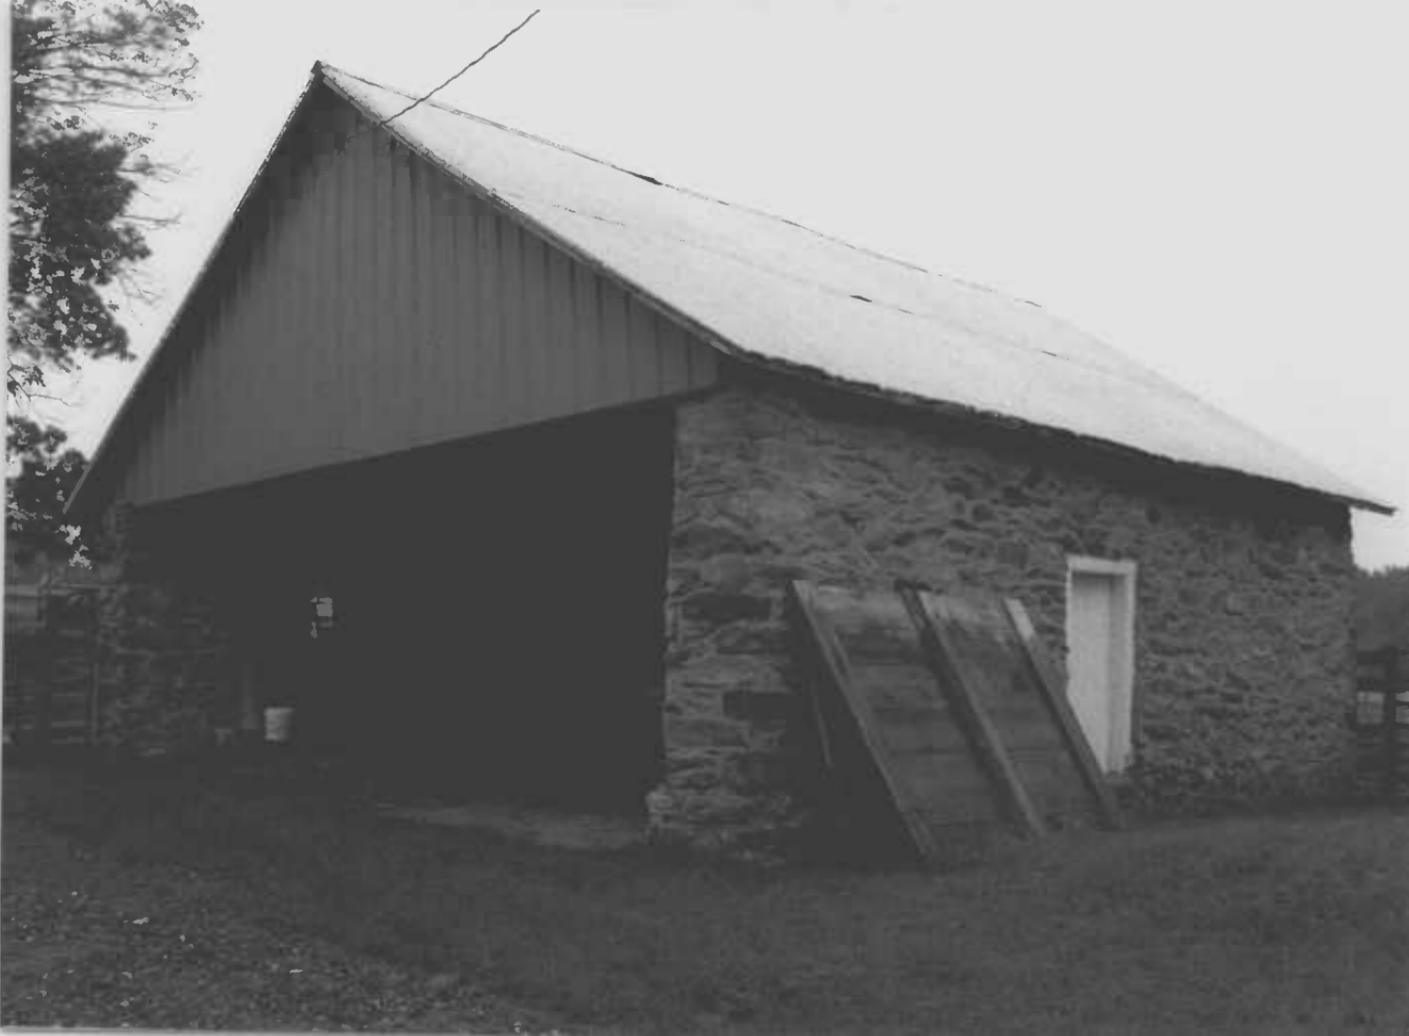
1. CARR 1500
2. Carroll County
3. Madeline Scheerer
4. June 1996
5. Maryland SHPD
6. Raver House
  - 7 314 Hanover Pike
  - NE elevation - small house
- 7 3/6

The one-and-a-half story, three bay by two bay fieldstone structure west of the barn may have been erected as a house to shelter farm workers or members of the extended family. The principal [east] facade wall has been removed as have the sash. Metal sheeting replaced the original cedar shingles on the gable roof which is perpendicular to the road. There are three casement windows on the remaining elevations, one on each side, and a wide plank door on the north elevation. There is no evidence of a spring within the structure or nearby, likely eliminating this structure as a potential spring house. Though there is no indication of an extant chimney or fireplace hearth, it may originally have had an exterior fieldstone chimney. It is possible that the missing wall on the east side contained the chimney and fireplace hearth, which would account for the lack of these features. The structure is less refined in its construction than the building labeled as the Fieldstone House, which suggests that it may have predated that structure or been used for servants.

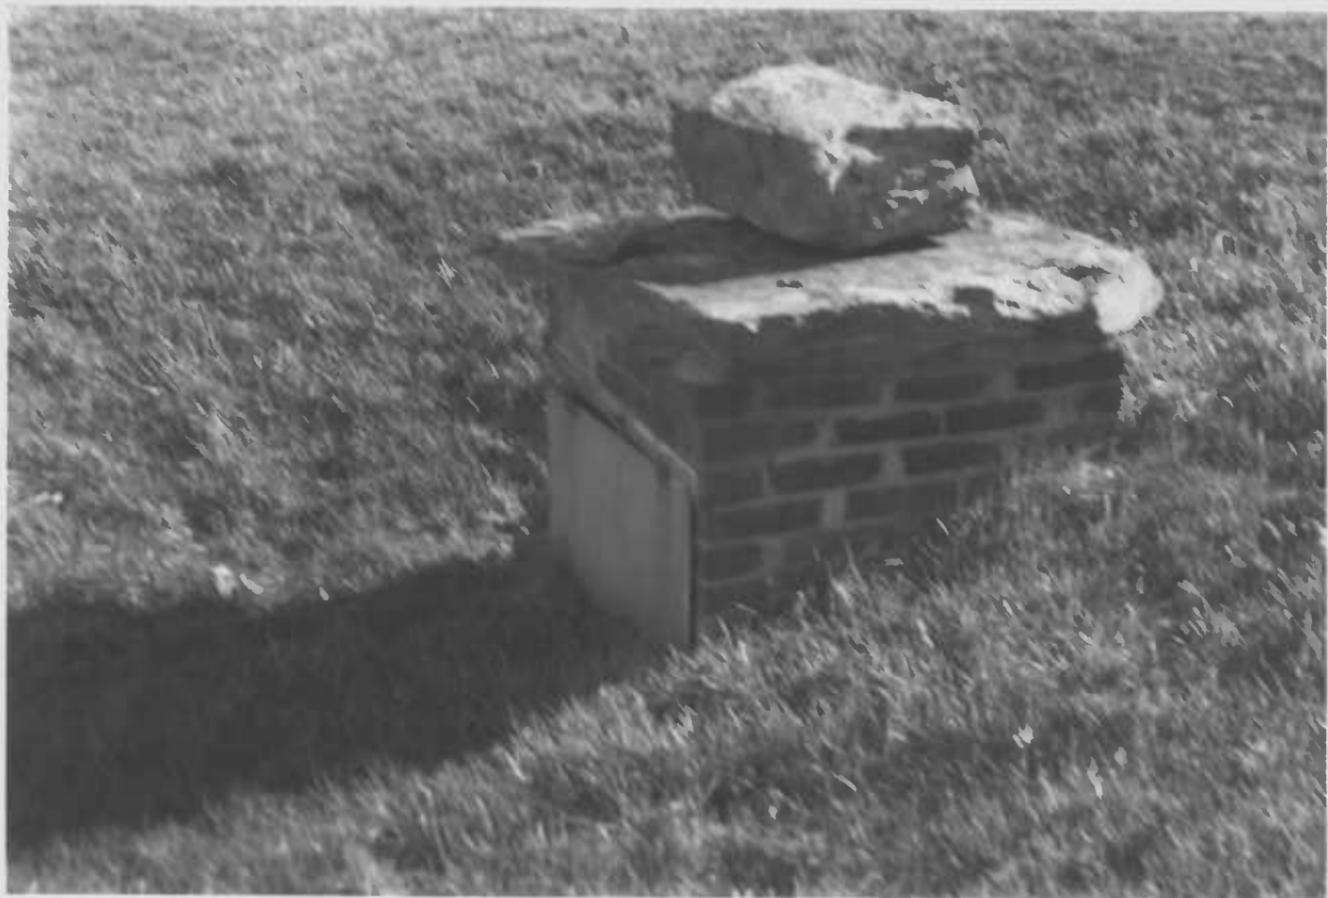
#4

1. CARR 1500
2. Carroll County
3. Madeleine Scheeper
4. March. 1997
5. Maryland SHPO
6. Rhodes Farm  
Chimney remains/well site
7. 5/6

According to the owner, the original well for the Fieldstone House was located to its southwest. The area holds a fieldstone ruin covered in high grass with an indent in the center that may have been the original well. A later well was dug on the south side of the Fieldstone House and its presence is indicated by the remains of a brick chimney covering the well site. The chimney may have been part of a mid-19th-c. smokehouse, but the owner has indicated that there was a well in that area prior to the erection of the brick structure.

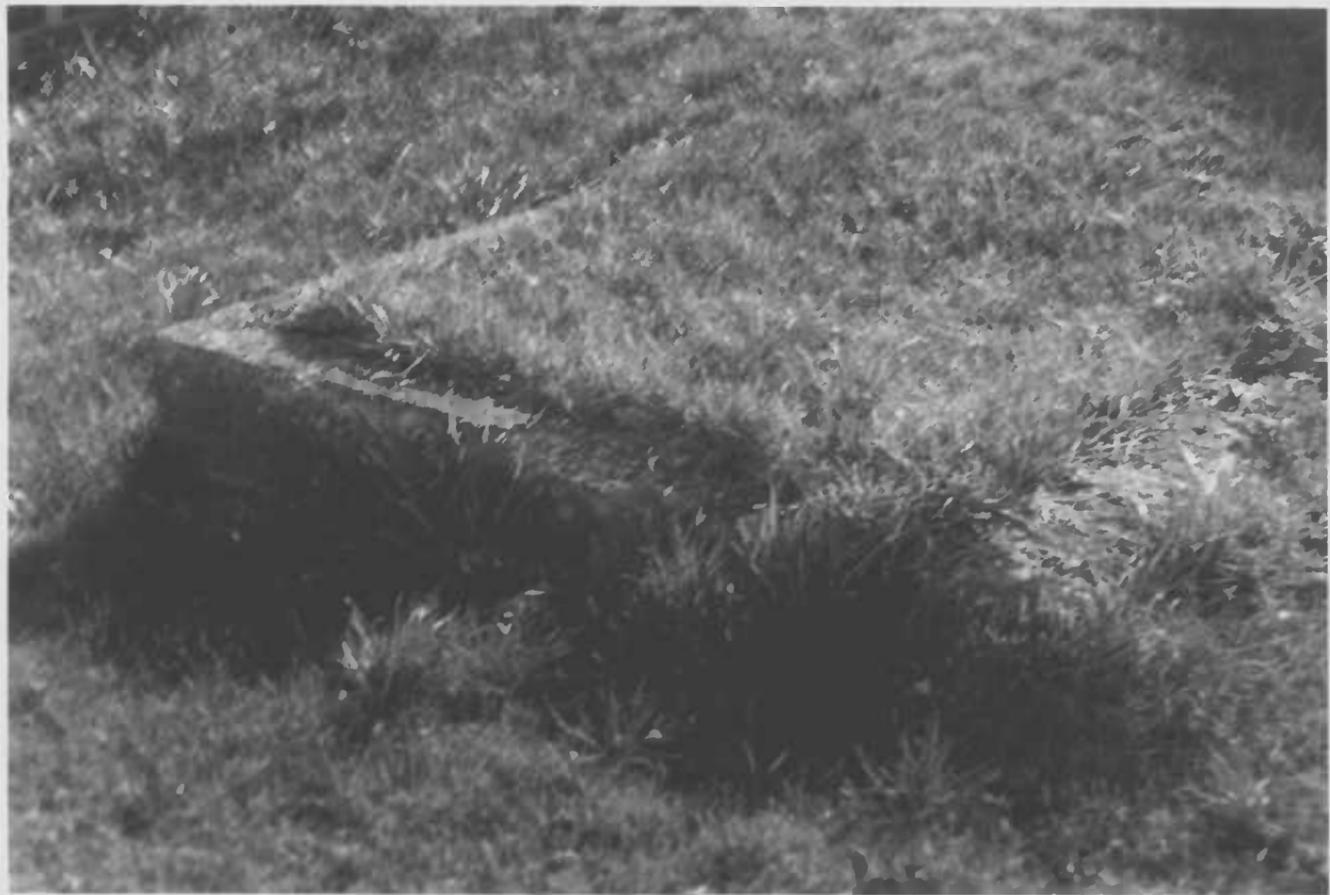
well - w of Fieldstone House
