MD 482 over east Branch

MARYLAND INVENTORY OF HISTORIC BRIDGES
HISTORIC BRIDGE INVENTORY
MARYLAND STATE HIGHWAY ADMINISTRATION/
MARYLAND HISTORICAL TRUST

MHT No. CARR-1559

SHA Bridge No. 6036 Bridge name MD 482 over East Branch

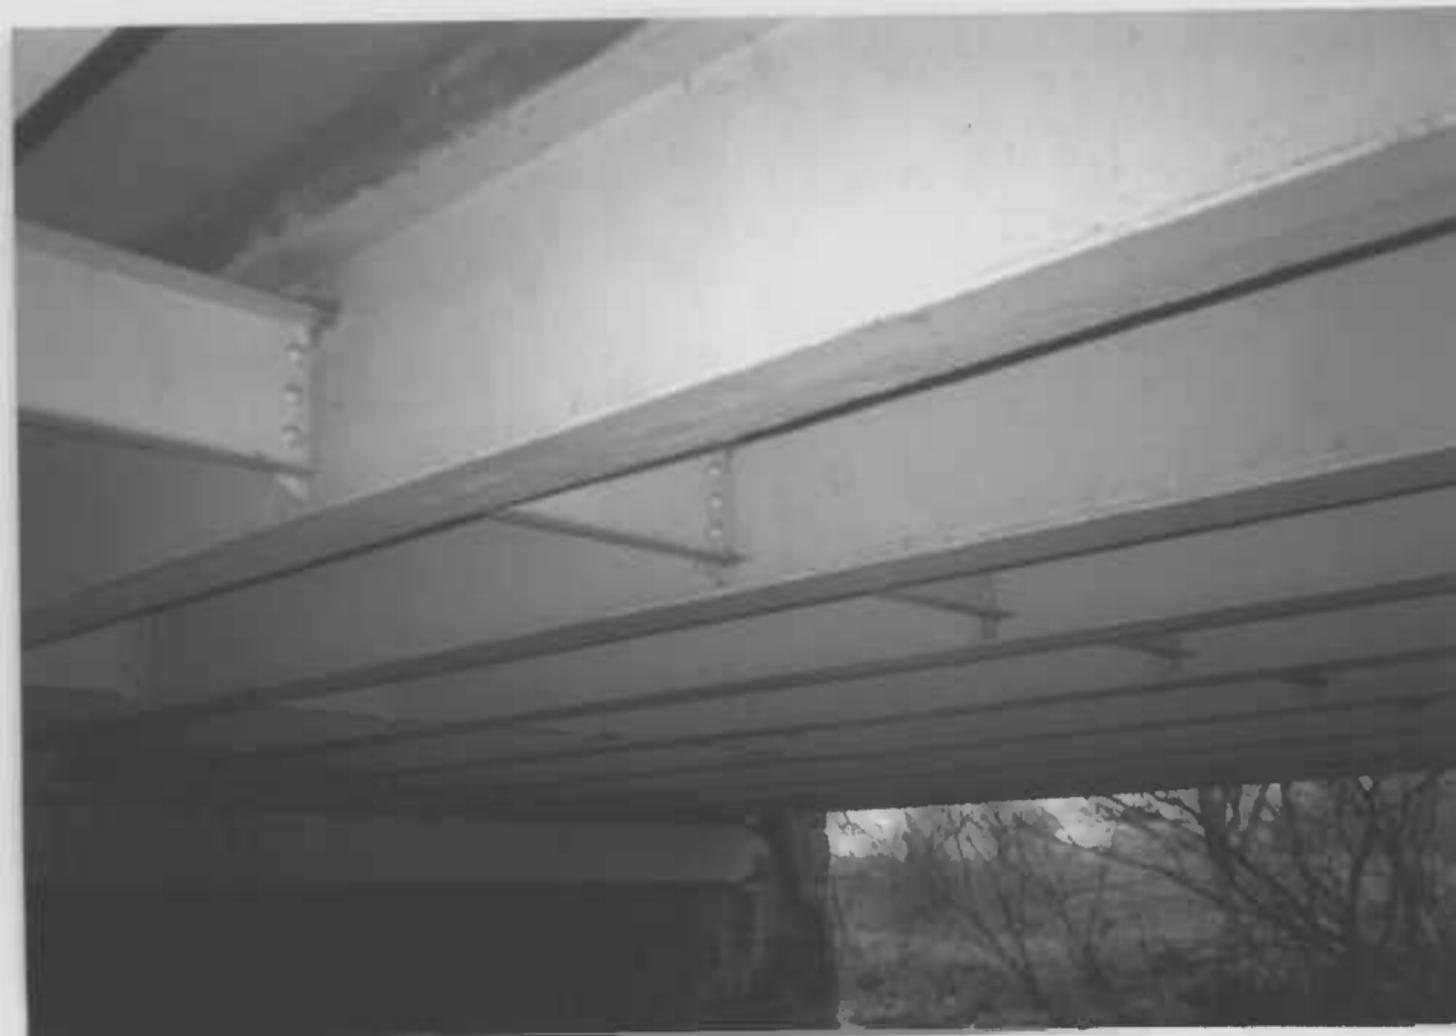
1. CARR-1559
2. MD 482 over EAST Branch
(6036)
3. Carroll
4. Eric Griffiths
5. 3-97
6. MD SHPO
7. detail of Girders under
Bridge
8. 10+6

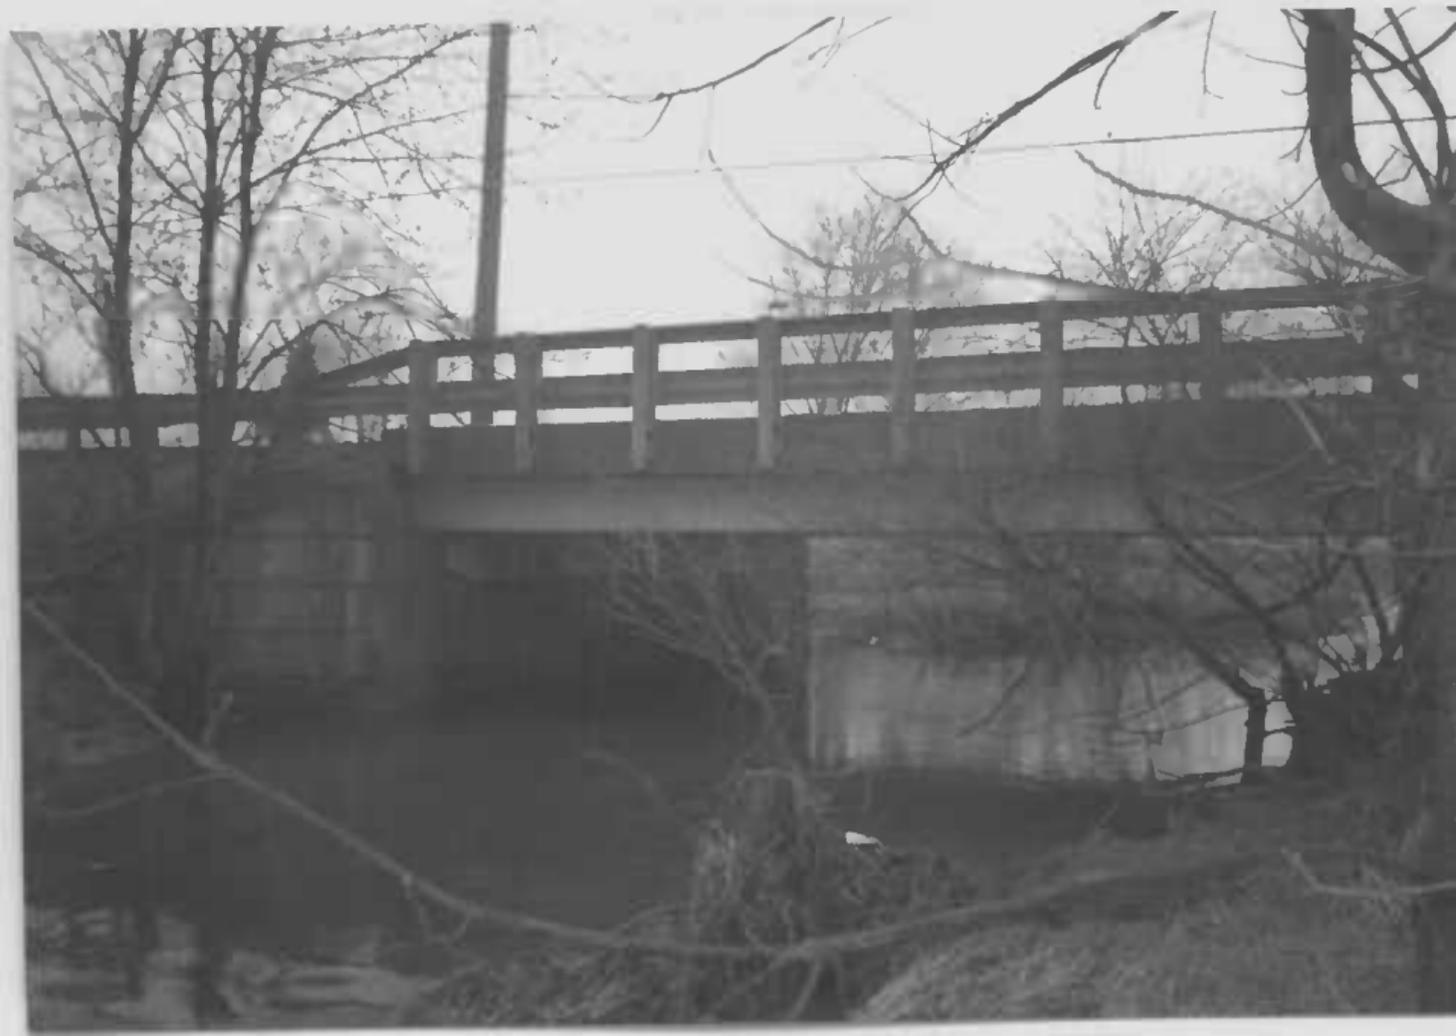
1. CARR - 1559
2. MD 482 over EAST Branch
(6036)
3. Carroll
4. Eric Griffiths
5. 3-97
6. MD SHPO
7. South Elevation of Bridge
8. 2 of 6

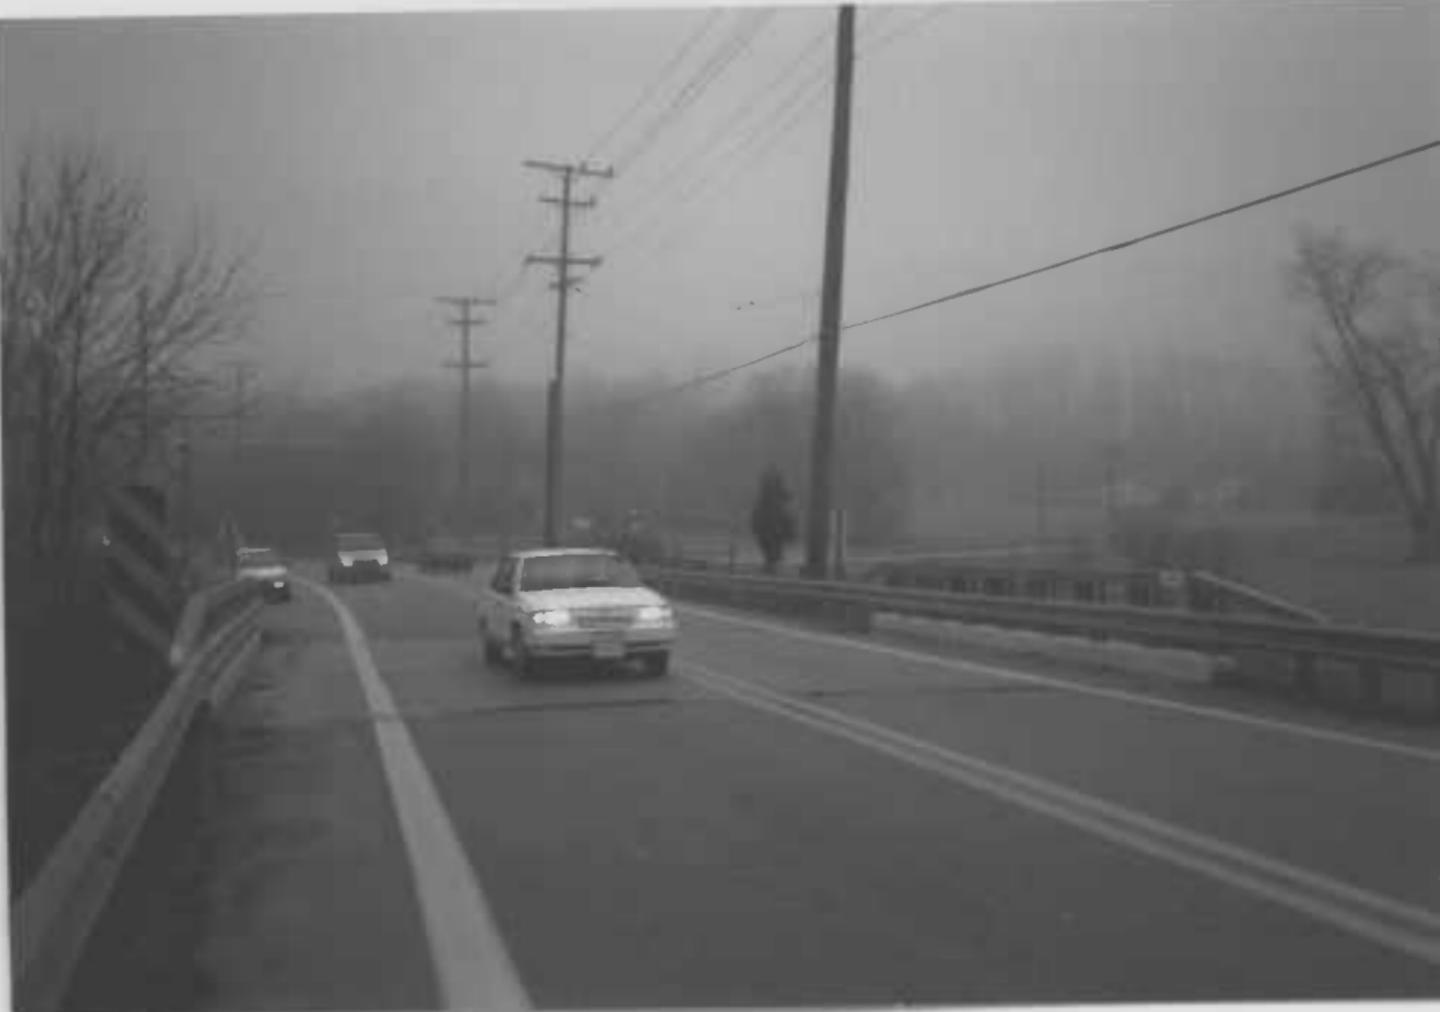
1. CARR-1559
2. MD 482 over EAST BRANCH
(6036)
3. Carroll
4. Eric Griffiths
5. 3-97
6. MD SHPO
7. West Approach
8. 30+ 4

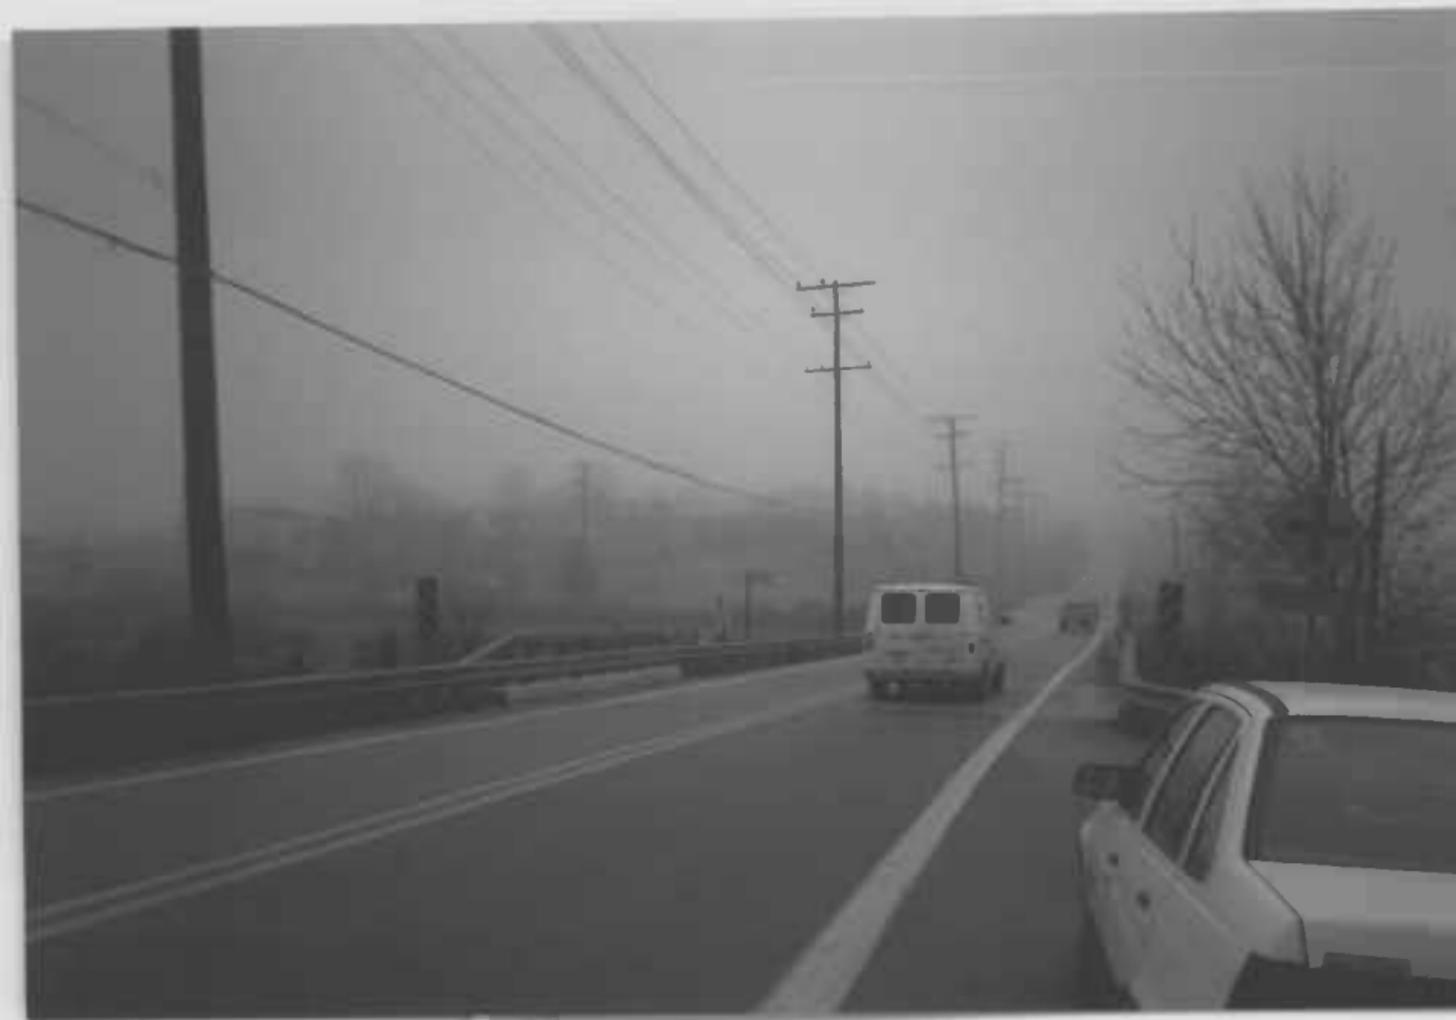
1. CARR-1559
2. MD 482 over East Branch
(6036)
3. Carroll
4. Eric Griffiths
5. 3-97
6. MD SHPD
7. EAST Approach
8. 4 of 6

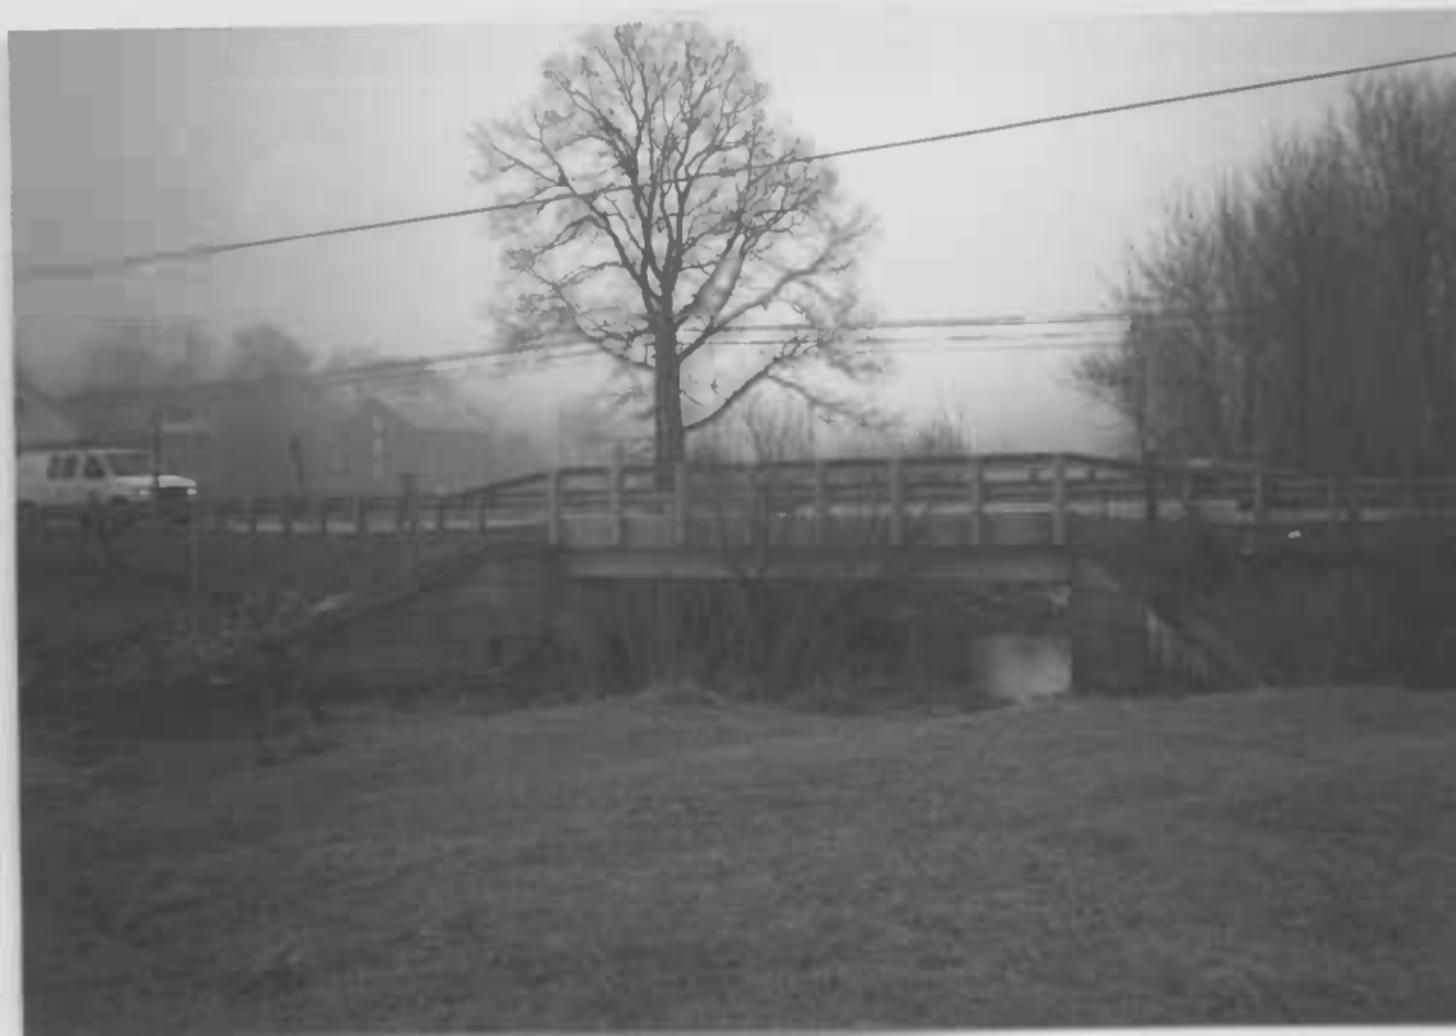
1. CARR - 1559
2. MD 482 over East Branch
3. Carroll (6036)
4. Eric Griffiths
5. 3-97
6. MD SHPD
7. North Elcuation
8. 5 of 6

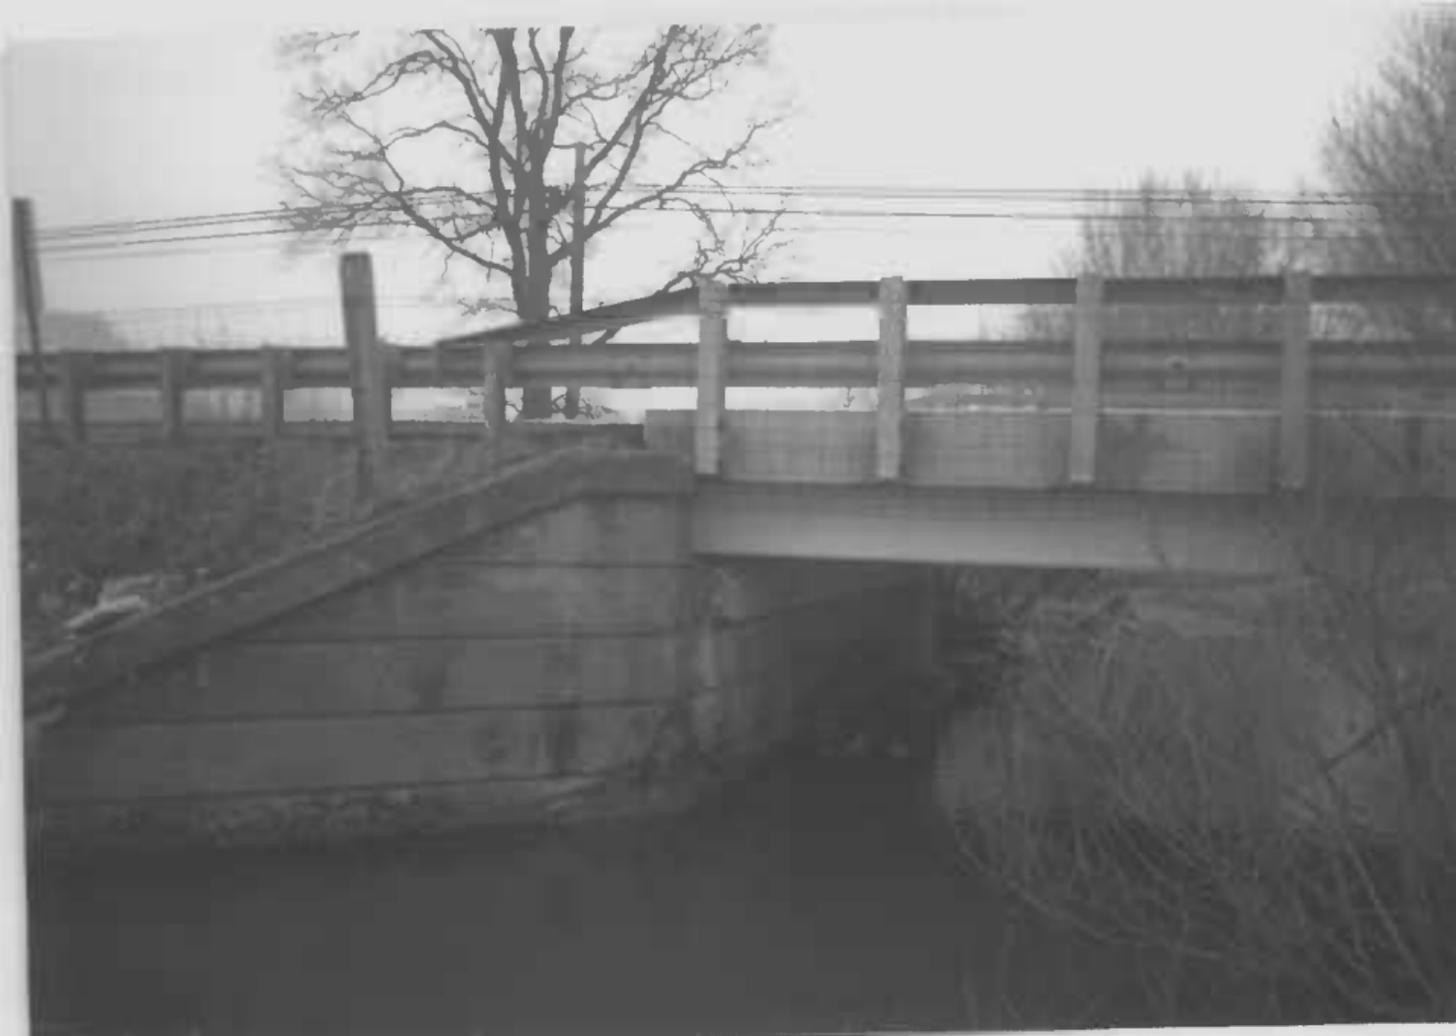
According to the 1995 inspection report, this structure is in fair condition with minor section loss, cracking, spalling, and scour. The girders have minor pitting and section loss in the web areas and bottom flanges. The concrete surface has some light surface erosion. The concrete is in poor condition in the substructure. The abutments have spalling and horizontal cracking. There is heavy spalling at the west abutment and wing wall. There is also scour along the northeast wing wall and the west abutment.

1. CARR - 1559
2. MD 482 over East BRANCH
(6036)
3. Carroll
4. Eric Griffiths
5. 3-97
6. MD SHPD
7. Condition of Northeast Wingwall
8. 60 of 6

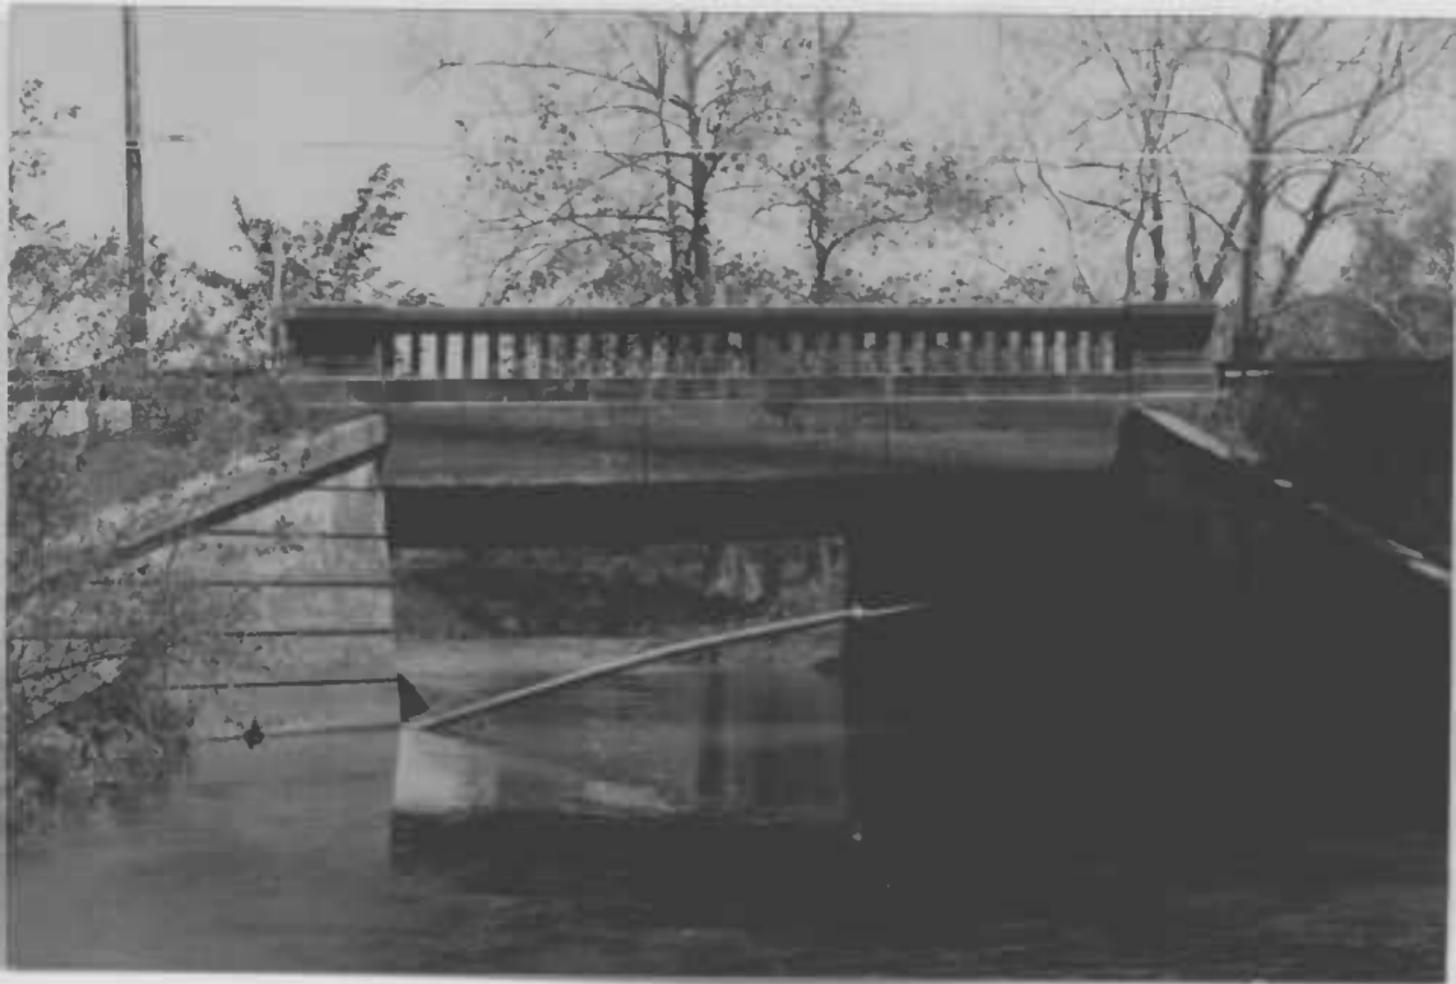
I.D PHOTO

Looking at S. end

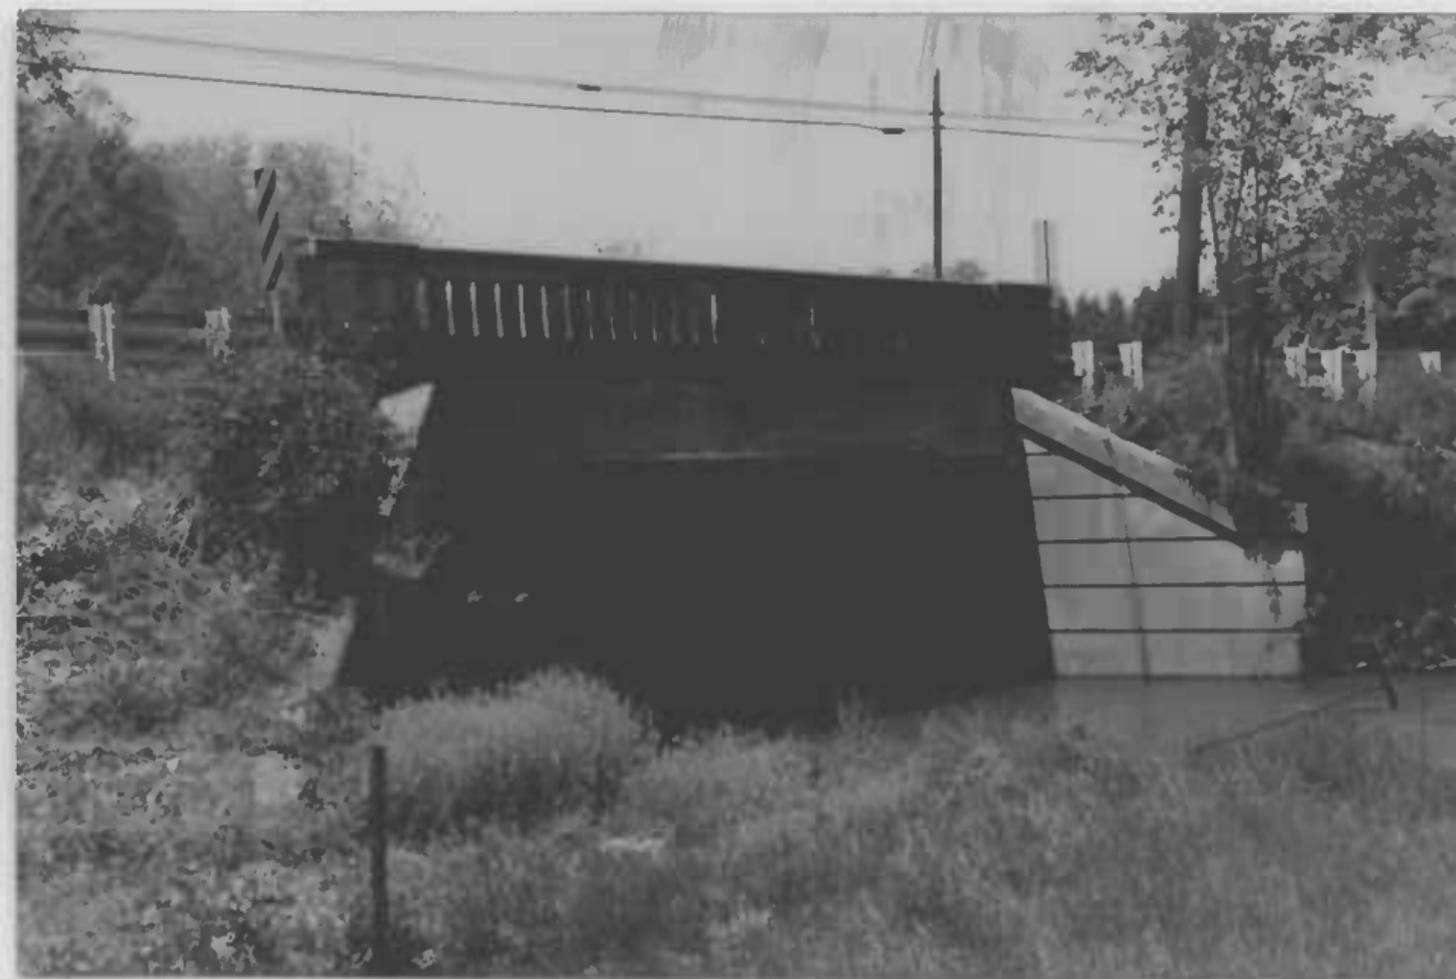
I. D. PHOTO

Looking at N. end
