CT-47

BRISCOE HOUSE

INVENTORY FORM FOR STATE HISTORIC SITES SURVEY

Stonesby (Briscoe House)

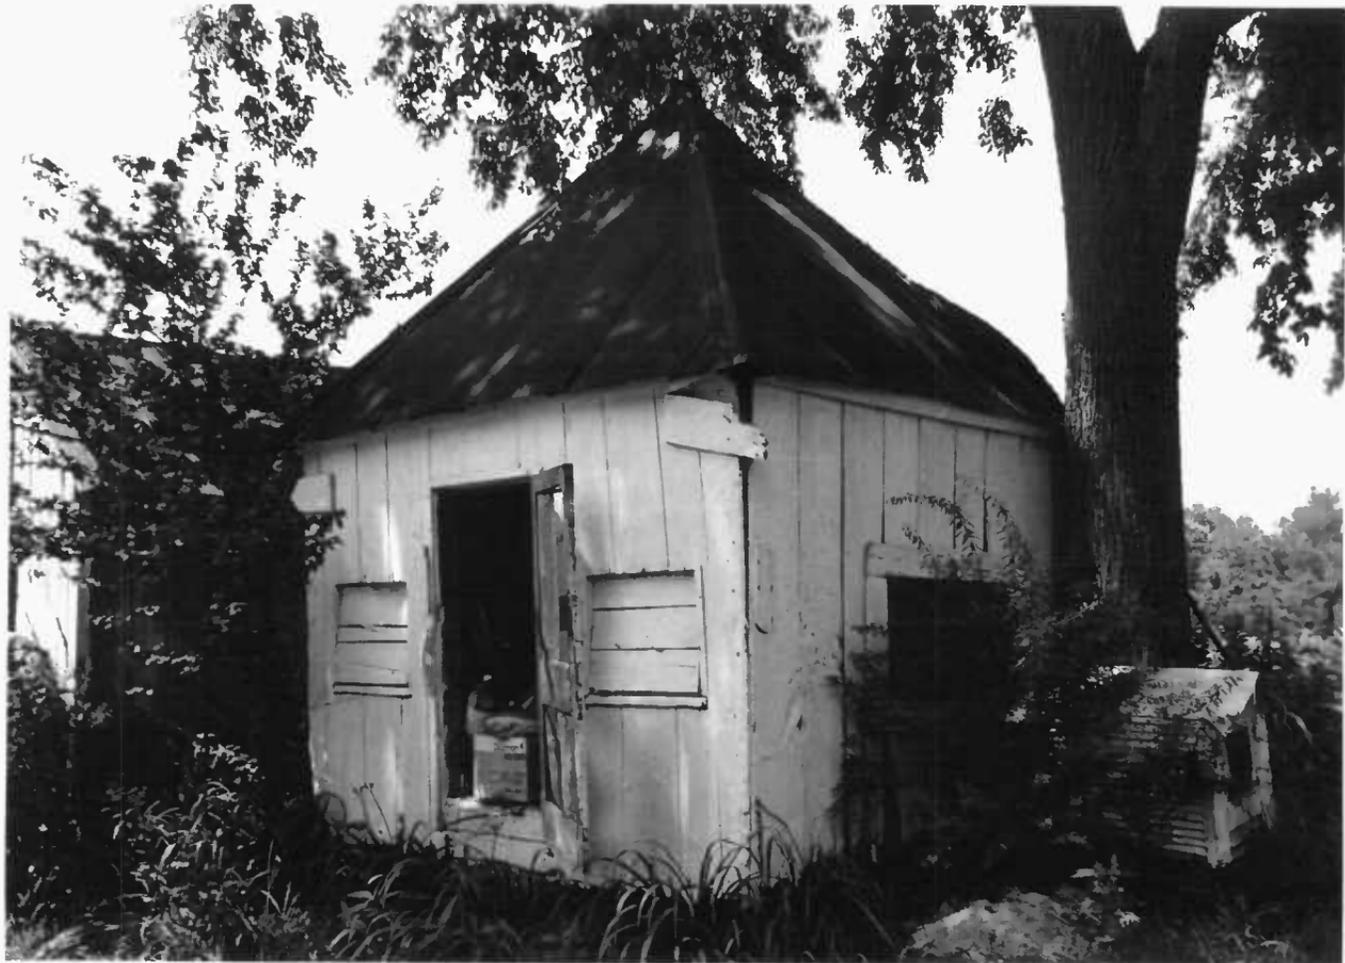
CT-47
STONKS BY
DAIRY
S.E.

This building also has a post-and-beam frame. The interior is lath and plaster; the exterior is covered with clapboards attached with cut nails.

Although it is presently obstructed, the present owner says that there is a small subterranean chamber below the floor of this little one-room structure.

The roof is tetrahedral. The supporting block is 9'3" square. The building rests on a 1' brick foundation and there are 75" between the sill and the eaves. The building is vented by a door and several tiny windows; in the front (west), the door measures 57" x 29" and the windows are 24" x 19".
