Fair Hill Natural Resources Management Area

MIHP # CE-1434

Maryland Inventory of Historic Properties Form

Inventory No. CE-1434

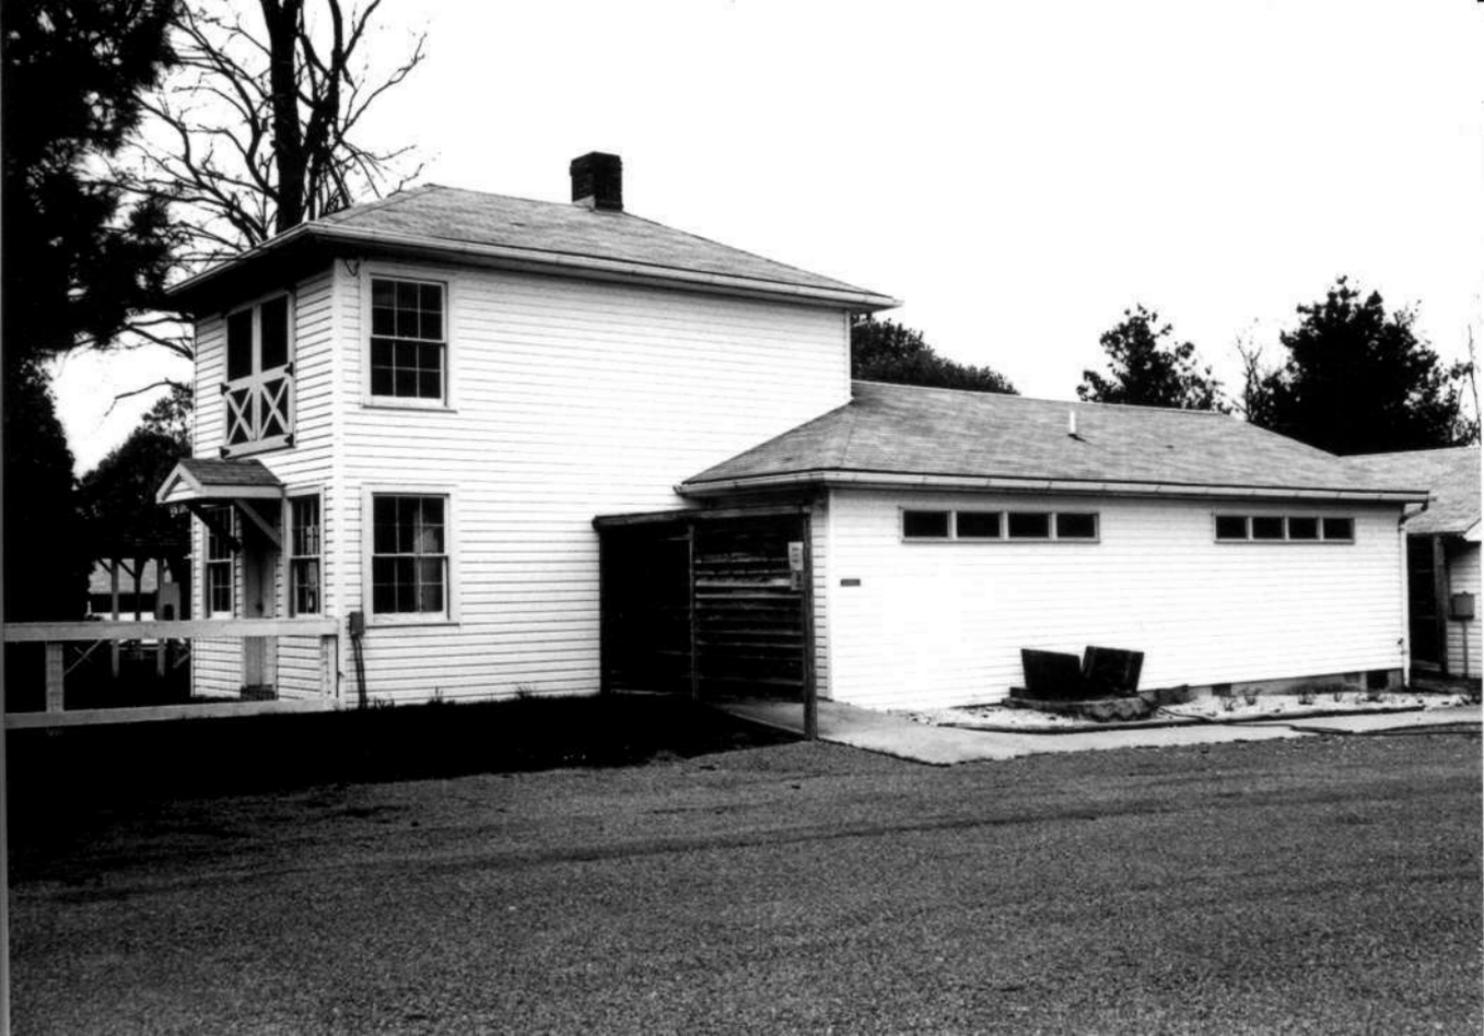
3/40

Secretary's office, looking NW

main block, constructed ca. 1935, contains offices. The one-story rear wing contains toilets and was constructed in 1988-1989 (Brower personal communication 7/24/2004). The building rests on a concrete foundation and was sheathed in vinyl siding in 1989 (MdDNR DMI 2003). The hipped roof over the main block and the gable roof over the rear wing are sheathed in composition roll roofing. The roof has a wide overhanging eave enclosed in metal. A central doorway is located in the south elevation of the main block. The main entry contains a six panel wood door and is sheltered under a front-gable hood supported by brackets. Paired, narrow, vertical beaded board wood doors with cross panels occupy the center bay on the second story. The windows in the main block are wood-frame, six-over-six-light, double-hung sash units. The rear wing contains modern doors and narrow single-light windows along the eave line. The building is in good condition. Damage to the vinyl siding was noted along the base of the west and south elevations. Holes were noted in the concrete foundation along the rear wing to access pipes.

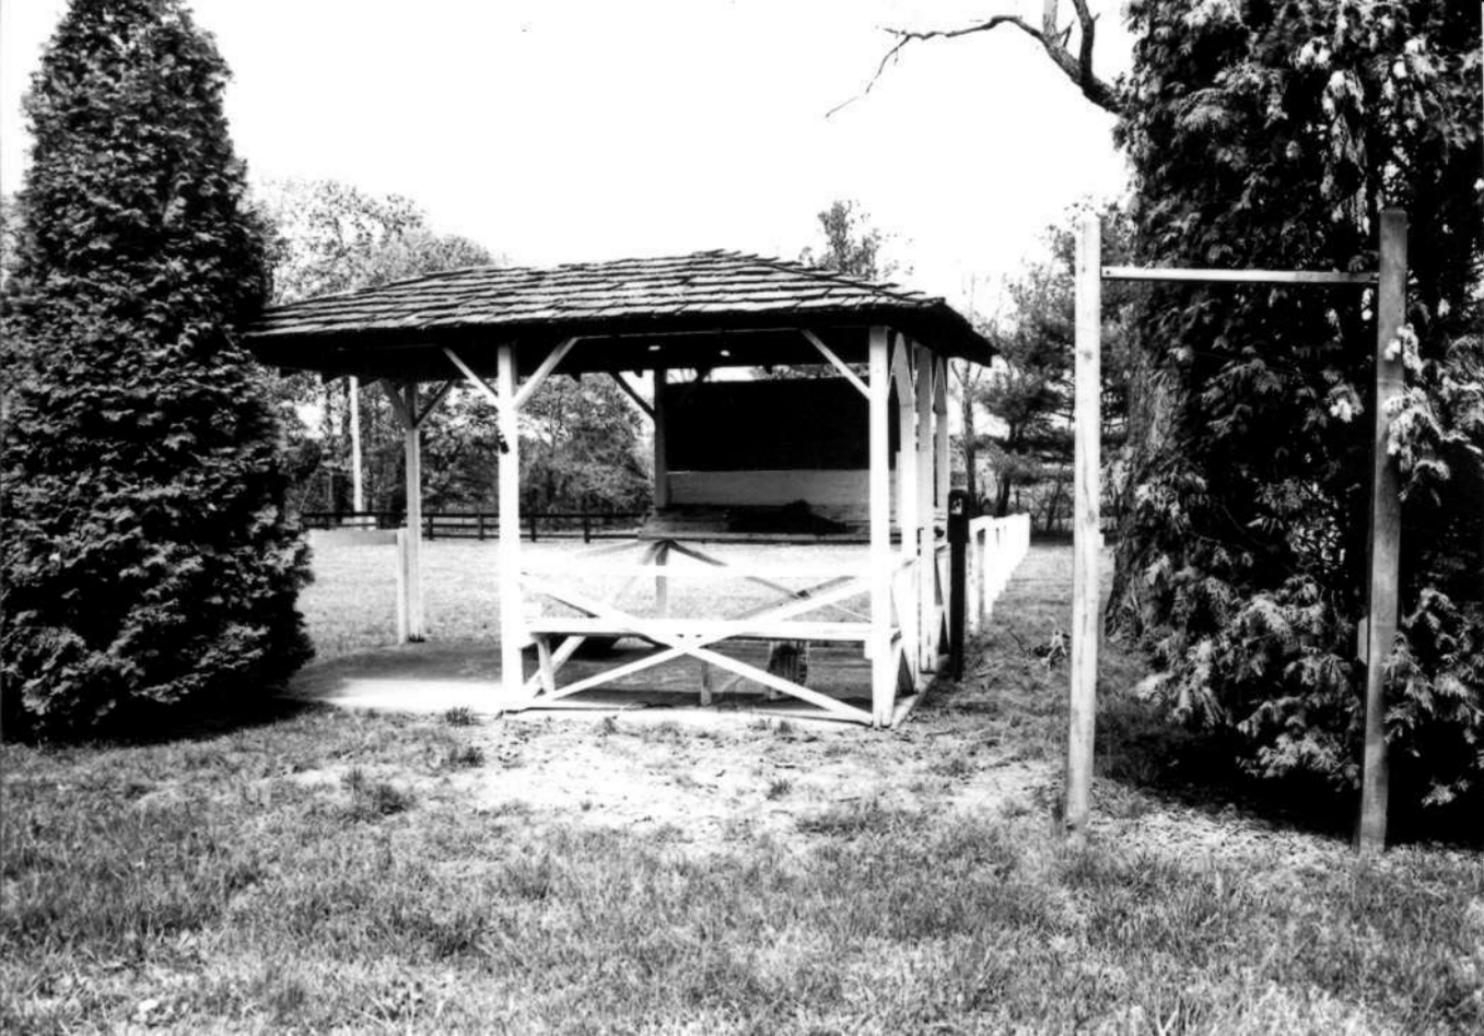
4/40

Jockey Weigh-In Pavilion, looking N

The Jockey Weigh-In Pavilion, constructed ca. 1935, is an open pavilion located west of the Secretary's Office. The hipped roof clad in wood shingles is supported by square wood posts that rest on a concrete slab. A chalkboard is attached to the framing on the north side of the pavilion. The pavilion is in good condition. Large cracks were noted through the concrete floor. The wood shingles exhibited deterioration along the eaves and the ridgeline.

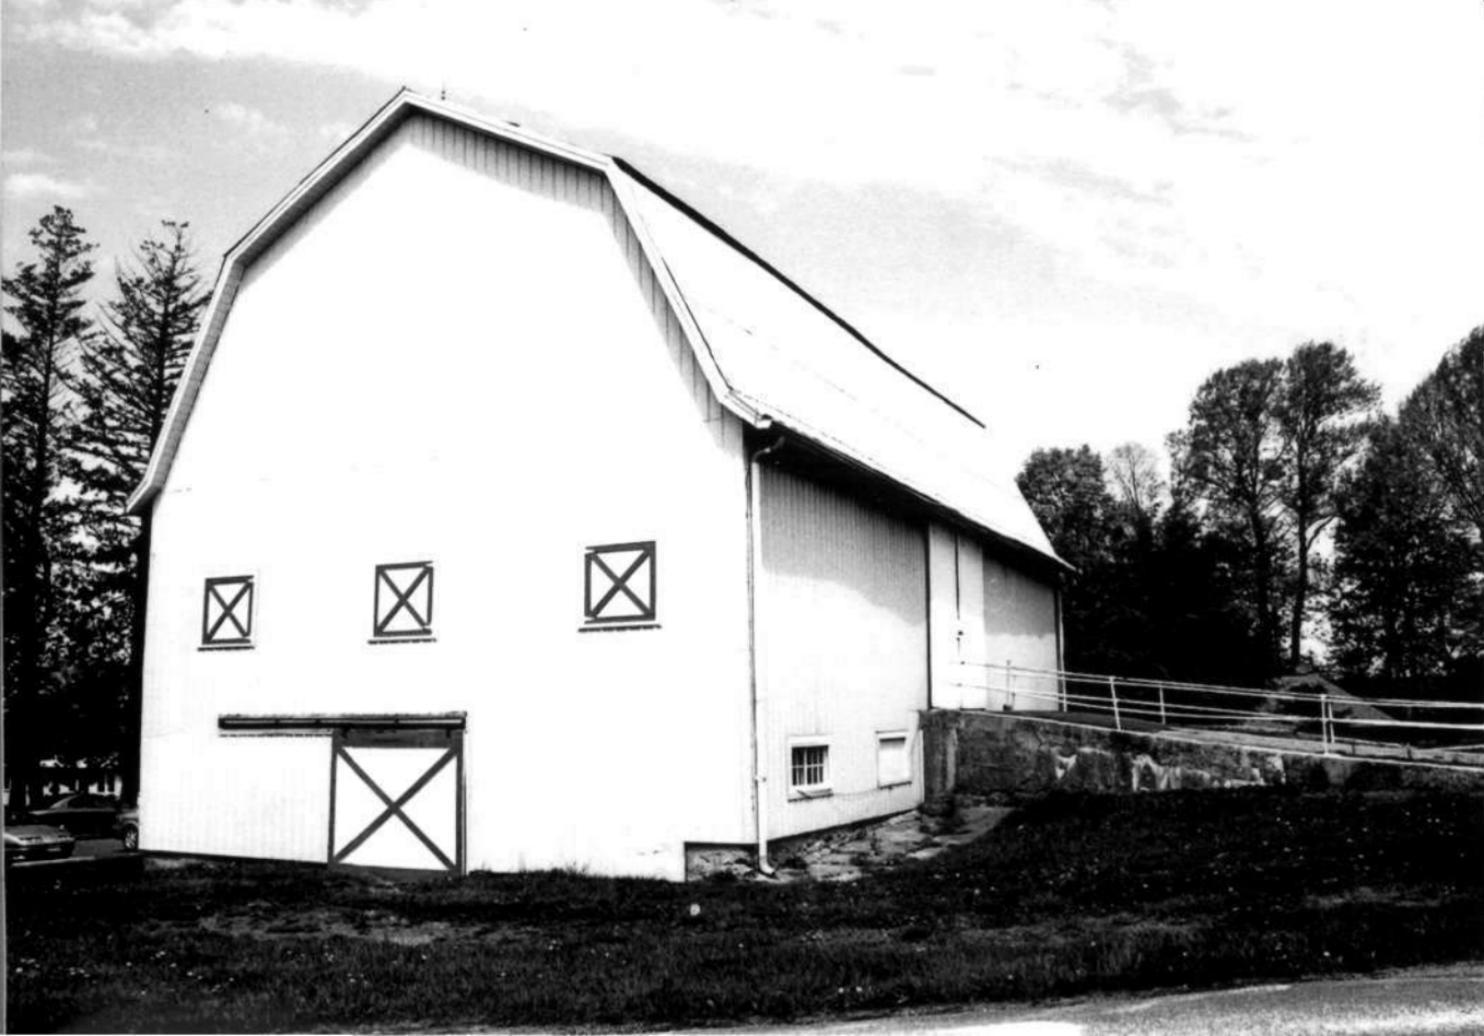
5/40

Ten barn, looking NW

The Tea Barn was constructed ca. 1935 as a bank barn that served as a hospital center on race days. The foundation is constructed of rubble fieldstone and has been parged with concrete. The upper portion of the barn is clad in metal. The gambrel roof is sheathed in corrugated metal and has a metal-clad cornice. The earthen bank is located on the east elevation. Access to the upper portion of the barn is through paired narrow beaded board wood sliding doors mounted on an exterior track. Sliding doors on the west and south elevation provide access to the lower level. Single wood doors are located on the lower level of the north and west elevations. The window openings on the lower level of the east elevation contain six-light, wood frame, sliding windows. Several openings are boarded up. The barn is in fair condition. Paint failure was noted on wood windows. The west stone wall has been buttressed by external wood supports, suggesting structural failure.

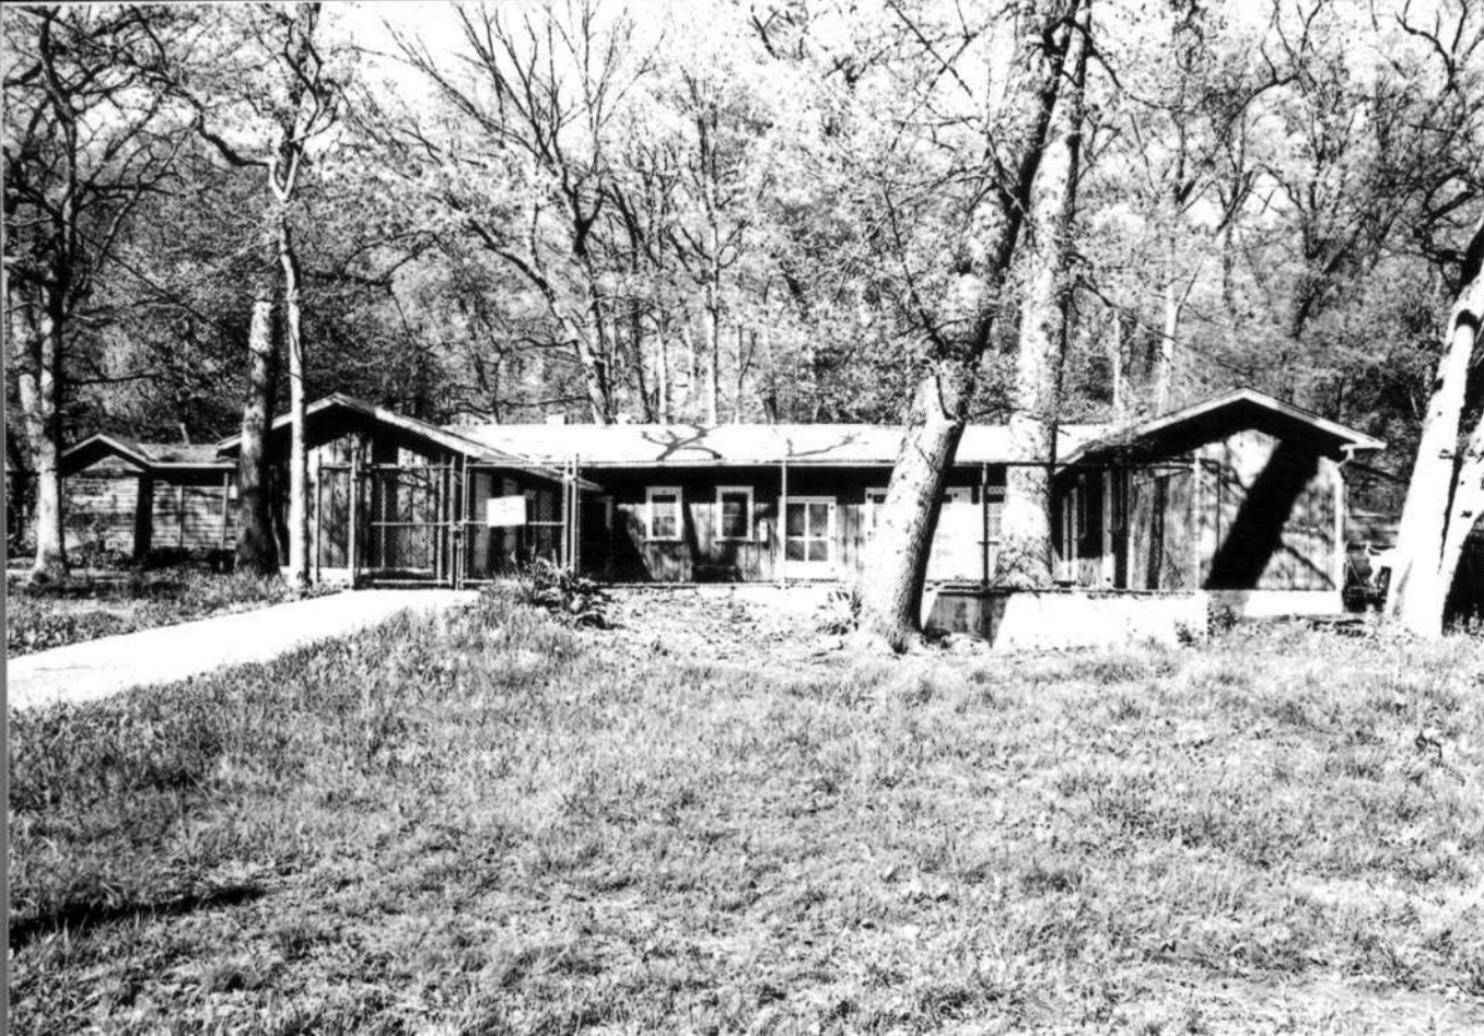
8/40

Dog kennel, looking N

The hunter barn and dog kennels are located south of the fairgrounds along Kennel Road. This is the area where Mr. duPont kept his hounds and hunters. The DOG KENNEL, constructed ca. 1935, is a one-story, wood-frame building that occupies a U-shaped ground plan with eight asymmetrical bays along the south elevation. The building rests on a concrete slab foundation and the walls are clad with board-and-batten wood siding. The intersecting gable roofs are sheathed with composition roll roofing. The cornice has eave boards along the side elevation and raking boards in the gable ends. The windows are six-over-six-light, double-hung sash units. Multiple, single five-panel wood doors provide access to the building along the south elevation. The kennel is surrounded by fenced pens. The kennel appeared in good condition.

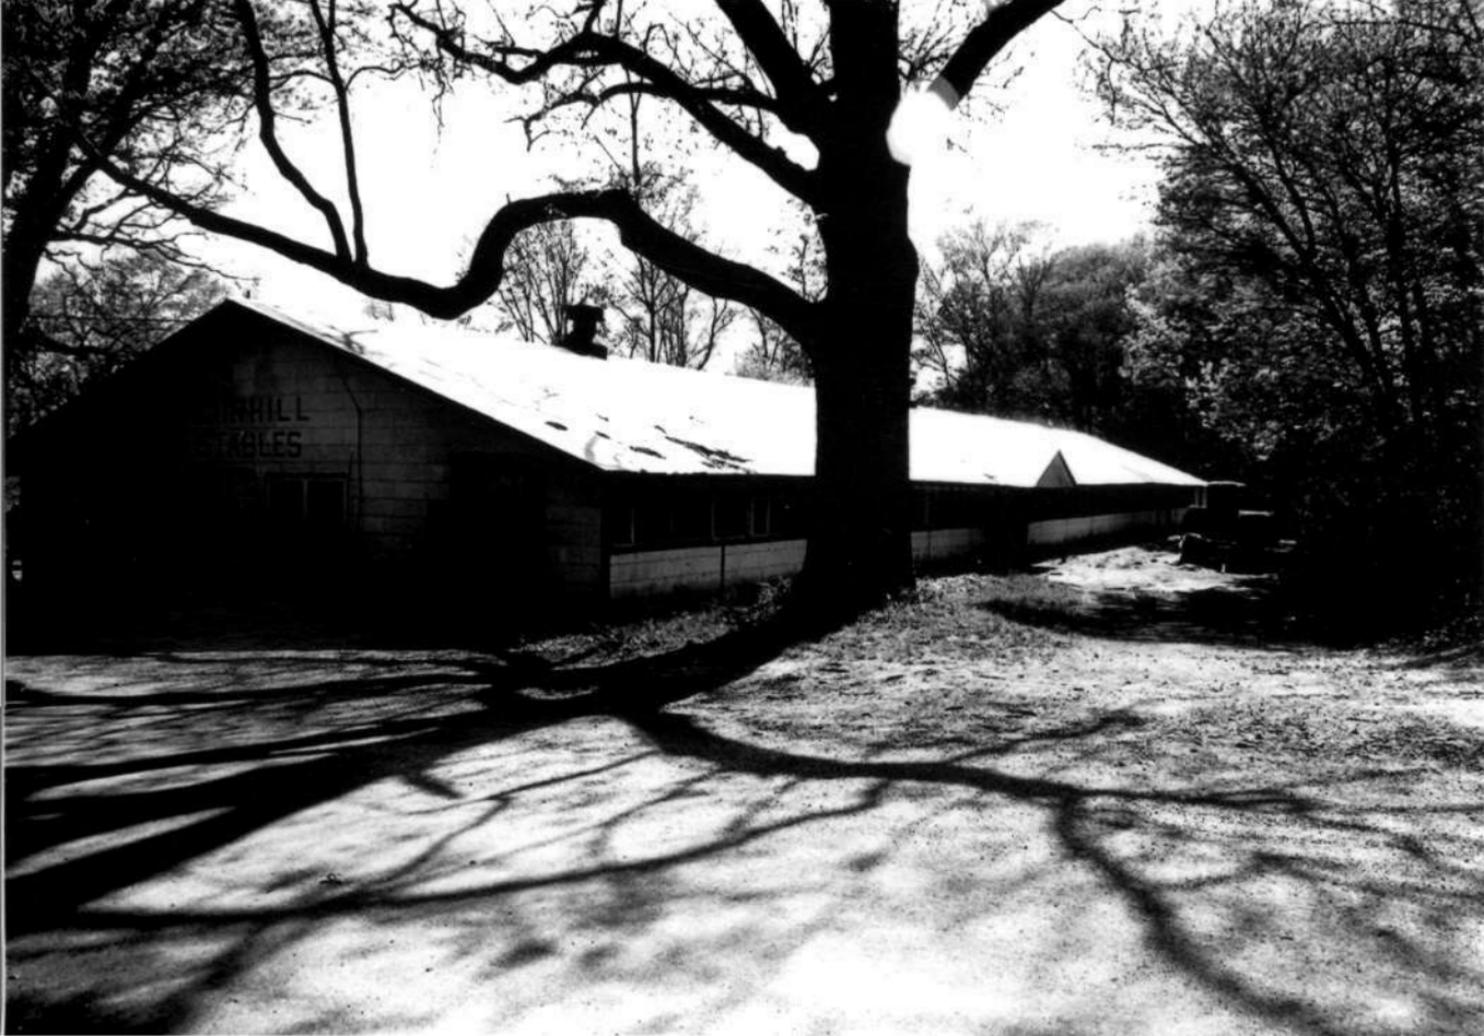
9/40

Hunter barn/office, looking SW

The HUNTER BARN/OFFICE was constructed in two stages. The earlier part of the barn was constructed ca. 1935; the barn was expanded ca. 1950 (Skinner personal communication 4/30/2004). The barn occupies a T-shaped ground plan and rests on concrete foundation. The exterior walls are sheathed in asbestos shingles. The wide gable roof is sheathed with corrugated metal. The rafter ends along the north and south elevations are exposed; raking boards are located in the gable ends. Two sets of doorways are located in each elevation. The doorways on the north and south elevations are paired sliding wood doors. Each door has four lights over a wood panel constructed of narrow beaded boards. The doors on the west elevation are wood Dutch doors. Two single wood doors with glass lights are located in the east elevation. A single six-light over two wood-panel door is located in the gable end of the wing that projects from the center of the south elevation, but there is no access step to the door. The north and south elevations have a continuous band of four-light, wood-frame, sliding windows that share a continuous sill. The windows in the east and west elevations are wood-frame, six-over-six-light, double-hung sash units with wood surrounds that have a lip molding on the upper casing. Offices occupy in the east end. The interior core of the main building contains two sets of stalls that are surrounded by wide aisles on the north and south elevations; the barn has one cross aisle. The interior wall of the stalls and the stall doors are clad with narrow beaded board siding. One set of doors on the north and south elevation is sheltered by a projecting gable hood supported by brackets. The overall condition is good. Paint failure was noted on exposed wood elements, such as window frames and surrounds, corner boards, wood areas above the continuous windows, and wood doors. Minor deterioration was noted at the bases of some of the large wood doors. Missing glazing was noted. Staining of the asbestos shingles was noted along the foundation of the north and east elevations. Minor cracking of some of the asbestos shingles was noted. Mortar failure

was noted in the short brick chimneystack in the office section of the building. The building retains overall integrity of design and workmanship, although the integrity of materials has been compromised by modern materials.

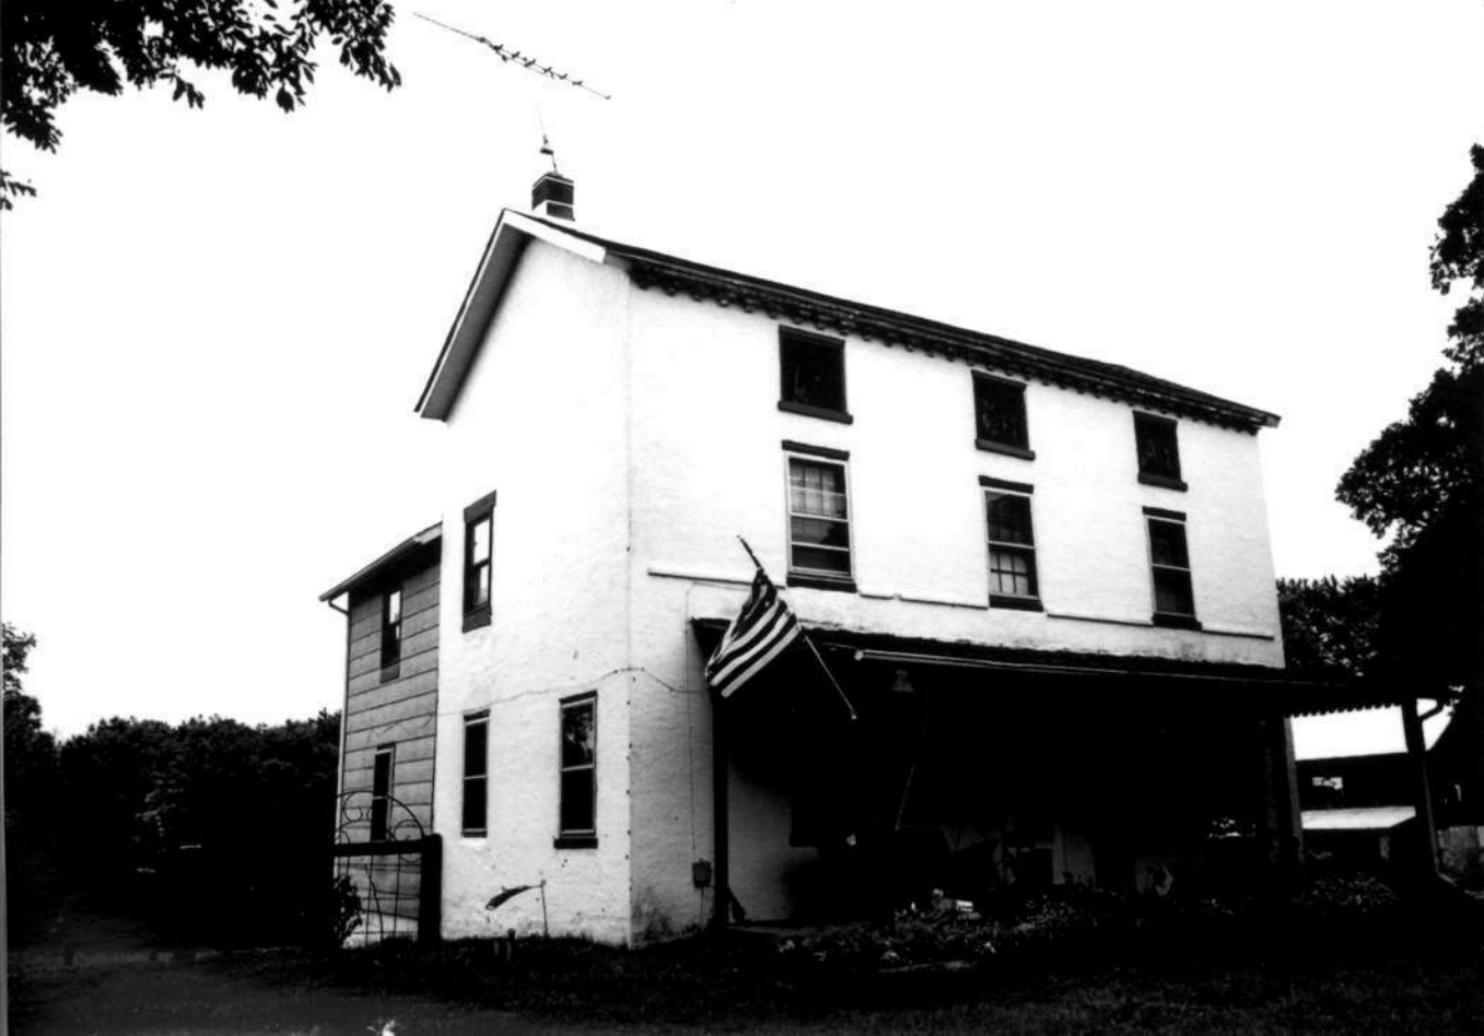
15/40

Rental House, 68 Big Elk chapel
Rd, looking S

The Rental House at 68 BIG ELK CHAPEL ROAD (MIHP # CE-1520) (former Higgins property), constructed ca. 1850 (Martenet 1858), is a two-and-a-half-story, three-bay by two-bay building that reflects the proportions and massing of the Greek Revival style. The main block is stuccoed brick and rests on a rubble stone foundation; the brick bond is not visible under the stucco. The side-gable roof is sheathed in asphalt shingles installed in 2003. Metal eaves were installed over the wood soffits in the gable ends and the chimney on the west end was removed in 2003. The front (north) elevation has three symmetrical bays and is ornamented with a narrow projecting beltcourse along the base of the second-story windows and a corbelled brick cornice along the north and south eaves. The centrally located doorway contains a modern wood unit with an oval light set under a wood-frame, three-light transom. The windows on the first two stories of the front elevation are wood-frame, six-over-six-light, double-hung sash units with simple wood lintels and sills. The third story windows are small, six-light units set under the eave. A cinderblock chimney projects from the east gable end. A full-façade, one-story porch spans the north (front) elevation. The shed roof of the porch is supported on square wood posts with chamfered corners. The porch has a concrete floor and steps. The main block is one room deep and has a stone-lined well under the kitchen (Chaplin personal communication 5/19/2004). A ca. 1940, two-story, wood-frame rear wing on the south elevation is clad in an asphalt-coated fiberboard (Chaplin personal communication 5/19/2004). The rear wing has one-over-one-light, double-hung sash windows. A one-story, shed-roofed addition spans the west half of the rear (south) elevation. The house is in good condition and retains integrity of design and materials.

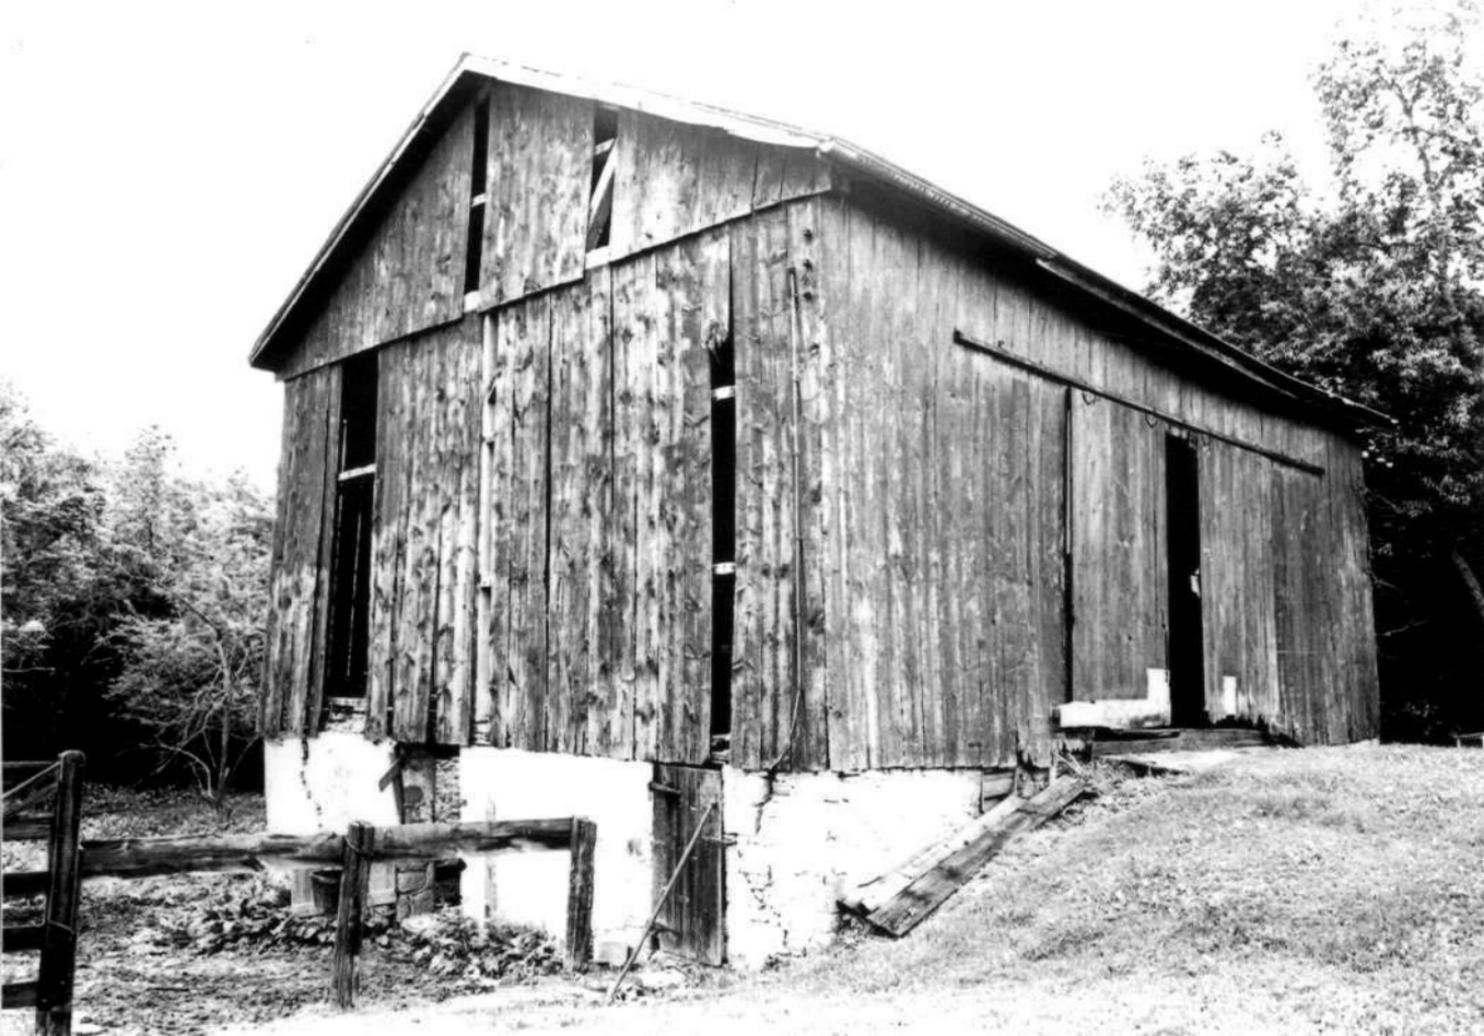
16/40

Bank barn looking S

The three-bay bank barn, constructed ca. 1850, has rubble fieldstone foundation walls along the east, north, and west elevations. The lower level of the south elevation is open; a conical stone column supports the cross beam. The west stone wall extends southward to enframe the west side of barnyard. The upper portion of the barn is constructed of pegged heavy timber framing with bents comprising end posts and a center post to support the cross beam. The roof is supported on canted queen posts that support a purlin. The roof is a common rafter system. The rafters are lapped without a ridgepole. The upper exterior walls are clad in flush vertical wood boards. The gable roof is sheathed in corrugated metal applied over wood shingles. The primary entry contains two sliding-track doors constructed of flush vertical boards on the north elevation. Two single doors were located in the east elevation. The barn is in fair condition. The lower stone walls are wet and the stall area was muddy. Large cracks in the mortar were noted on the southeast and northeast corners. Mortar erosion was noted along the west wall. Deterioration in the wood sill on the south and west elevations were noted. Missing cladding boards were noted on the east and south elevations. Deterioration was noted along the bases of the wood cladding boards, in the eave boards, in the bases of the sliding doors, and in the two single doors in the east elevation. The barn has integrity of locations, materials, design, and workmanship.

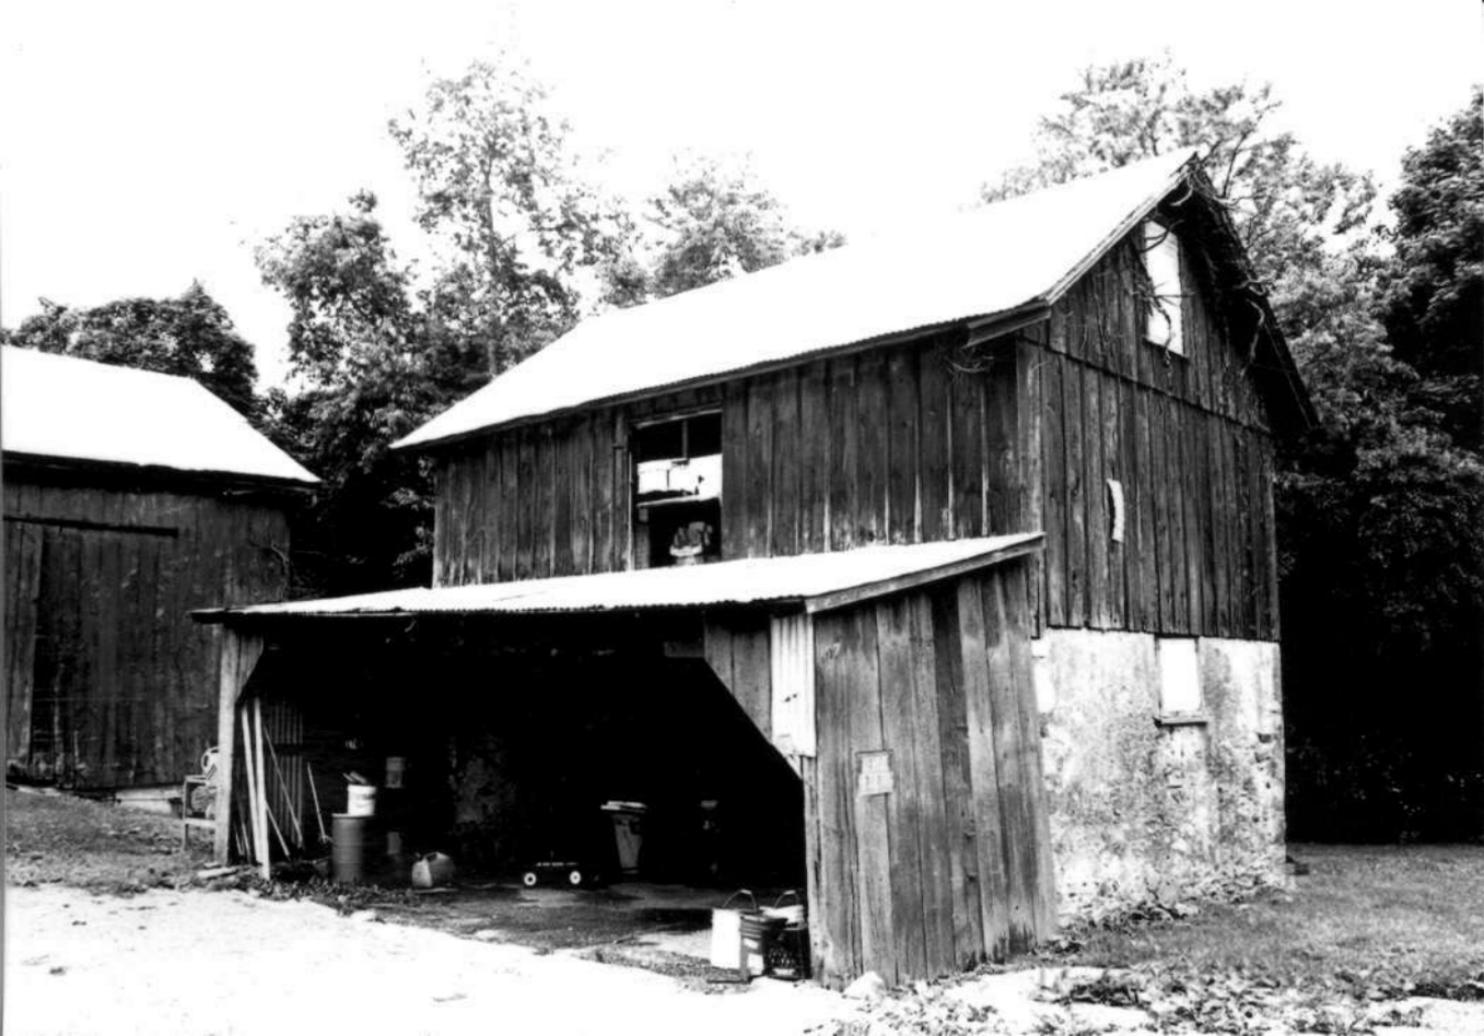
17/40

Carriage Hse, looking S

The ca. 1850 one-bay by one-bay carriage house, which exhibits similar construction techniques as the barn, is two stories. The lower walls are constructed of rubble fieldstone parged with cement on the south, west, and north walls; the east elevation is open. The upper portion of the building is timber frame with hewn and pegged beams clad in board-and-batten wood siding on the north, west, and south elevations. The upper portion of the east elevation has vertical siding with missing battens to accommodate a later one-story, shed-roofed addition attached to the east elevation. The gable roof is sheathed in corrugated metal and has two narrow eave boards and raking boards in the gable ends. Louvered openings are in the upper gable ends and a centrally-located window is in the east elevation. A wood-framed opening is located in the north stone wall. The building is in fair condition. Deteriorated parging along the base of the west wall indicates moisture penetration. Deterioration was noted on the bases of the wood cladding boards on the east and north elevations and the southwest corner. A large crack in the mortar of the north stone wall stretches from the wood-framed opening to the ground. Deterioration was noted in the wood window muntins and glazing was missing. Paint failure was noted on all wood elements. The building has integrity of location, materials, design, and workmanship.

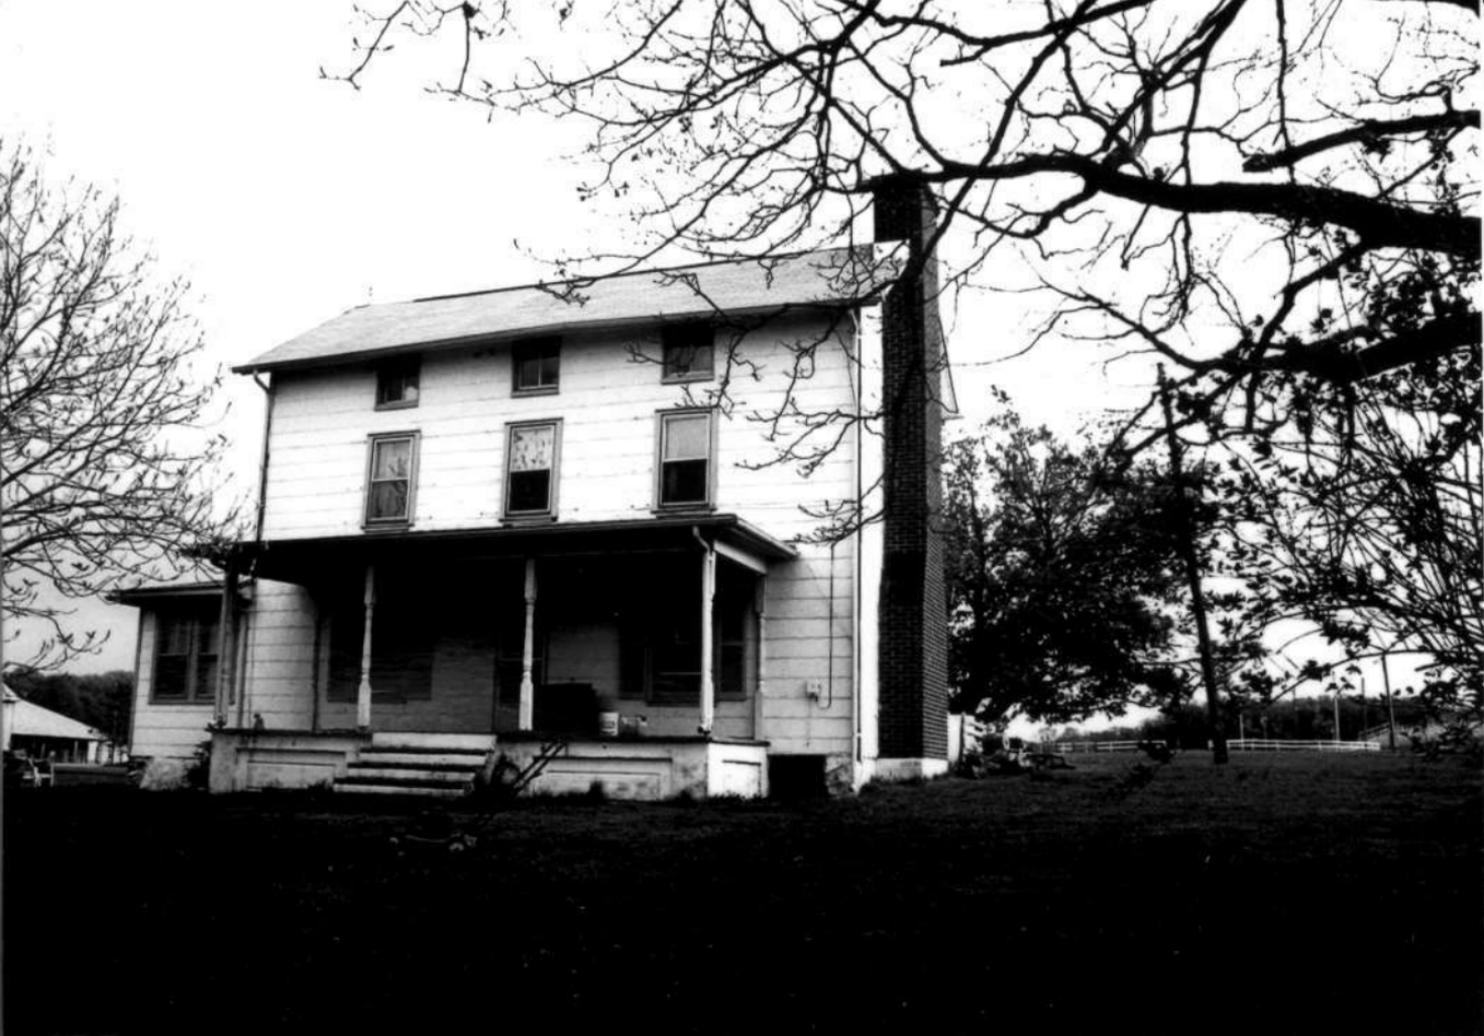
looking S
18/40

J. Moore Hse CE-1003

The Jas. (James) MOORE HOUSE (MIHP # CE-1003) comprises a two-and-a-half-story main block constructed ca. 1870 and a two-story rear wing constructed ca. 1900. The house appeared on the 1877 Lake, Griffing & Stevenson map of Cecil County. The house rests on a stuccoed stone foundation. The original clapboard walls currently are clad with asbestos shingles. The main block is three-bay by one-bay

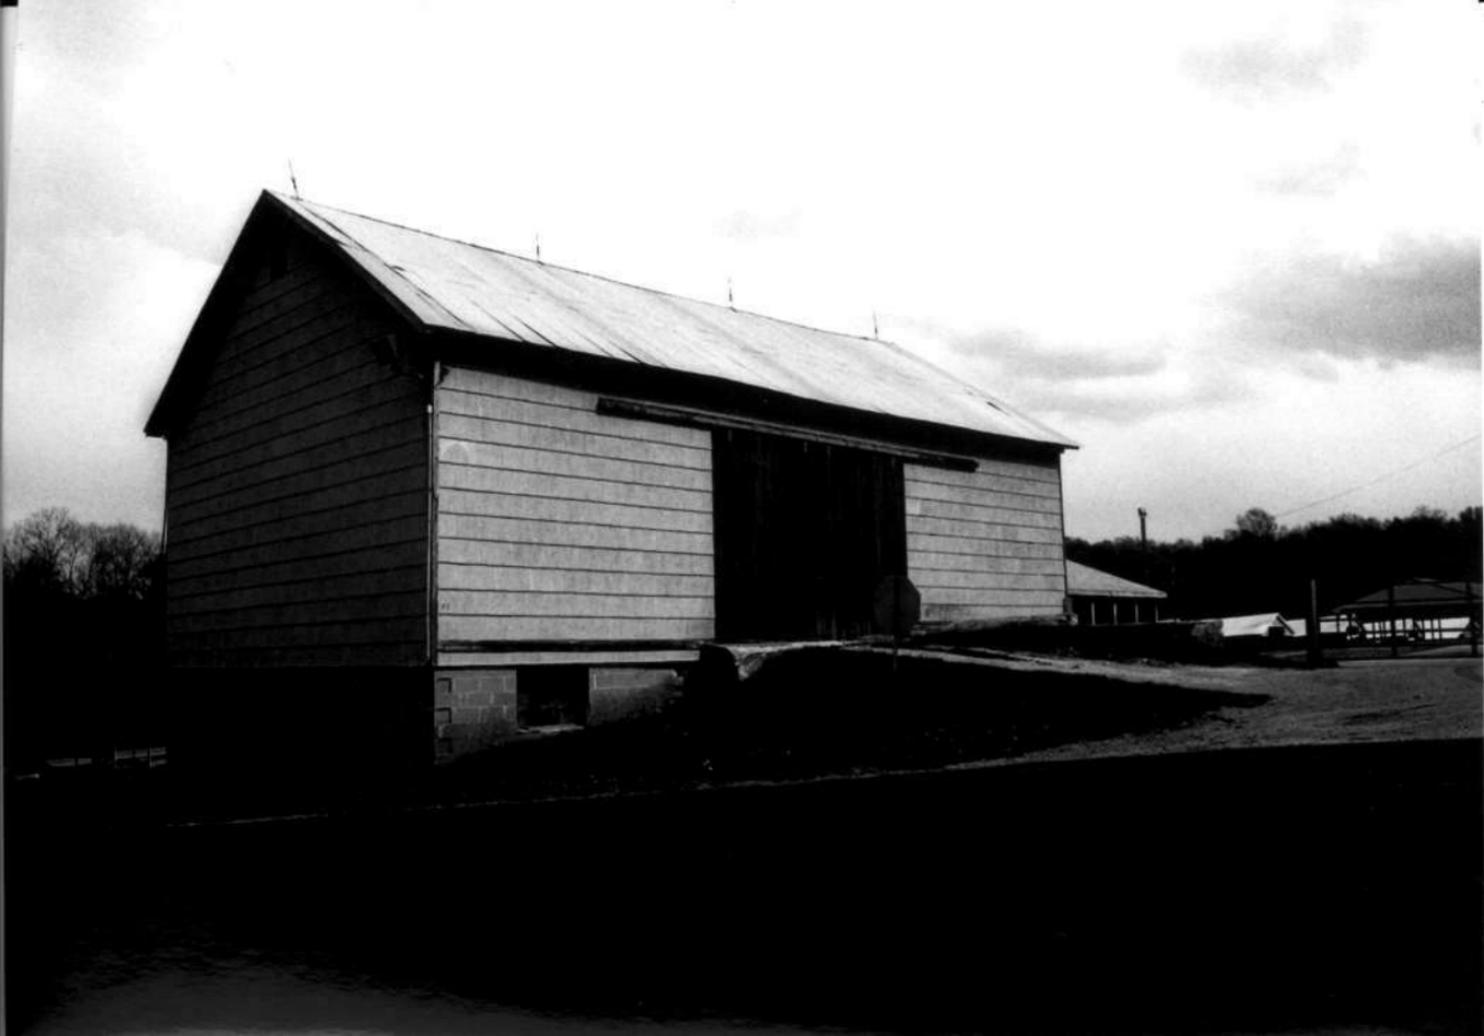
19/40

Moore Barn, looking SW

The former Moore barn, constructed during the early twentieth century, currently is associated with the Fairgrounds. The three-bay bank barn has an irregularly coursed rubble fieldstone foundation with a wood-frame upper level. The stone foundation is parged with cement. Concrete block was noted in the foundation on the northwest corner and east wall. The upper level is sided with asbestos shingles. The west elevation is banked. The doorway in the west elevation contains paired sliding doors constructed of narrow vertical beaded wood boards. The forebay on the east elevation is supported on stone walls. The southeast corner of the forebay is enclosed with concrete-block walls. Two hinged single wood doors on the foundation level are located on the north elevation. Paired six-light, wood-frame windows are located on the foundation level of the south elevation. The gable roof is sheathed with corrugated metal. The barn exhibits cracking in the mortar joints in the concrete-block foundation and in the some sections of the stone foundation. Deterioration was noted at the base of the wood doors on the bank elevation. The barn is in good condition.

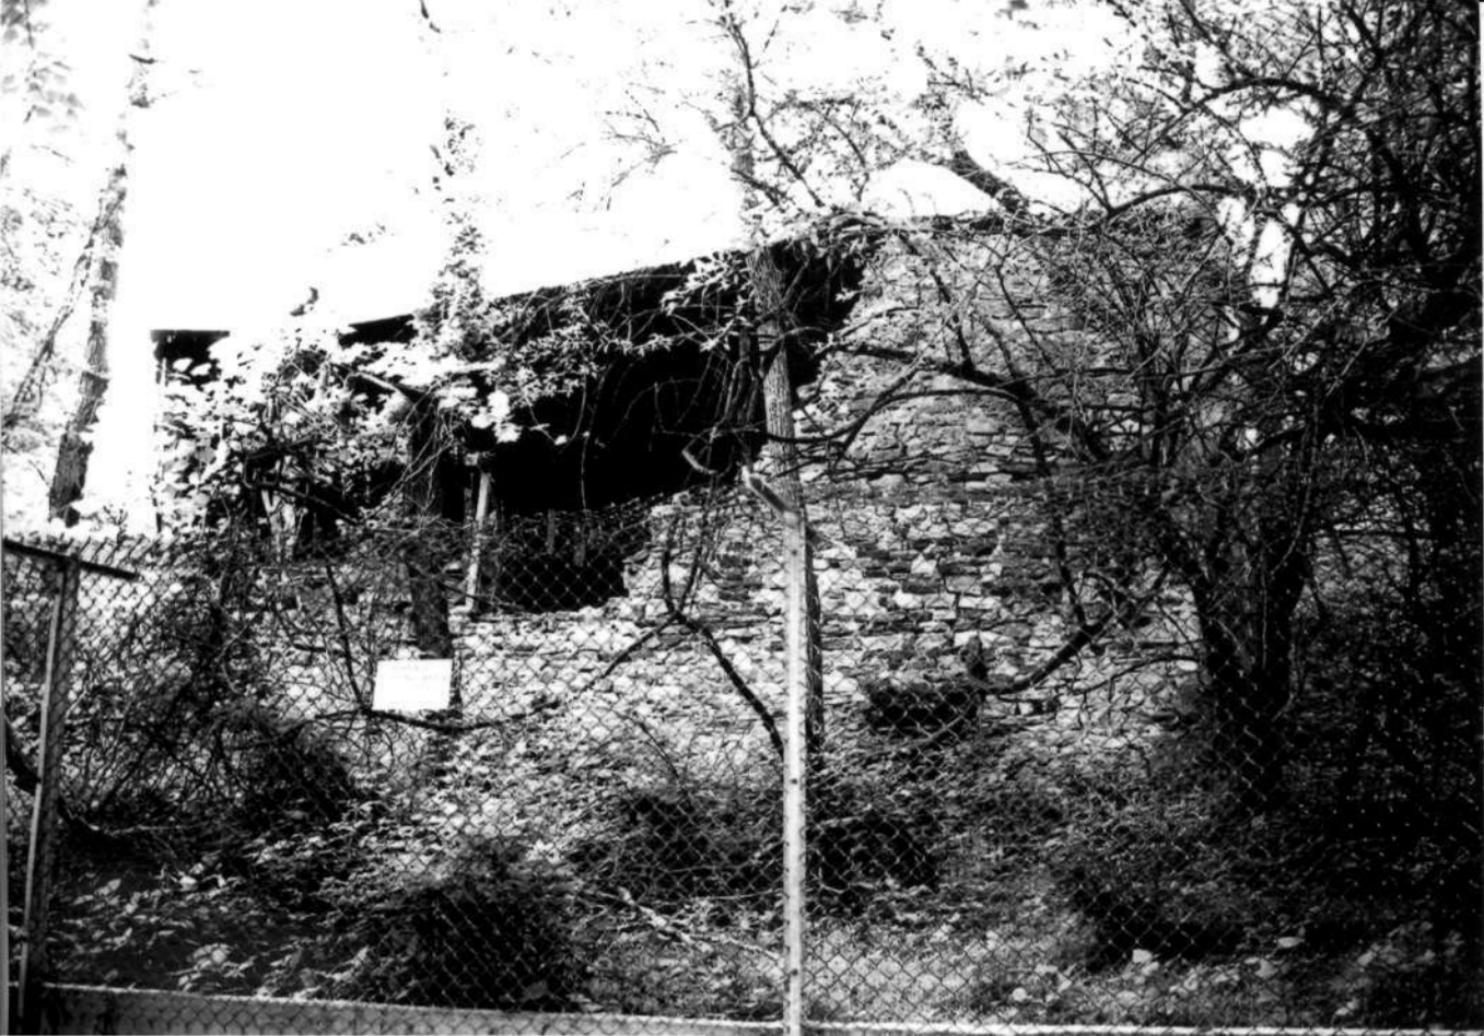
25/40

McFarland Barn, looking S

The former MCFARLAND BARN, constructed ca. 1880 (USGS 1898), is located north of MD Rte 273 and south of the super fence. Because of restricted access, only the north, east, and west elevations of the barn were visible during the survey conducted on 22 May 2004. The foundation and west gable end of the

barn are constructed of rubble fieldstone. The upper section of the barn's east end is constructed of board-and-batten wood siding. The three-bay barn has heavy timber framing with canted queen posts supporting the roof purlin. No ramp was visible on the north, east, or west elevations, though the doorway was elevated above the ground level on the north elevation. No forebay was located on the north elevation; the foundation on the north elevation was flush with the upper portion of the barn and window openings were noted in the foundation wall. The common rafter roof is sheathed with corrugated metal. Doorways were located in the center of the upper portion of the north and south elevations. The doors on the north elevation were missing. The barn has integrity of location, materials, design, and workmanship. The barn is near ruinous condition. The west and north stone walls exhibited cracks in the mortar with some missing stones. The wood wall cladding on the northeast corner and selected boards on the north and west walls are missing. The doors were missing. The wood sill on the northeast corner is rotted away. The barn no longer appears structurally sound.

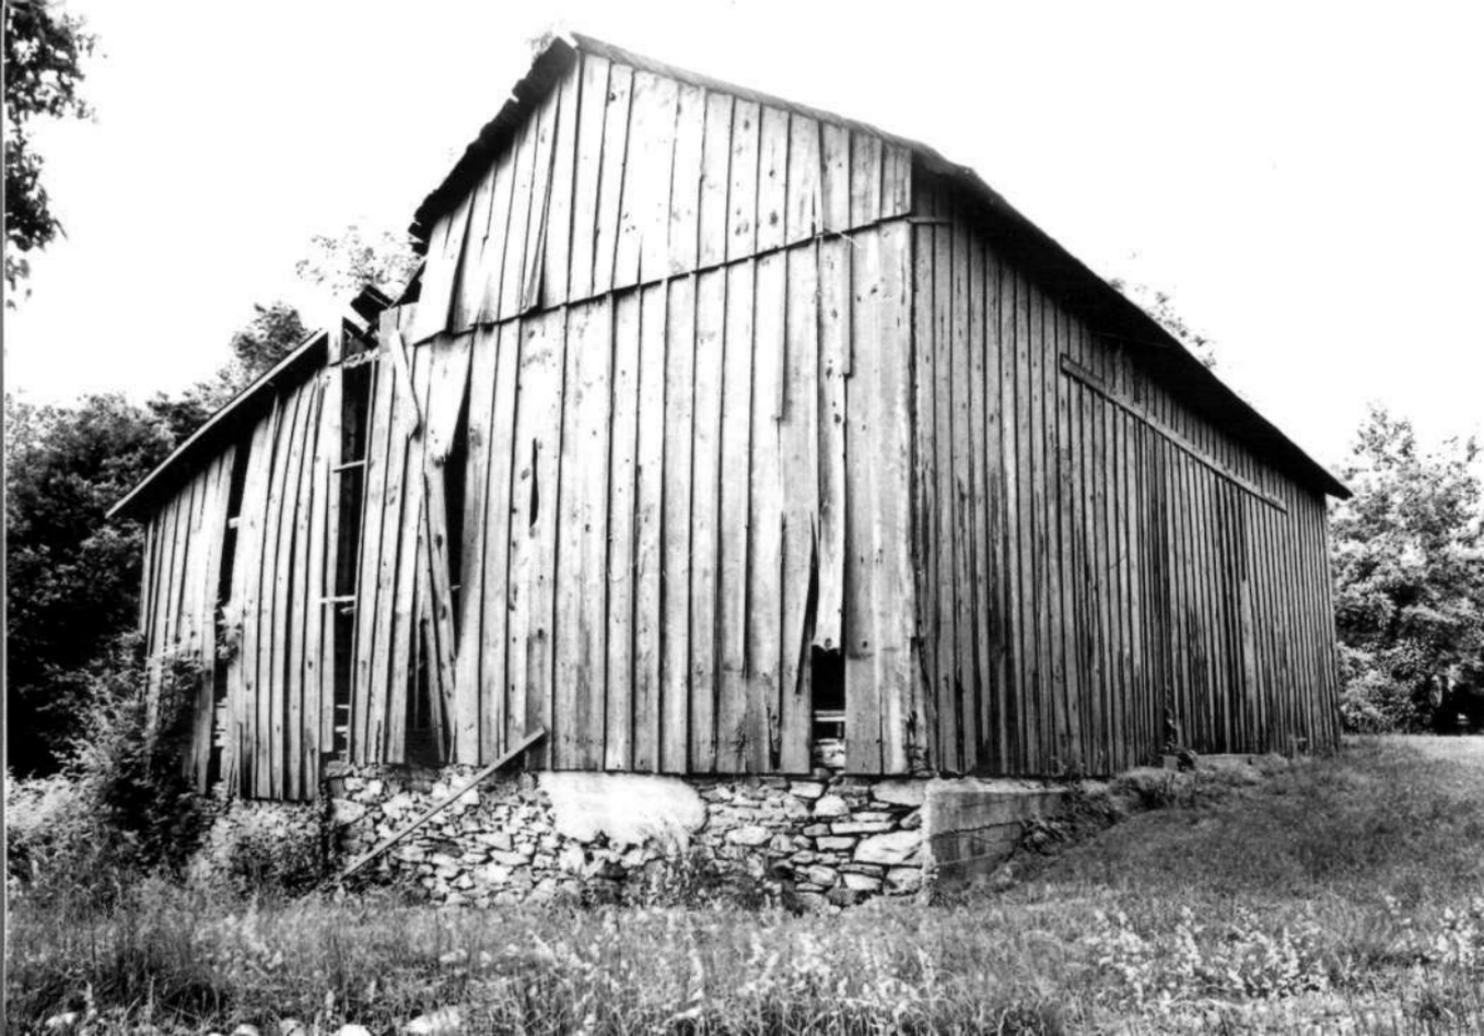
26/40

Hathaway Barn 2,
looking W

The former Hathaway Barn 2, constructed ca. 1920, is a bank barn that has a rubble fieldstone lower level and a heavy timber frame upper section. The foundation wall on the east elevation indicates that the barn was extended along the south elevation. Concrete parging has been applied over the north and west foundation walls. The bents of the upper portion consist of two end posts tied by a cross beam. Upbraces extend from the end posts to the cross beam. The exterior walls are clad in board-and-batten siding. The gable roof is sheathed in corrugated metal and has a slight kick over the extension along the south elevation. The north and west elevations are banked. The forebay on the south elevation is supported by the stone wall extension on the east elevation and a concrete wall on the southwest corner. The original

doors were in the north elevation as evidenced by a track attached to the siding. The north wall has been resided. Board-and-batten, sliding-track doors currently occupy the west elevation. The barn has integrity of location, materials, design, and workmanship. The barn is in poor condition. Vegetation is growing along the west walls. Sections of the stone foundation, particularly under the east and west walls, are failing. Mortar has eroded and some stones have fallen out. The siding exhibits signs of deterioration, missing and loose battens. The east end is missing cladding, some boards exhibit deterioration, and buckling of the cladding was noted. Sections of the corrugated metal roofing are rusted. Substantial deterioration of the roof was noted on the south elevation of the barn. Roofing is missing and the barn is open to the elements.
