CAPSULE SUMMARY - SAYLOR BARN 'A' (CT-1080)

Maryland Historical Trust State Historic Sites Inventory Form

Survey No. CT-1080

and/or common Saylor Barn A

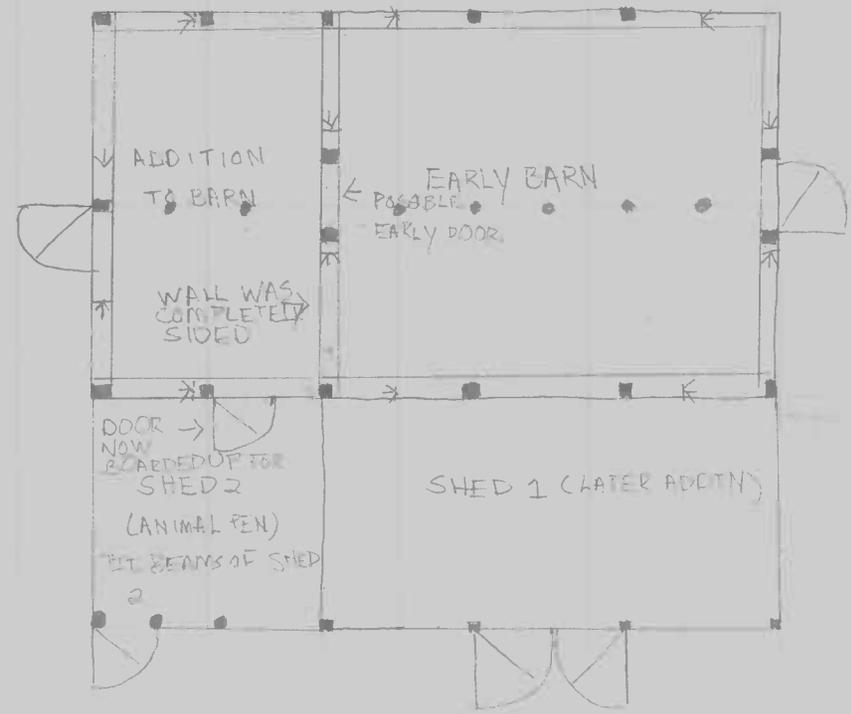
BARN #2053 SAYLOR BARN 4/6/90

The original barn measured twenty-four by twenty feet and had doors on the east and west sides. The roof has been entirely rebuilt on this section, probably several times. An addition was built onto the west end during the period from ca. 1860-1890. At a date sometime during the twentieth century, a shed was built onto the south end. This shed was divided into two sections, one of which was an animal pen, and the other section was for hanging tobacco. The roof, siding and many of the timbers have been replaced throughout the structure over the years.

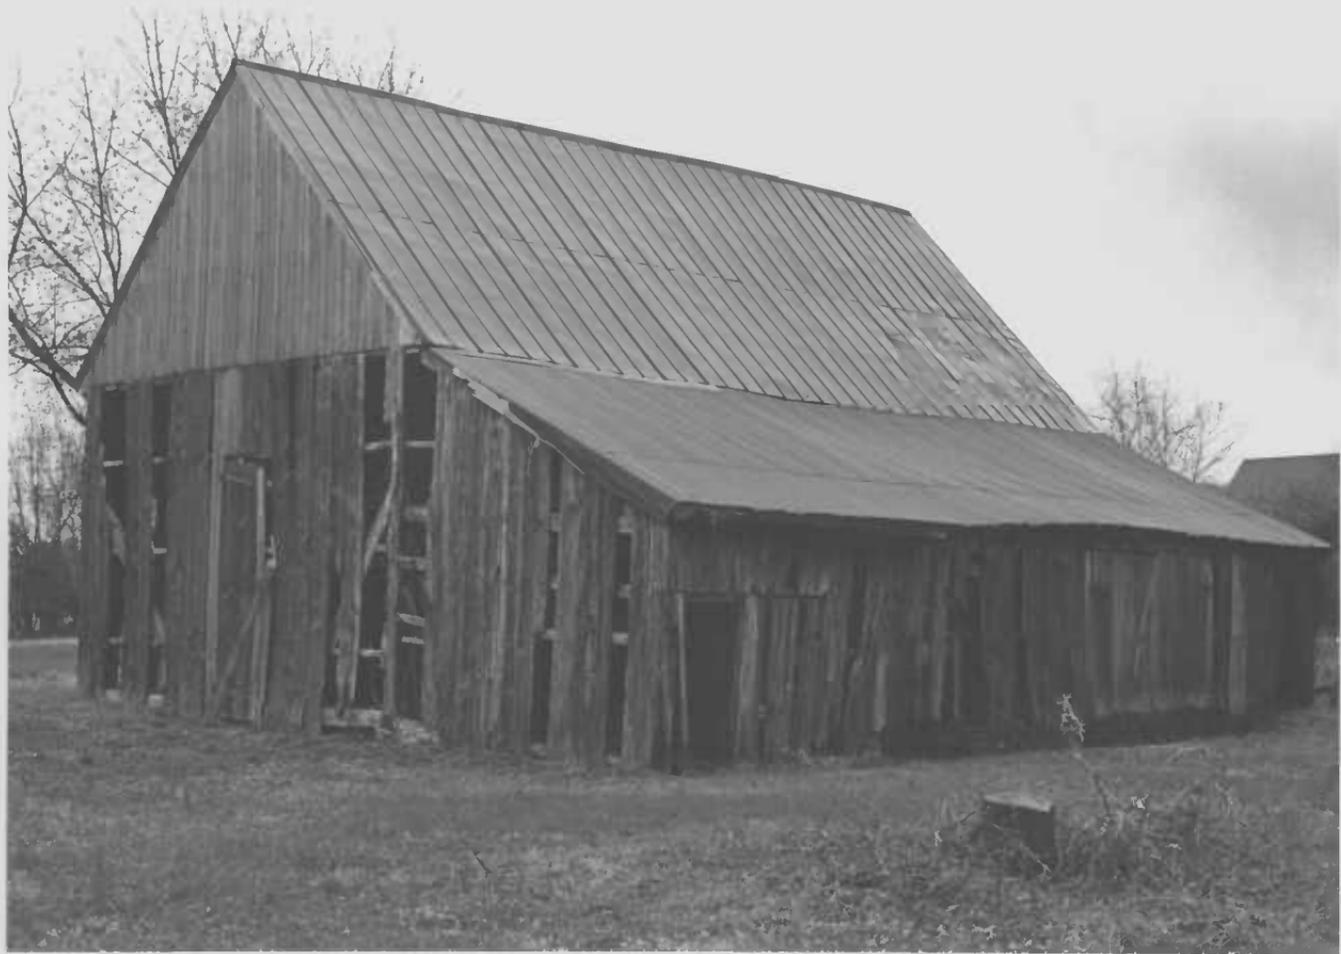
CT- 1080

Saylor Barn A

Southwest
