CAPSULE SUMMARY CT-1111 PROUT BARN B

# Maryland Historical Trust State Historic Sites Inventory Form

and/or common Prout Barn B

## 7. DESCRIPTION CT-1111 PROUT BARN B

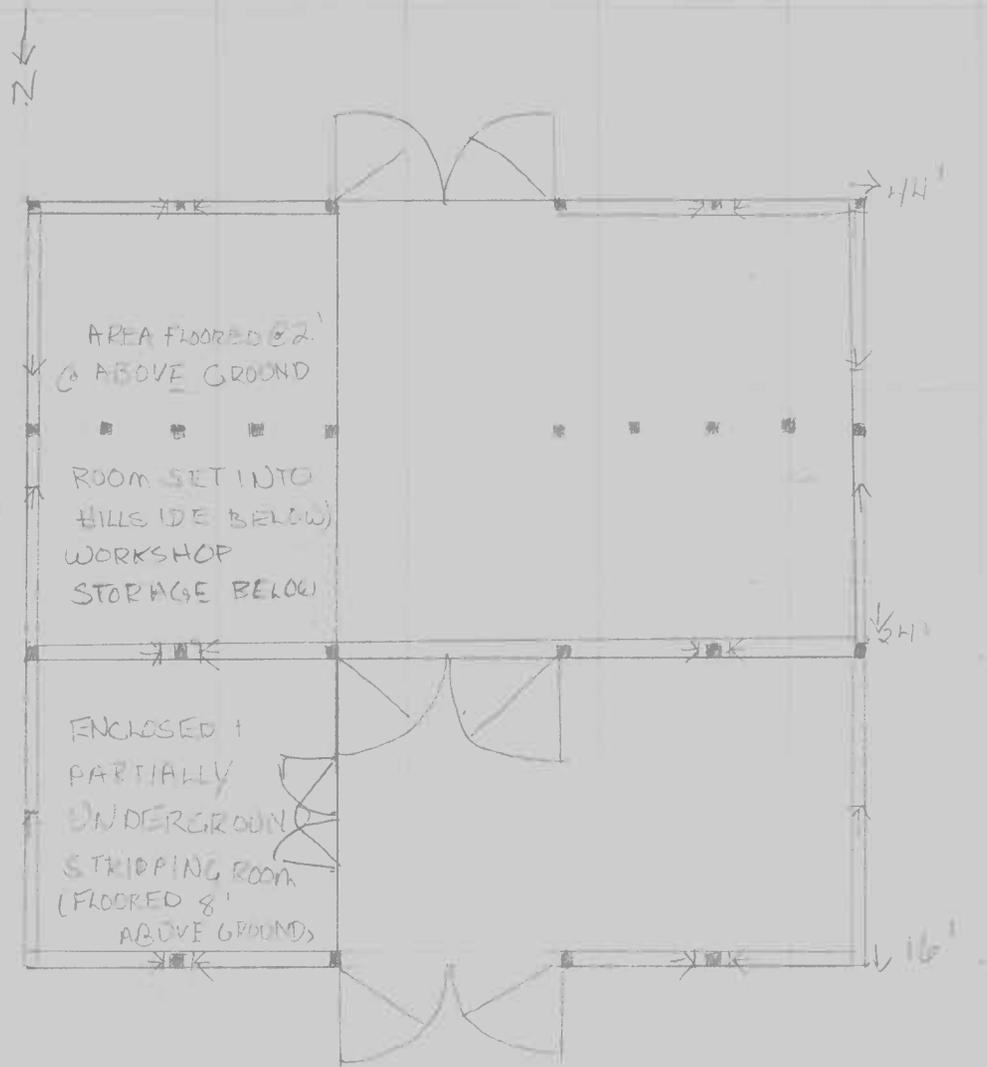
BARN # 2084  
CT-1111

There is a twelve foot wide double door on the south side of the barn facade, and pintel holes on the north side of the barn facade where a corresponding door once stood. The twelve foot wide north-south aisle divides the barn into east and west sections. The east sixteen foot wide section of the barn is floored above and has a room excavated beneath it. This room is a workshop/storage area built of concrete block and is accessed by an exterior door on the east side of the barn. Above the room the section is floored two feet above ground. The west section of the barn is designed exclusively for hanging tobacco. The barn frame is supported on cinder block masonry piers. It is a light timber frame with circular sawn lumber toe-nailed with wire nails. Queen braces from the tie beams to the second tier pole level provide bracing in addition to the down braces.

Plain vertical wall siding with hinged ventilation doors covers the exterior. There are three doors on the west gable end, three on the east gable end, and four on the south facade. The siding extends below the sill to the ground, and the eaves of the barn are blocked by an extra board nailed between the rafters and the false plate. The north side of the barn was once sided, but this was removed with the addition of the shed. The roof rafters are on four foot centers and rest on a flat false plate. There are two windbraces on the west end diagonals and two collars that support the roof. Standing seam metal covers the roof. The top plate is a circular sawn plate formed of two two by six inch timbers nailed together in an inverted L shape. The tier poles are separated by forty-three inches vertical distance and are circular sawn timbers. The posts down the central axis are circular sawn and have wooden blocks nailed to their sides on which the tier poles are supported.

There is a sixteen foot wide shed addition on the north side, built into the slope that descends to the northeast. The frame of this shed is supported on concrete block masonry piers. The construction materials and techniques are the same as those in the barn. Vertical wall siding covers the exterior. There are five hinged ventilation doors on the north side. The north side of the barn is sided and enclosed beneath the sill. There is an enclosed partially underground stripping room in the northeast corner of the shed. It is floored eight feet above ground, and excavated approximately two feet below ground level. A door leads into the stripping room from the west shed. There is electricity and fluorescent lighting in this stripping room.

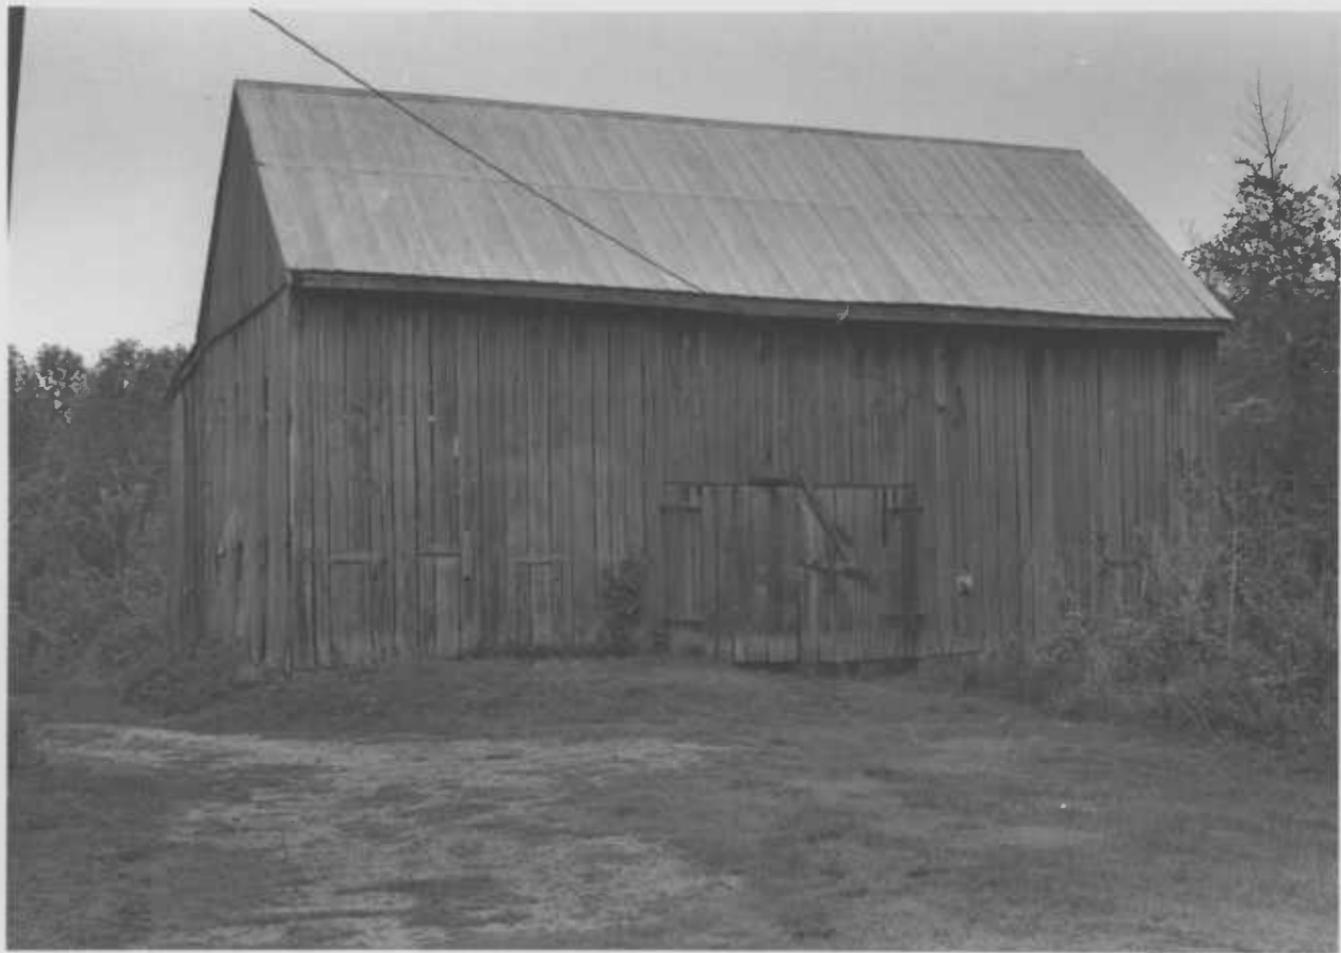
CT-1111 Prout Run B

Southwest
