CAPSULE SUMMARY CT-1118

Maryland Historical Trust State Historic Sites Inventory Form

and/or common Hallowing Point Barn A

7. DESCRIPTION CT-1118

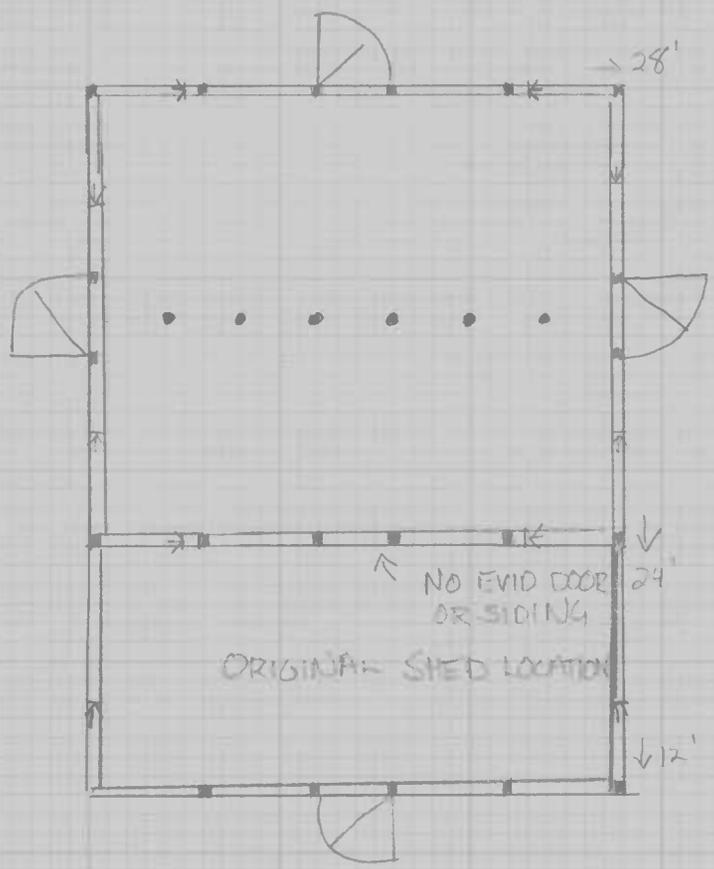
BARN # 2091 HALLOWING PT, BARN A 5/8/90 TO

Concrete block masonry piers and large unmortared field stones support the barn frame. The posts are hewn and joined via mortise and tenon joints with trunnels. Nails are cut, some have variety in heads, possibly early. The down braces are hewn and dovetailed. Horizontal nailers are circular sawn, mortised and nailed. Plain vertical siding with some hinged ventilation doors covers the exterior. There is one door on the east side, two on the west, and five on the north. There is some early siding of very wide two foot boards attached with fully mature cut nails on the north side of the barn. The rafters are on four foot centers and rest on a flat false plate. The top plate is hewn. There are no windbraces and three collars help support the roof. The tier poles are separated by forty inches vertical distance. They are peeled logs supported by bracket/boards nailed to the poles that run down the central axis. There is no evidence of siding or door ever extant on the south side of the barn, therefore the south shed is probably original. Almost all of the shed including tie beams, rafters, plates, braces, posts are circular sawn. Possible that it has been entirely rebuilt?

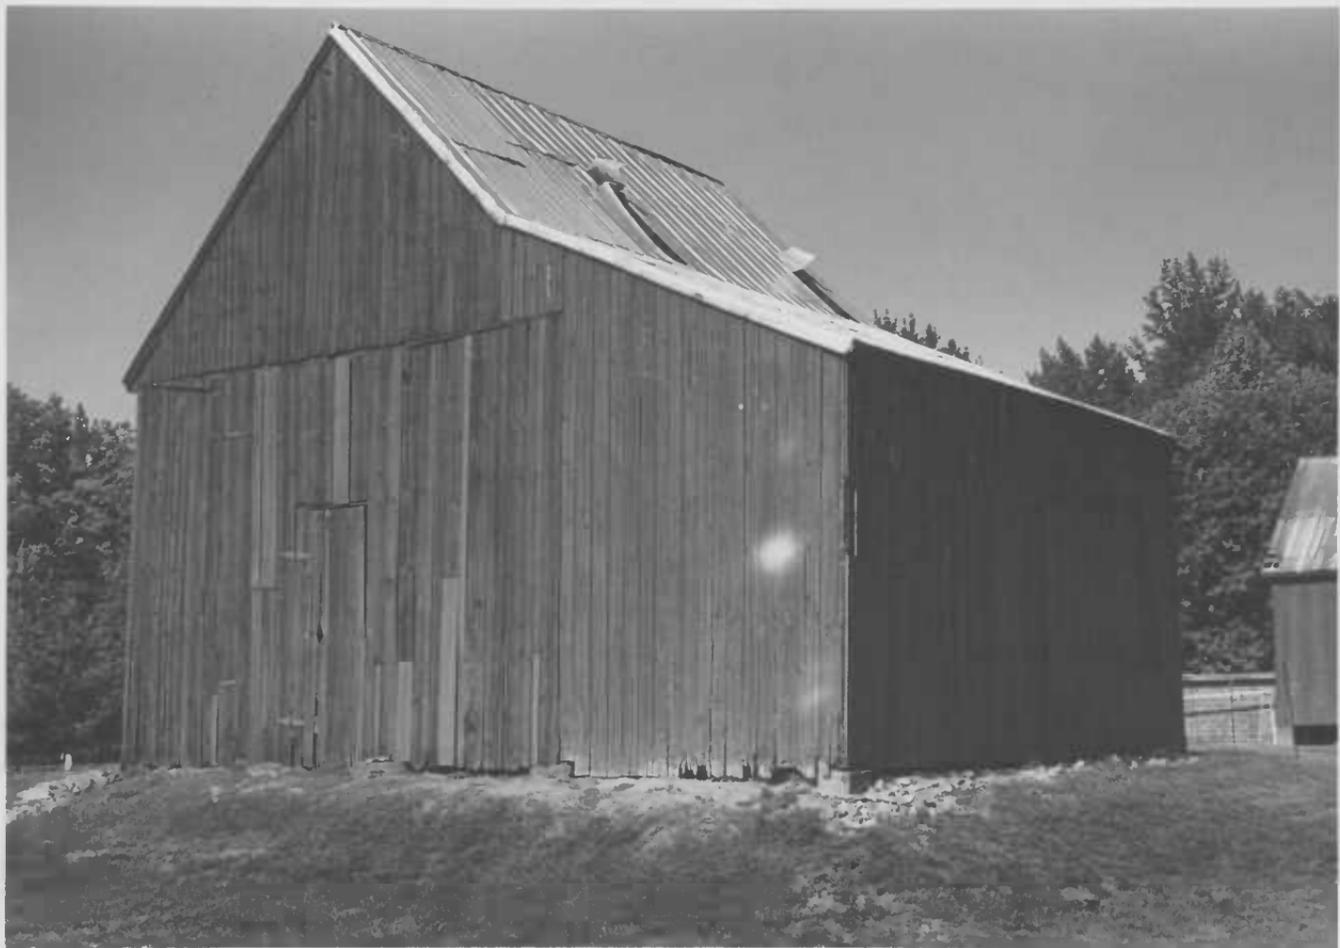
CT-118 Hollowing Point Barn 'A'

South west
