Capsule Summary  
SM-627  
Jutland Farm  
St. Inigoes Vicinity  
Private

SM-627, Jutland Farm  
St. Mary's County  
Maryland Comprehensive State Historic Preservation Data

**Maryland Historical Trust**  
**State Historic Sites Inventory Form**

Survey No. SM-627

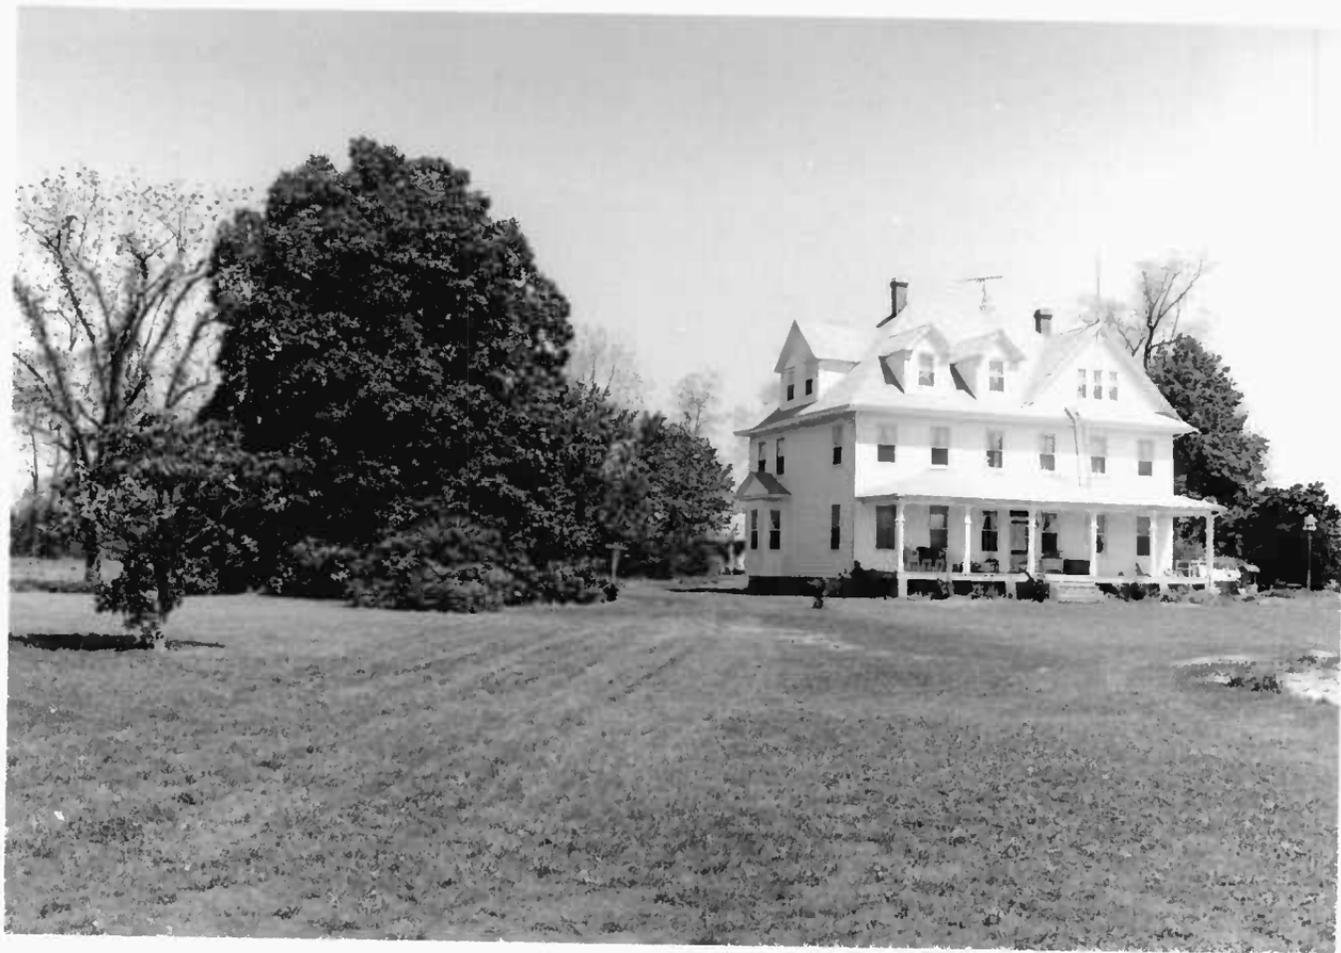
1 of 6

still elevations

The primary or south elevation is pierced on the first floor by a centrally located door flanked on either side by three, one-over-one, double-hung sash windows. A modest porch, supported by concrete and stone piers and lined with square, but chamfered columns shade the first floor fenestration. A larger series of stairs, indicated by two brick supports, has been replaced with a smaller set of concrete steps. The second floor is pierced by six, one-over-one windows. The roof features a large cross gable and two gable dormers. The cross gable, embellished by a large pendant, features a series of three, one-over-one windows. Each of the dormers exhibit cornice returns which outline a one-over-one window.

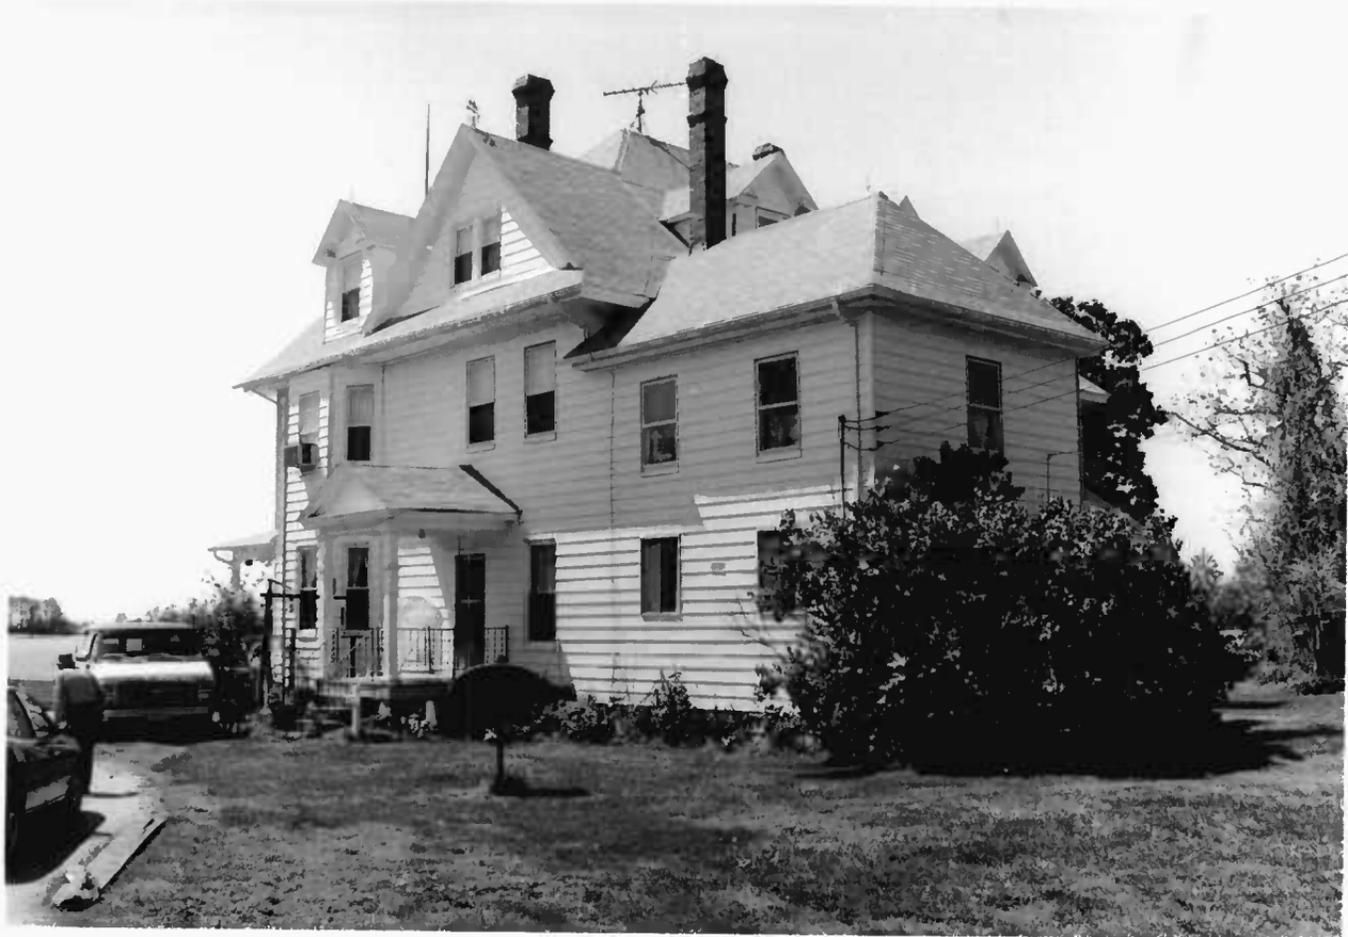
2 of 6

N+E elevations

The north elevation is composed of the main block's rear and the service ell. On the main block's first floor is a single one-over-one window. The second floor is pierced by two, one-over-one windows and a sliding sash window. The roof is pierced by three gable dormers which exhibit cornice returns. Each of the dormers feature one-over-one windows. The service wing is pierced on the first floor by a sliding sash window and on the second floor by a one-over-one window. A three-pane-over-three-panel door and a two-over-two window are situated on the north side of the porch which extends to the west side of the ell.

The side of the main block and service wing represent the east elevation. The first and second floor of the wing are each pierced by two windows. The first floor features sliding sash

while the second floor exhibits one-over-one windows. The main block's first floor features a side entry door emphasized by a portico which consists of chamfered porch posts and a pediment. The first floor is further lit by a one-over-one window and a three sided, two story, projecting bay window. Each of the bay window's sides is pierced by a one-over-one window. The second floor is pierced by two, one-over-one windows. A cross gable with two, one-over-one windows, and dormer with a one-over-one window project from the roof.

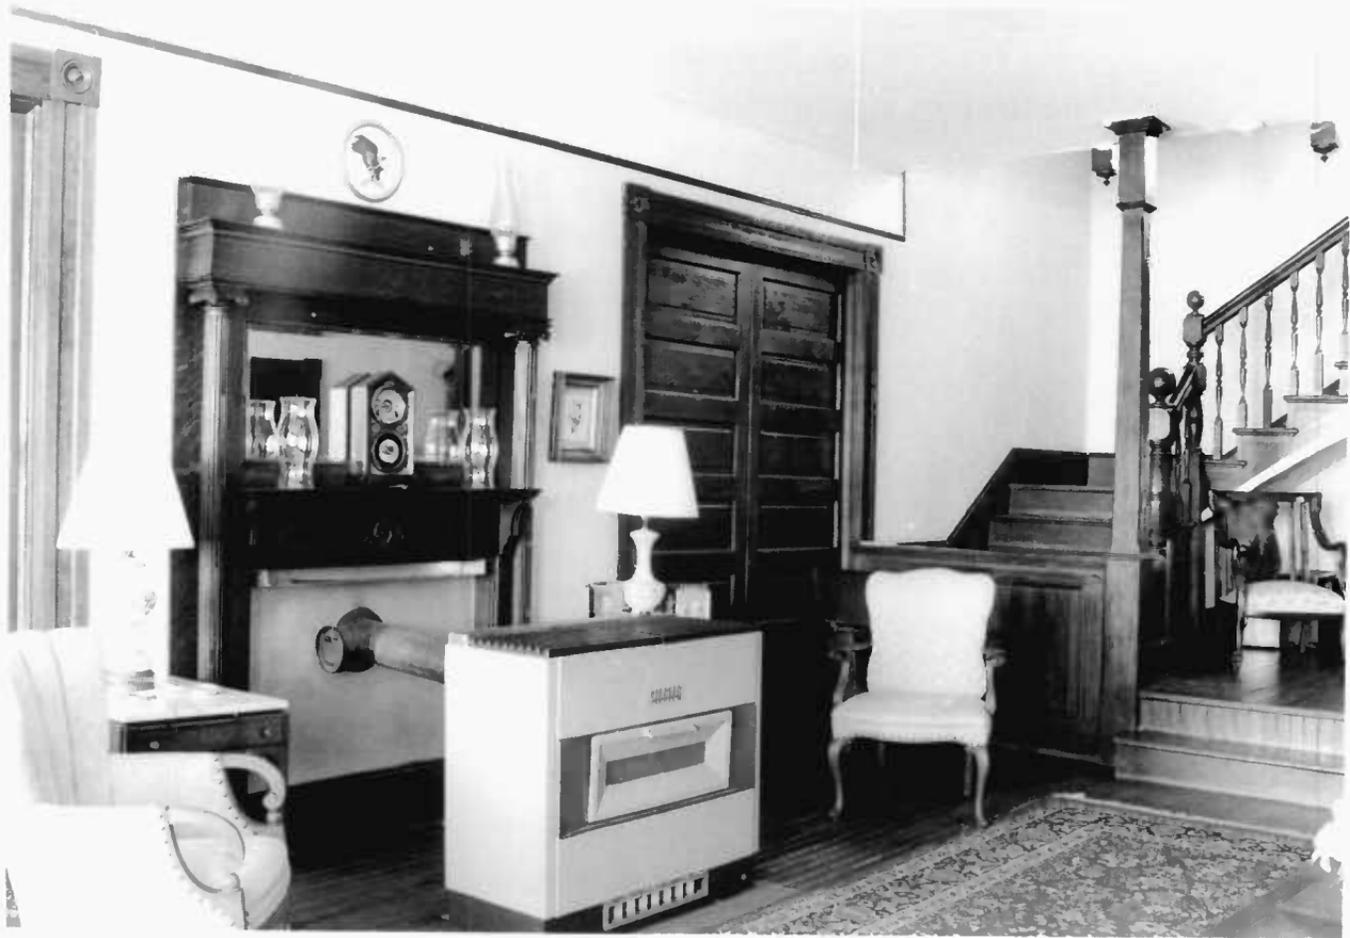
3 of 6

Interior - central sitting room - looking NW

Similar in plan to Burlington (SM-144), the house at Jutland Farm features a grand central stair hall that disseminates visitors into every room on the first and second floors. This hall features an interesting mantle that features reeded Corinthian columns, composition moldings, egg-and-dart surrounds, and a beveled glass overmantle. It also features a grand, open newel staircase embellished with turned balusters and newels with rounded and reeded caps. A niche created by a semi-circular arch lies directly underneath the stair. To the west of the hall are two parlors entered via and connected by two, pocket sliding doors. Each of these parlors feature elaborate corner fireplaces similar to that found in the hall. To the east of the hall is a dining room (now used as a bedroom) and a hallway that leads to the kitchen, side door, and stair to the second floor. The stair is decorated with a more modestly turned newel and balusters. The kitchen consists of one large room. According to Bevins and Jean Morris, a service stair to the second floor above the kitchen was removed. All of these rooms feature door and window surrounds with corner blocks decorated with paterae.

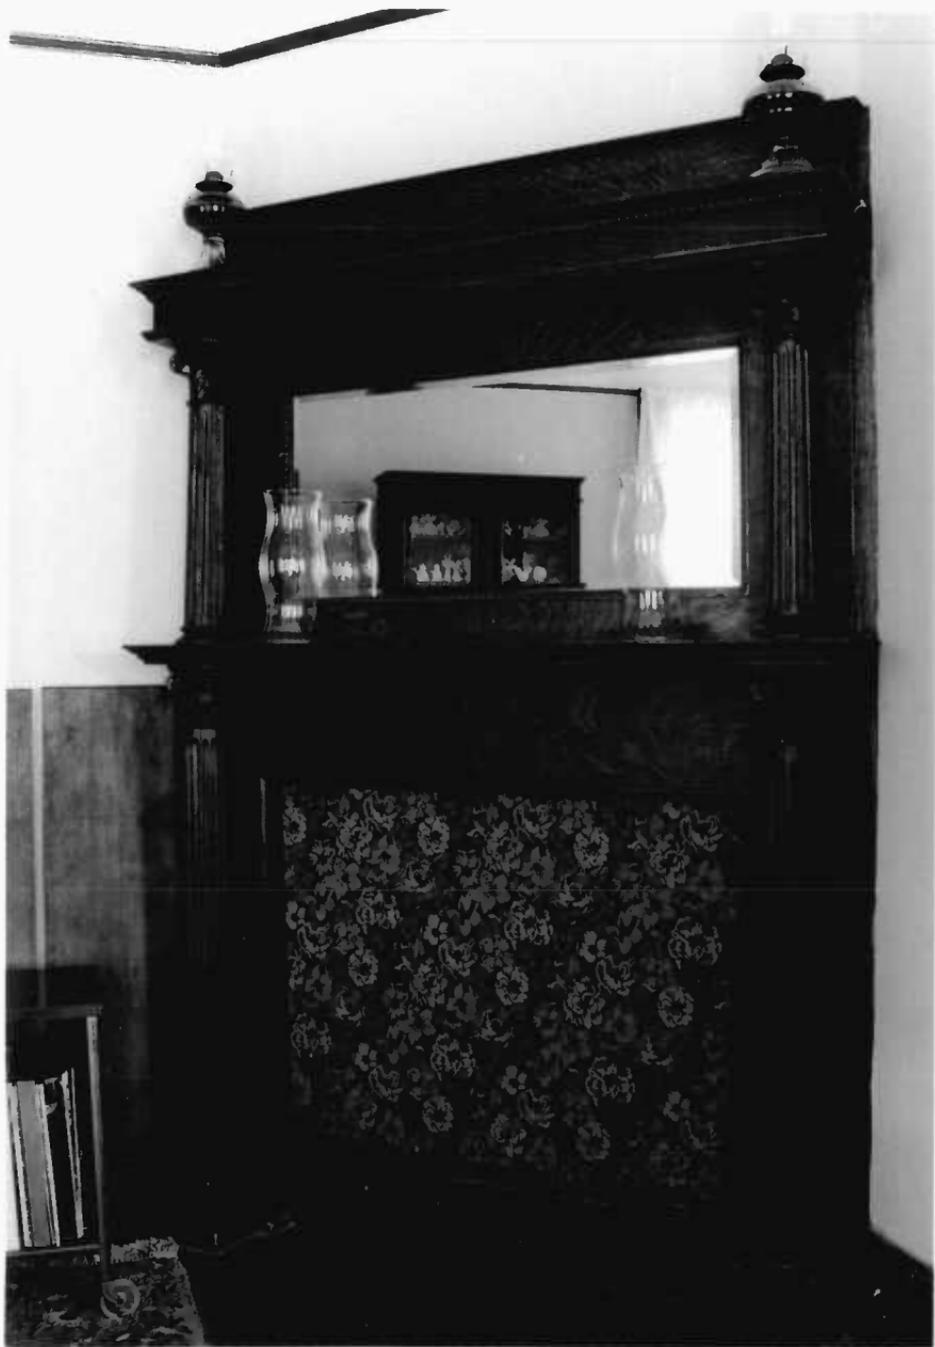
4 of 6

Interior - SW corner parlor - looking NE

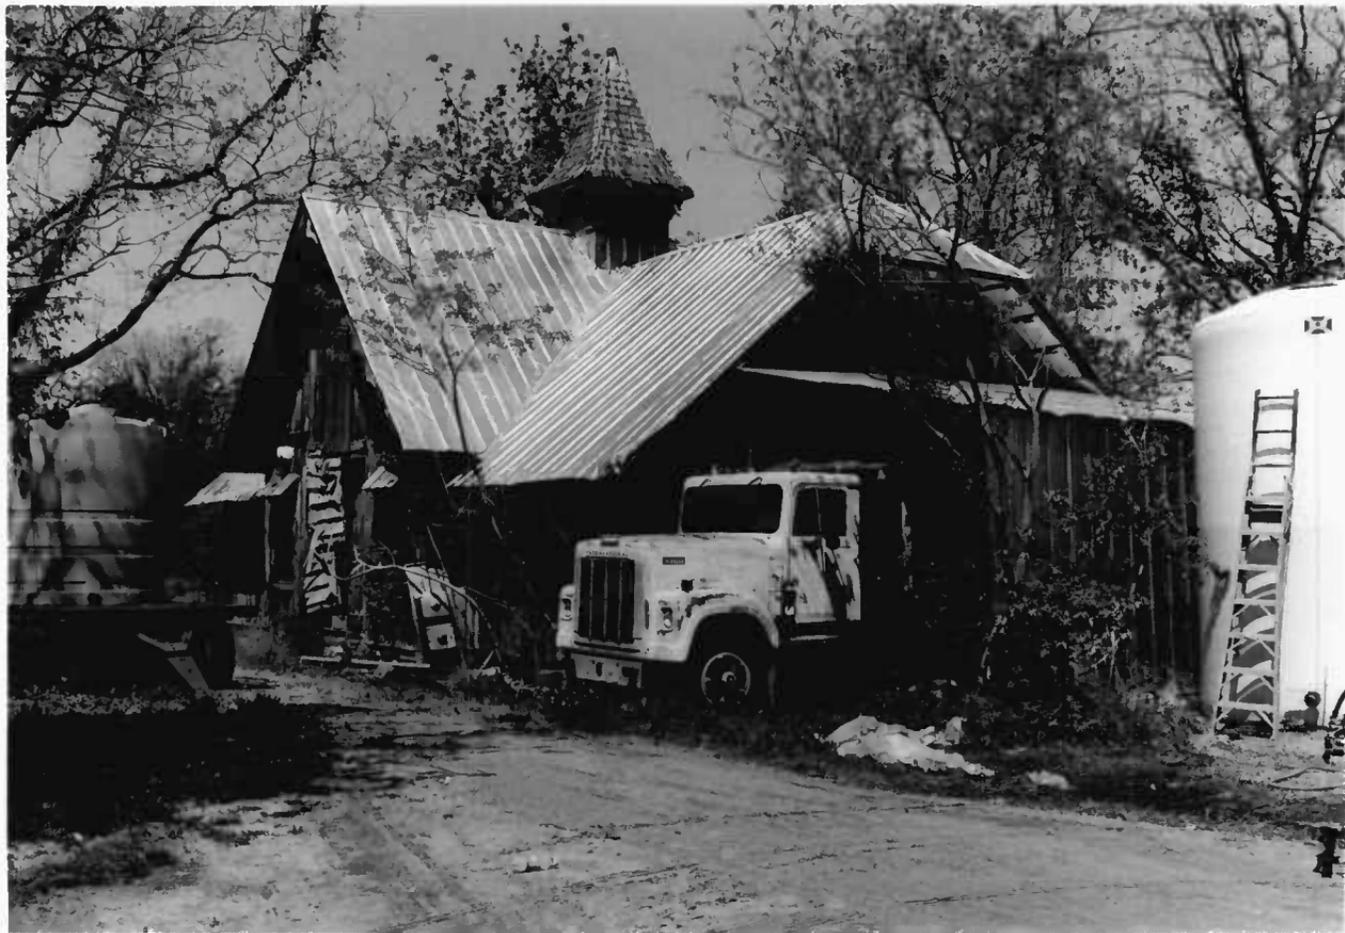
5 of 6

Carriage House - S+E elevations

Just to the north of the house stands a tri-partite designed, gothic-style carriage house. The building combines the functions of stabling horses, storing hay, and maintaining a carriage. To accomodate these diverse operations the building consists of a two story, three bay central section with a roof line that runs north/south. The smaller one-story, three bay wings feature roof lines that run perpendicular to the center part. The entire building rests on a dry laid, stone foundation. Constructed of circular sawn lumber, the walls are covered with vertical board-and-batten siding attached to the frame with mature cut nails. The roof is covered with a newly painted, raised-seam metal roof. A large cupola projects from the roof peak of the central block. It features scroll sawn brackets that support a boxed cornice. The steep, four-sided, belcast-eave roof of the cupola is still sheathed with the original cedar shingles.

The primary or south elevation features the most elaboration and attention to architectural detail. It consists of the center section's gable front and the sides of the two wings. The east wing is pierced by a door and two, three-over-three, double-hung sash windows. The central block features a centrally located, elaborate set of swinging doors. Each of the doors feature lancet or gothic arched bays outlined by strips of trim. The doors are flanked on either side by a six-over-six window. Just above the central doors is a hoist and opening for the storage of hay. The center section is further emphasized by a scalloped vergeboard. The west wing, like the east, is pierced by two, three-over-three windows and a door.

The east elevation features a later, shed roof, garage addition with a corrugated metal roof. The attic story of the east wing is pierced by a single bay.

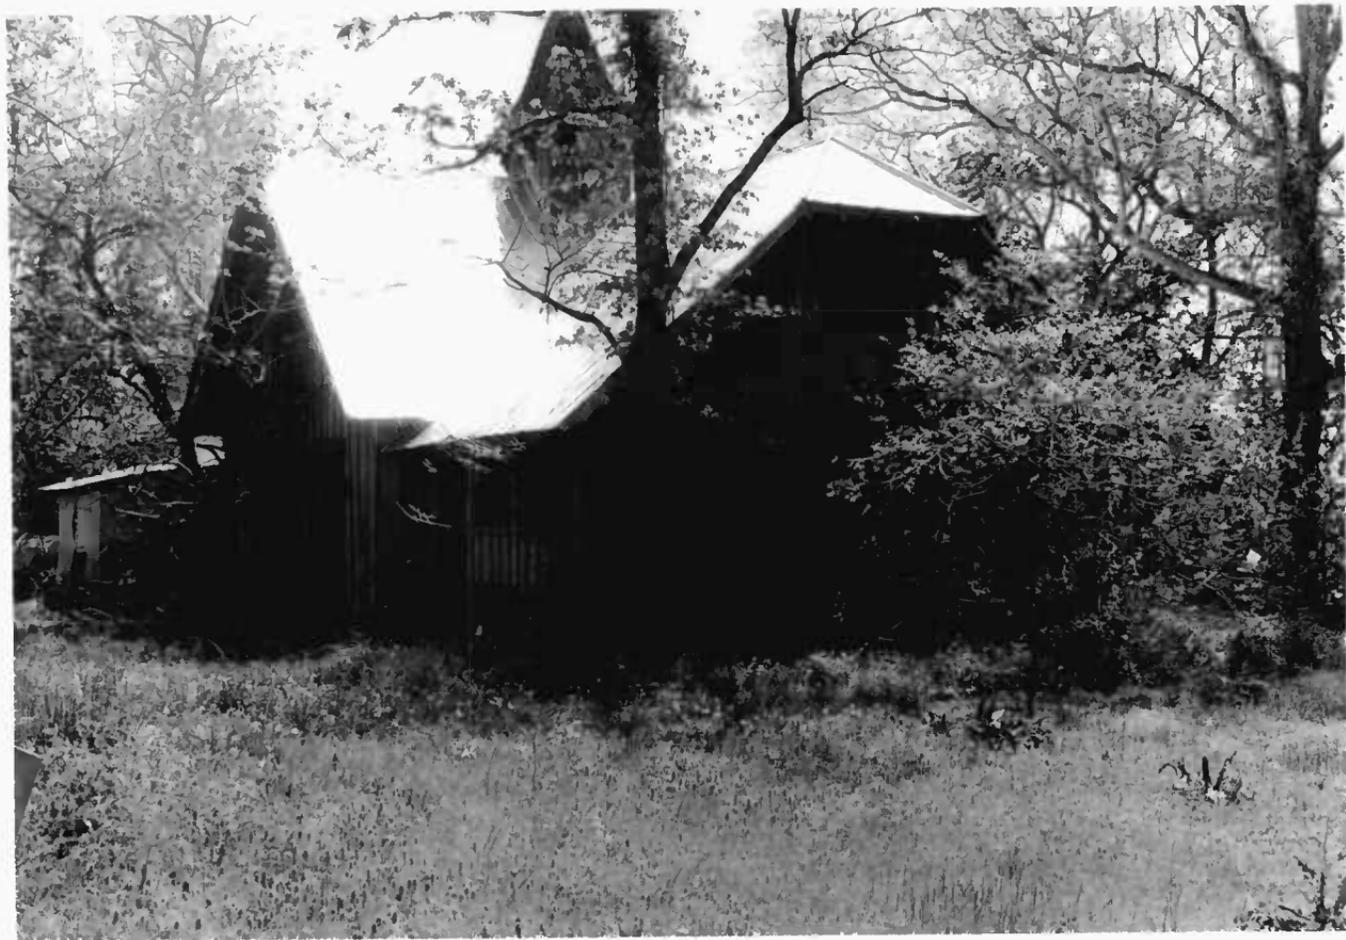
6 of 6

Large house - N+W elevations

The west elevation consists of the main block's side and the service wing. The main block is pierced on the first floor by a one-over-one window and a projecting, one story, three-sided bay window topped by a closed bed pediment. Each side of the projecting bay displays a one-over-one window. Immediately above the bay are two, one-over-one windows. The roof features a large gable dormer whose fenestration consists of two, one-over-one windows. The service wing's first floor is shaded by a shed roof porch. Supported by a series of brick piers, this enclosed porch is pierced by two sets of two-over-two windows. The second floor of the building is pierced by two, one-over-one windows.
