MARYLAND HISTORICAL TRUST
DETERMINATION OF ELIGIBILITY FORM

Property Name: Rosedale Manor Inventory Number: SM-101
Address: Greenwell State Park City: Hollywood Zip Code: 20636
County: Saint Marys USGS Topographic Map: Hollywood
Owner: State of Maryland Is the property being evaluated a district? yes
Tax Parcel Number: _____ Tax Map Number: _____ Tax Account ID Number: _____
Project: ADA Renovations Agency: DNR
Site visit by MHT staff: no X yes Name: Tania Tully Date: 12/11/2002
Is the property is located within a historic district? yes X no

Property/District Name: Rosedale Survey Number: SM-101

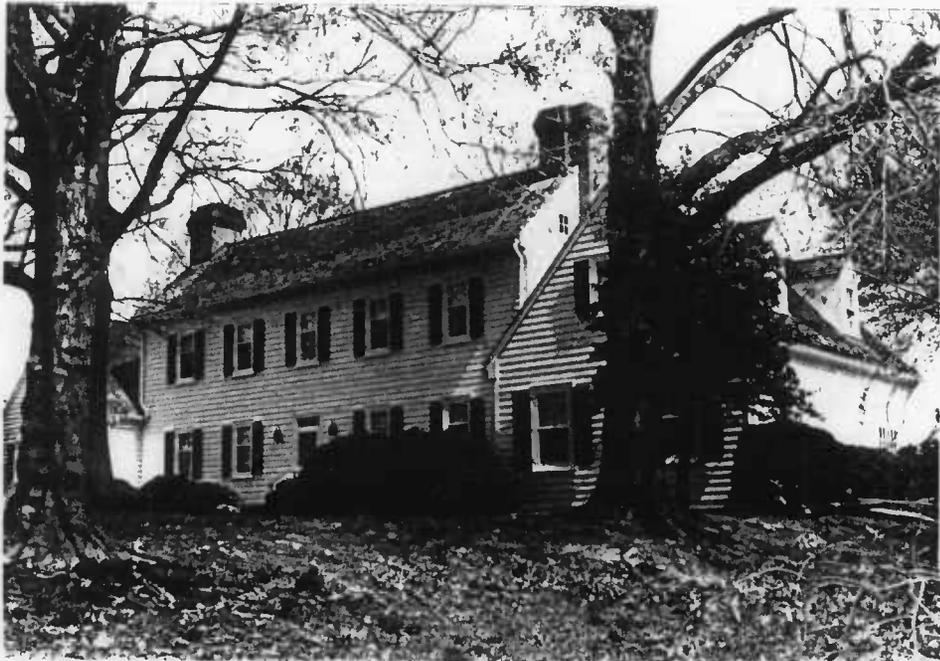
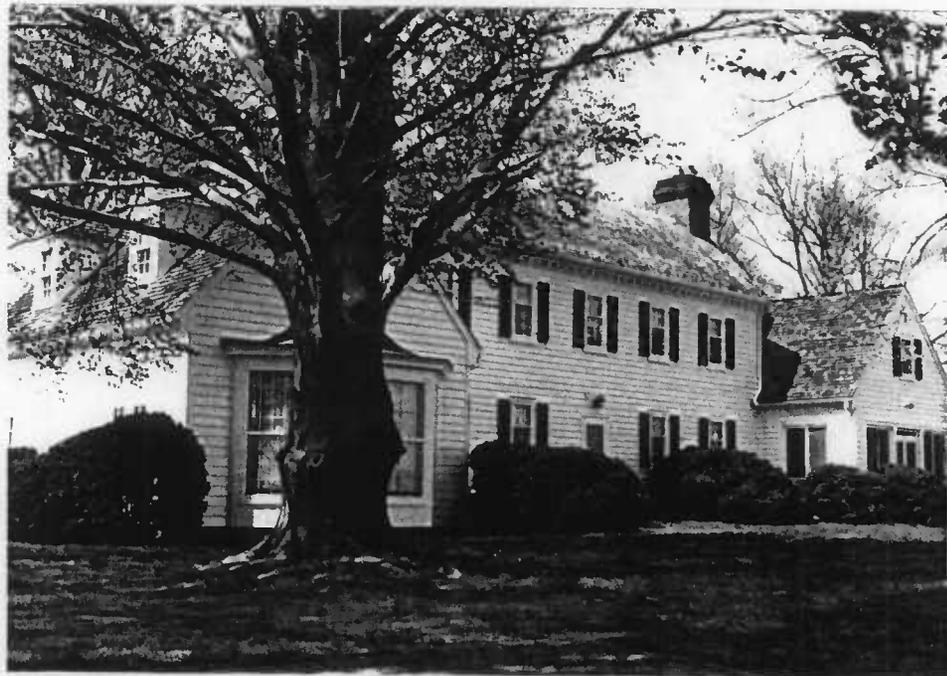
Situated on a promontory affording broad vistas of the Patuxent River, the principal residence on the Rosedale property is a three-part frame structure composed of a two-story, five-bay, gable-roofed central block flanked by matching one-story wings. The wings, set at a right angle to the main block, project forward of the front and rear elevations of the latter, giving the house an "H"-shaped plan. The approach facade of the central block features a transomed door flanked by two six-over-nine pane sash windows, with five evenly spaced windows of matching sash above. The same door location and fenestration pattern is repeated on the opposite side of the house, the only difference being that there is no transom over the door. This portion of the building features brick foundation walls, lapped beaded siding and wood roof singles. The eaves are trimmed with modillion blocks and there is a large, "T"-shaped, brick chimney stack at each end of the roof ridge. All of the windows are fitted with louvered blinds.

The flanking wings have matching fenestration on their southwest (approach) ends but differ on the other elevations. The northwest wing, which houses kitchen-service spaces at the first-floor level, is not as "formal" in external appearance as the southeast wing, the latter having two double-leafed French doors in its southeast wall, two gable-fronted dormers above these, and a wide, bow-shaped window at its northeast end. The northwest wing has a door and smaller windows in its northwest elevation and an enclosed porch at its northeast end. Like the main block, the wings are clad with beaded siding and have wood shingled roofs.

All of the exterior wall and roof coverings, all of the masonry work, and all of the trimwork of both the central portion of the building and its flankers are twentieth century.

TOP: View of main house (1) from southeast.
BOTTOM: View of main house from northeast.

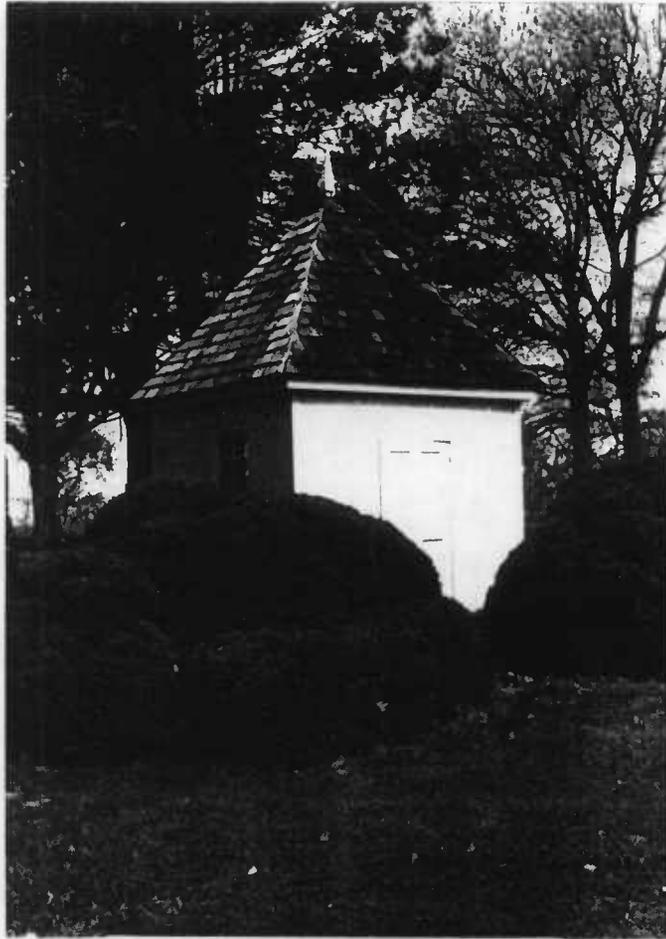
Measuring 8'-3" on a side, this is a small wood-framed structure with a pyramid roof. The exterior walls are sheathed with wide, horizontal, flush boards. Some of this siding, notably on the upper parts of the side and rear walls, is original, while other boards are twentieth-century replacements. The roof is sheathed with wood shingles. There is a simple boxed eave cornice with beaded facias and a narrow crown molding, all of a profile typical of the 1830s and 1840s. A four-panel door with reproduction hardware is centered in the southeast elevation. The building stands on continuous, common-bond brick foundations.

The interior of the garden house features a brick tiled floor, plastered walls and ceiling, and simple trimwork. All of these finishes are twentieth century. The building's wall framing is completely sealed within modern finishes; the roof rafters, visible from a small trap door in the ceiling, are sawn and appear to be mid nineteenth century while the shingle nailers are of more recent vintage.

View of garden house (2) from south.

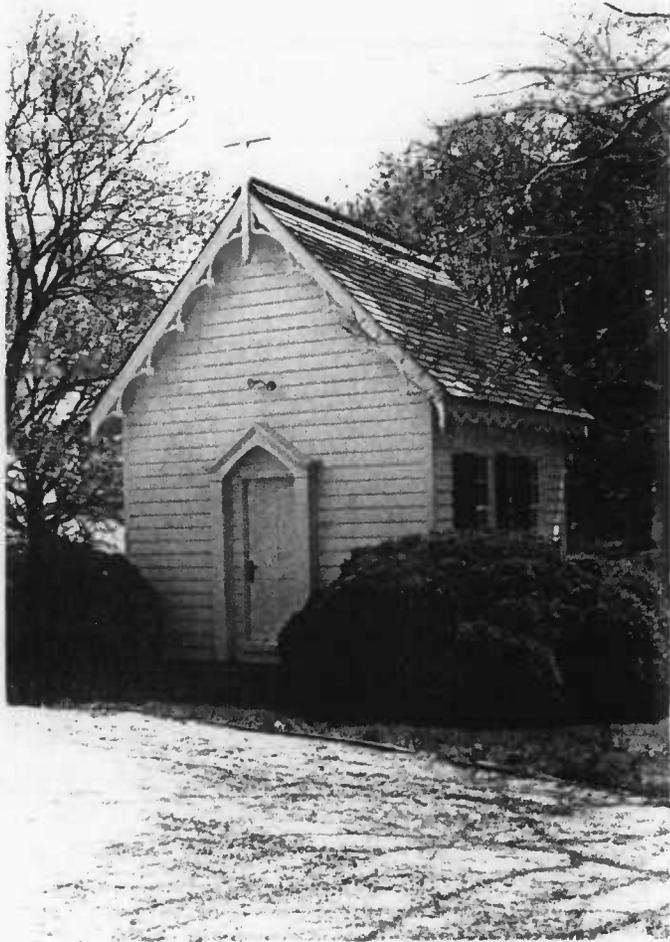
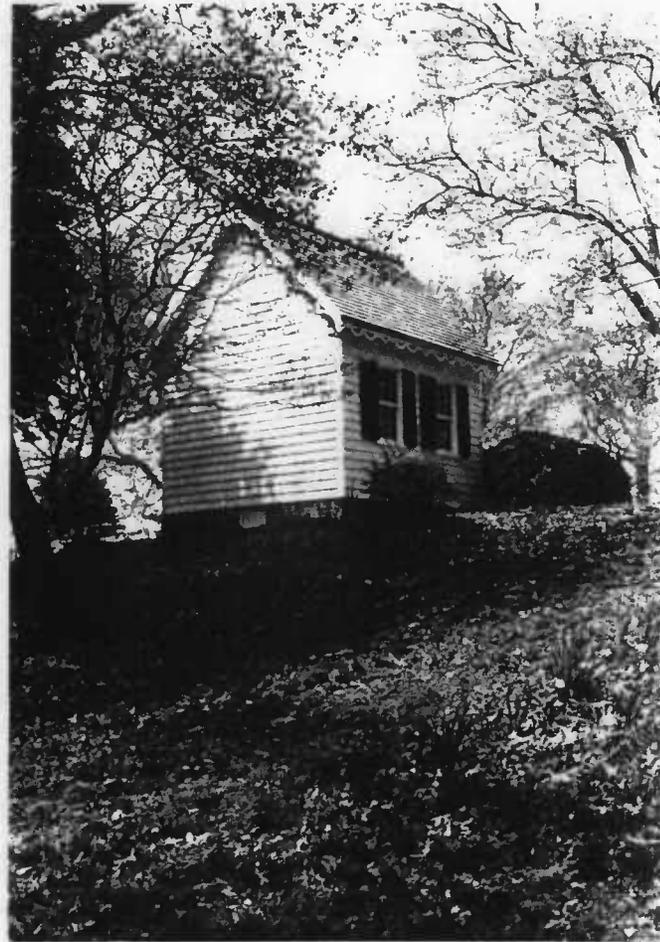
located to the right (southeast) side of the beginning of the circular drive fronting the house, and directly opposite the drive from the garden house (2), the chapel is a one-story, 14x16-foot, gable-roofed frame structure whose northwest-southeast axis parallels that of the main house (1). The entrance door is centered in the northwest end within a slightly projecting, vaguely Gothic-style enframingent. There are two sash windows in each side wall, all with louvered shutters. The building stands on common-bond brick foundations, the exterior walls are clad with lapped siding and the roof is wood shingled. The most notable exterior feature of the building are pierced and scalloped fascia boards ornamenting the overhanging eaves of all four elevations. The pattern of cutouts and scallops of the two end elevations are similar to but do not precisely match that of the side elevations. Additionally, the boards of the northwest (front) elevation have trefoil-shaped drops between the scallops and at their bottom ends. This same elevation features a wooden cross with a carved, pendant-shaped base affixed to the apex of the gable. With the exception of the ornamental fascia boards, all of the building's exterior finishes are twentieth century.

The chapel's interior contains a single room with a vaulted ceiling. The walls have wainscoting of wide, vertical, beaded boards below the line of the window sills. The remaining wall areas and the ceiling are plastered. The floors are random width boards surface-nailed with wire nails. An altar at the southeast end of the room

LEFT: View of chapel (3) from south. RIGHT: View of chapel from north.

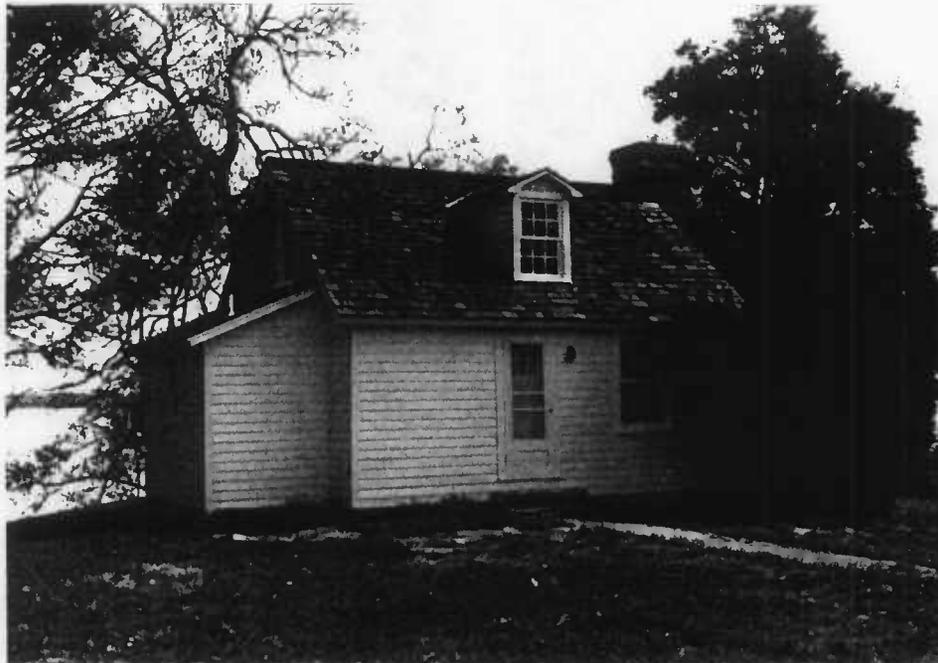
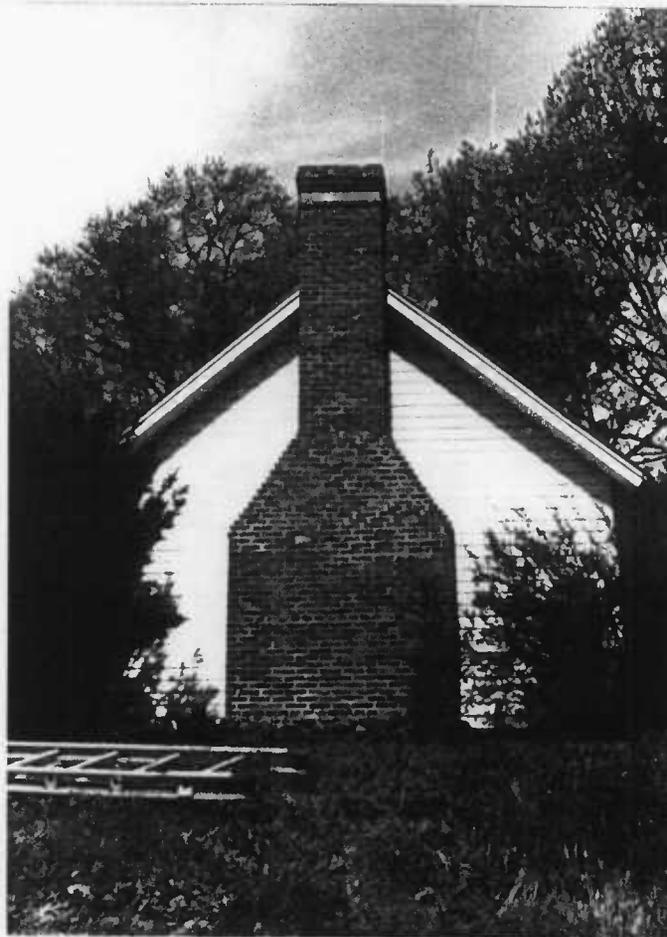
Perched on a knoll a short distance southeast and across a ravine from the main house (1), the guest house is a small, two-bay frame structure whose gable roof follows a northwest-southeast axis. There is a shed-roofed wing at the northwest end, a single, gable-fronted dormer on each side of the roof, and a massive exterior chimney with stepped shoulders at the southeast end. Both the building and the chimney are underpinned with foundations composed of fossilized river marl and shells, a building material sometimes found in historic building foundations along the lower Potomac and Patuxent rivers. These foundations do not appear to date earlier than the twentieth century, though may have been constructed using material salvaged from another building. All of the exterior finishes of the buildings, including sash and doors, lapped siding and wood roof shingles are twentieth century.

The interior of the guest house contains a single principal room with front and rear doors, a fireplace centered in its southeast wall and a narrow stair with winders in the west corner. The floor is of random width boards, all surface nailed with wire nails. The walls are partially sheathed with a combination of flush vertical and lapped horizontal boards, and plaster. The ceiling features exposed ceiling joists bearing straight and circular saw marks. The flooring and possibly the ceiling joists are salvaged materials. All other finishes are twentieth century. A door in the room's northwest wall opens into a modern bathroom housed within the shed. Above is a single bedroom with plastered knee walls and sloped ceilings, random width flooring, and closets on the southeast wall. The trim and wall and ceiling finishes of the attic and shed rooms are also twentieth century.

The interior and exterior of this building were recently (1994) refurbished.

TOP: View of guest house (4) from south.
BOTTOM: View of guest house from southeast.

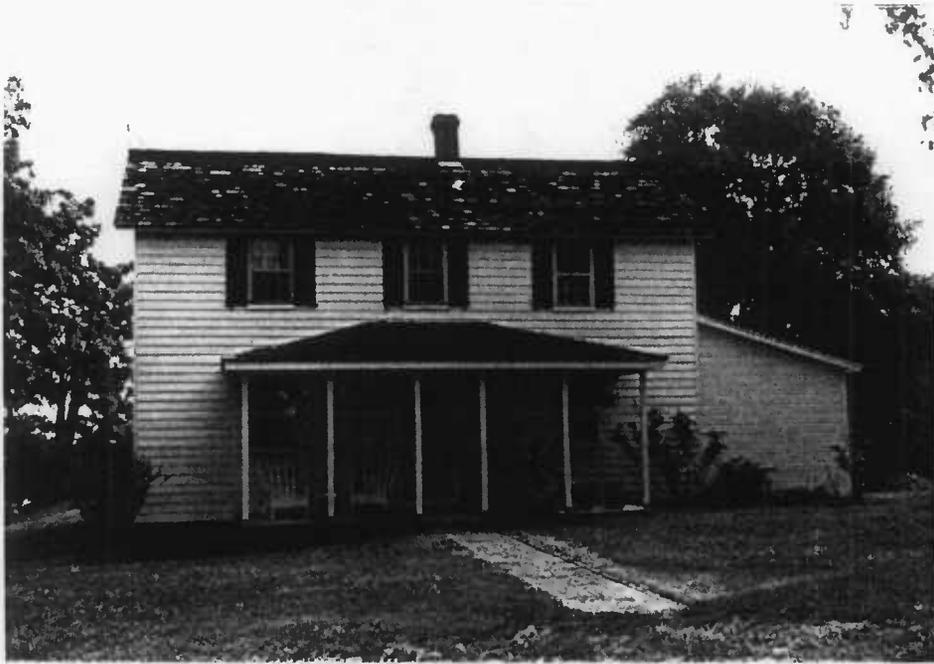
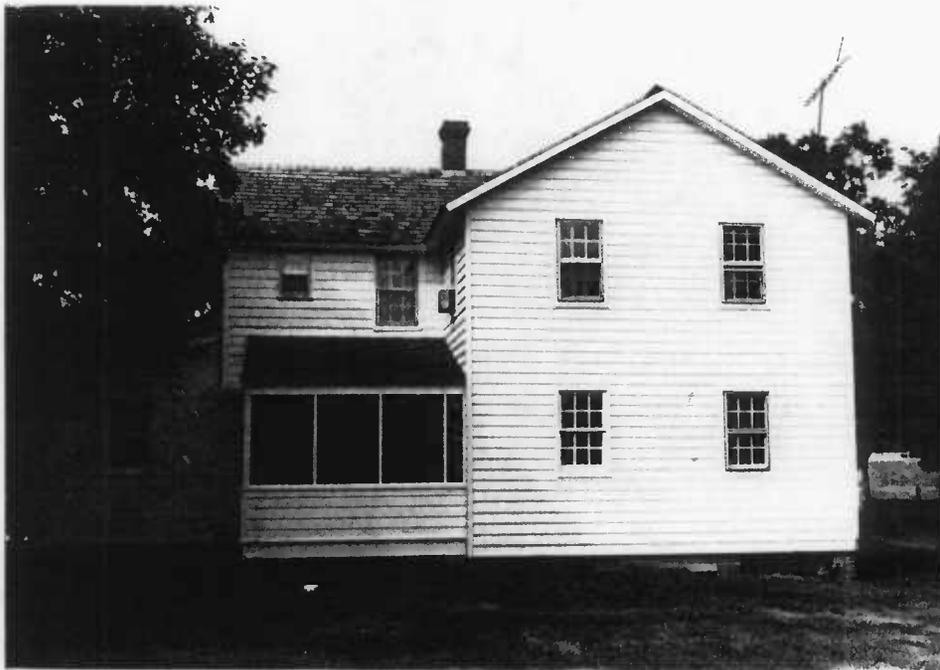
Built on the same axis as the main residence, this is a two-story, ell-shaped frame dwelling with lapped siding and a wood-shingled roof. The southeast, front elevation is three bays wide at both floor levels with the centered entrance door and two flanking windows sheltered by a hip-roofed porch. The northeast, rear wing is also two stories high but only one bay wide on a side and two bays wide at the end. The wing covers about half the rear elevation of the main portion of the house. Between the southeast side of the wing and the southeast end of the house is a shed-roofed screened porch. The wing appears to have been an addition to the main block, though it may be contemporary with it. A more modern shed-roofed addition stands at the southeast end of the main block. All of the exterior of the building appears to have been recently refurbished. Access to the interior was not gained.

TOP: View of tenant house (5) from southwest.
BOTTOM: View of tenant house from northeast.

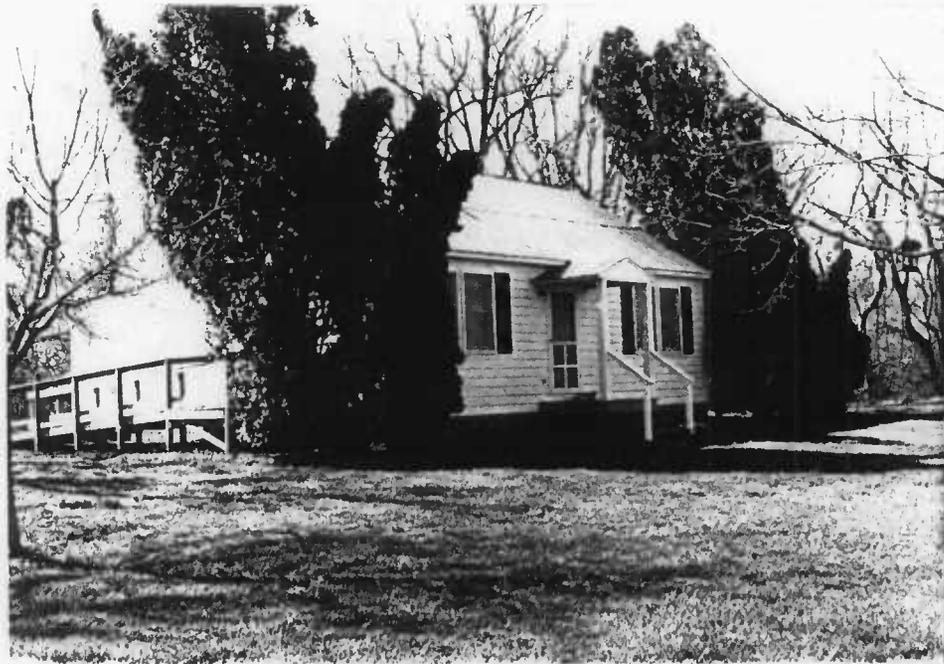
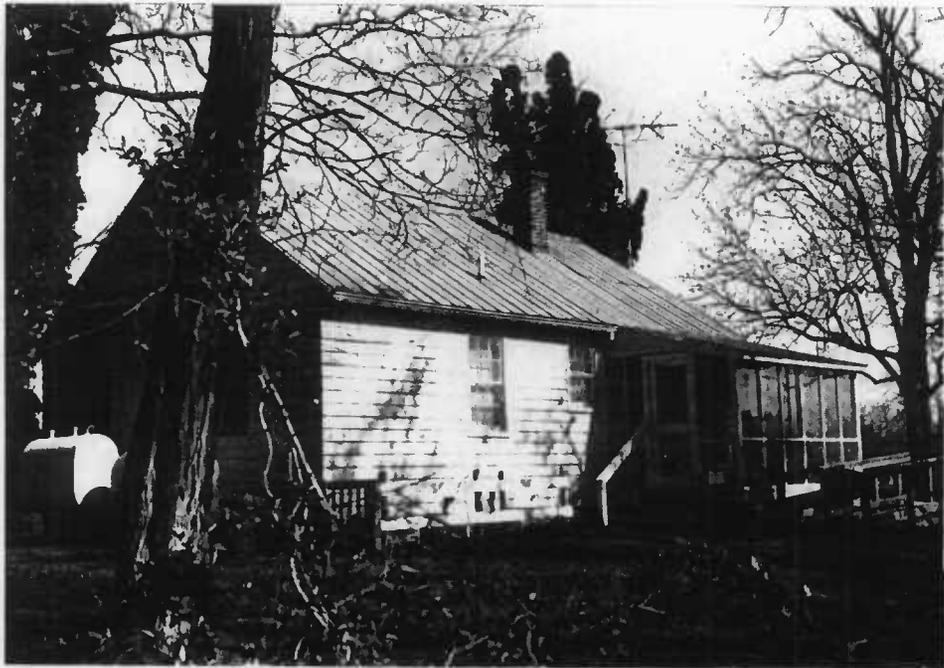
Separated from the main complex of buildings at Rosedale by fenced pastures, this is a one-story, clapboarded frame structure with a metal clad gable roof. Unlike most other gable-roofed buildings on the property, the house was built on a northeast-southwest axis. The northwest, front elevation has a centered door sheltered by a small gable-roofed porch and flanking double-unit windows. The two end elevations are each two bays deep, and there is a series of windows of various sizes, a door and a small shed-roofed screened porch across the rear.

The interior of the house contains a living room, kitchen, bath and two bedrooms, all with modern finishes. An enclosed stair provides access to a full cellar with a poured cement floor and concrete block walls. The attic, accessed by a trap door in the ceiling of a first-floor hall, is unfinished. All exposed and accessible framing members are twentieth century. The interior and exterior of this building was recently (1994) refurbished.

TOP: View of tenant house ("Francis Knott House" 7) from north. BOTTOM: View of tenant house from south.

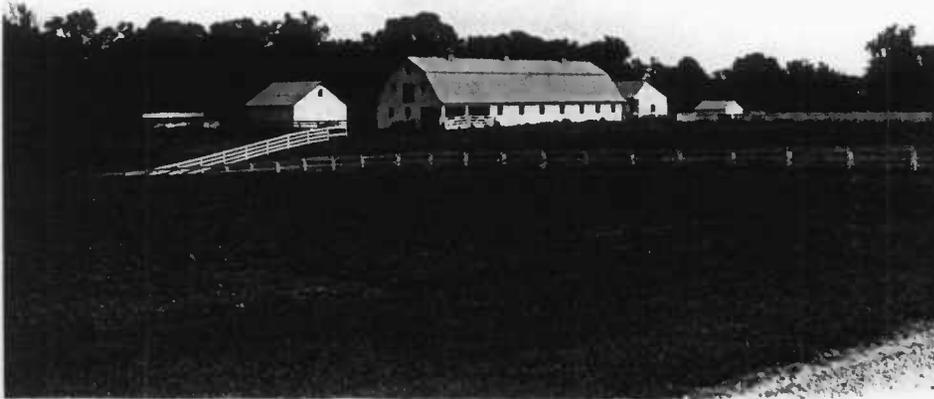
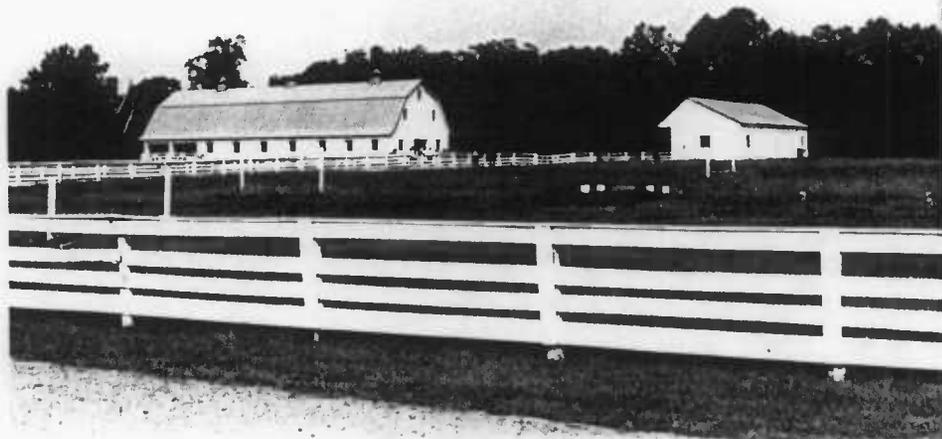
This is a small grouping of farm buildings that includes a large, gambrel-roofed, masonry block and frame livestock barn, a shed for horses, a large corncrib, and two small sheds. The buildings, all of which are painted white and in good repair, were constructed between about the late 1940s or early 1950s and 1971. The complex is visible from the entrance drive near the approach to the house but separated from the road and house complex by board-fenced paddocks and pastures.

TOP: View of barn complex (8-12) from southeast.
BOTTOM: View of barn complex from northeast.

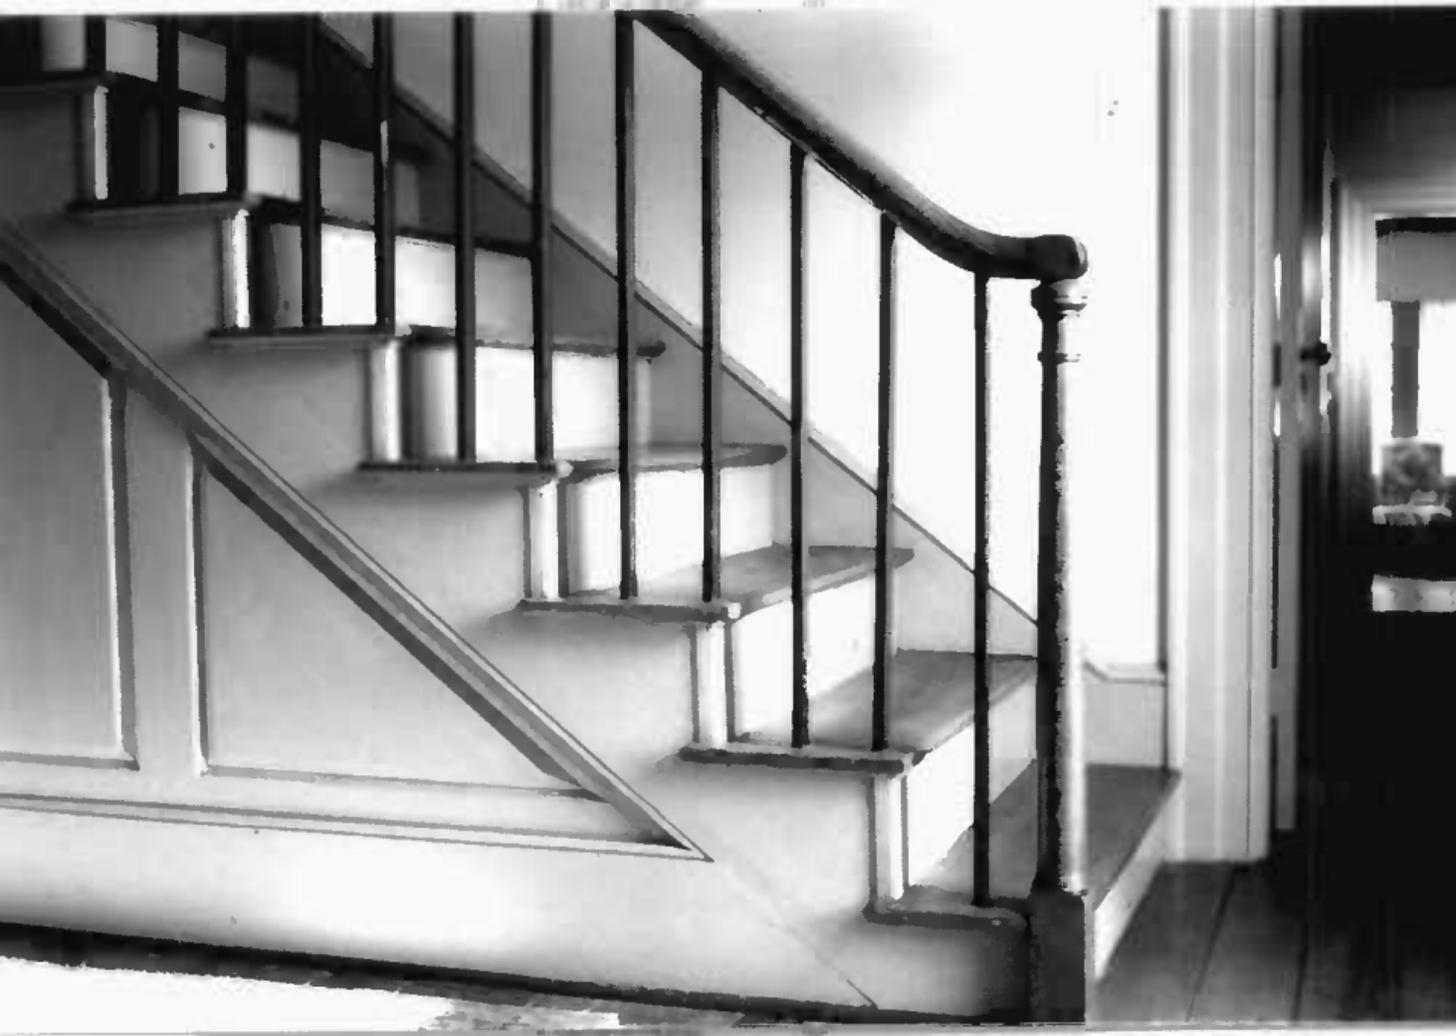
3/17

The central stair passage features the same original flat-paneled dado as the parlor and raised paneling trimmed with quirk ogee moldings sheathing the staircase.³ The stair has "slender columnar newel posts, a round handrail; straight, rectangular balusters; and treads edged with strips of reeding--all typical of the more restrained woodwork of the 1830s!"⁴ (The tread on the second step from the bottom was replaced by Park Supervisor Francis Knott a couple of years ago.) In the second floor hallway the attic stairs are also enclosed with the original raised paneling like downstairs.

MAIN HSE., STAIR DETAIL, 1ST FLOOR

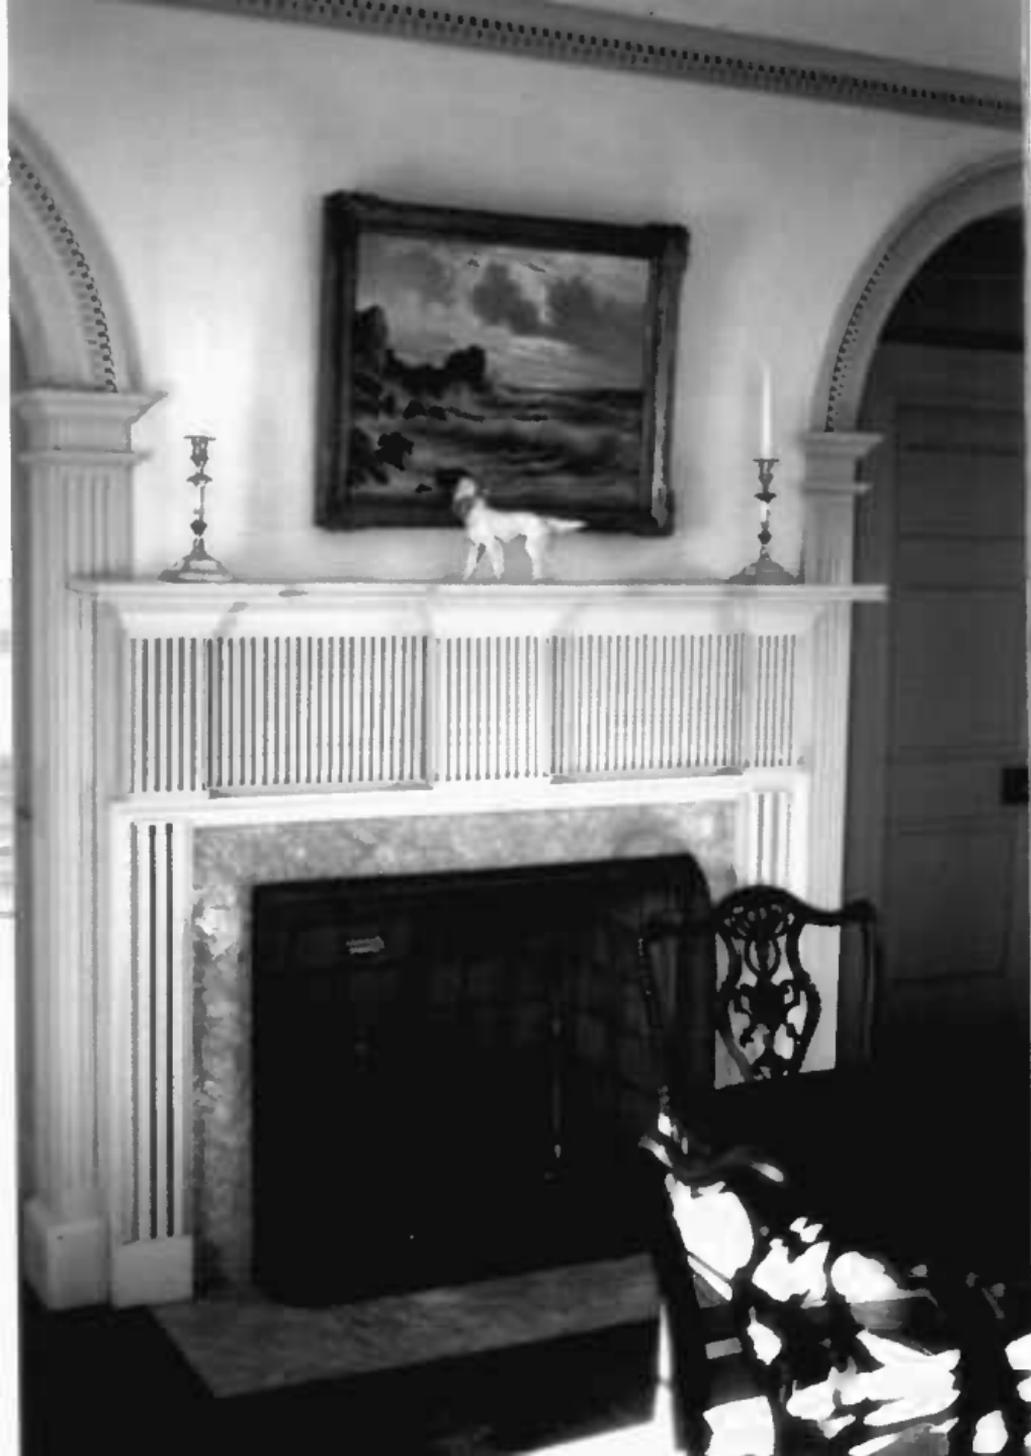
4/17

The most formal room in this portion of the house is the present dining room where two arched doorways trimmed with fluted pilasters, fretwork and keystones flank a marble-faced fireplace framed by a mantel featuring series of narrow colonettes on both the pilasters and

MAIN HSE., DINING RM MANTEL

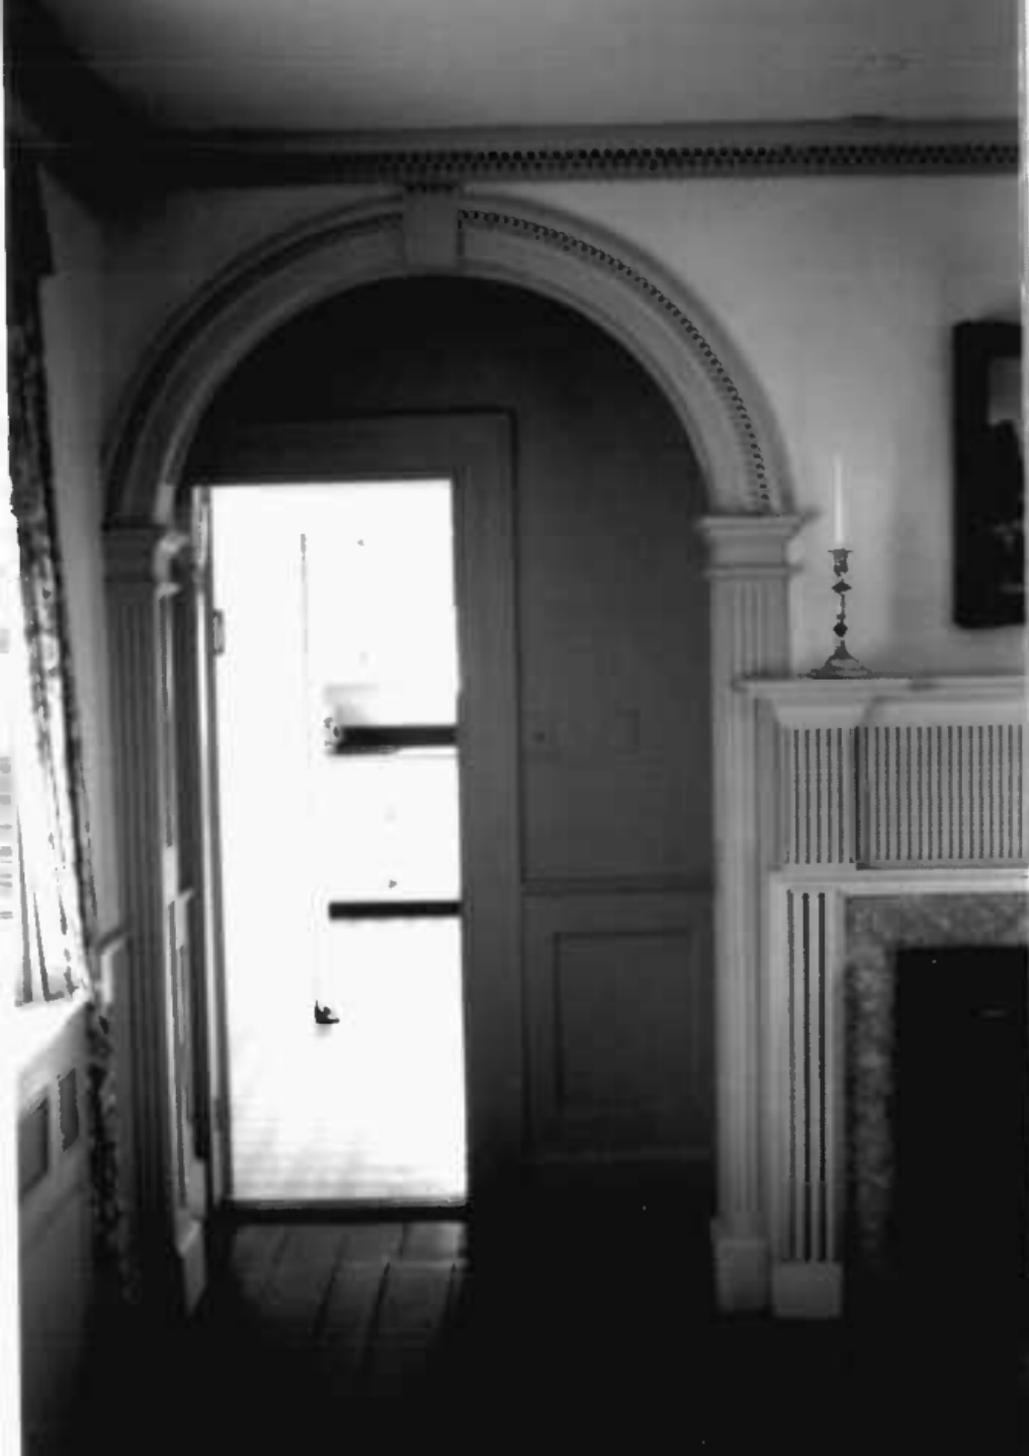
6/17

~~MAIN~~ HSE., DINING RM., ARCH

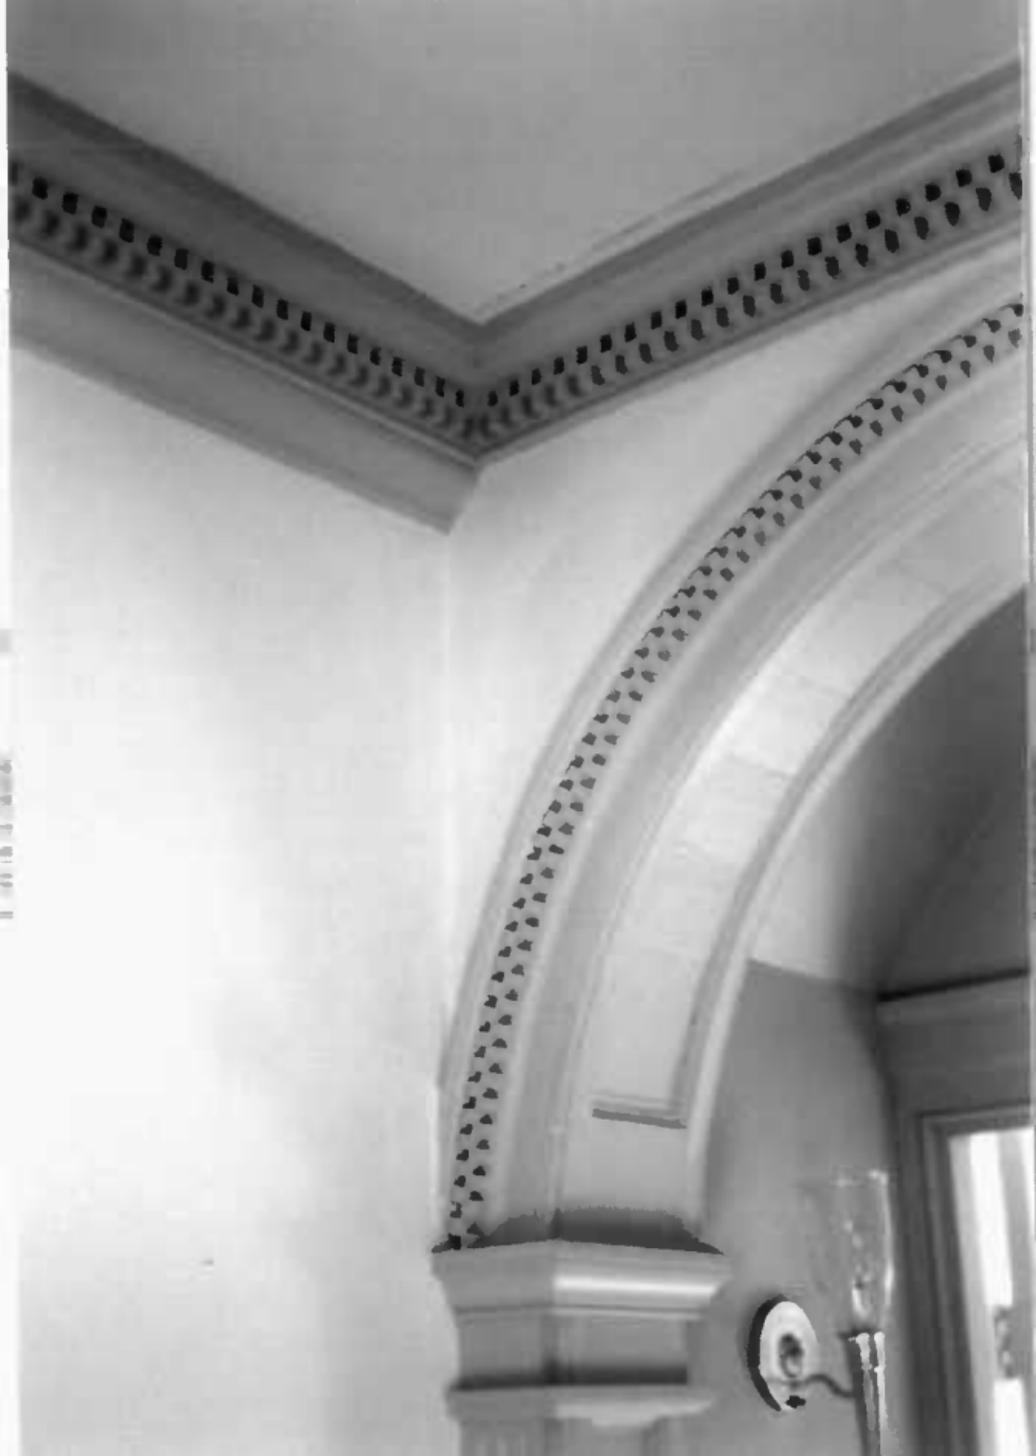
7/17

the frieze. Other woodwork in this room includes a bold ceiling cornice with fretwork and blind-paneled wainscoting. The ceiling cornice and wainscoting designs in the dining room are repeated in the adjacent stair hall. The stair, which rises along the southeast wall, has a narrow, turned newel, a shaped rail and straight balusters. The outside ends of the stair risers are decorated with applied reeding. The characteristically simple Federal styling of the stair balustrade and applied reeding is in sharp contrast to bold, raised paneling enclosing a small stair closet. The woodwork of the adjacent southeast room, or parlor, is much more restrained. Here, there is no wainscoting and the fireplace, though faced with marble, has a fairly simple mantel with gougework decorations on the frieze.

MAIN HSE., DIN. RM., ARCH DETAIL

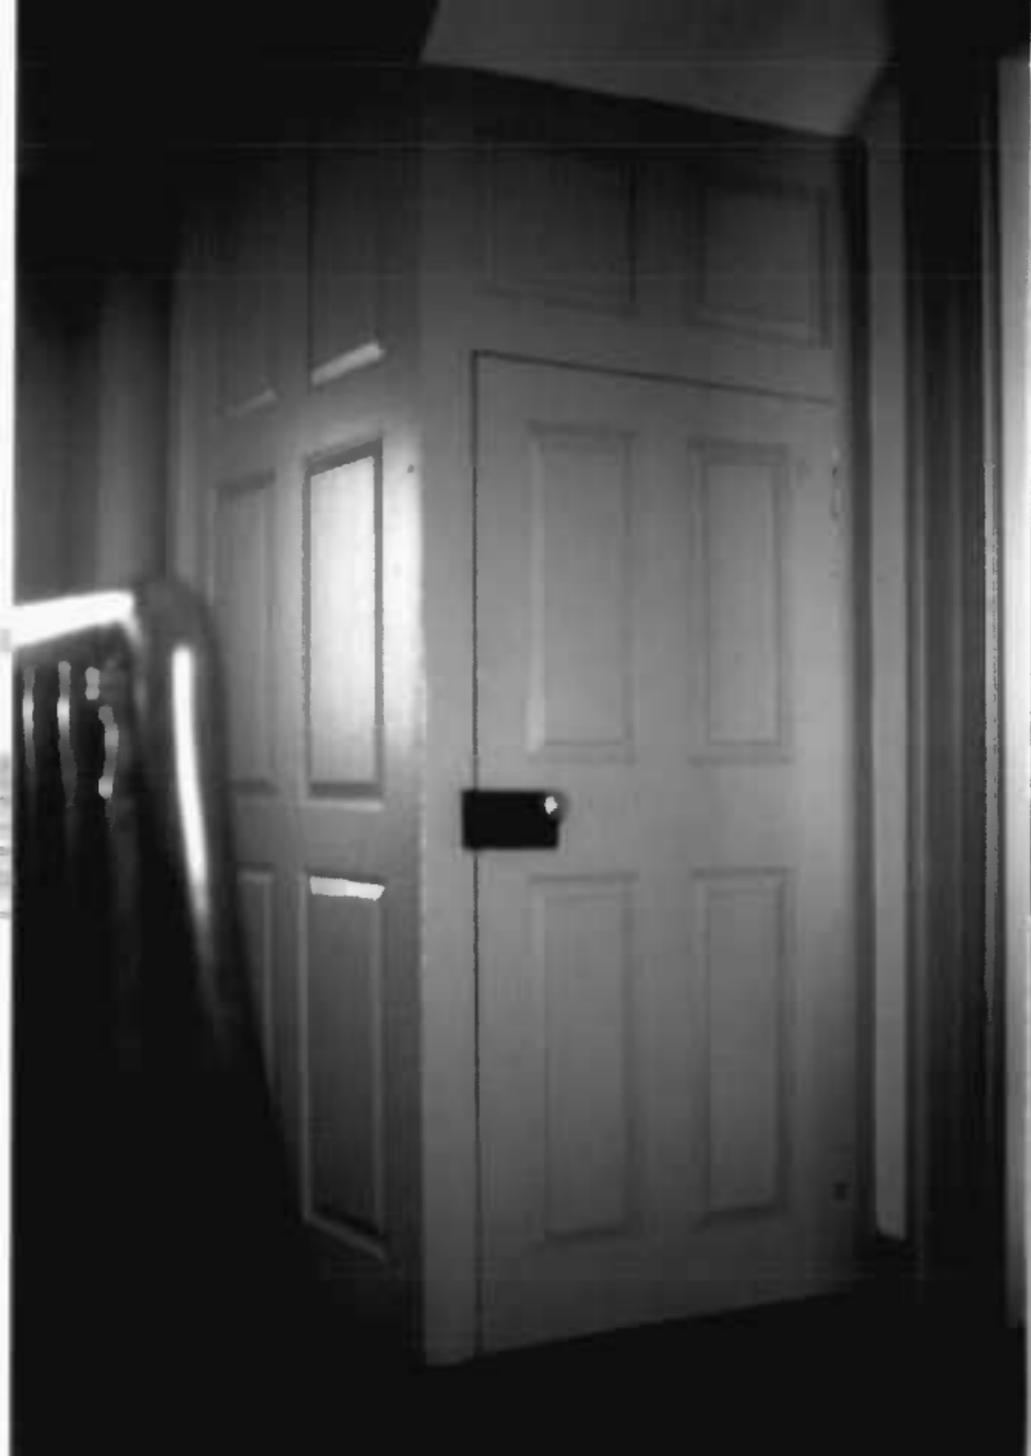
10/17

The second-floor hall has a ceiling cornice matching that of the hall below. Floor-to-ceiling raised paneling encloses the attic stair and both the stair door and a door opening onto a small closet beneath the stair are similarly paneled. The two bedrooms have window and door trim corresponding in profile with that of the first-floor doors and windows. Each bedroom has a fireplace with marble facings and hearth, and mantels matching that in the first-floor southeast room. With the exception of the paneling and doors of the attic stair, and the balustrade of the main stair, all of the woodwork in the second-floor rooms appears to be twentieth century.

MAIN HSE., ATTIC STAIR & STAIR CLOSET DOOR

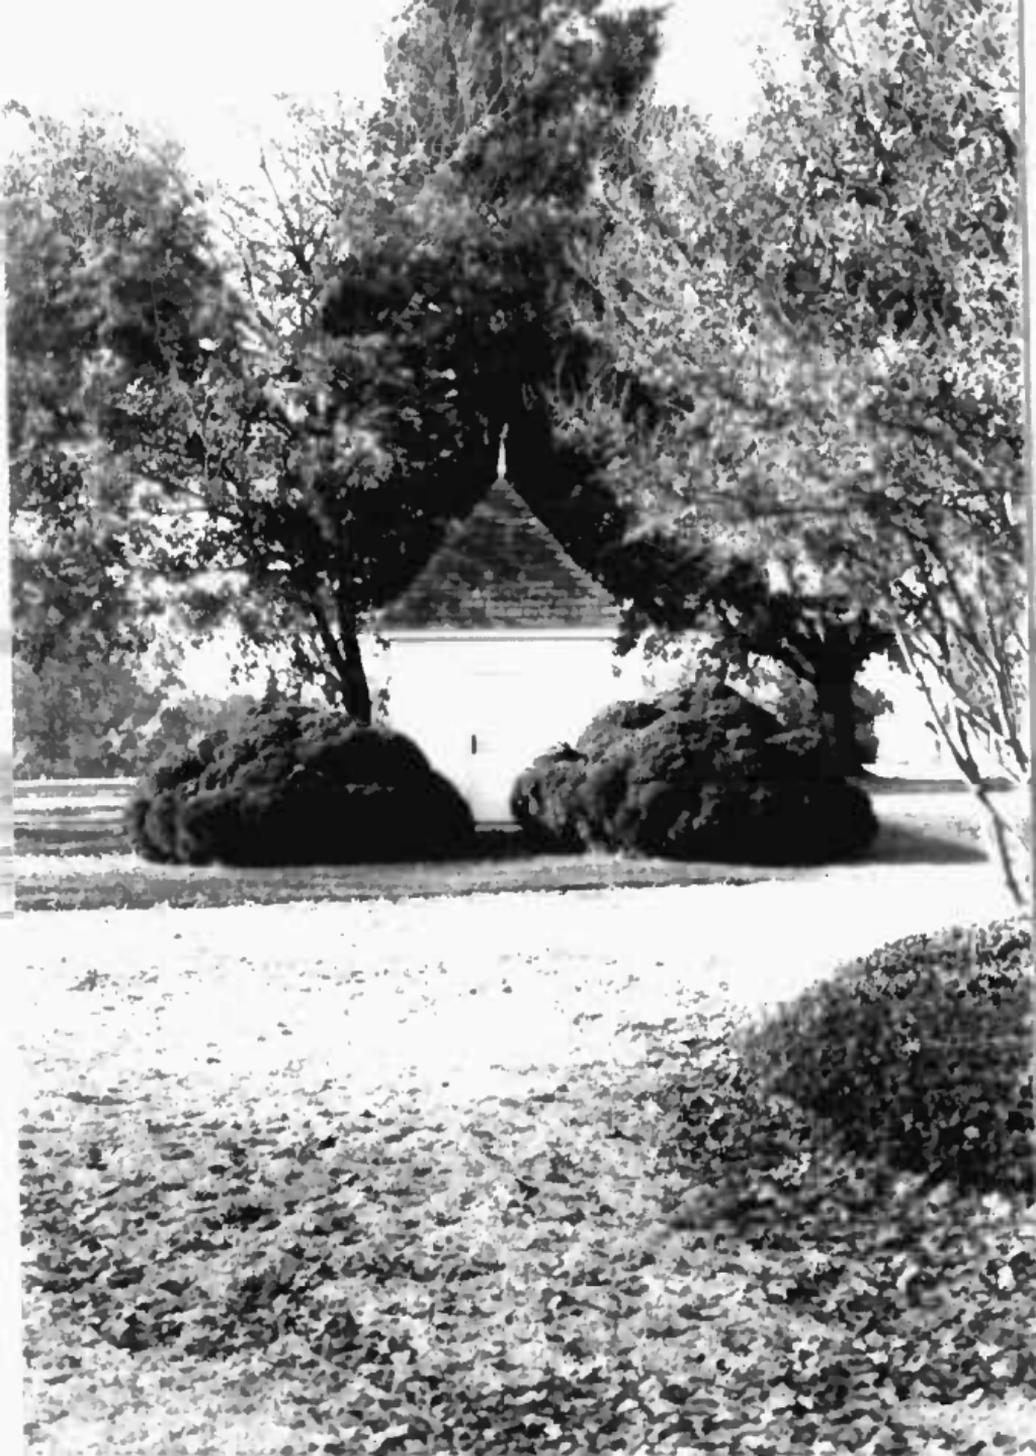
12/17

GARDEN HSE., FROM E-SE

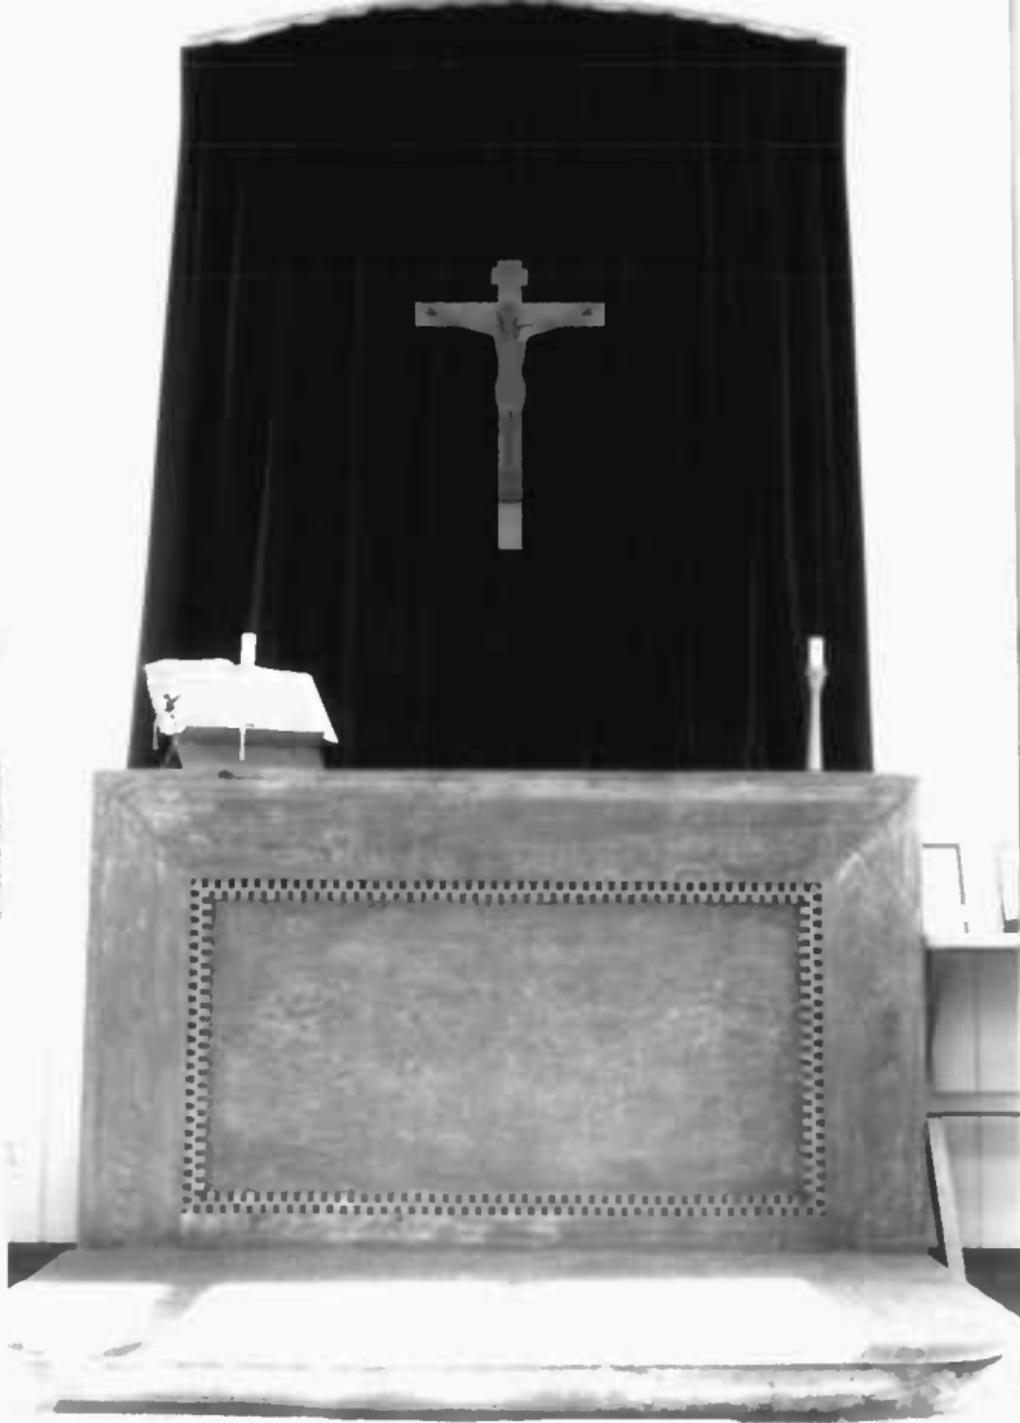
14/17

is constructed of yellow pine boards and plywood and was formerly painted white. With the exception of the flooring, which may be salvaged materials, and perhaps some of the window sashes, the interior finishes are twentieth century.

CHAPEL, ALTAR
