S M -120
RIVER VIEW
Oakley
Private

**NATIONAL REGISTER OF HISTORIC PLACES
INVENTORY -- NOMINATION FORM**

River View

By Edward H. Kirtz Jr.

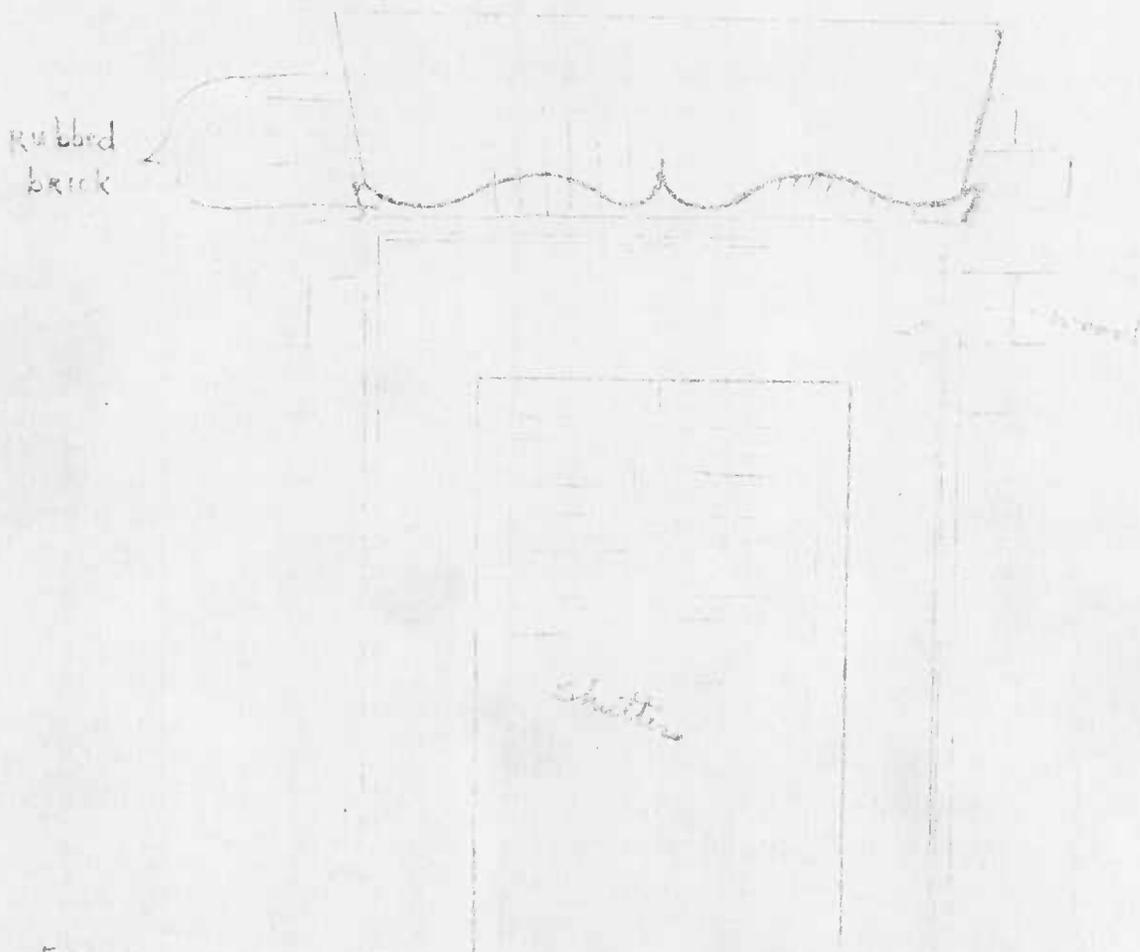
①

- CURVILINEAR windows heads of carved brick on land front
(windows on river front appear to be the same but are covered by present porch roof.)

This is similar to Holly Hill (#176 p131) except that the curves do not touch the wood of the window frame, and are shallower. Also, the ends rise up and extend slightly beyond the rubbed brick. The depressions are about an inch deep and the same rubbed brick extends down to the woodwork.
The flat woodwork is very wide around all the windows.

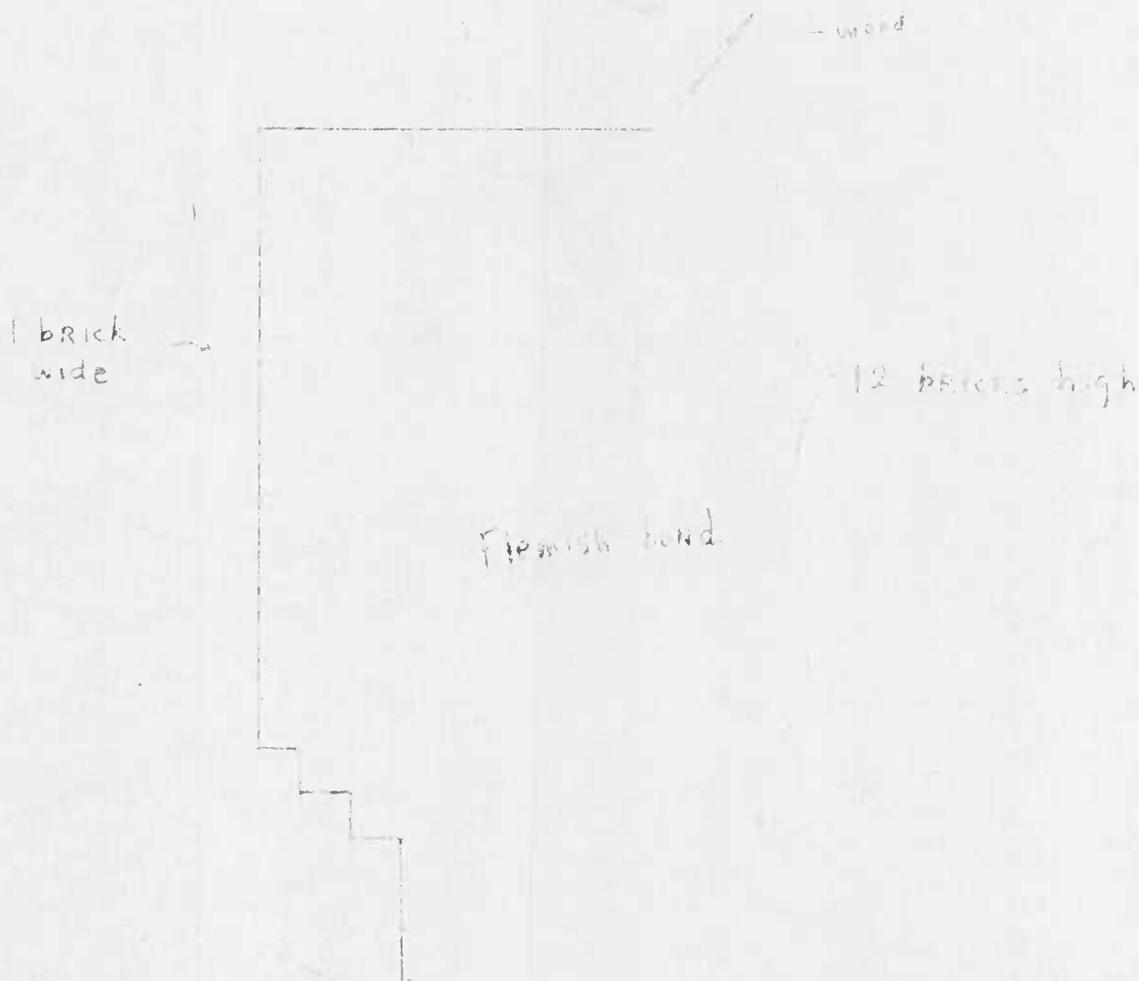
corbeled parapets at the eaves on the land side
(551 p. 45)

These projections are very
slanting from the side view. Somehow,
the end board of the cornice ticks
on and shows.

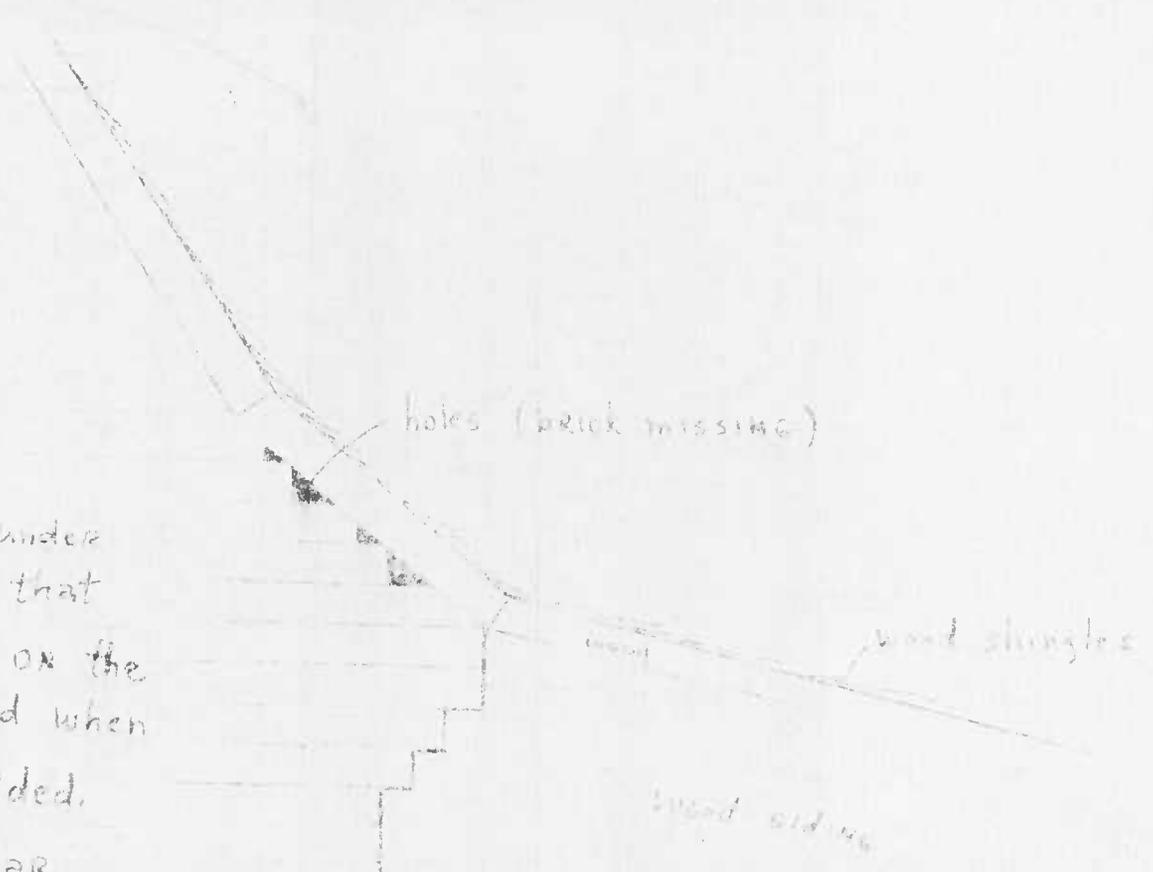
(4) The eaves on the RIVER side are splayed and the brick under them is corbeled.

The missing brick under the splay suggests that arapets like those on the north were removed when the porch was added.

There is no similar deterioration (?) along the steeper parts of the gables.

The splay is a sort of bridge that makes the main roof continuous with the porch roof. (I think the splay is larger than I have shown.)

²At the south front of the house the "parapets" had been removed, perhaps when the present porch was built.

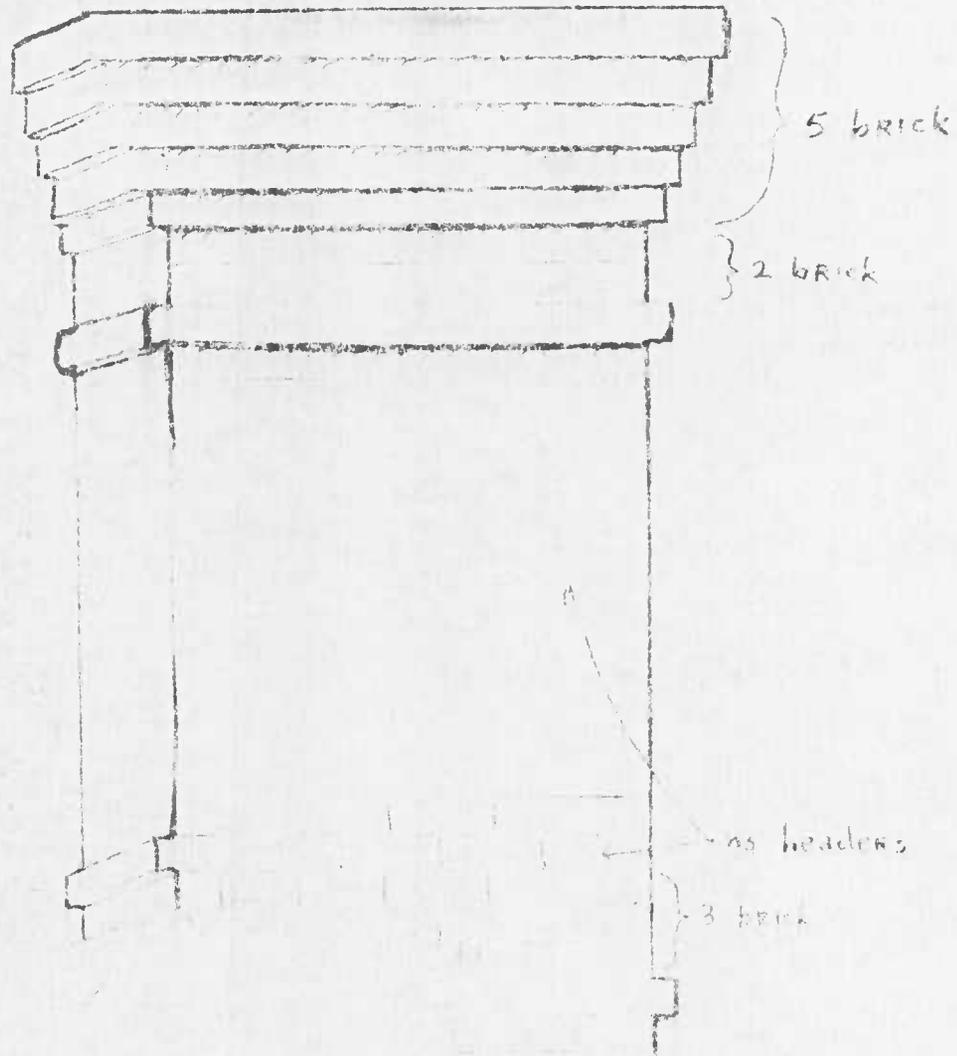
5.

Chimneys (identical on each end).

River side

land side

common bond

glazed headers

Water course - 1 curved brick
about 1/4 gal. per hour

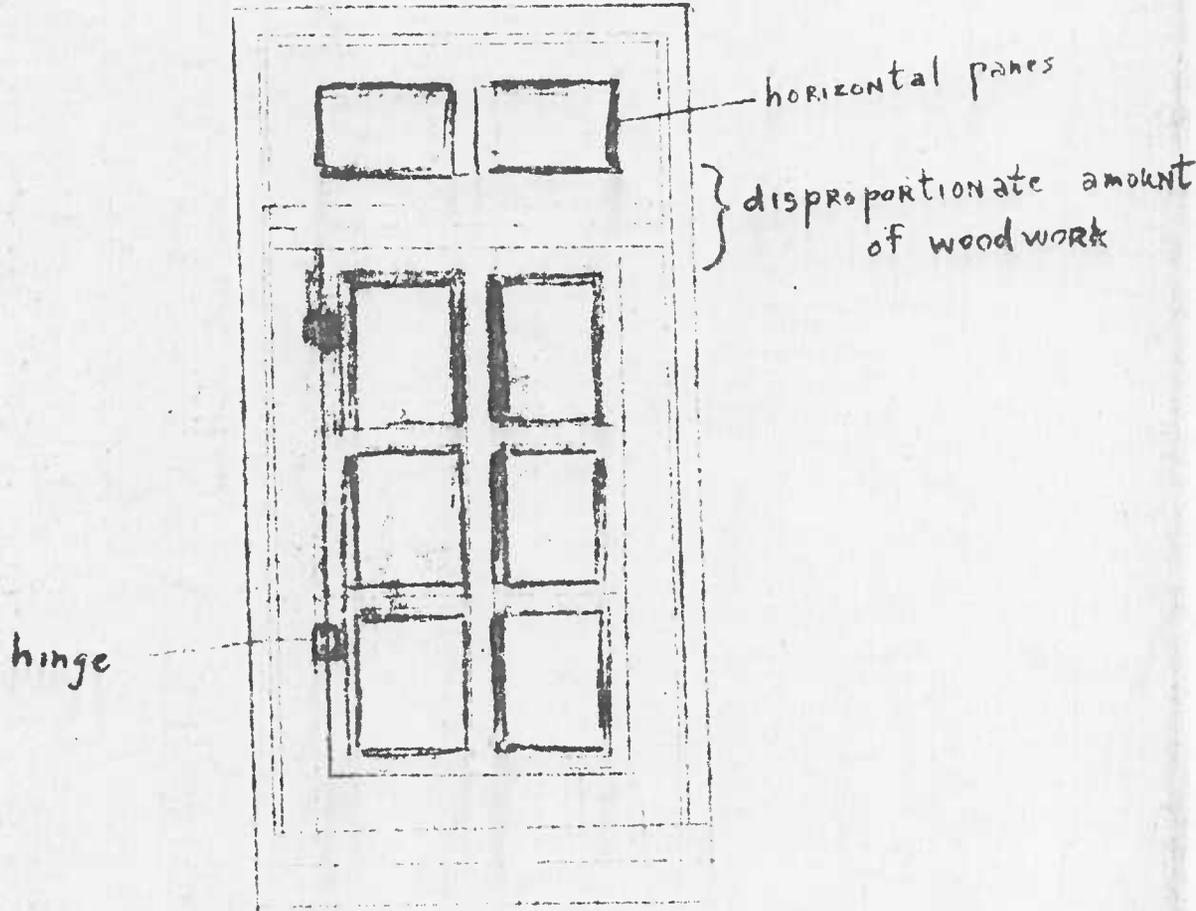
3 small gable windows (very rough sketch)

(The top part looked like a TRANSOM, but I couldn't tell if it is hinged. I couldn't make out the detail of the hinges. The effect of these little windows is quite odd. They suggest a medieval window made over to sash.)

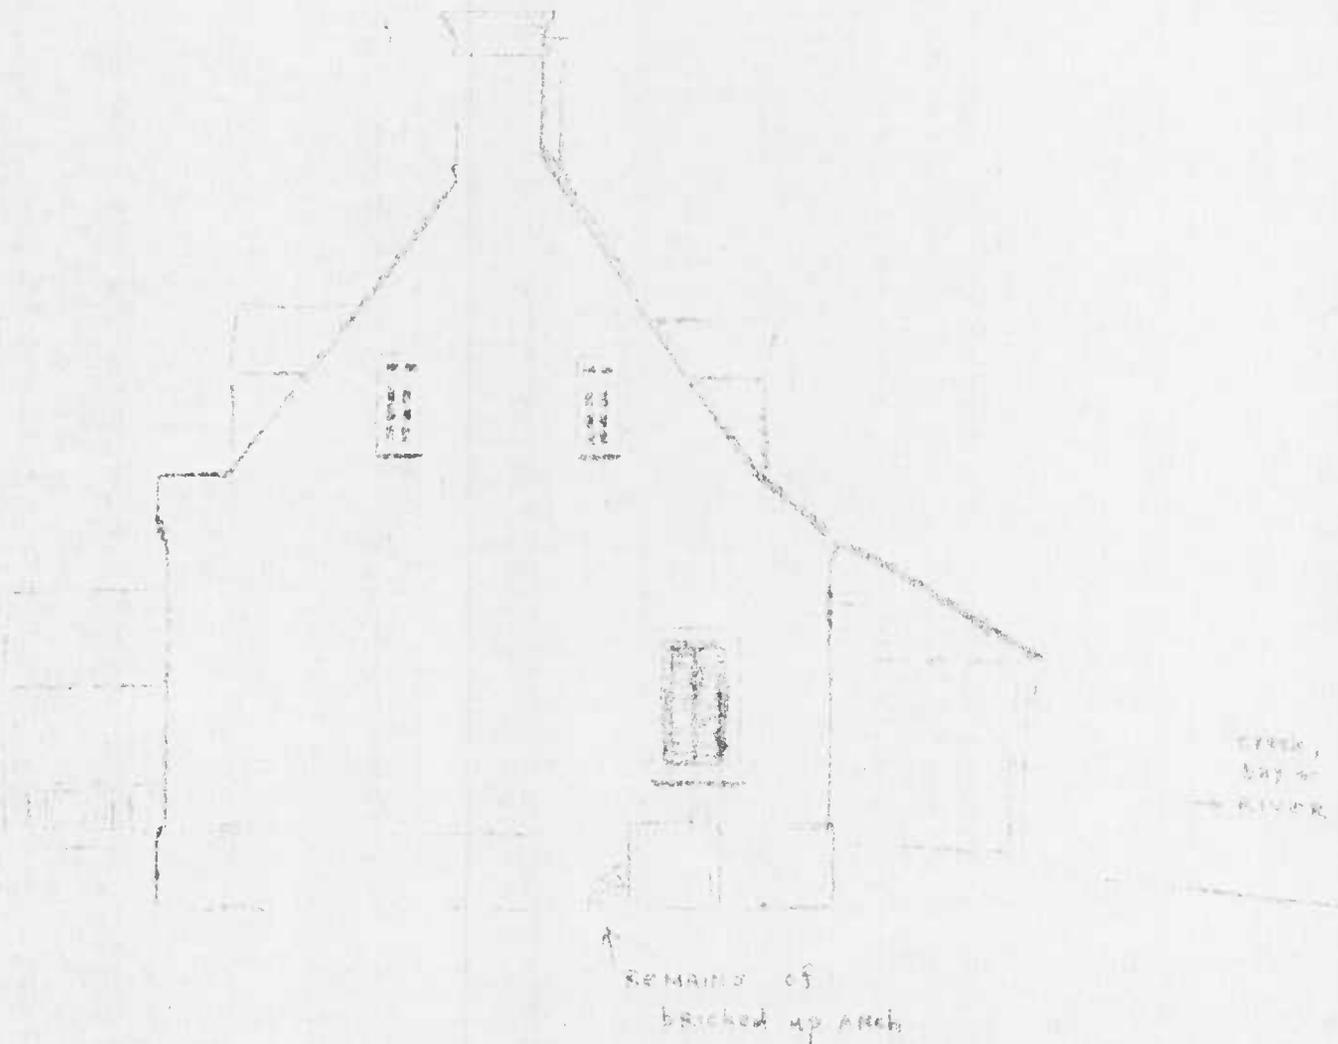
Free sketch of Gable end

All windows seem to have wood sills.

(On the opposite Gable end extend three attached, low, extremely narrow shutters of wood.

New shutters on the first floor window seen in this end seem to conceal the wide woodwork (?). Also, this window lacks the curvilinear rubbed brick head. Headers on this end do not seem to be glazed as on opposite end.
