Maryland Historical Trust State Historic Sites Inventory Form

and/or common Myrtle Point Barn

Survey No. SM-377

Myrtle Point Barn
St. Mary's County, Maryland
Camille Wells, Recorded 12/19/86

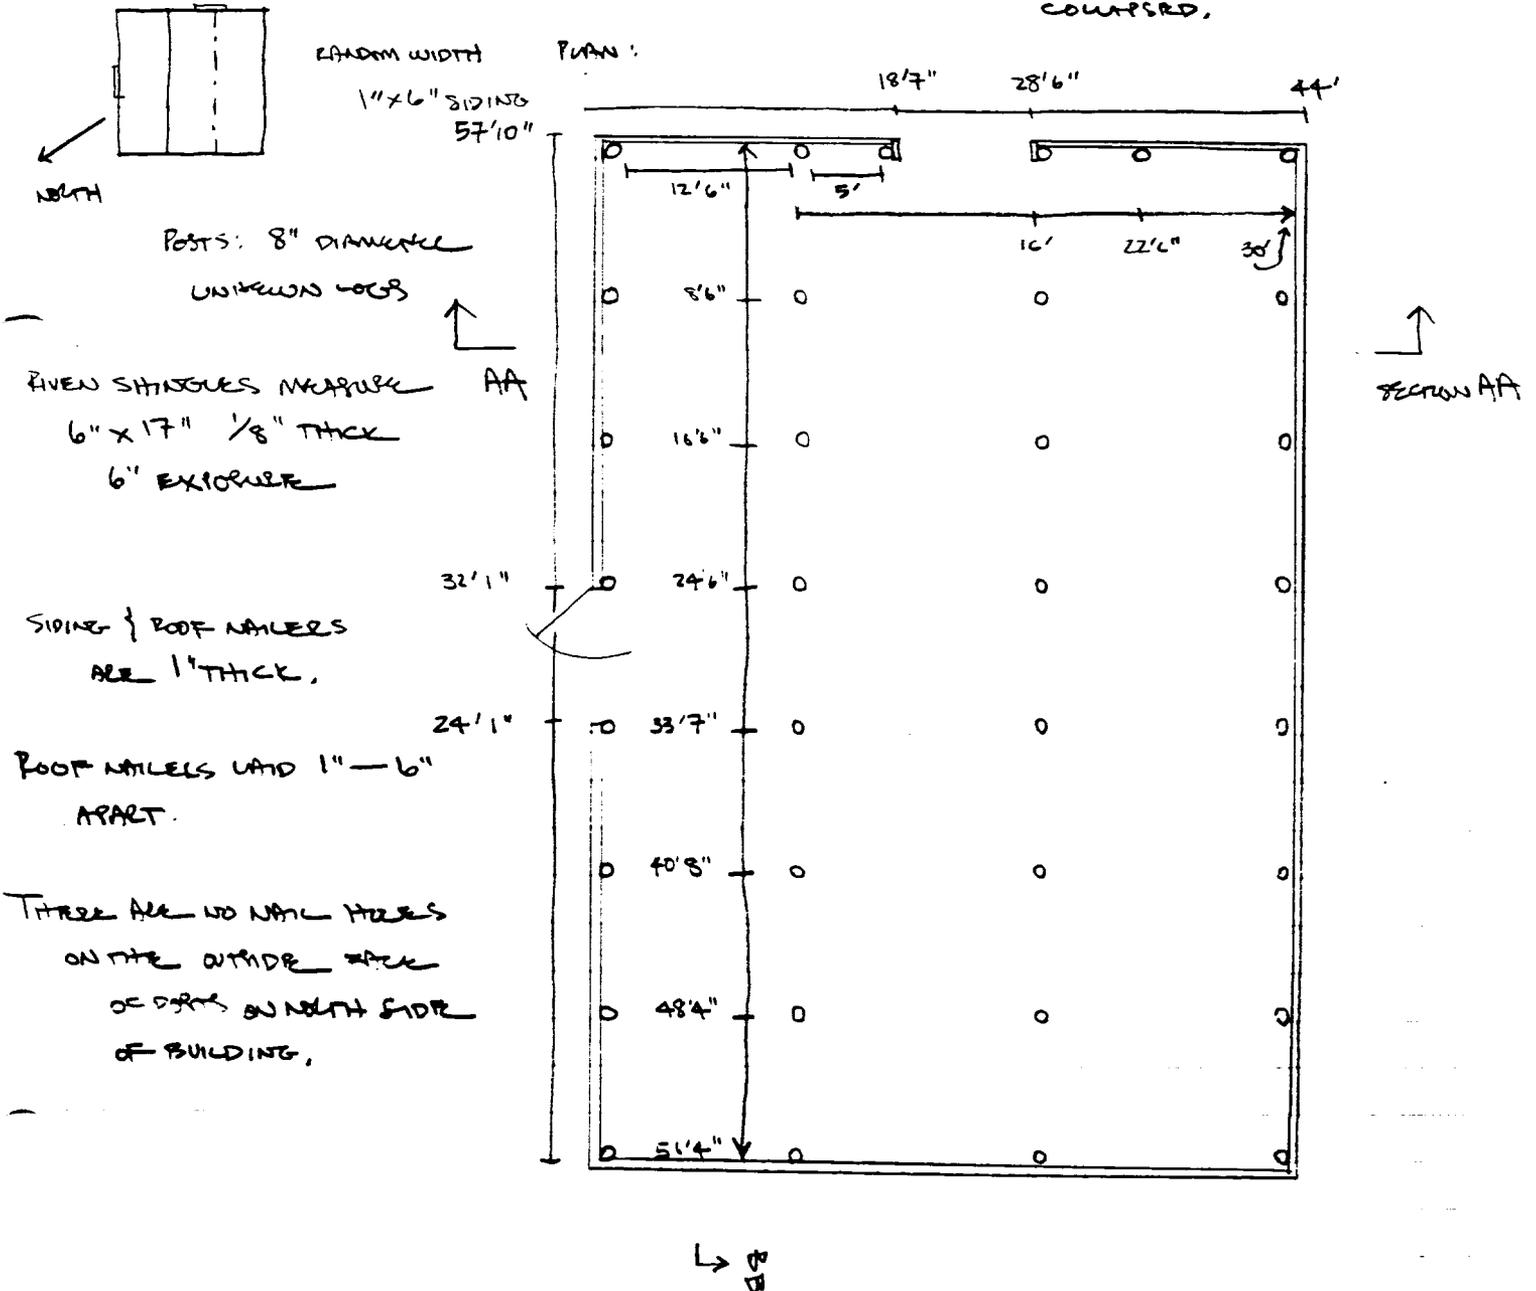
s earthfast tobacco barn is located in thick woods and other brush of Myrtle Point Road within sight of the Patuxent River. Its ridgeline is oriented northwest-southeast. The site is flat.

The tobacco barn is supported on earthfast posts--three rows of them. The central row is set in the plane of the ridgeline. It is gable roofed. Horizontal nailers affixed onto the backs of the posts carry random-width circular-sawn sheathing. The entire structure is wire nailed.

The gable roof was originally covered with wood shingles affixed to horizontal nailers, but this roofing was covered over with sheet metal.

At an early date, the original structure was extended on the northeast side by a shed addition that runs the length of the structure.

THE BARN HAS ALMOST COMPLETELY COLLAPSED.

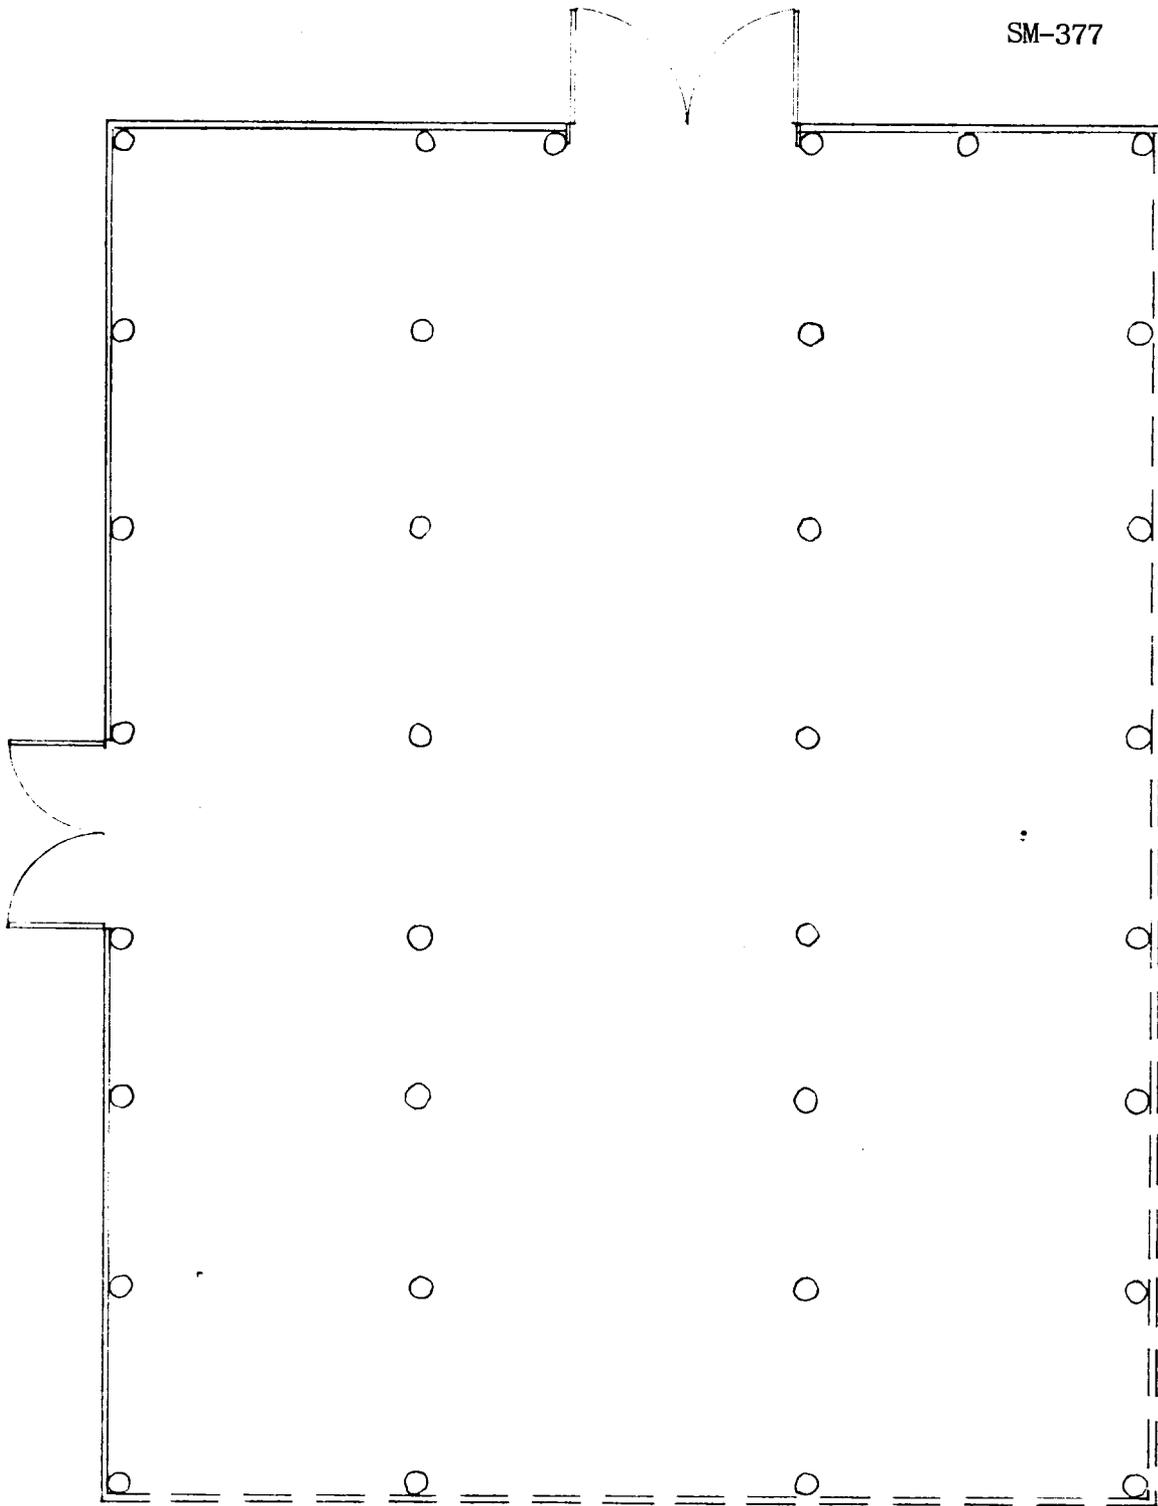
SM-377

MYRTLE POINT BARN

FIELD NOTES,

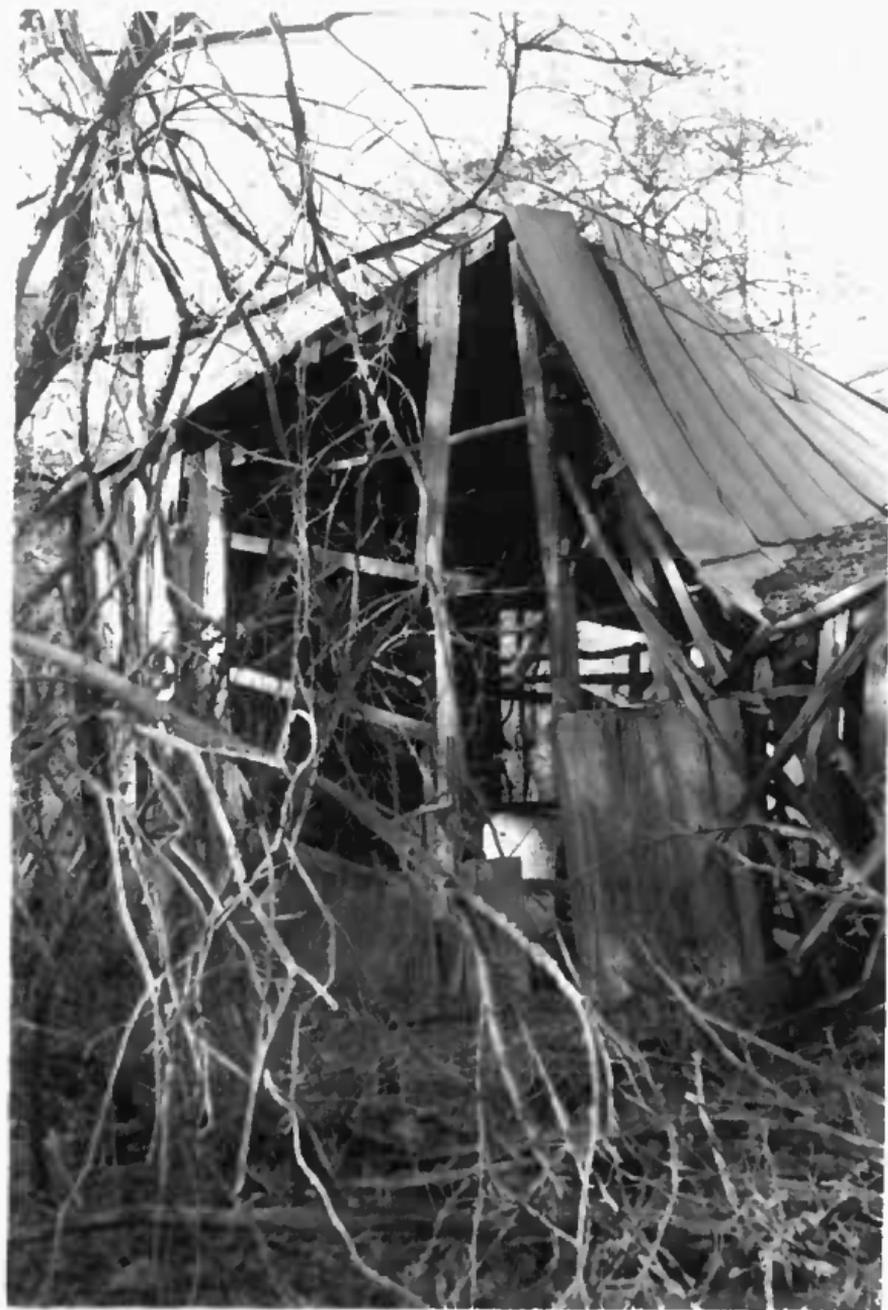
View from north of shed and collapsed barn.

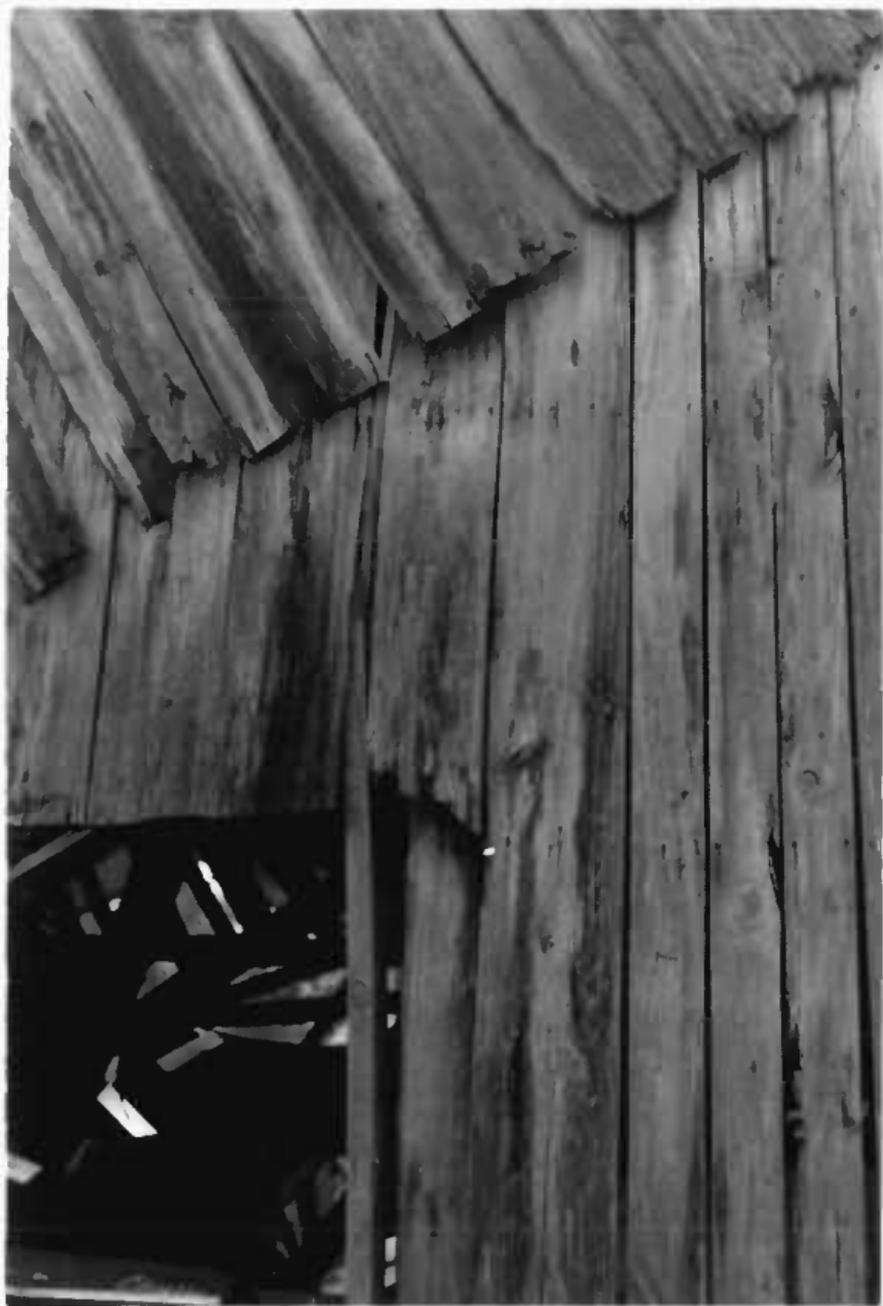
SM-377

Myrtle Point Tobacco Barn
Town Point vicinity, St. Mary's County, Md.
Camille Wells, Photographer
December 19, 1986
Detail of vertical-board siding.

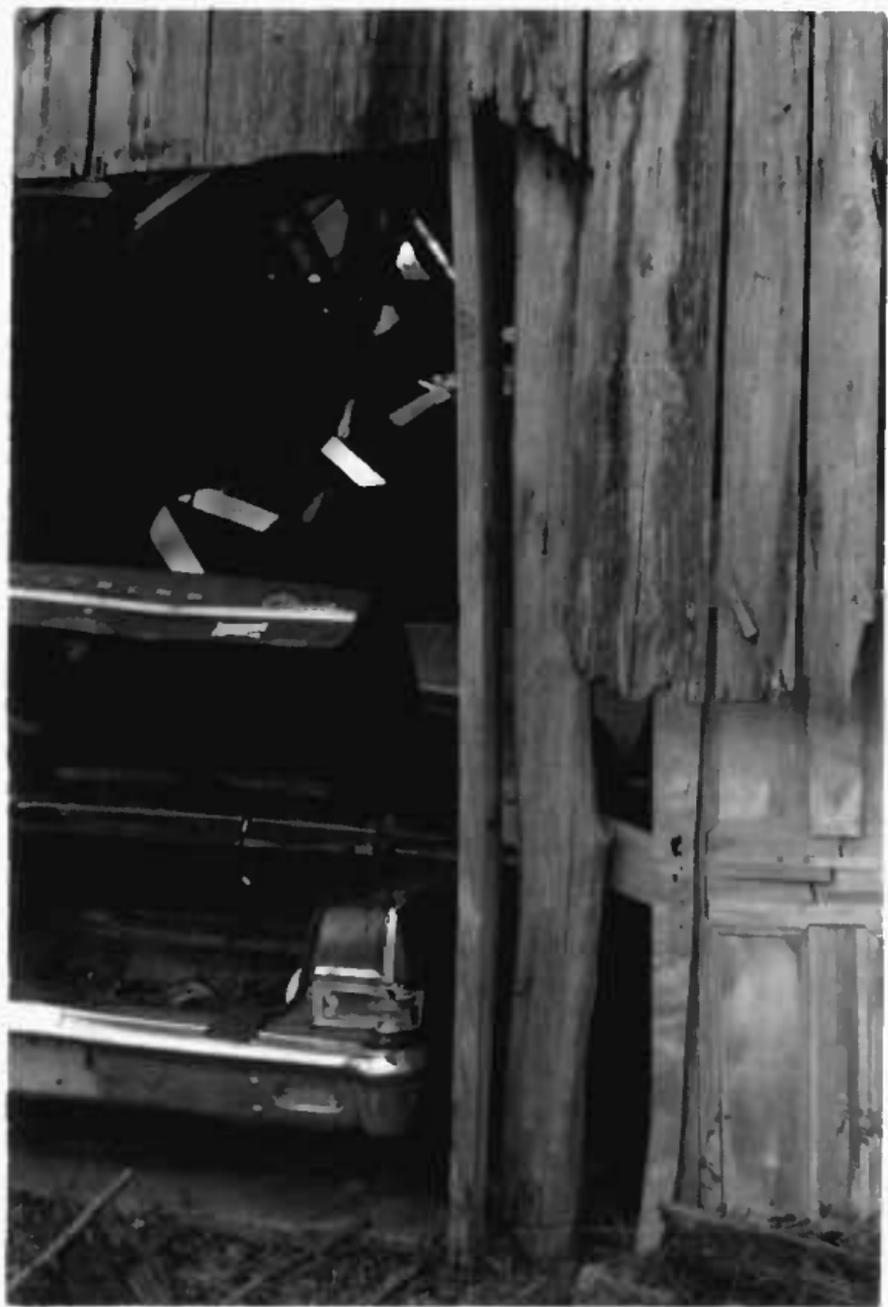
SM-377

Myrtle Point Tobacco Barn
Town Point vicinity, St. Mary's County, Md.
Camille Wells, Photographer
December 19, 1986
Detail of east gable-end door and Rambler.

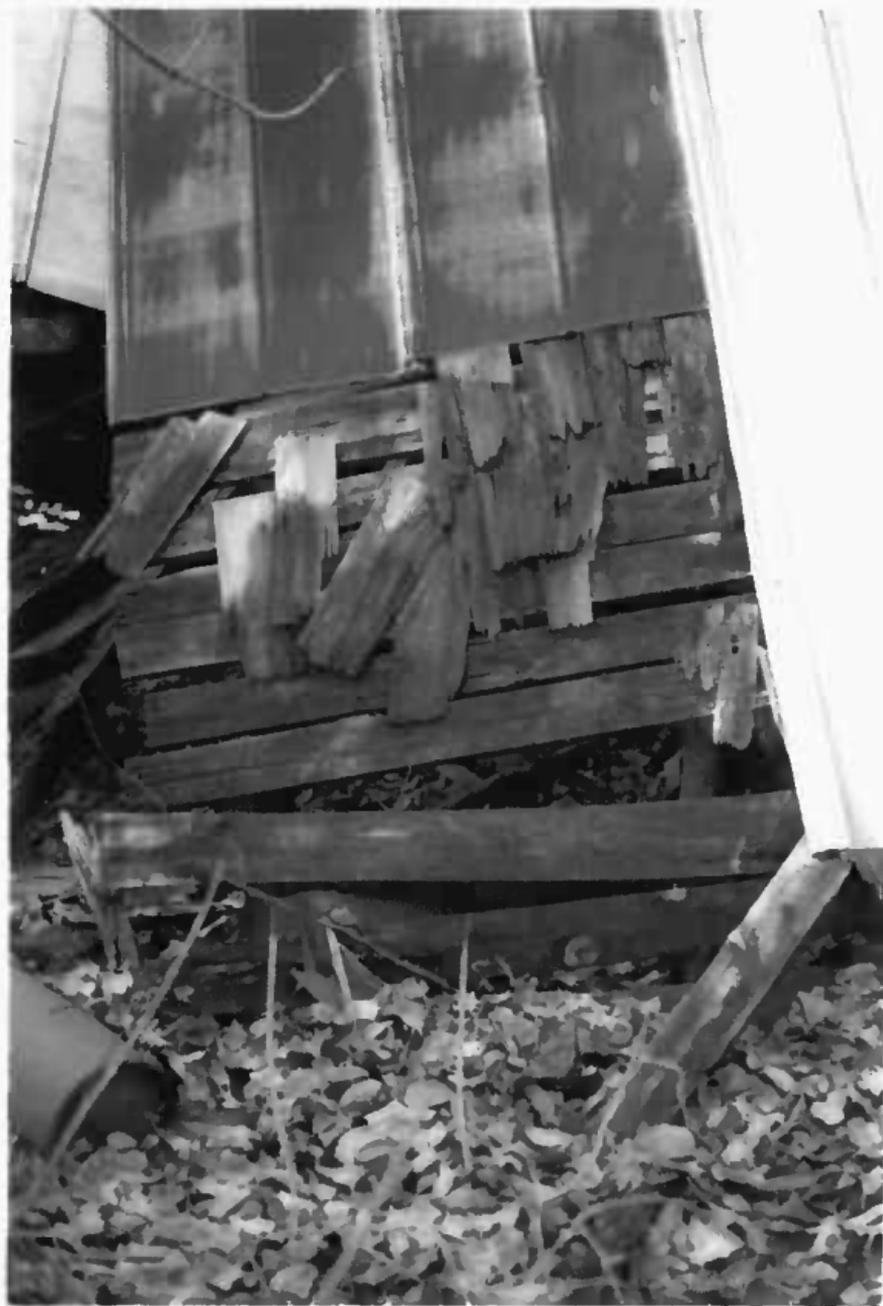
SM-377

Detail of roofing nailers and shingles.

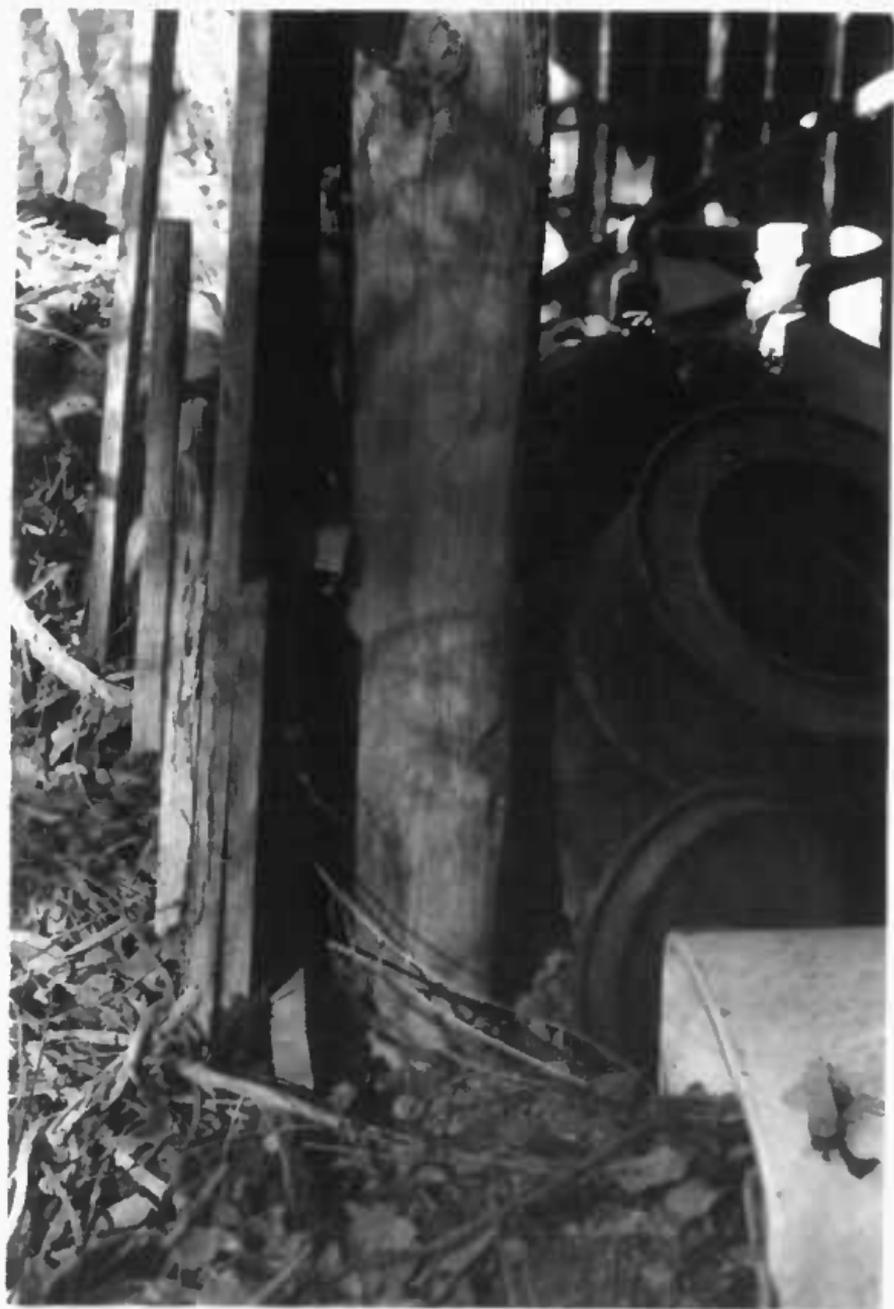
SM-377

Myrtle Point Tobacco Barn
Town Point vicinity, St. Mary's County, Md.
Camille Wells, Photographer
December 19, 1986
Detail of earthfast post.

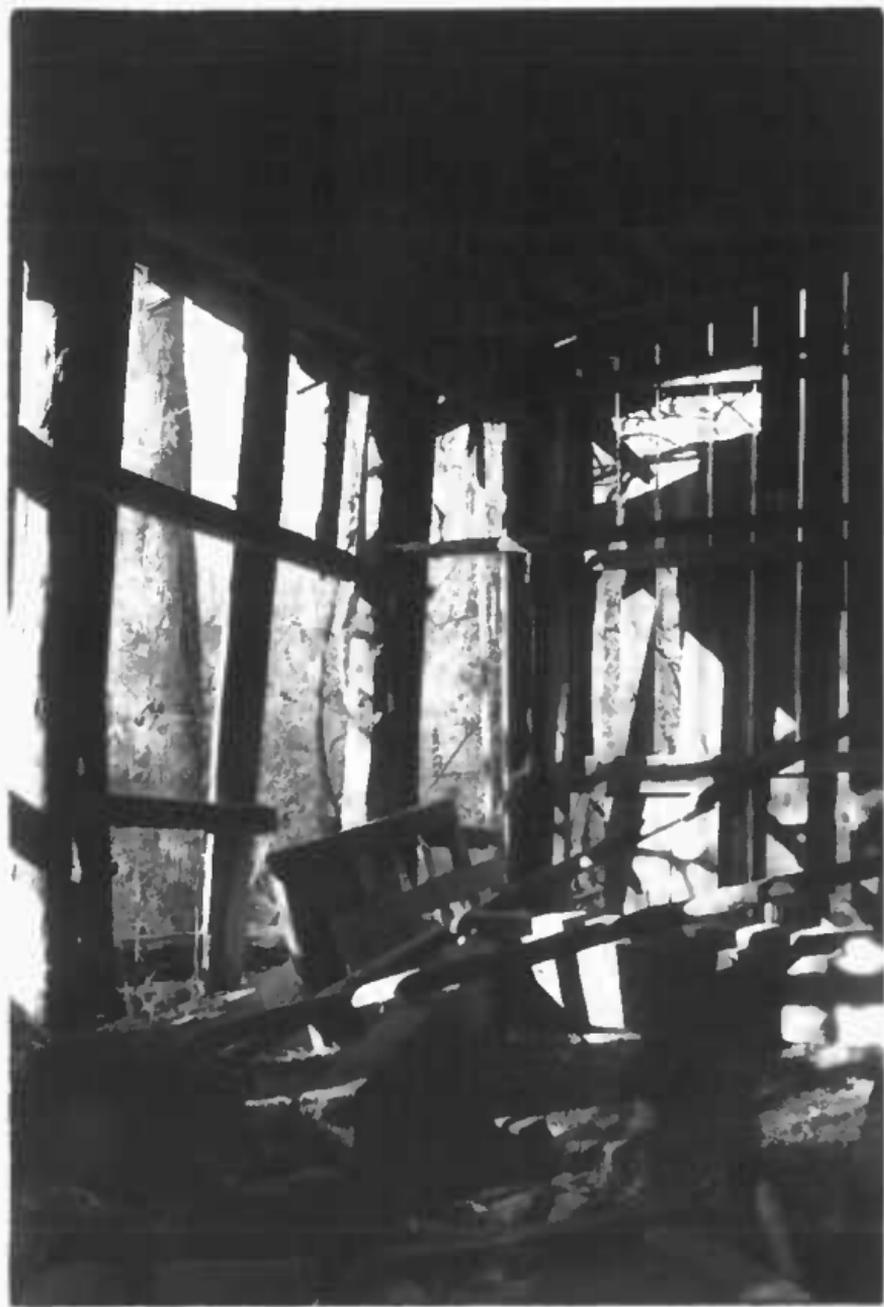
SM-377

Myrtle Point Tobacco Barn
Town Point vicinity, St. Mary's County, Md.
Camille Wells, Photographer
December 19, 1986
View from the interior of east corner.
