K-257

Reese's Corner House  
Near Rock Hall  
c. 1820-40

# Maryland Historical Trust State Historic Sites Inventory Form

historic  Ree's Corner House

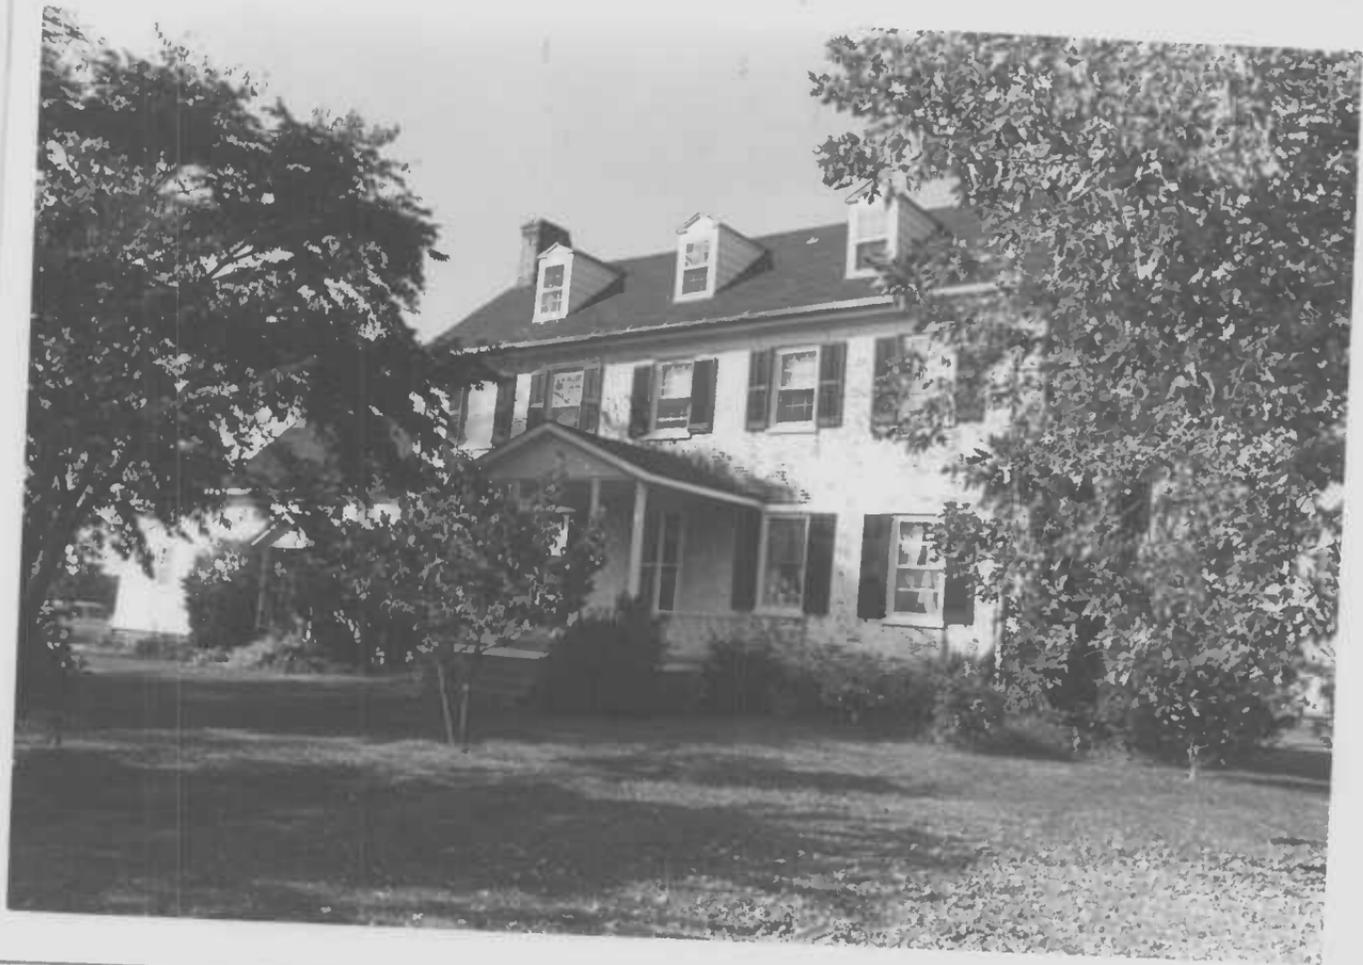
REESE's Corner House

This brick house is almost three times as large as it was first constructed and consisted of only the three bays seen at the left of the photograph. At some time in the early to mid nineteenth century the house was enlarged by the addition of two, two-story bays and completely rebuilt. Interior woodwork, windows, and dormers date from this time. The kitchen wing, the 1-1/2 story addition, may date from this rebuilding or later. When first constructed, Reese's Corner House probably resembled nearby Rosedale (K-259). As rebuilt it contains significant and complete interior detailing that illustrated the incorporation of Greek Revival design into a house of late Federal proportions.

Wing A is the 1-1/2 story wing visible at the left of the photograph. B stands at the gable of Wing A.

SE.
