**MARYLAND HISTORICAL TRUST
DETERMINATION OF ELIGIBILITY FORM**

Property Name: Ware Neck Farm Inventory Number: D-110
 Address: 5465 Handley Road Historic district: yes no
 City: Cambridge Zip Code: 21613 County: Dorchester
 USGS Quadrangle(s): Cambridge
 Property Owner: James F. Handley Tax Account ID Number: 002847
 Tax Map Parcel Number(s): 61 Tax Map Number: 31
 Project: US 50: Cambridge Maintenance Shop DO348A21 Agency: State Highway Administration
 Agency Prepared By: EHT Traceries, Inc.
 Preparer's Name: Carrie Albee Date Prepared: 6/13/2006

MARYLAND INVENTORY OF HISTORIC PROPERTIES
ADDENDUM

Property Name: Ware Neck Farm
Property Address: 5465 Handley Road, Cambridge, MD 21613

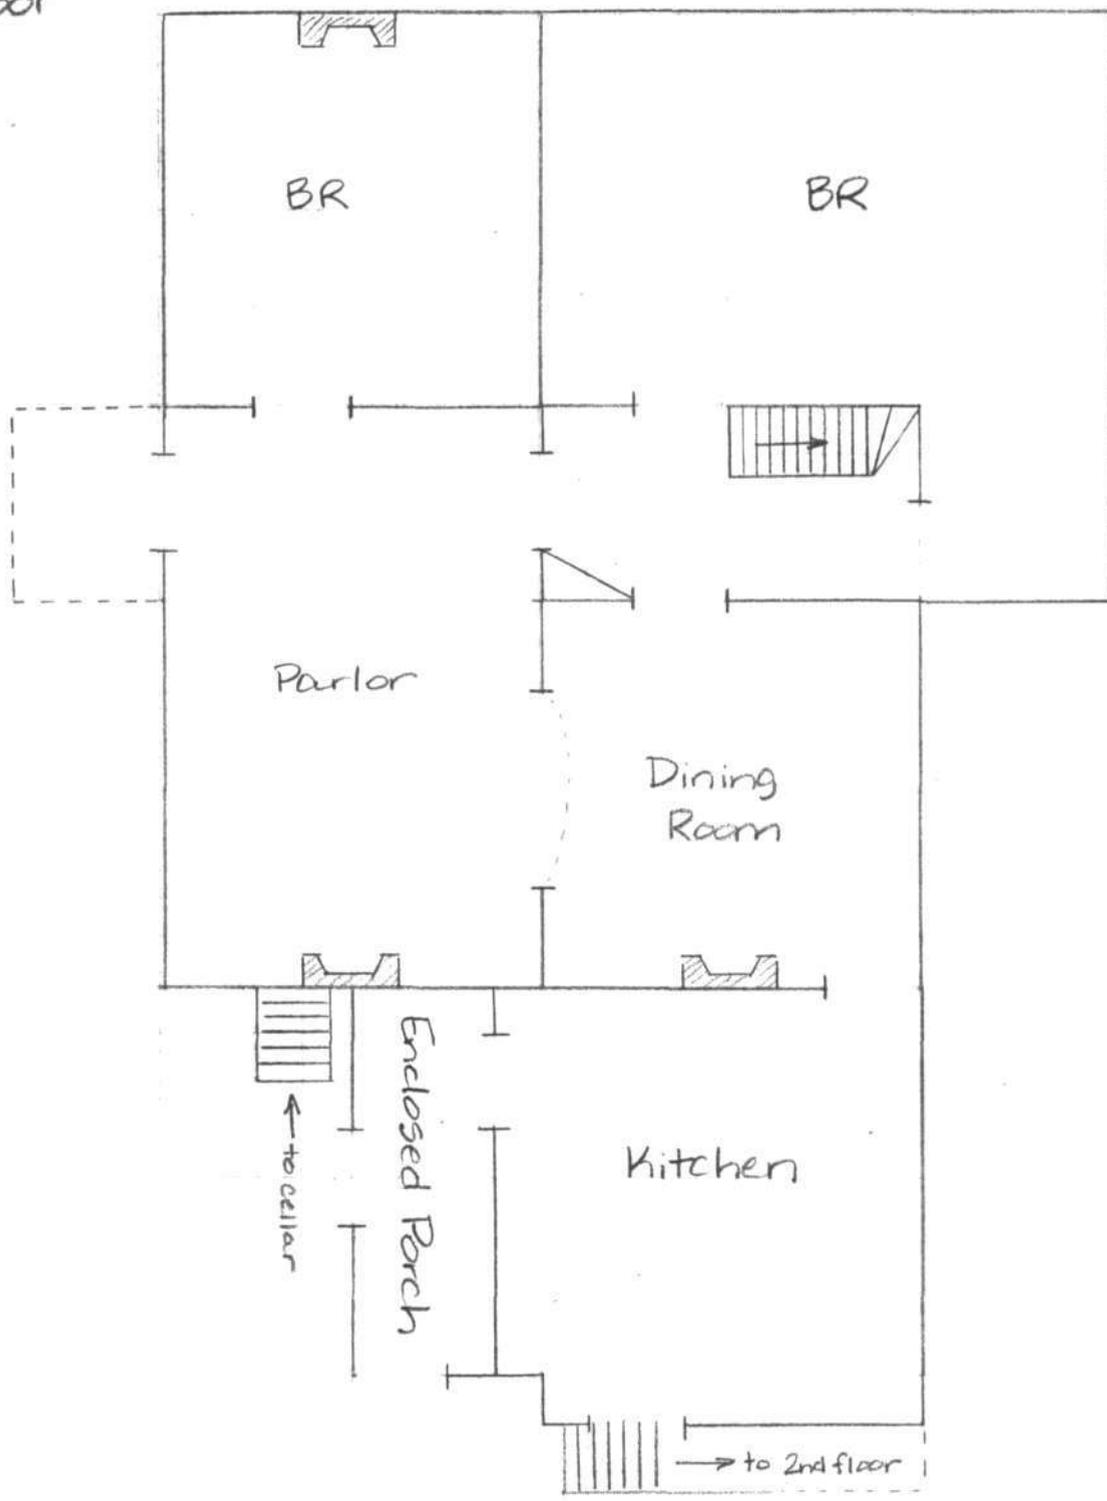
First Floor

The interior of the dwelling, as noted in the 1975 survey, was extensively renovated in the early twentieth century, presumably with the construction of the west addition. The stair hall is located in the rear of the main block, rather than directly across from the main entrance. Ms. Denton indicated that this stair may have been moved. The dining room features a chair rail. The dining room and parlor are separated by an arched opening, and the two rooms have matching fireplaces and chimneys on the east wall. These fireplaces, and one in the west bedroom, have been boarded up. Each wood fireplace surround is unique in form. Wood floors appear to be original, including the wood floor in the west addition.

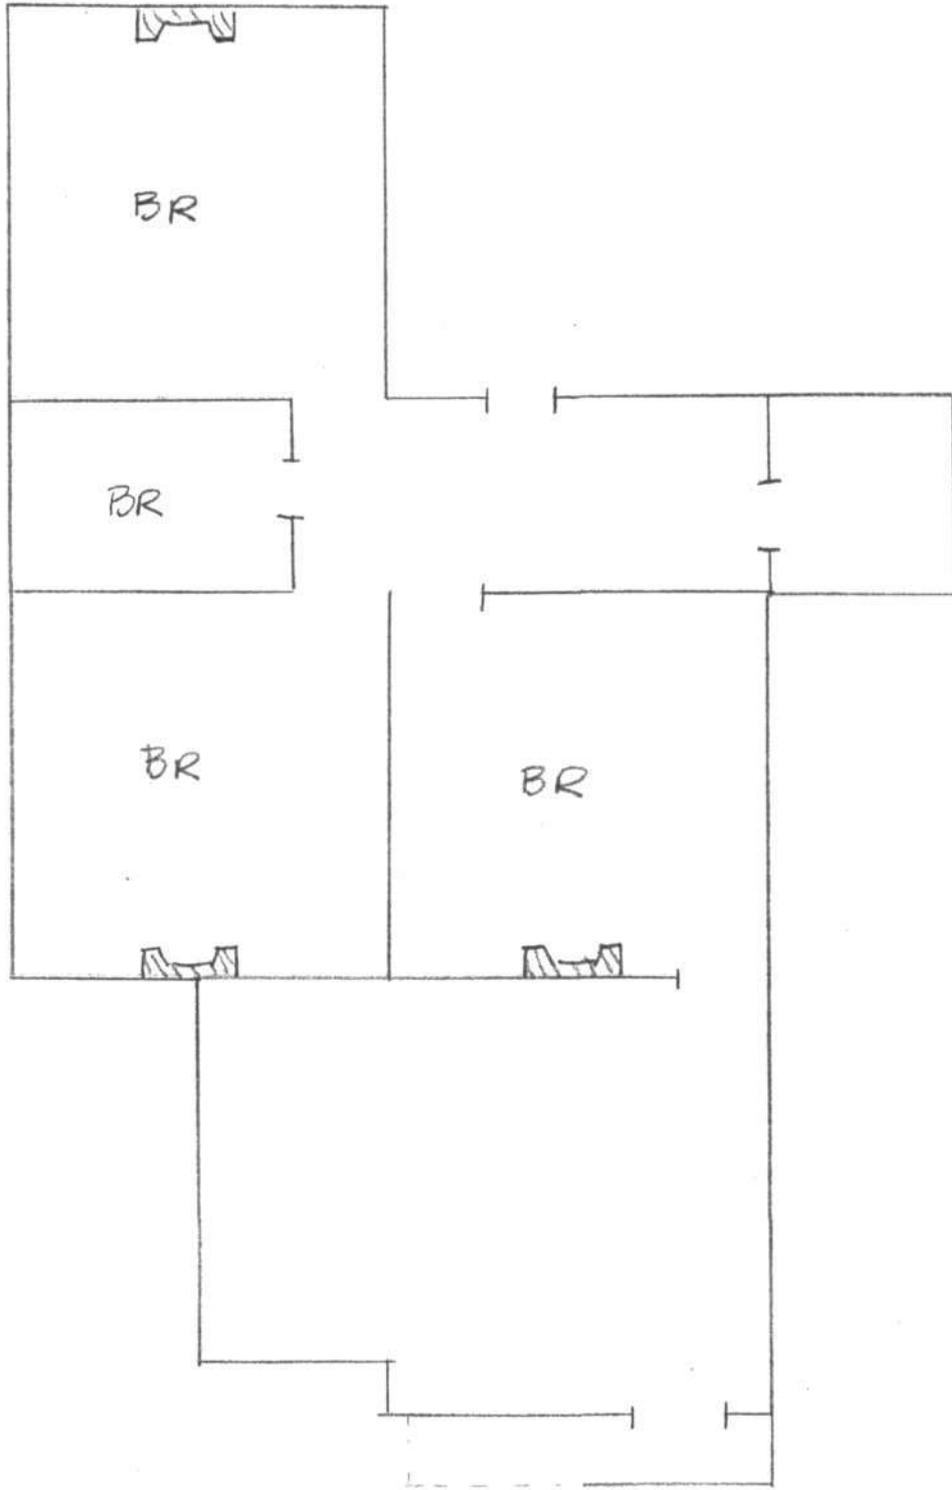
Second Floor

The second floor features four bedrooms arranged around the stair landing. The flooring is not original. Ms. Denton indicated that the flooring had been removed for repair and then was lost in a hurricane flood and had subsequently been replaced. The locations of the three fireplaces on the second floor correspond to those of the first floor. A stair leading from the landing to the attic is present on the north side of the dwelling. Access to the apartment over the present kitchen is gained through the northeast bedroom. According to Ms. Denton, the attic and basement each have three rooms.

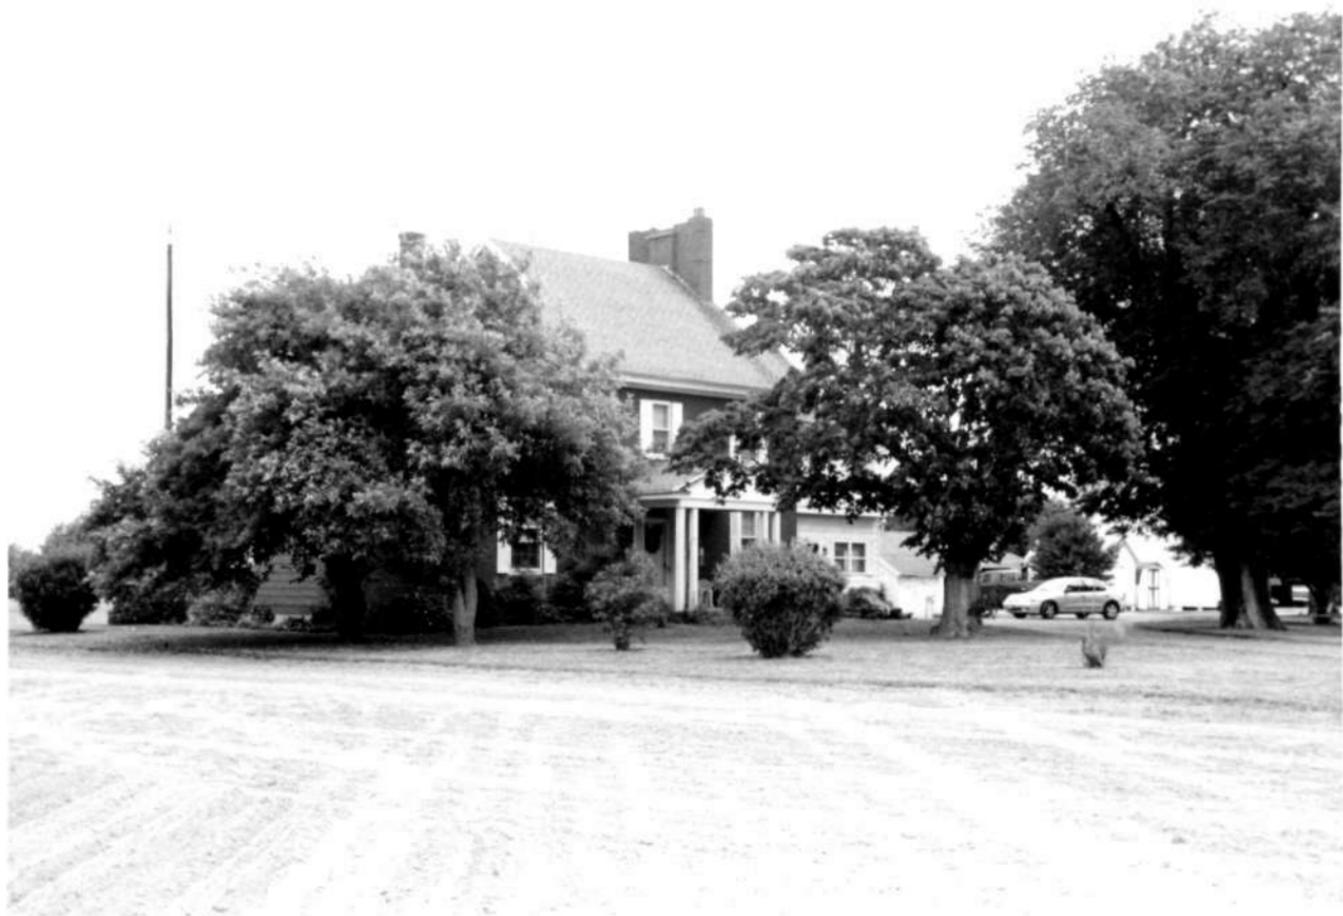
#1 of 7

Main House View NE

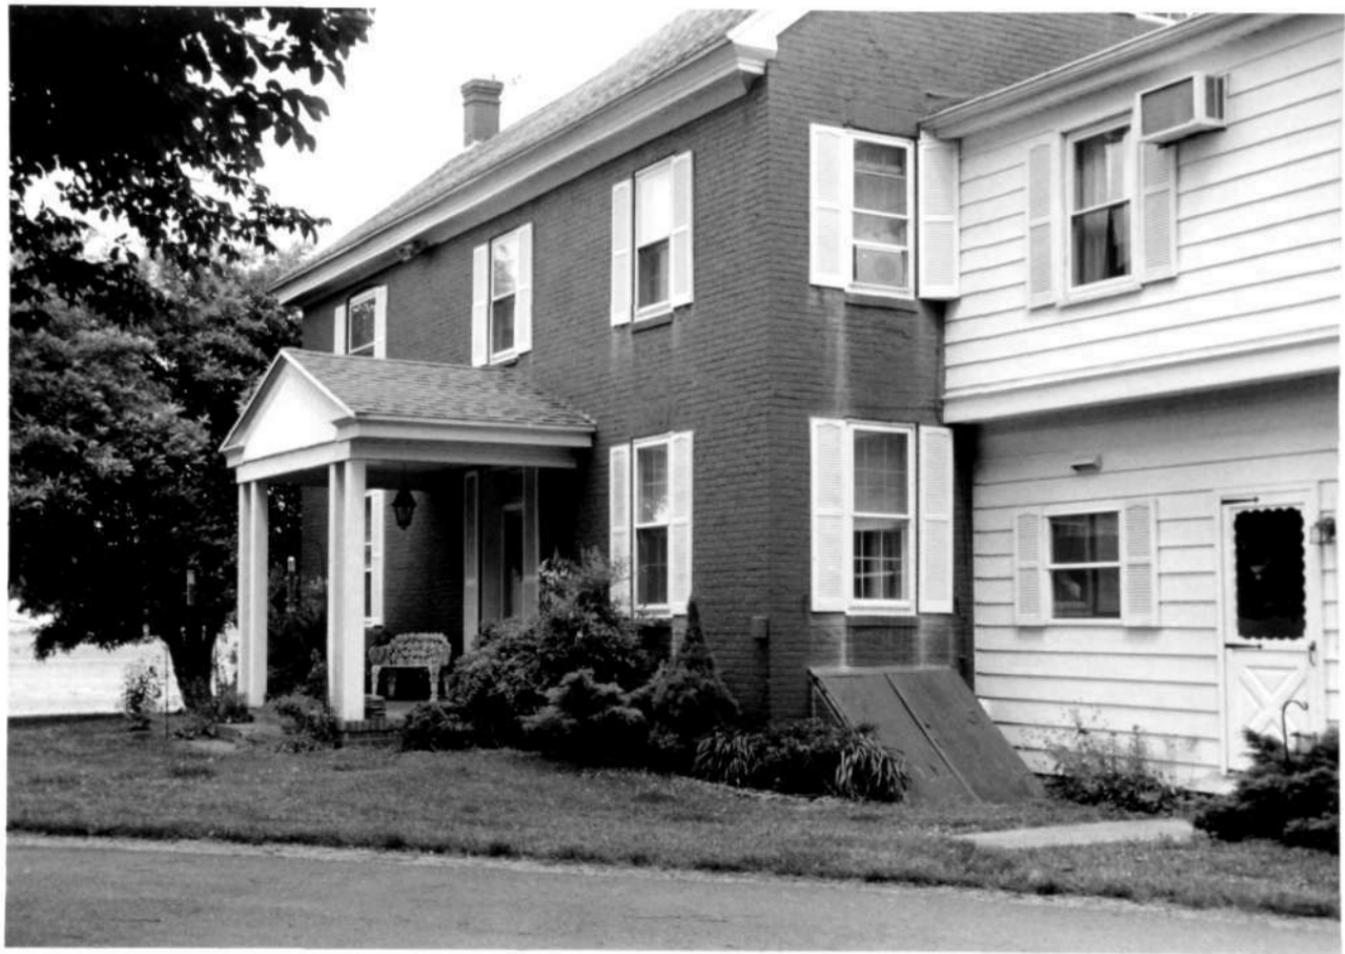
#2 of 7

The primary dwelling on the site appears to date to the late eighteenth or early nineteenth century. The original main block of the house was constructed as a two-and-a-half-story, side-gable structure of brick with a two-bay-wide façade facing south. The façade now features a one-story portico that appears to have been added in the latter part of the twentieth century. The single-bay brick addition, standing two stories in height with a side-gabled roof, was built during the early twentieth century on the west elevation of the main block. This addition gives the main block of the building a central-entry plan, rather than the side-entry plan as originally constructed. It has a brick interior chimney at the west end. Projecting from the east elevation is a large two-story, wood-frame addition with a steeply pitched side-gabled roof. The addition, reflecting influences of the Victorian-era, is finished with overhanging boxed cornices with an ogee-molded profile, raked cornice in the gable ends, and returns. A tall corbelled interior brick chimney projects from the roof at the east end. Based on the form, chimney, and cornice, this addition appears to have been added in the late-nineteenth century. A two-story, wood-frame addition with a shed roof projects from the south elevation of this addition, obscuring any Victorian-era ornamentation and fenestration on the addition's façade. This shed roof addition appears to date to the 1960s or 1970s. The foundation of the Victorian-era addition has been parged, presumably to obscure the construction of the shed-roofed addition. Both the Victorian-era addition and the shed-roofed addition are clad in aluminum siding and have 1/1 metal-sash windows and 12/12 windows.

Main House, South Facade.

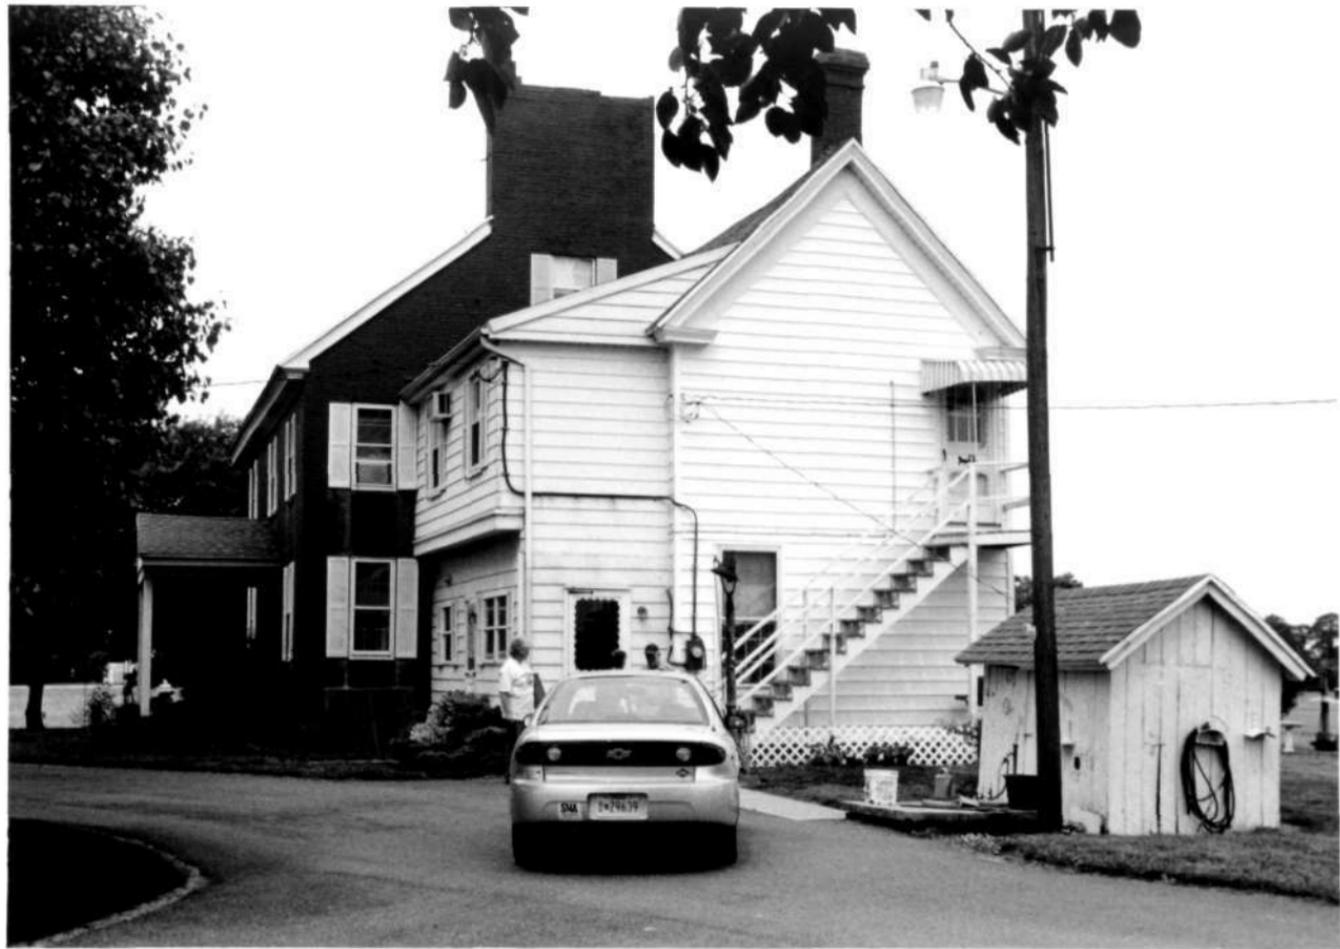
#3 of 7

Main House, View W

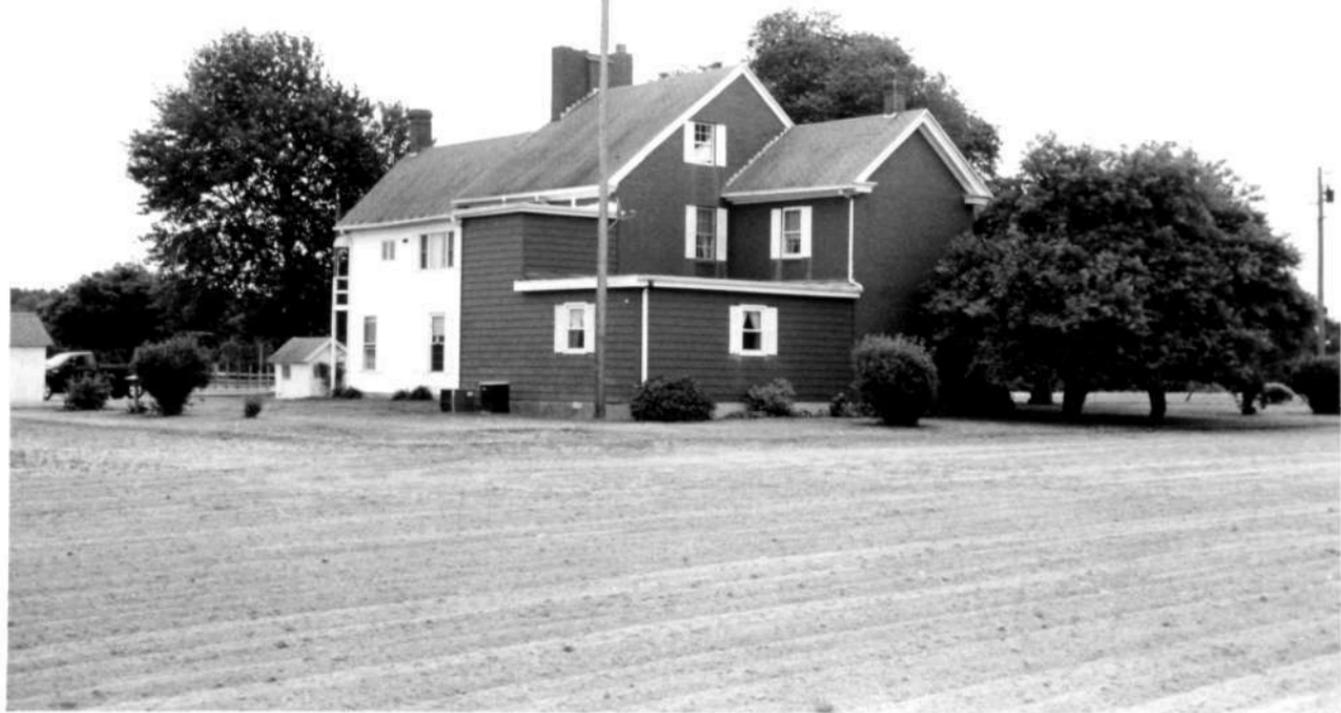
#4 of 7

Additionally, the fenestration on the north elevation of the Victorian-era addition has been altered and obscured by the application of the aluminum siding. The second story currently has a fixed picture window flanked by 1/1 metal-sash windows, and paired metal casement windows. A secondary entry has been created from a former window opening on the second story of the east side elevation of the Victorian-era addition. A wood-frame, flat-roof bedroom suite addition, dating to the 1960s or 1970s, extends from the north rear elevation. Set on a solid masonry foundation of concrete, the addition is clad in aluminum siding.

Main House, View SE

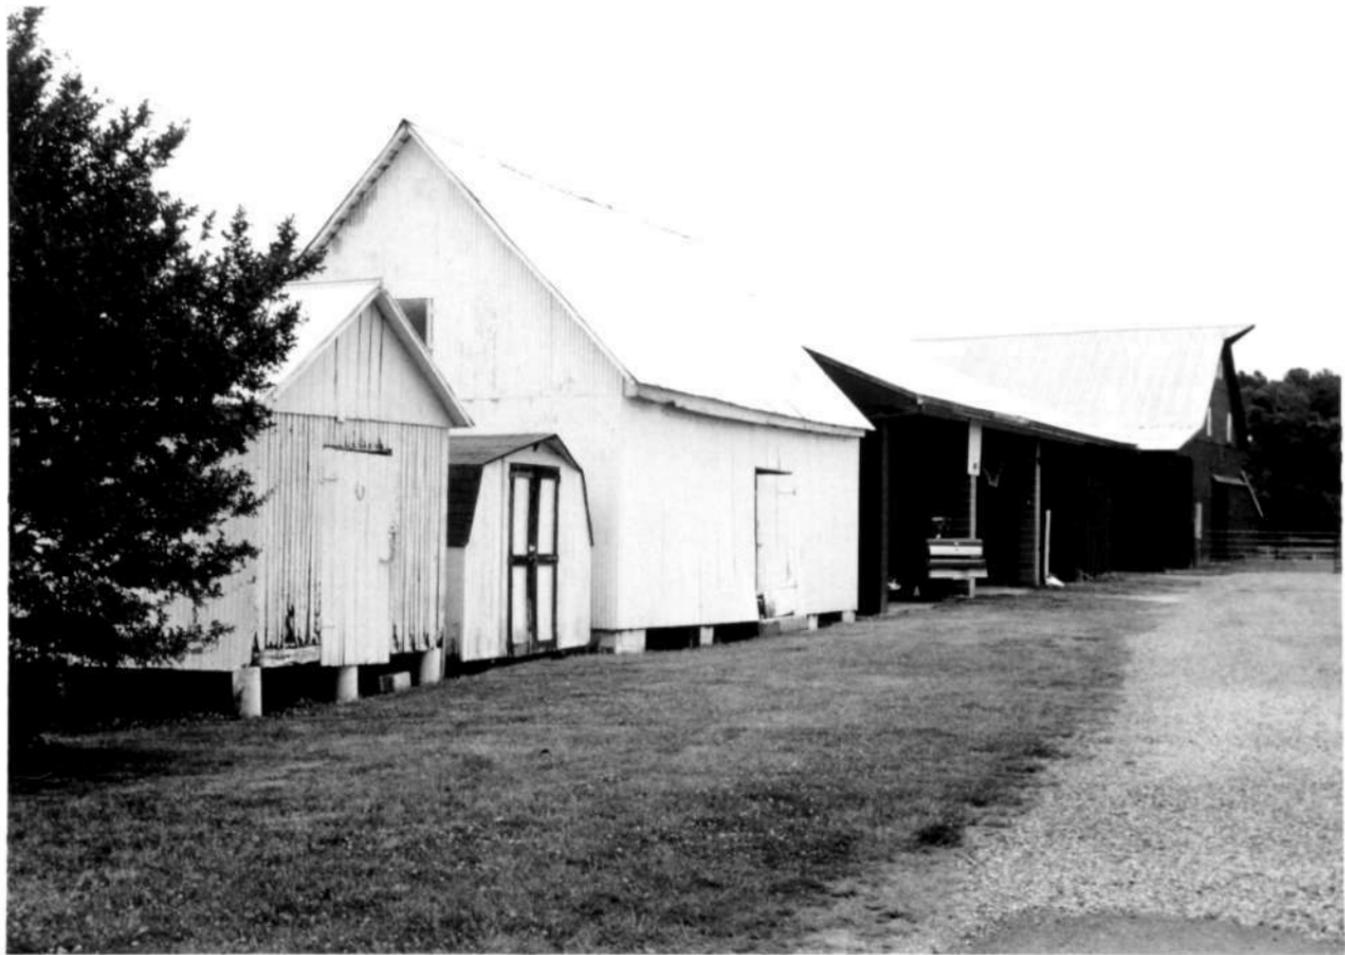
Arranged in a line extending east from the dwelling is a series of associated outbuildings. Closest to the house is a one-story, wood-frame pump house, and east of that is a one-story wood-frame smokehouse. These two buildings are similar in appearance, with front-gabled, asphalt-shingled roofs and flush, vertical-board cladding, and may date to

the late nineteenth or early twentieth century. East of the smokehouse is a one-story, concrete-block garage dating to the mid-twentieth century. Mr. Handley indicated that this garage replaced an earlier wood shed. East of the garage is one-story, wood-frame corncrib, possibly dating to the late nineteenth century. East of the corncrib is a one-story, prefabricated shed. East of the shed is a large wood-frame, side-gable building described by Mr. Handley as a grainery. Exterior investigation of the grainery revealed pegged rafters and metal strap-hinges on the south door consistent with a late-eighteenth- or early-nineteenth-century date of construction. East of the grainery is a one-story implement or tractor shed dating to the 1960s, according to Mr. Handley. East of the implement shed and completing the row is a large wood-frame livestock barn that appears to date to the early twentieth century.

Outbuildings, View NE
#5 of 7

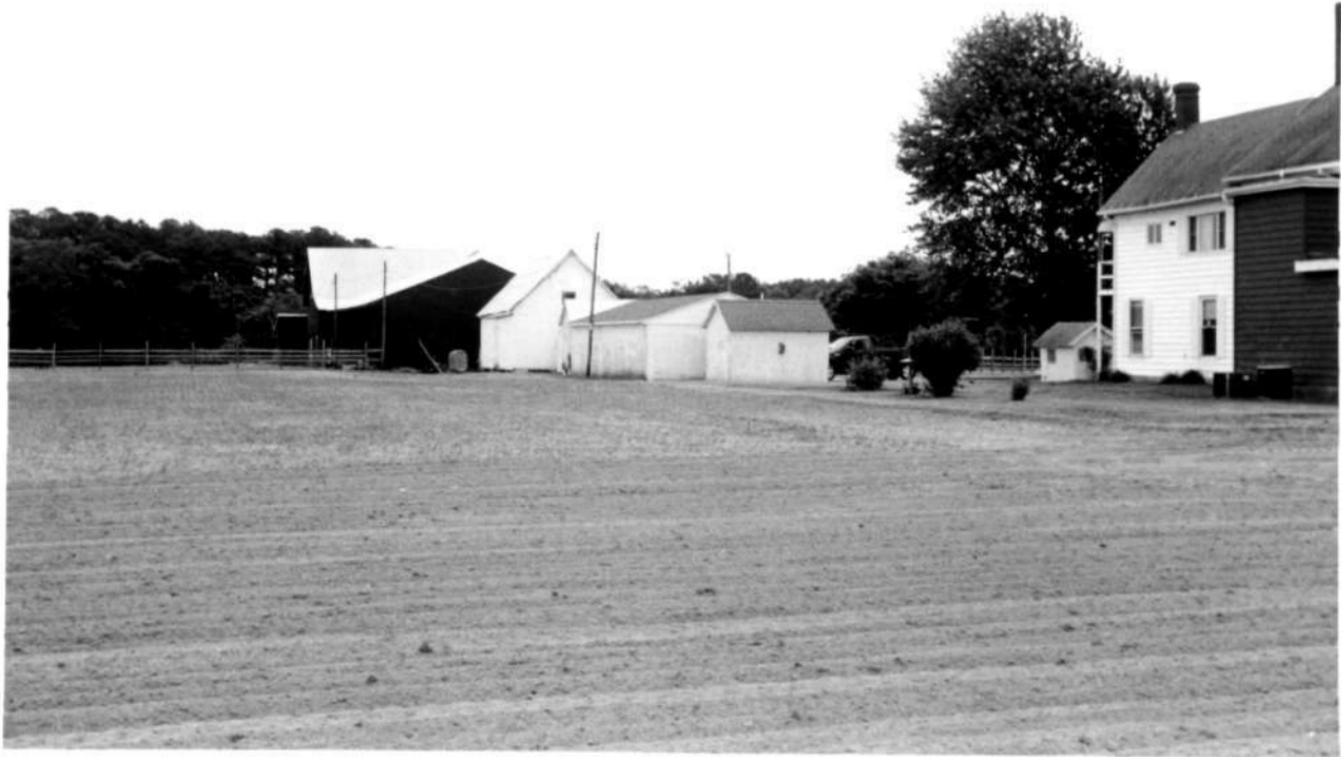
D-110
Ware Neck Farm
5465 Handley Road
Dorchester Co., MD
EHT Traceries
5-25-2006
MDSHPO
Outbuildings, View SE
#6 of 7

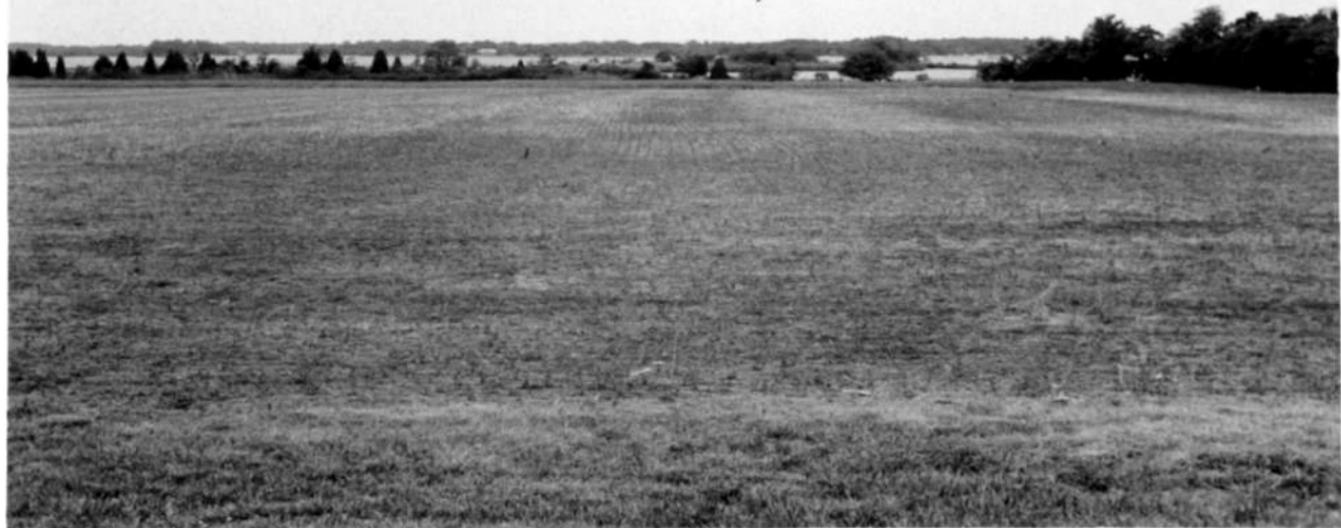
#7 of 7

The 52-acre parcel is located at the north end of Handley Road, and extends north to the Choptank River and east to Hurst Creek. The property is currently planted with soybeans and sunflowers. A fenced paddock for horses is also present, located to the east of the dwelling.

Agricultural Fields, View N to Choptank River
