Old James Baker Farm

Chestertown

Maryland Historical Trust State Historic Sites Inventory Form

Survey No. K-464

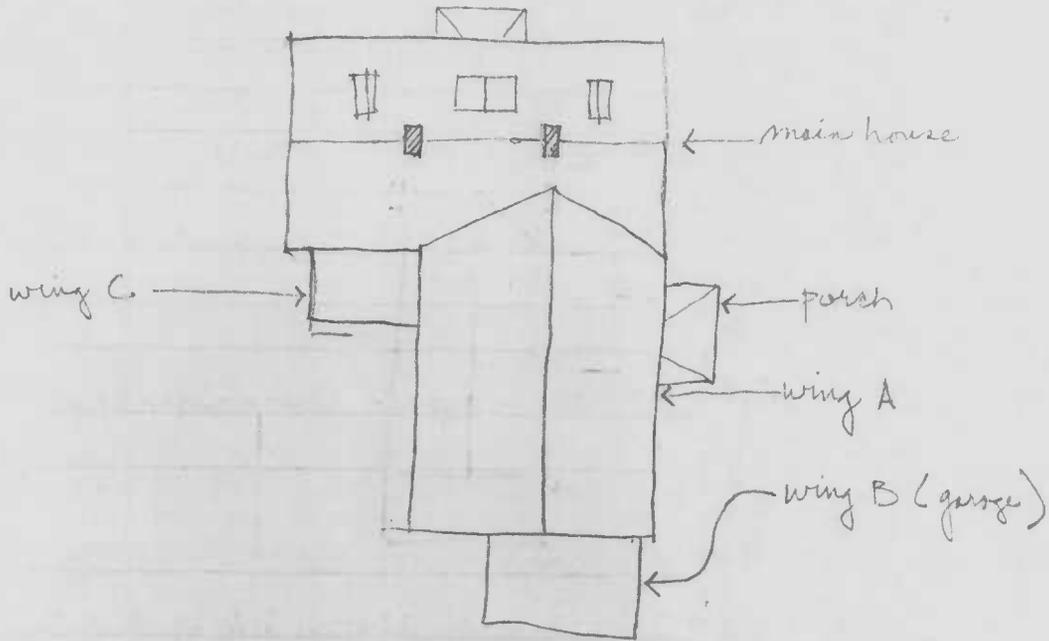
SKETCH PLAN.

1. Size - Main Section: 2½ stories, 3 bays wide, 2 bays deep
 Wing A: 2½ stories, 2 bays wide, 3 bays long
 Wing B: 1 story, 1 bay wide, 2 bays deep
 Wing C: 1 story, 2 bays wide, 1 bay deep
2. Plan type - Central hall with rear ell and other additions
3. Roof type - Gable
4. Chimneys - Located adjacent to central partitions of main section; made of brick. Decorated with corbelled caps - chimneys appear to be of recent date
5. Material/walls - All are frame covered with aluminum siding about 1978.
6. Roof/Materials - Main Section: ribbed sheetmetal
 Wing A: same
 Wing B: asbestos
 Wing C: asbestos
7. Material/Foundation - All are brick.
8. Age - Main Section: circa 1880
 Wings: 2½ story ell is contemporary with house. Garage (wing B) and laundry (wing C) are modern additions.
9. Style - Victorian vernacular

Old James Baker Farmhouse

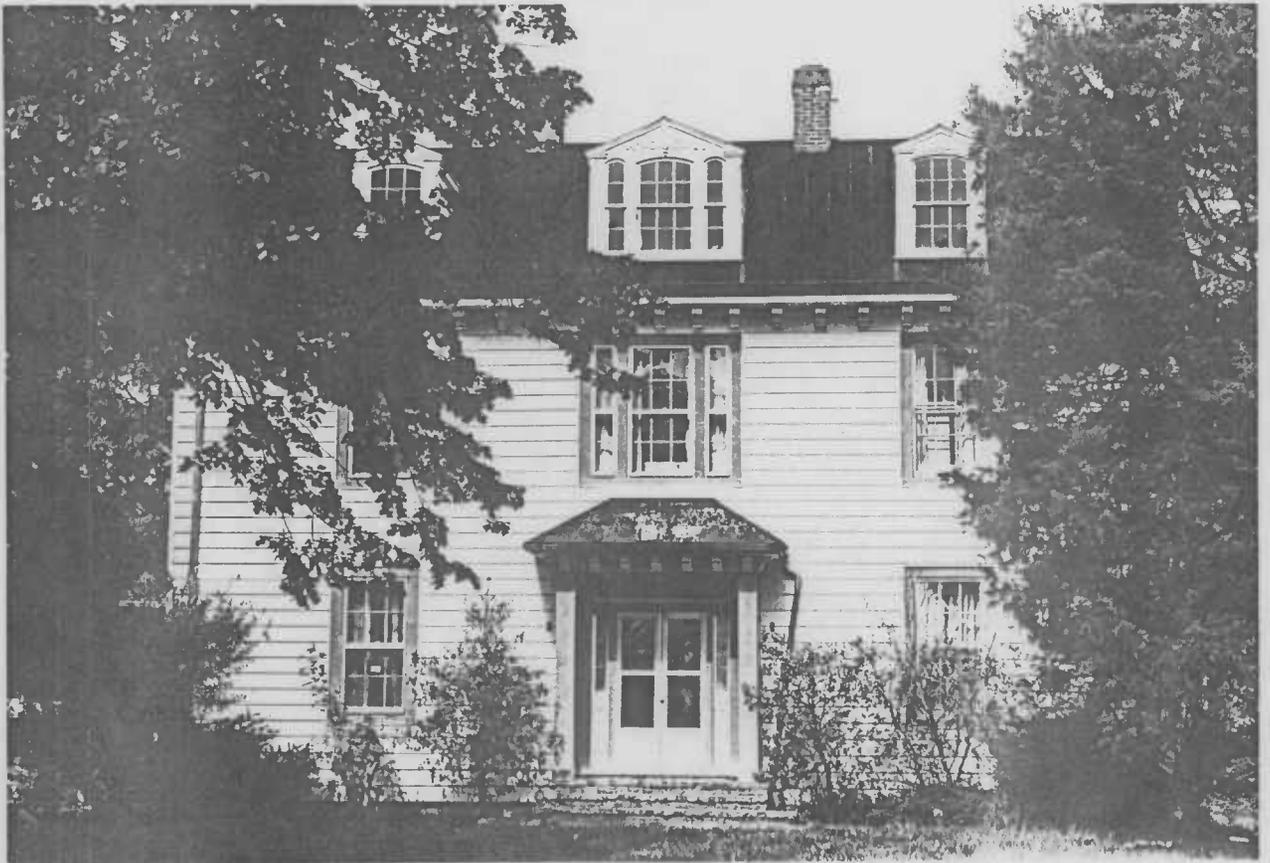
JAMES BAKER FARM (K-464)

This house is a rectangular, gable-roofed structure with a rear ell. Three bays wide and two deep, the primary decoration is the emphasis of the central windows and door with sidelights.

View to West

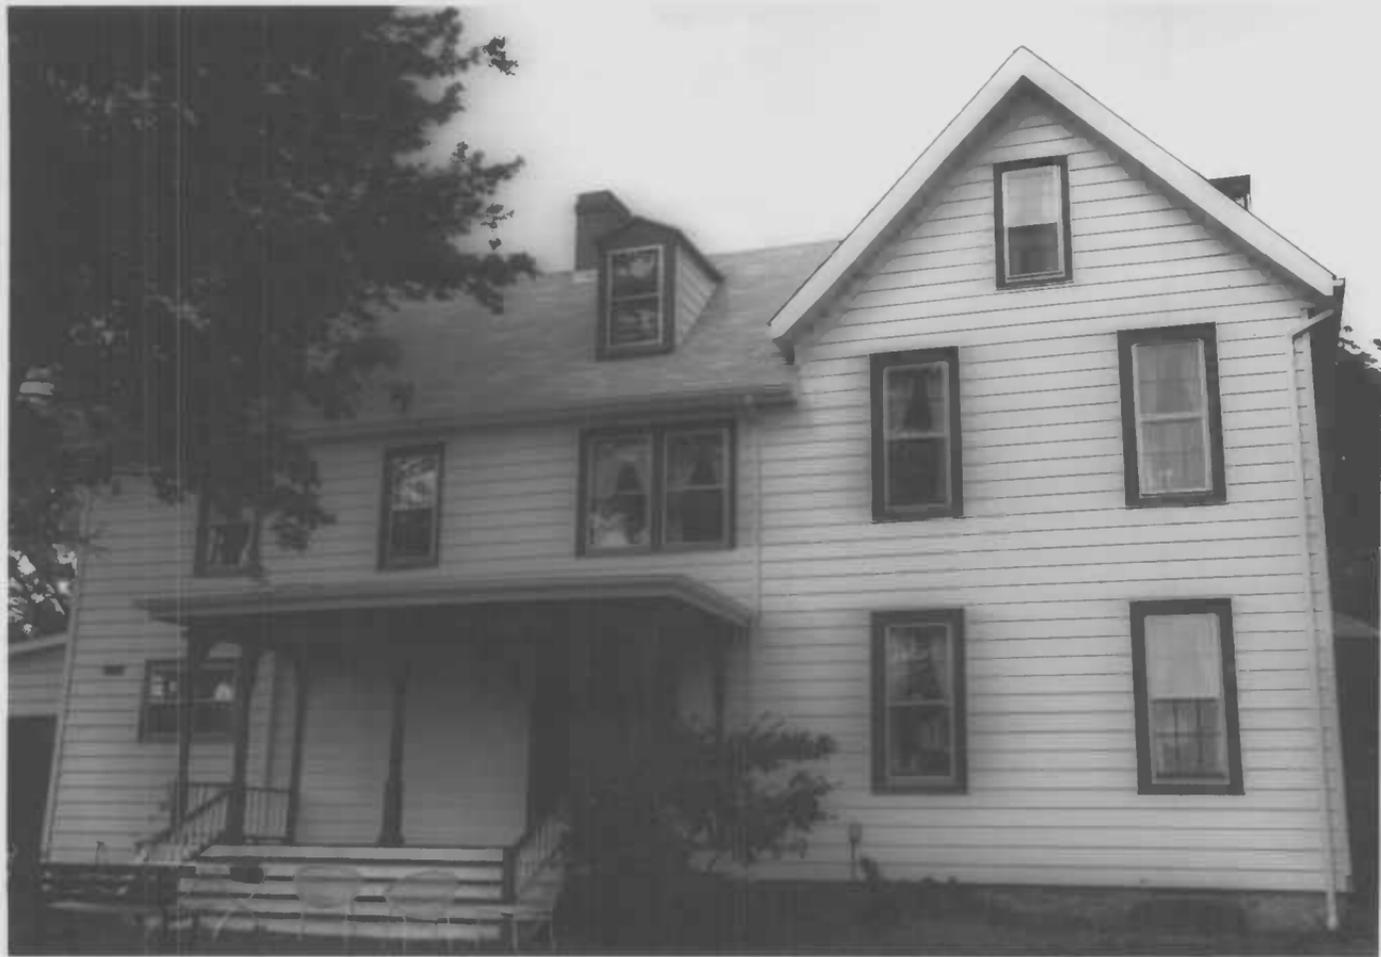
K-464-34

View to north

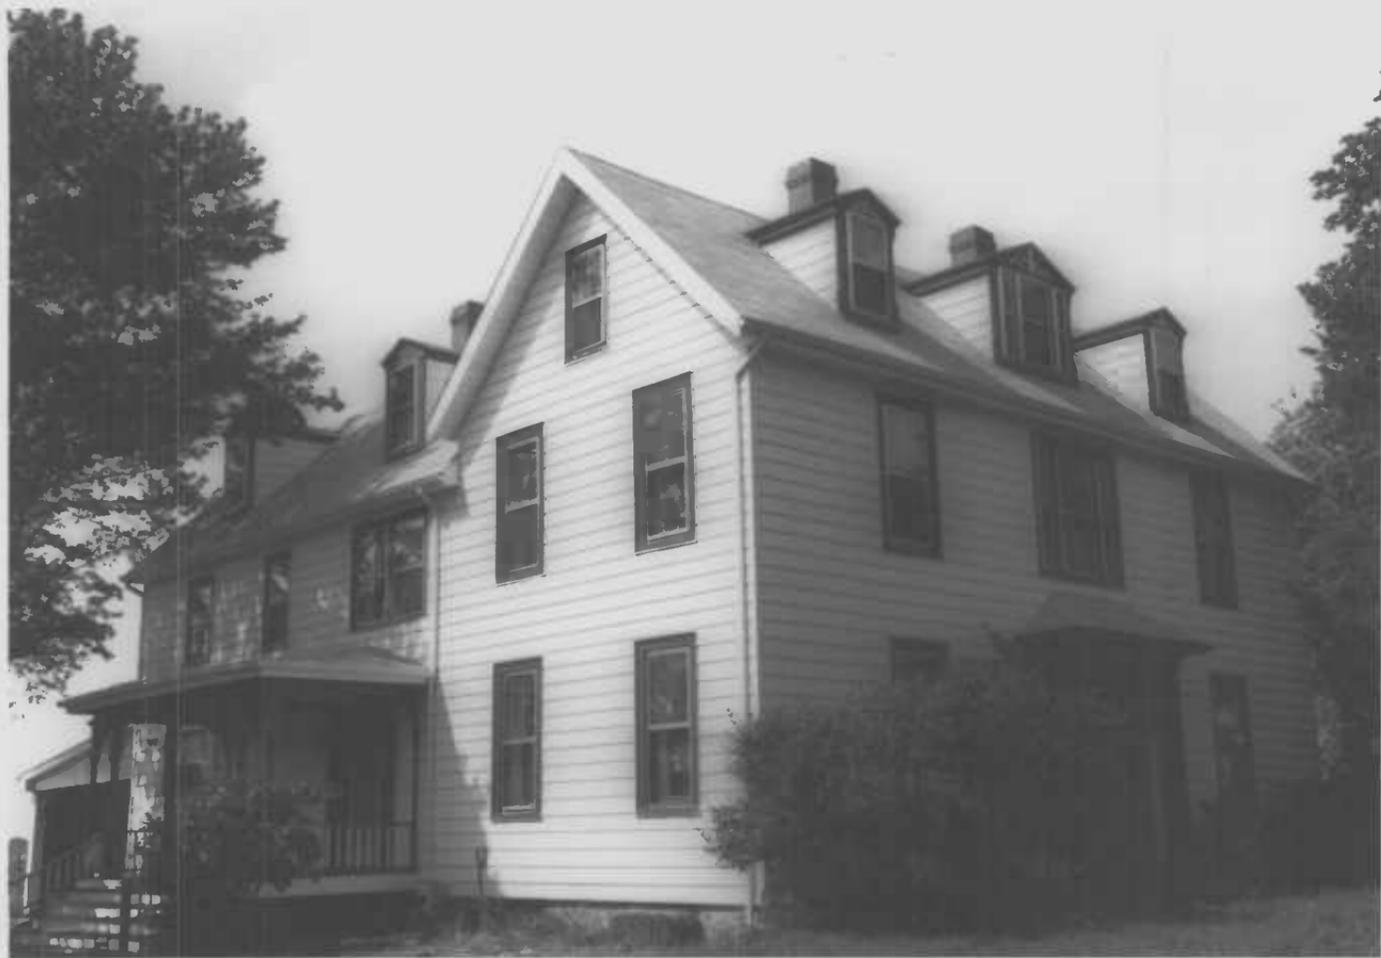
K-464-33

View to northwest
