Maryland Historical Trust State Historic Sites Inventory Form

historic Violet Hill Farm

Survey No. K-466

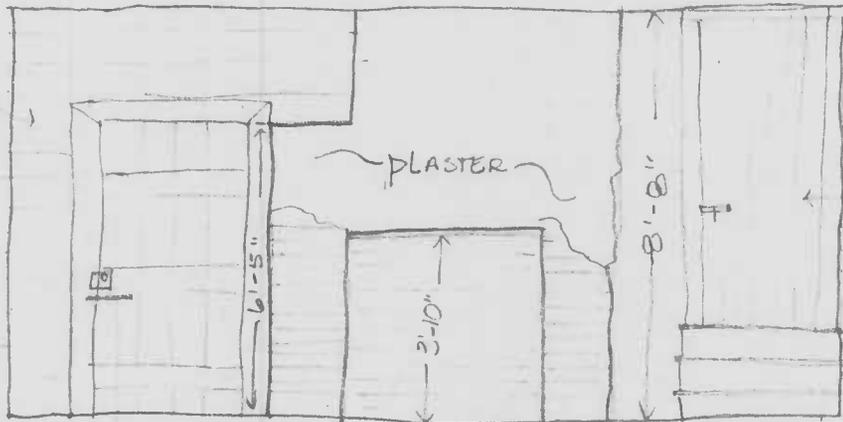
VIOLET HILL FARM - K-466

NARROW BEADED
BOARD DOOR W/
C.I. LATCH

(HEARTH: 6'-2" x 2'-0")

ORIG. KITCHEN FIREPLACE

4. Roof Details - Very simple overhang. No moldings
5. Porch - Concrete steps lead to doors. No porches although the main facade probably had a porch.
6. Color - Current: white/green shutters
Historic: ?
7. Other - In interior, rear room of ell has a broad fireplace with no damper, a steel lintel, and a corner stair, enclosed, beside it. All boarding, hardware, and flooring in the room is typical of the Victorian period. Fireplace is sketched on attached sheet.

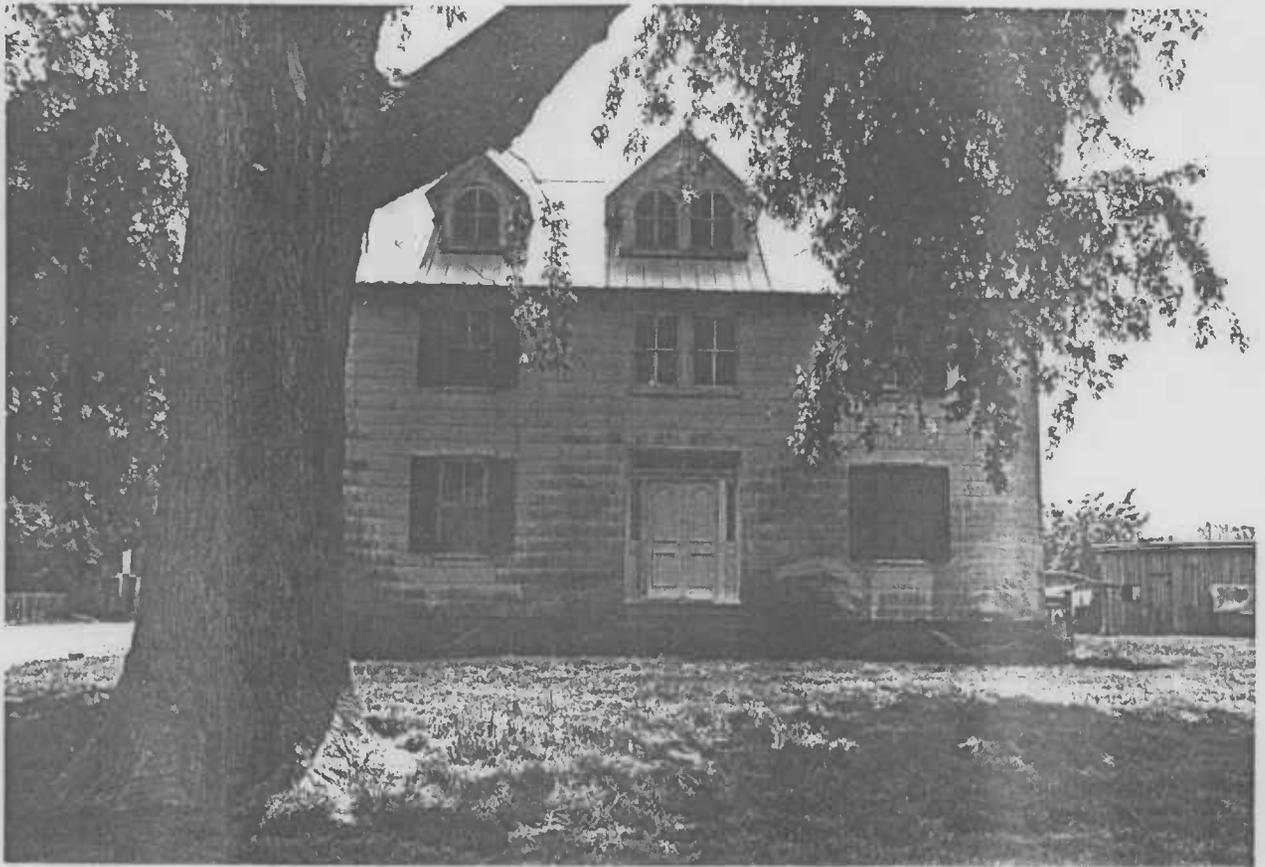
VIOLET HILL (K-466)

View to Southeast

A 2½ story, three bay Victorian farm house, Violet Hill is a frame structure with a gable roof. There is a rear ell, and chimneys and a central stair/entry hall. A very large fireplace in the last ell room has an exposed fireback and may indicate that this section predates the main house.
