Maryland Historical Trust State Historic Sites Inventory Form

Survey No. K-468

historic Bristol Farm

and/or common Herbert Usilton Farm

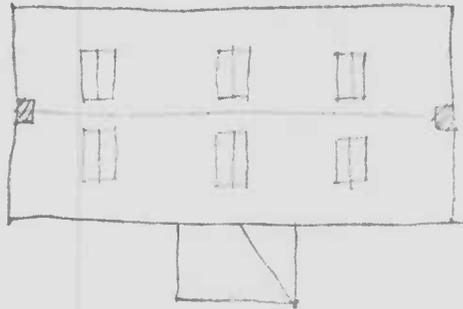
SKETCH ROOF PLAN
HERBERT USILTON HOUSE K-468
6/81 MLE.

A five bay wide, 2½ story frame house, this building has late Victorian detailing throughout but appears to rest on an earlier field stone and brick foundation. It is one room deep with a central hall plan and a shed-roofed kitchen wing at the southeastern gable.

1. Size - Main Section: 2½ stories, 5 bays wide, 2 bays deep
 Wing A: Modern - 1 story, 1 bay wide, 2 bays deep
 Wing B: Demolished - Side Kitchen -
2. Plan type - Central Hall, one room deep; side wing.

3. Roof type - Main Section: Gable
 Wing: Shed
4. Chimneys - Location: Enclosed in 2 gable ends
 Materials: Brick
 Decorative elements: None; chimneys are supported
 by brick piers in cellar

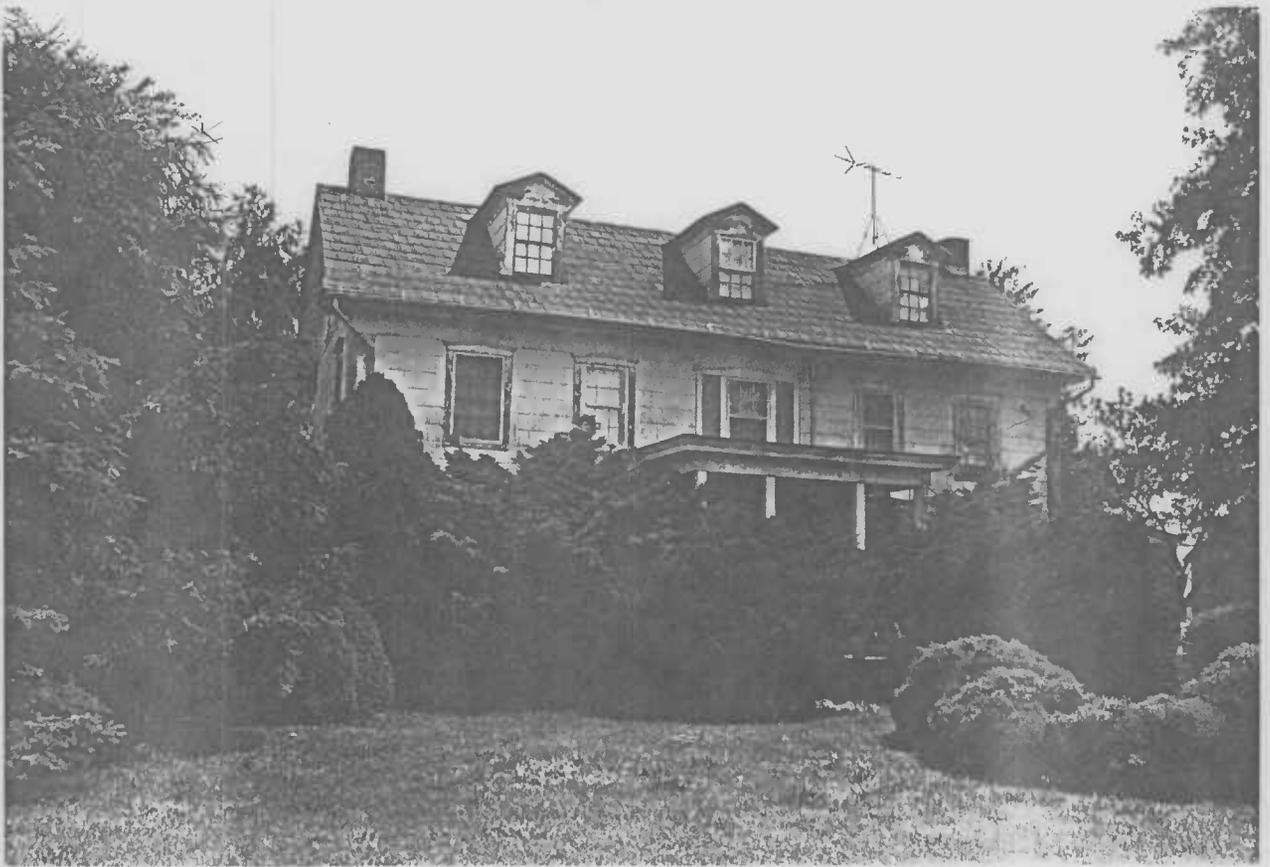
View to Northeast

1. Doors - Main Entry: Located in the center of southwest facade,
 door has single light side light; a 3-light transom. Like the front
 windows this door has a sloped lintel with Greek ogee and fillet hood
 moldings. The door has an upper light and a pair of panels with
 bolection moldings with block corners.
 Secondary entries: Located in modern kitchen. A rear
 door in the northeast facade has been covered over on the exterior.
 Basement entry in east gable. Same foundation description as above.
2. Windows - Main Section: type - double-hung
 lights - 6/6; central window, front, has
 side lights.

3. Dormers - Three in each roof slope. Gable with widely overhanging eaves and a return, bracketed pilaster base and 6/6 sash.

5. Porches - A three-bay wide, one-bay deep front porch with flat roof, box cornice with cyma and fillet crownmold and plain square replacement columns.

HERBERT USILTON FARM (K-468)
