K-474

J. Wickes Farm
Broad Neck
c. 1850's

Maryland Historical Trust State Historic Sites Inventory Form

ELIASON FARMHOUSE (K-474)

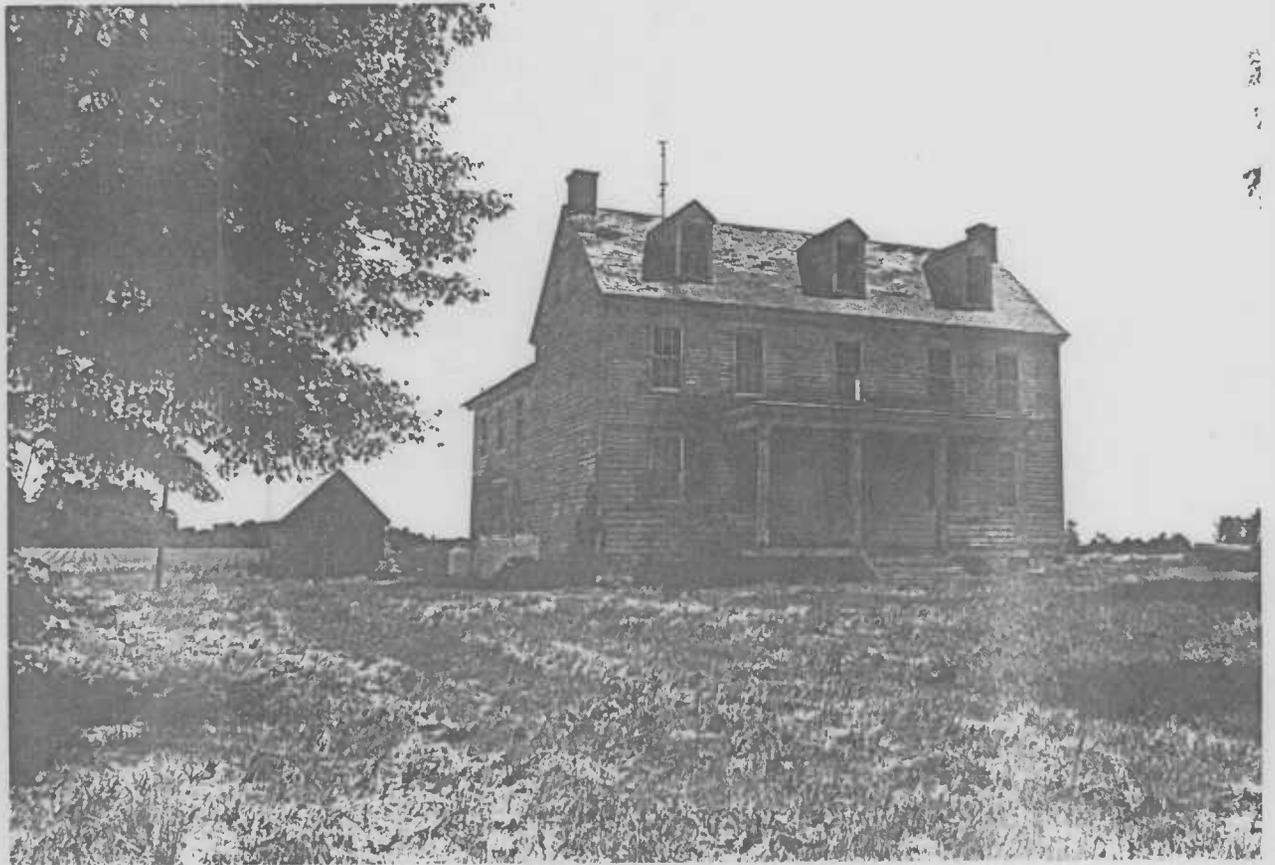
View to North

Facing south with a view of the head of Sinai Cove, this house is 5 bays wide, 2½ stories tall, and one room deep. It is frame. The central hall building has its kitchen in a gable-roofed rear ell. A simple structure, its chief decoration is a bracketed cornice on the main roof and the wide front porch.
