Poplar Hill  
Fairlee  
mid-19th century

Maryland Historical Trust  
State Historic Sites Inventory Form

Survey No. K-479

historic Nicholson Farm

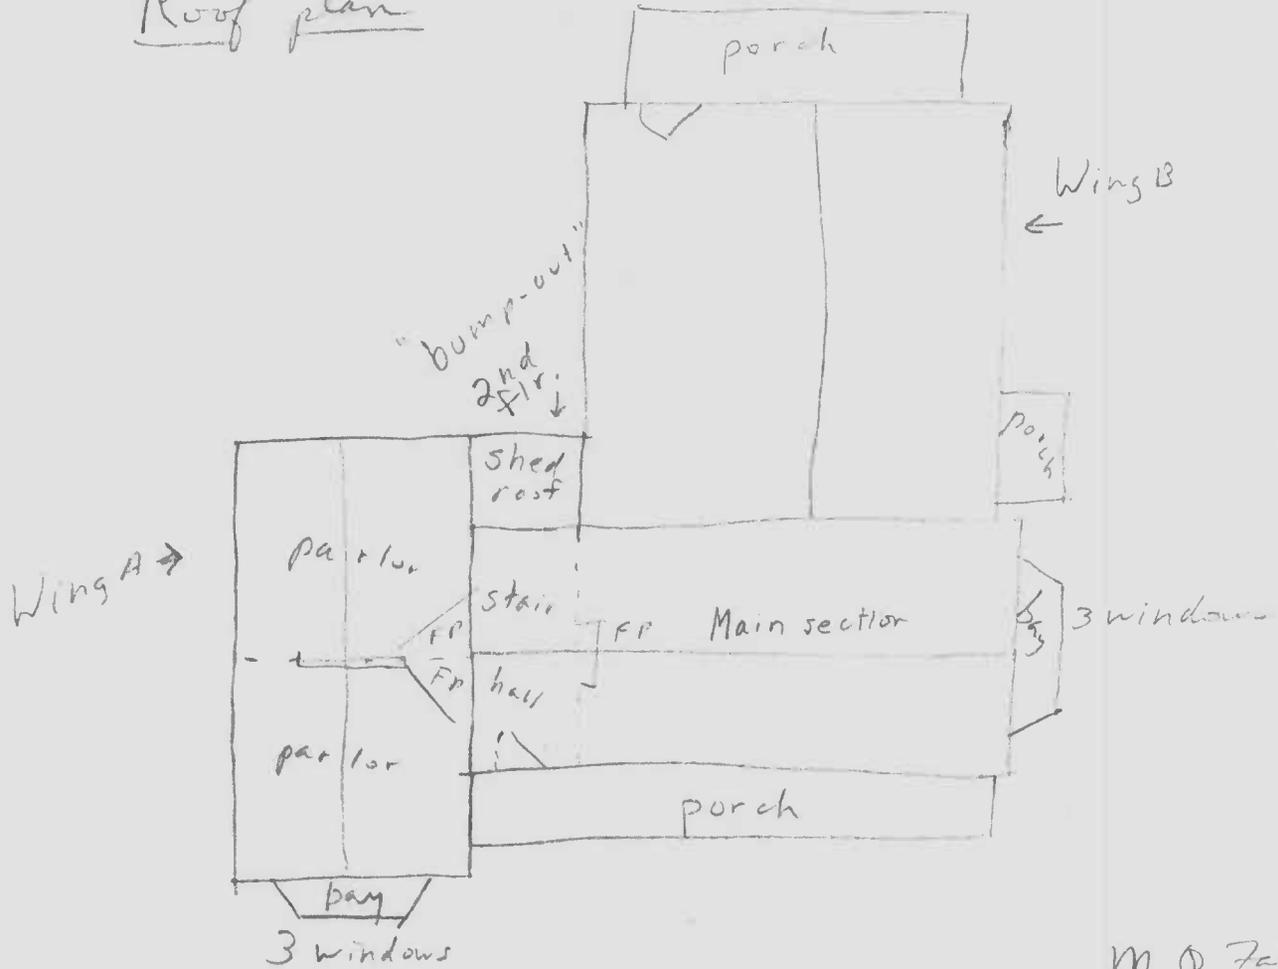
Roof plan

1. Size - Main Section: 2½ stories, 3 bays wide, 1 bay deep (1 bay window with 3 windows)
  - Wing A: 2 ½ stories, 1 bay wide (bay with 3 windows), 2 bays deep (25' - 30'); to north end of main section.

- Wing B: 2½ stories, 2 bays wide, 3 or 4 bays deep (to rear of main section).
2. Plan type - Main section as used here includes only side entry and stair hall and large room (originally the dining room). On the other side of the hall, under a roof perpendicular to the main section's roof, are 2 rooms, on the first floor - front and rear parlor. The house's three parts were conceived and built as a whole, with the 2 front portions utilizing two axes and intended to be the "main", public portions.

3. Roof type - Main section: gable
  - Wings: gable
4. Chimneys - Located in the 1) center east gable end of Wing B: small, for stove. 2) thru roof ridge of main section between center and northern bay. 3) about 7 ft. to the north of chimney #2 just within Wing A but still through ridge line of main section. These 2 chimneys serve fireplaces in rooms on each side of the main entry hall. The northernmost chimney serves two first-floor corner fireplaces.

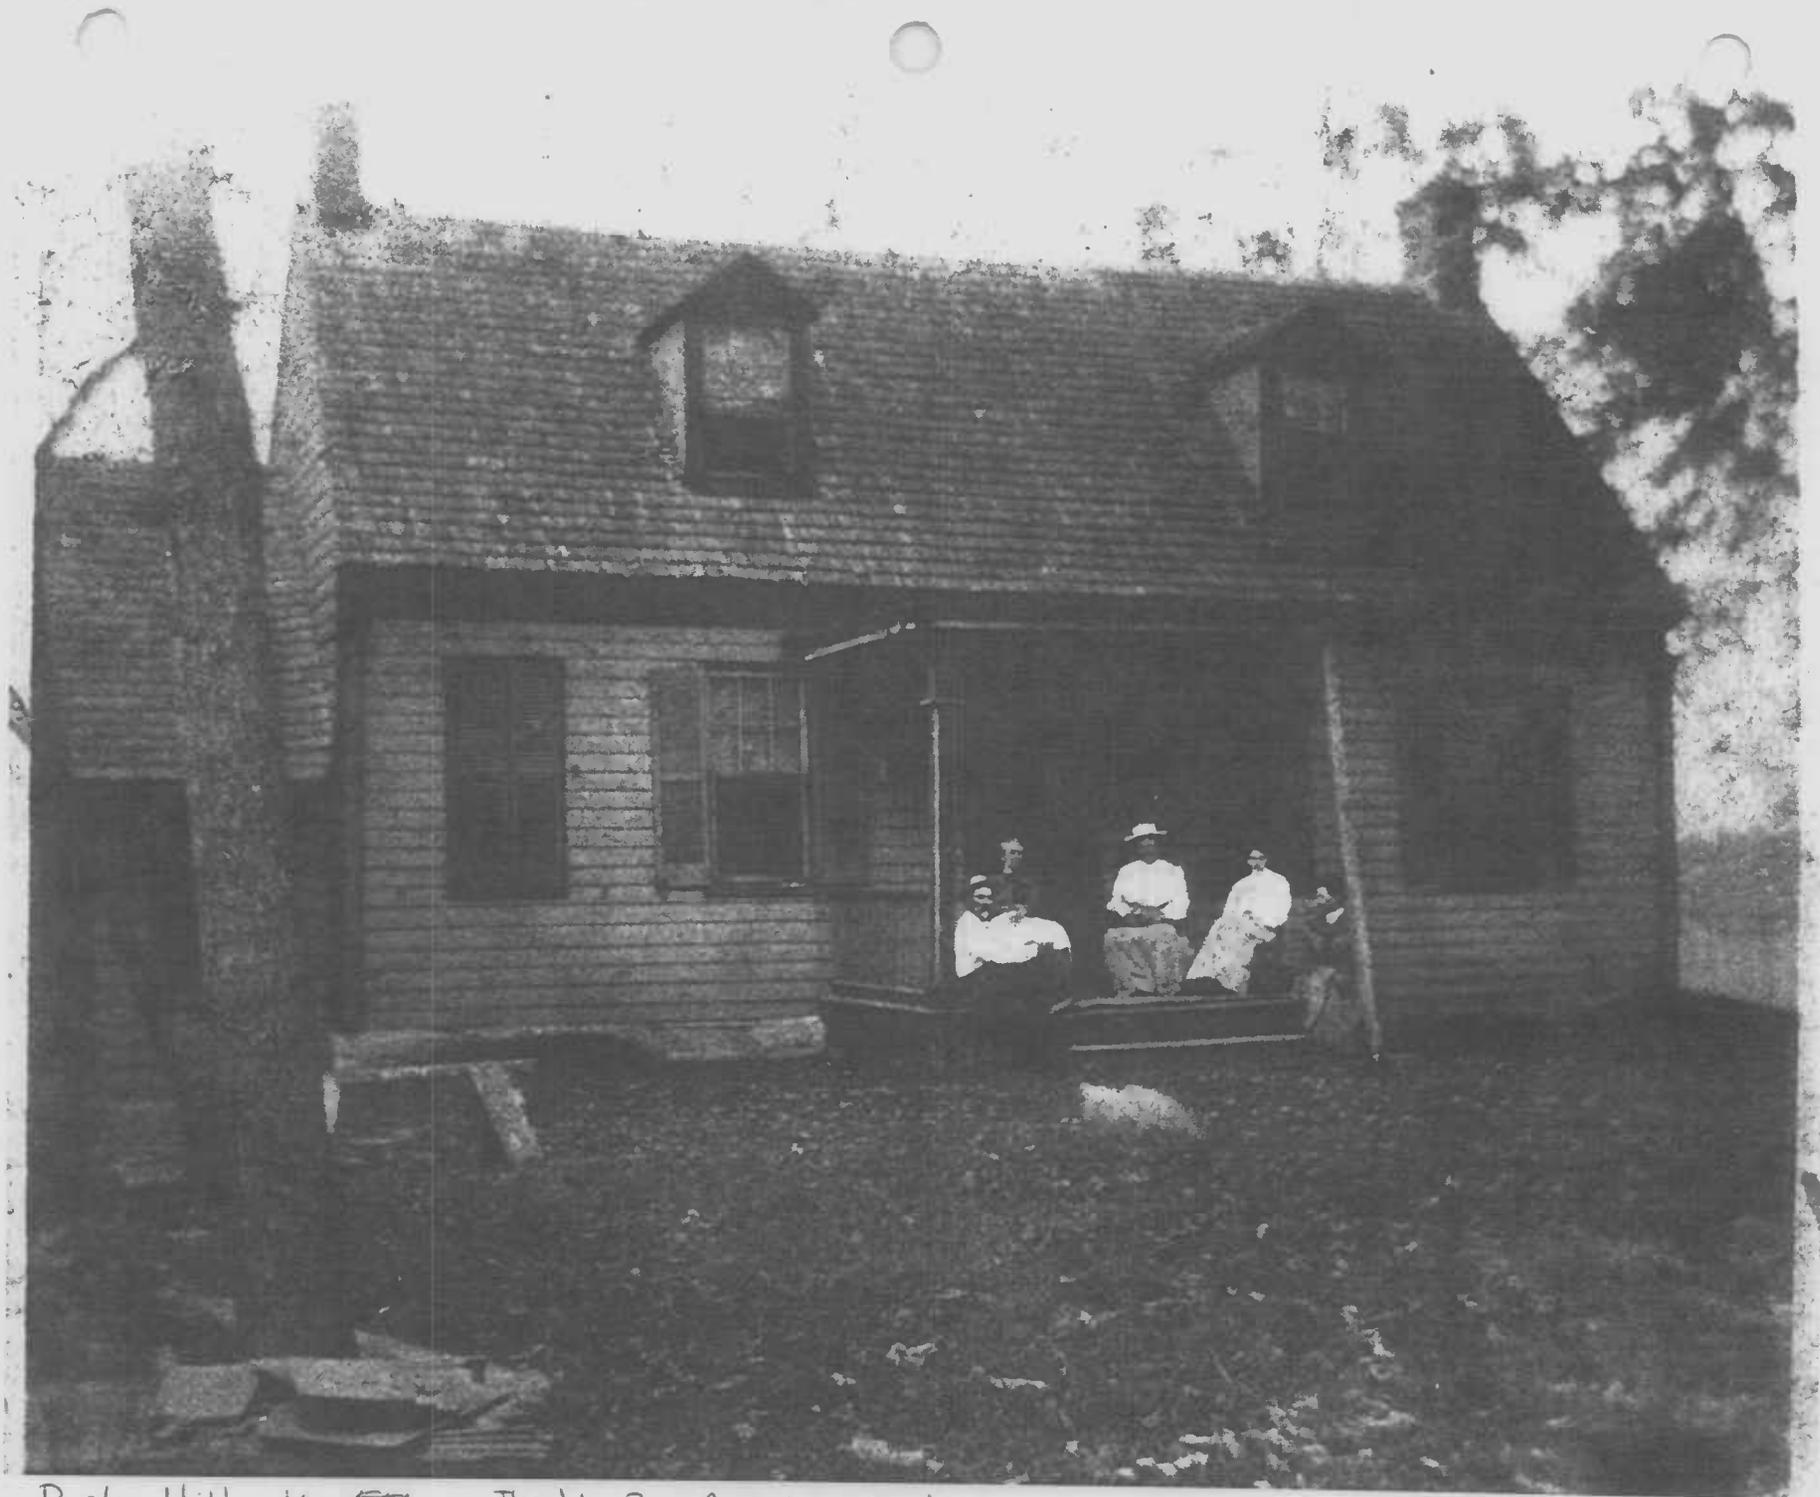
Nicholson family photographs show a house five bays long with a central entrance covered by a flat-roofed porch. The windows all have 6/6 sash and louvered blinds, all appearing 19th century in origin. One curious feature pictured is a large window on one side of the chimney and a smaller casement on the other. This feature along suggests the possibility that the larger window was installed when the house was "remodeled" rather than an original design.

Poplar Hill K-~~479~~ - The John Parr Nicholson Family - taken before 1905

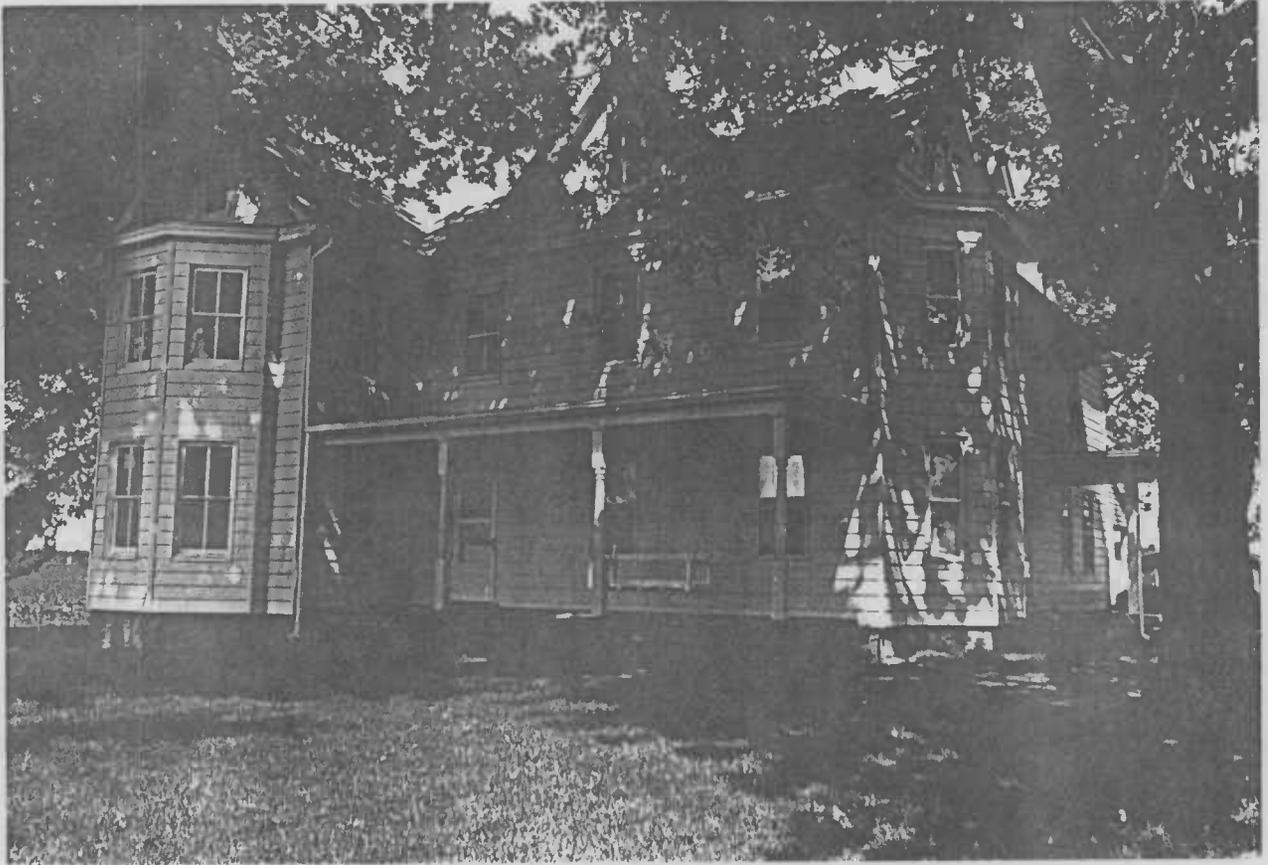
View to Northeast

Built about 1895-1900, all three gable-roofed sections of this large farmhouse were built at the same time. Visible while approaching the house are two three-window bays. A broad central gable in the "main section" balances the gable end of the parlor wing. A wide front porch also ties those two sections visually.
