Tayman-Chance House

# Maryland Historical Trust State Historic Sites Inventory Form

Survey No. K-584

and/or common Chance House (preferred)

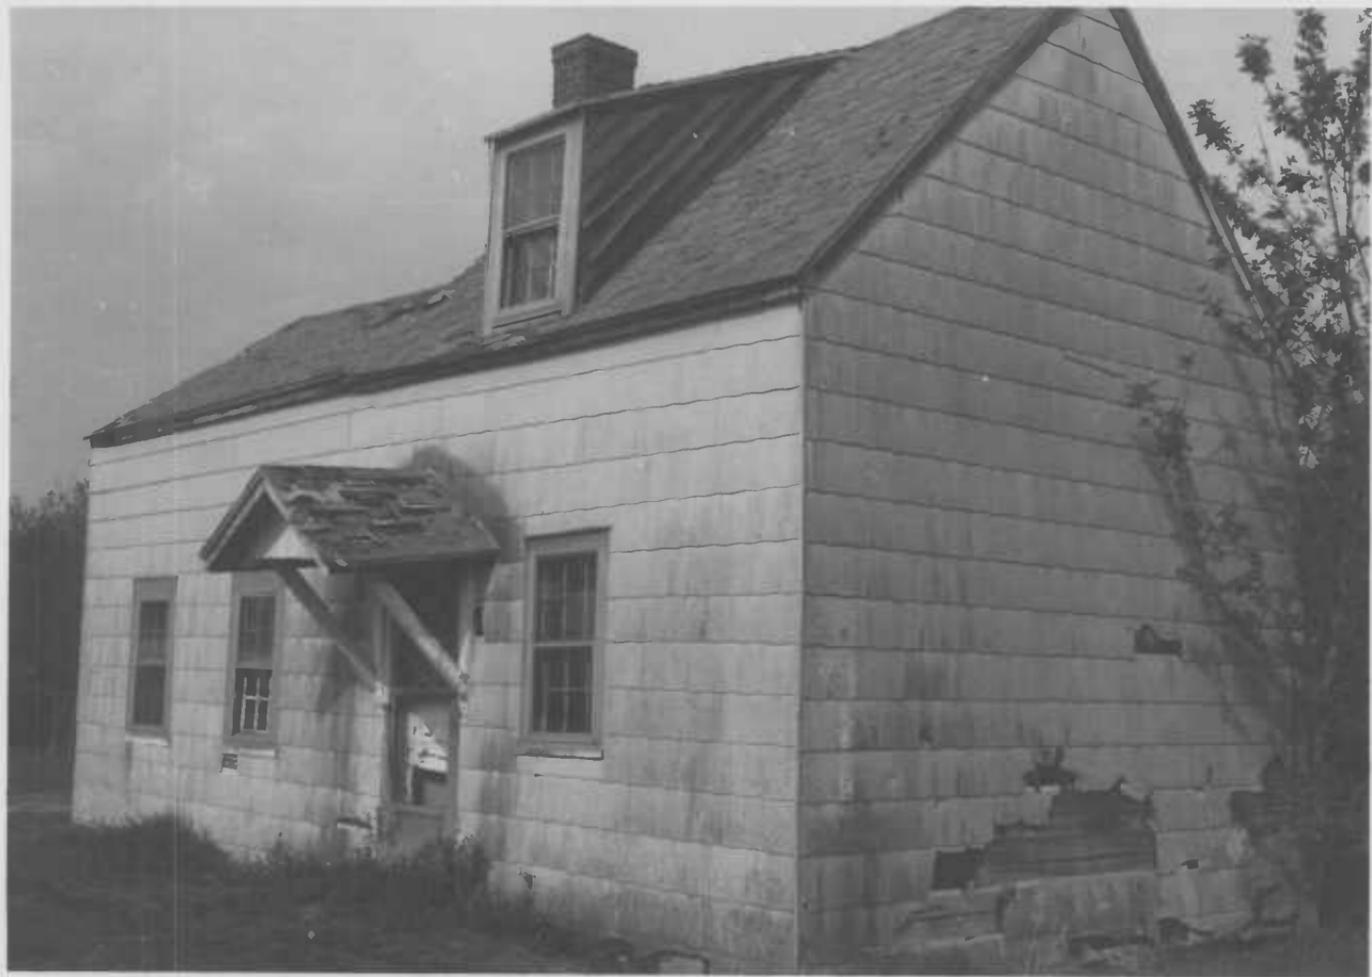
K584-20

The southern section is about 15 feet wide and 16 feet . The later, north wing, with its front (west) wall flush with the earlier section's, is about 16 feet wide by 14 feet deep. Both sections are two bays wide. The added section also appears to be true 1-1/2 storey in height, but its roof is considerably lower and the pitch somewhat shallower than that of the earlier section.

Both sections are now covered with asbestos shingles over horizontal, lapped weatherboard, which is exposed in some places; some may be replacement material.

View to northeast

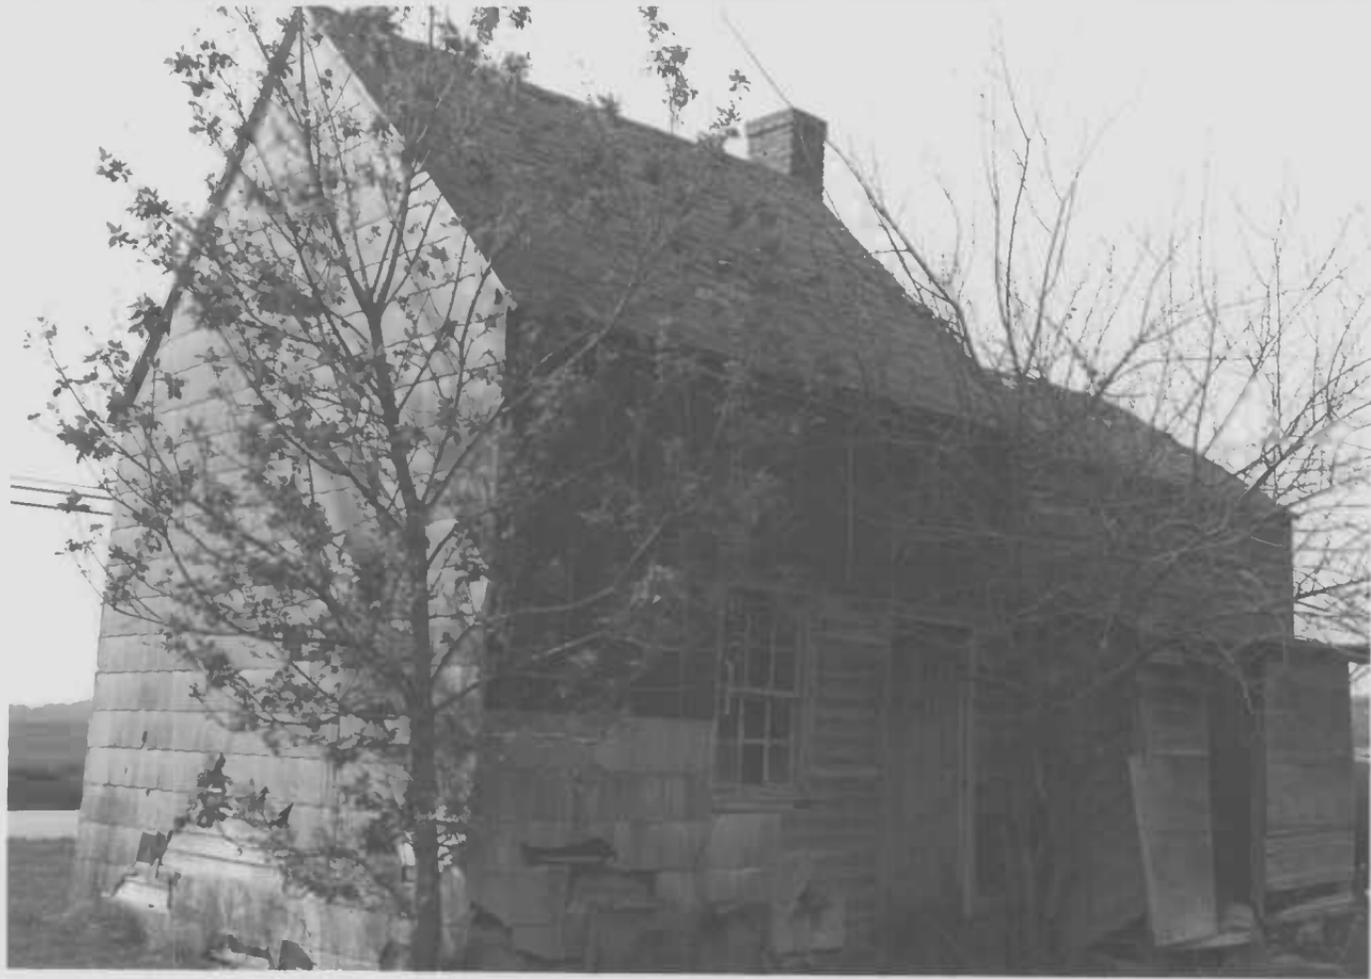
K584-24

The door and window in both front and rear walls, opposite each other, are not placed with reference to a center point but set somewhat to the north. The materials do not seem to be original. The double-hung sash have 6-over-6 lights. There are no windows on the south end.

There is a single shed-roofed front dormer in the main section, slightly to the north of center. The sash are double-hung with 6-over-6 lights. The aluminum storm window-screen cover face details. The cheeks are of lapped weatherboard applied diagonally, following the pitch of the main roof.

View to northwest
