National Register of Historic Places Inventory—Nomination Form

historic Bishopton

city, town Church Hill vicinity of congressional district First

Continuation sheet Queen Anne's County, Maryland Item number 7

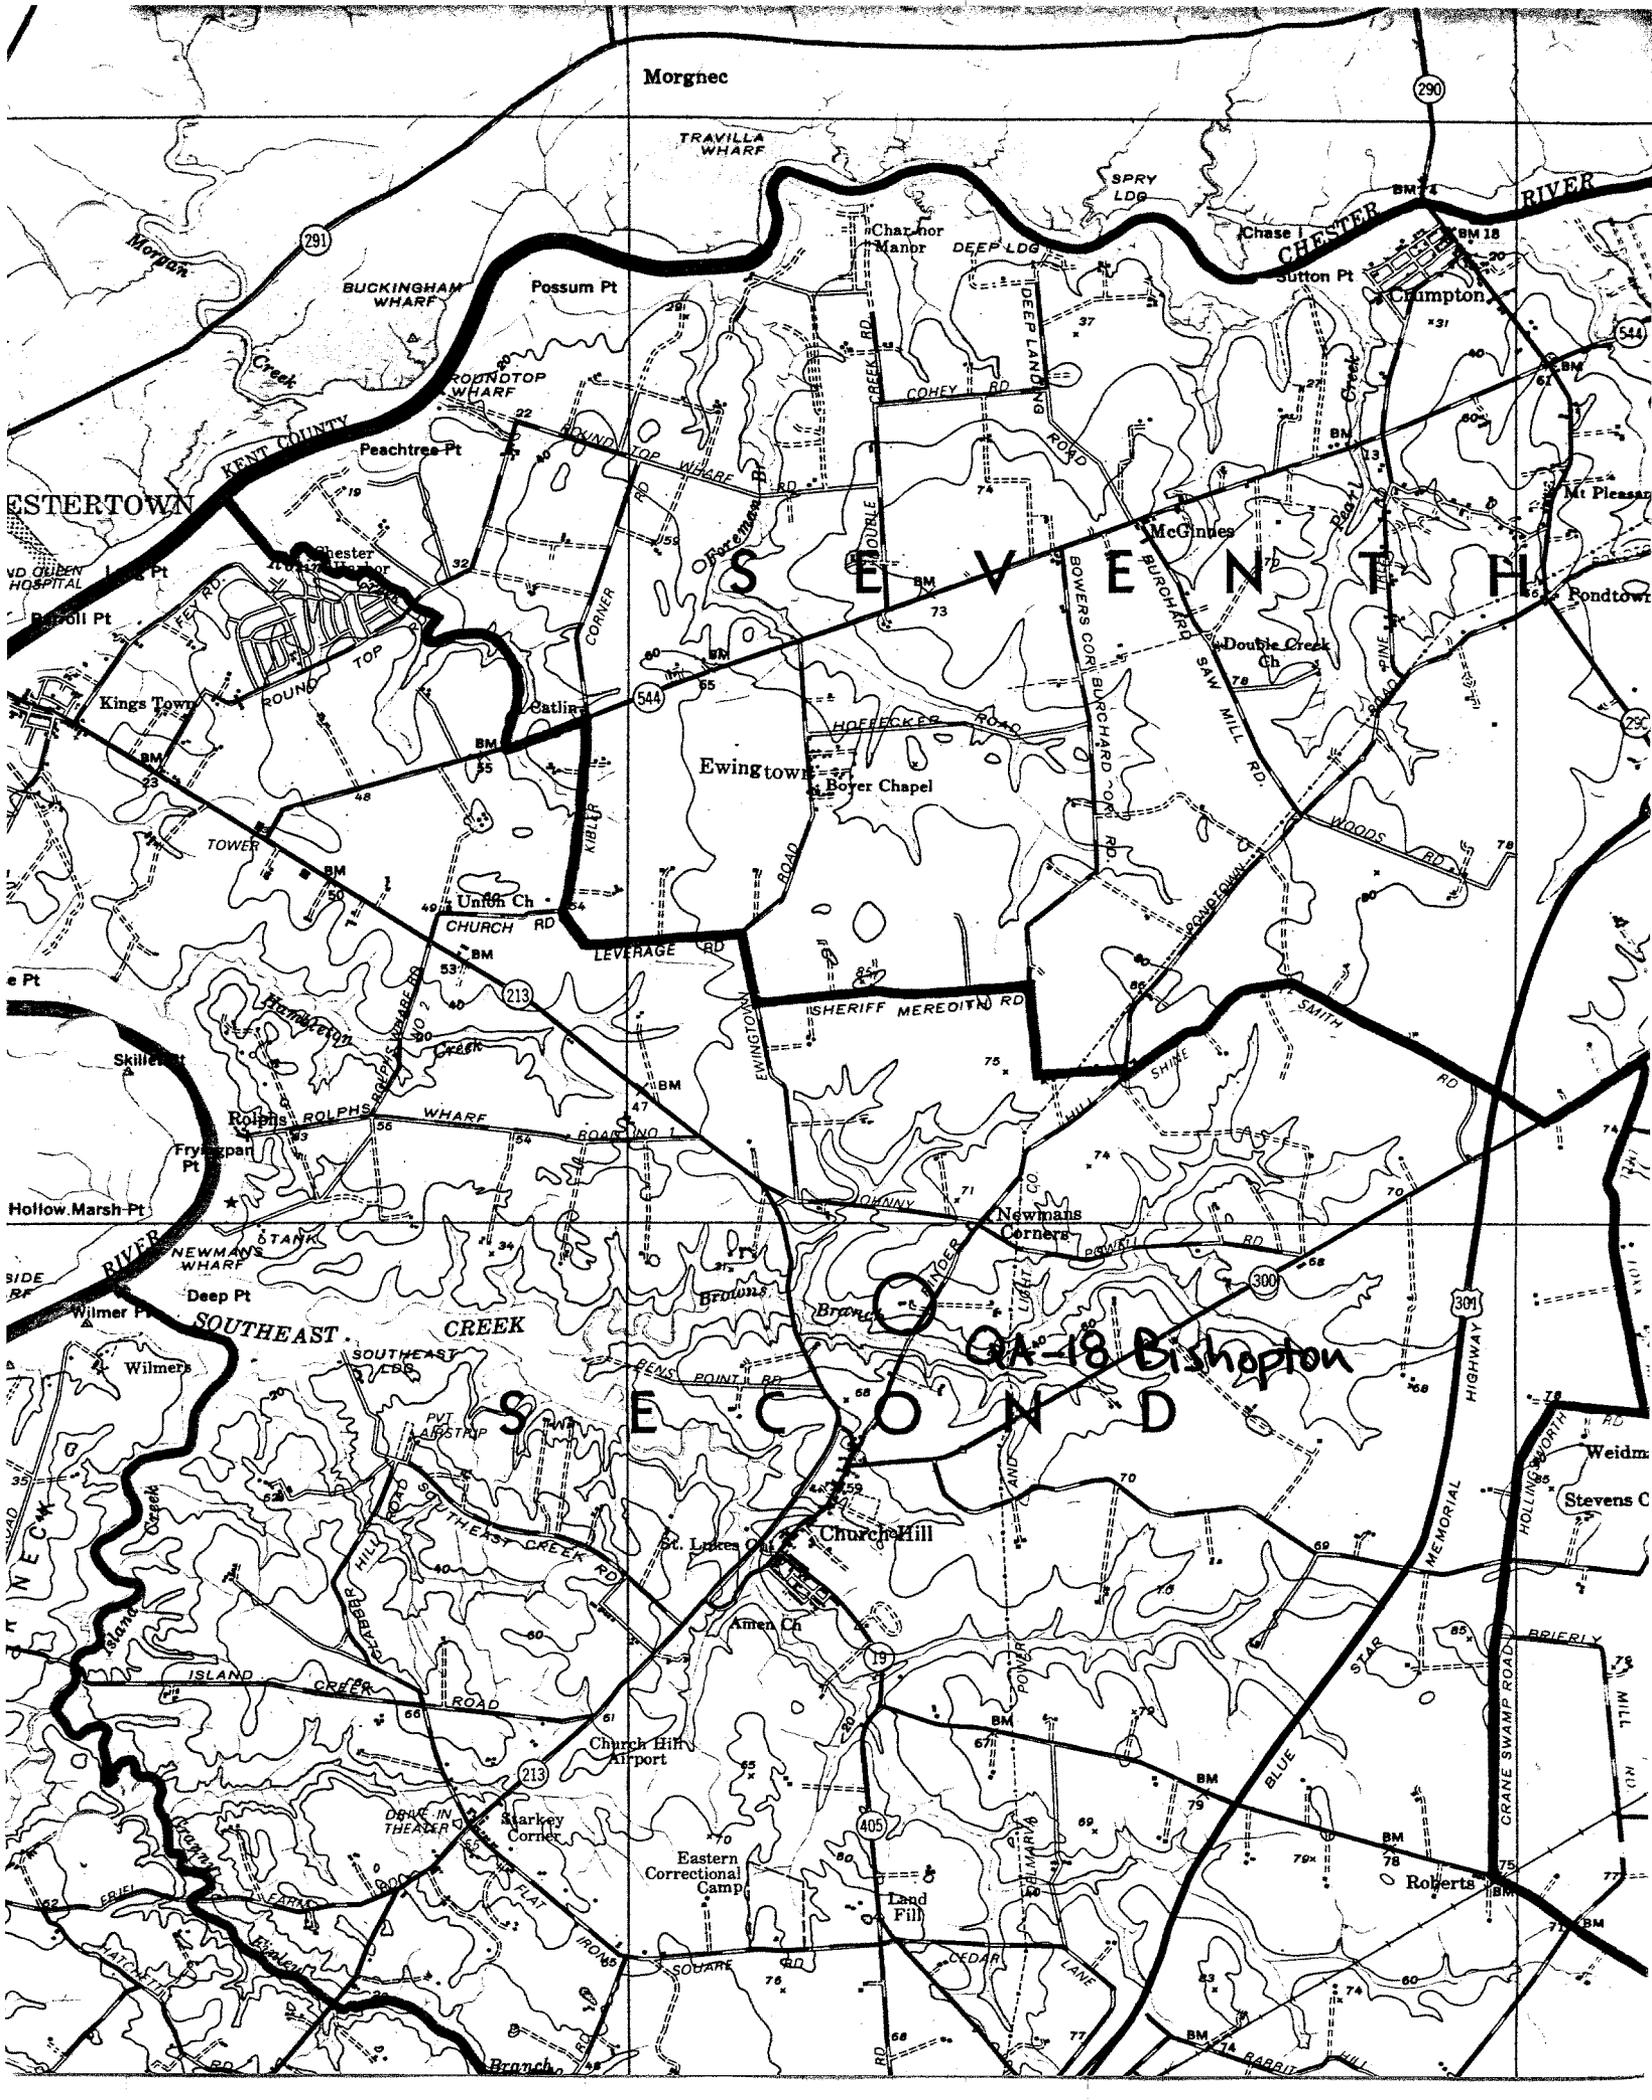
PLAT OF BISHOPSTON FARM
 2ND DISTRICT, QUEEN ANNES CO. MD.
 LIBER. C.W. No. 72 folio 670
 ROBERT W. & LYNN S. BRADY
 23.077 ACRES +/-
 improvements not to scale

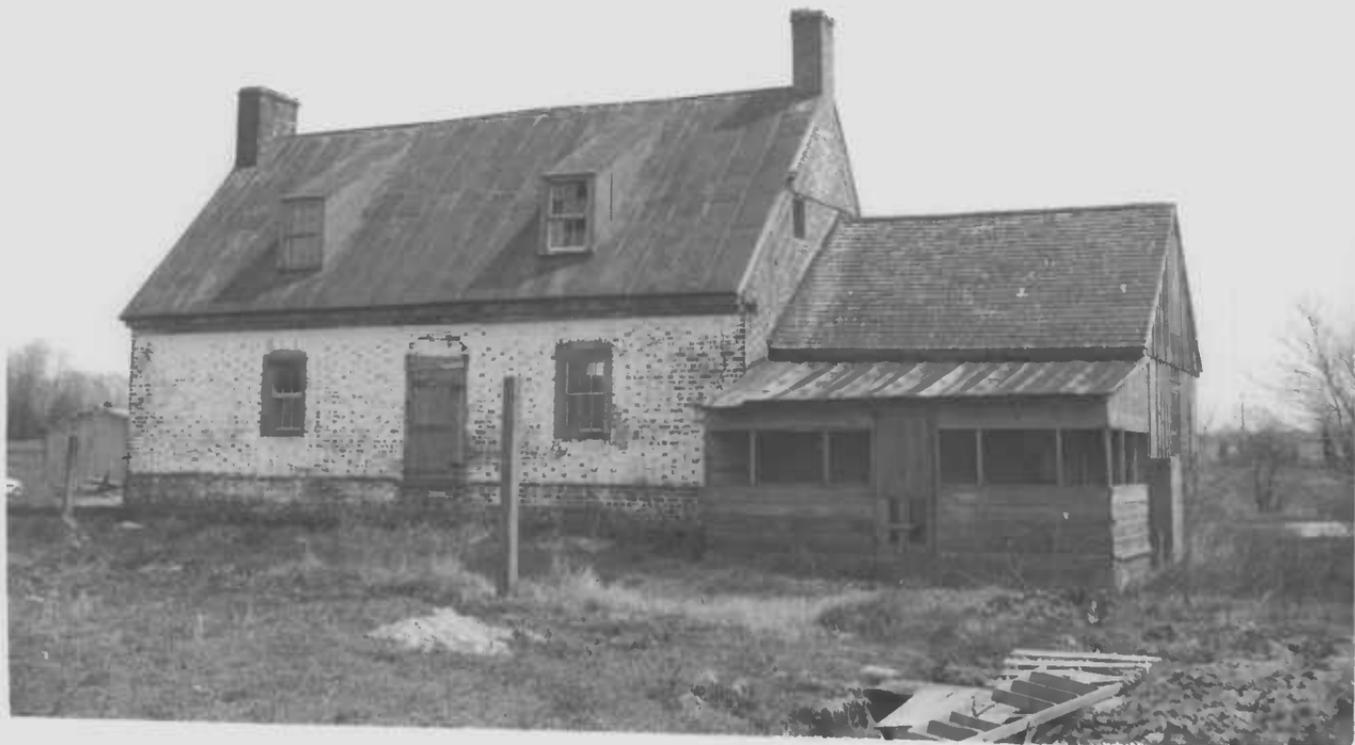
QA # 18

West facade

The west facade remains largely undisturbed. The door is offset slightly to south of center, flanked by single 6/6 windows on each side. Two 6/6 shed roof dormers are ranged across the steeply pitched roof. The brickwork is laid in glazed header Flemish bond above a plain water table and an English bond foundation. The window openings have segmentally arched lintels one brick high. Glazed headers alternate with plain stretchers in the arches. The lintel above the door has been reworked. The window frames are not original and are tricked out with early 19th century trim. The roof is covered with modern split shingles and the dormers and cornice are entirely rebuilt.

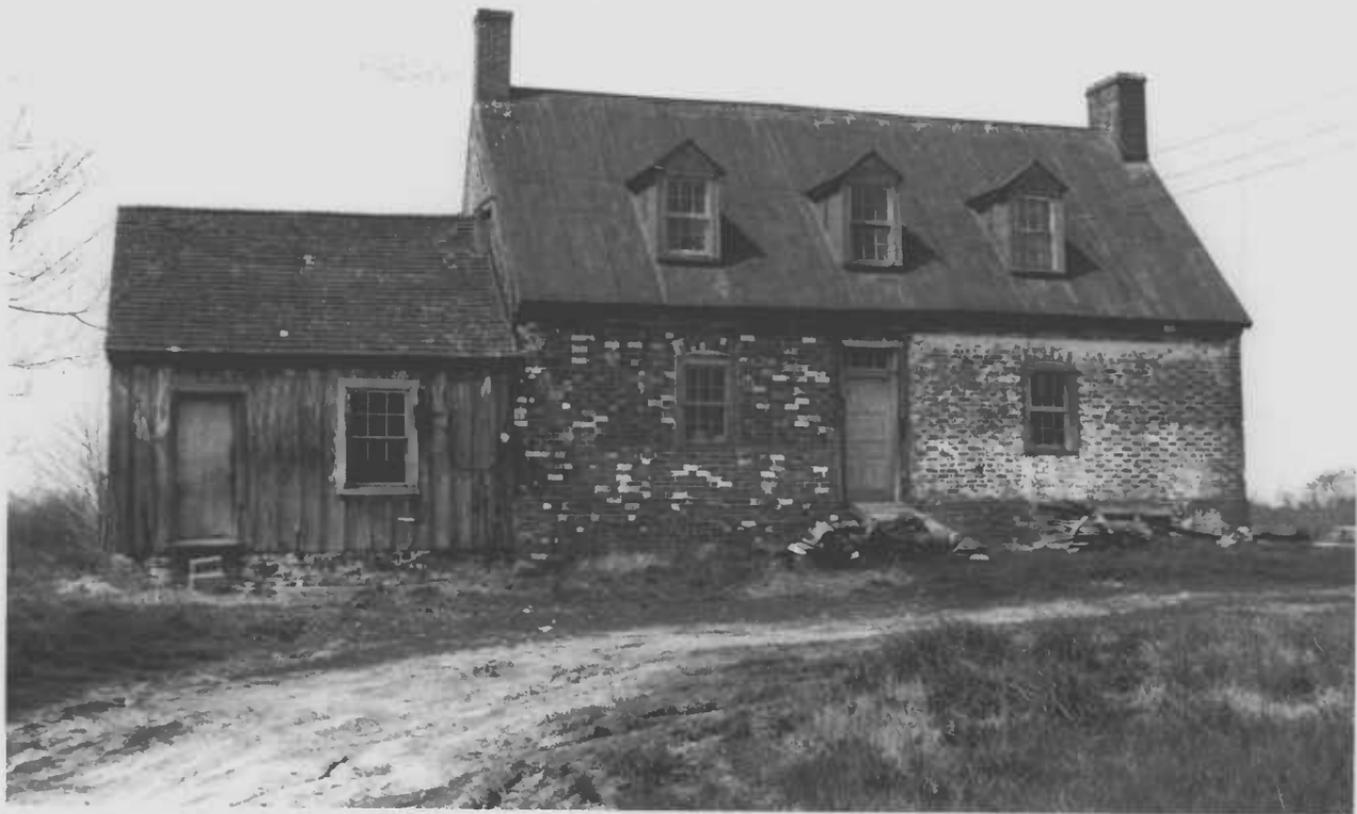
QA-18

Bishopton
Church Hill vicinity
James W. Valliant, 1973
East facade

The east facade is similar to the west facade except the south end of the wall has been extensively repaired. The center door is flanked by single 6/6 windows; three 6/6 gable roof dormer windows are ranged across the second story. These dormers are pilastered with cornice returns and blocks, typical of the Federal period. The roof is covered with modern split shingles; the cornice is rebuilt.

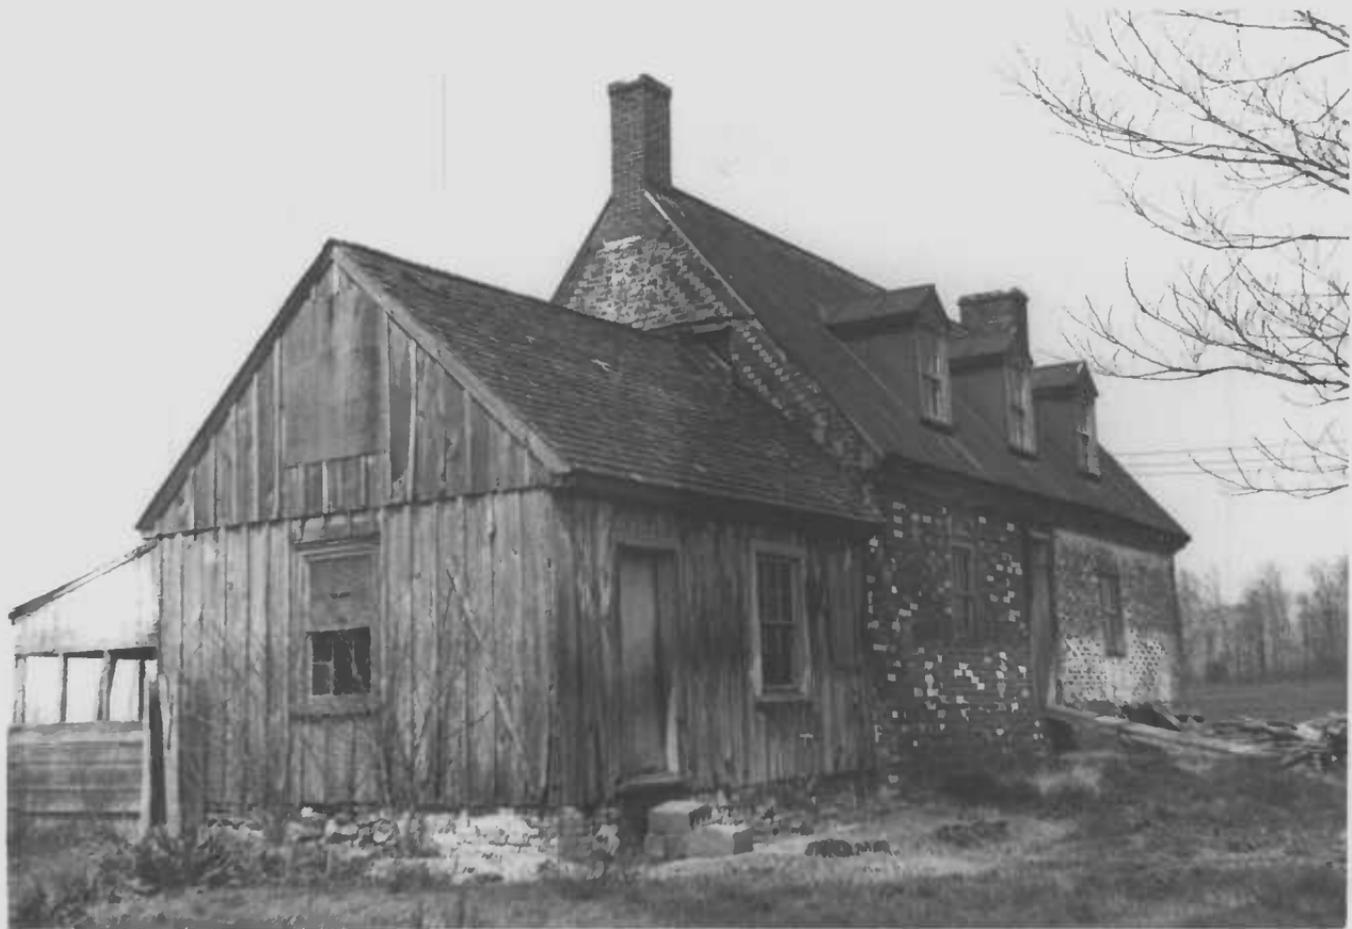
QA-18

Bishopton
Church Hill vicinity
James W. Valliant, 1973
View from Southeast

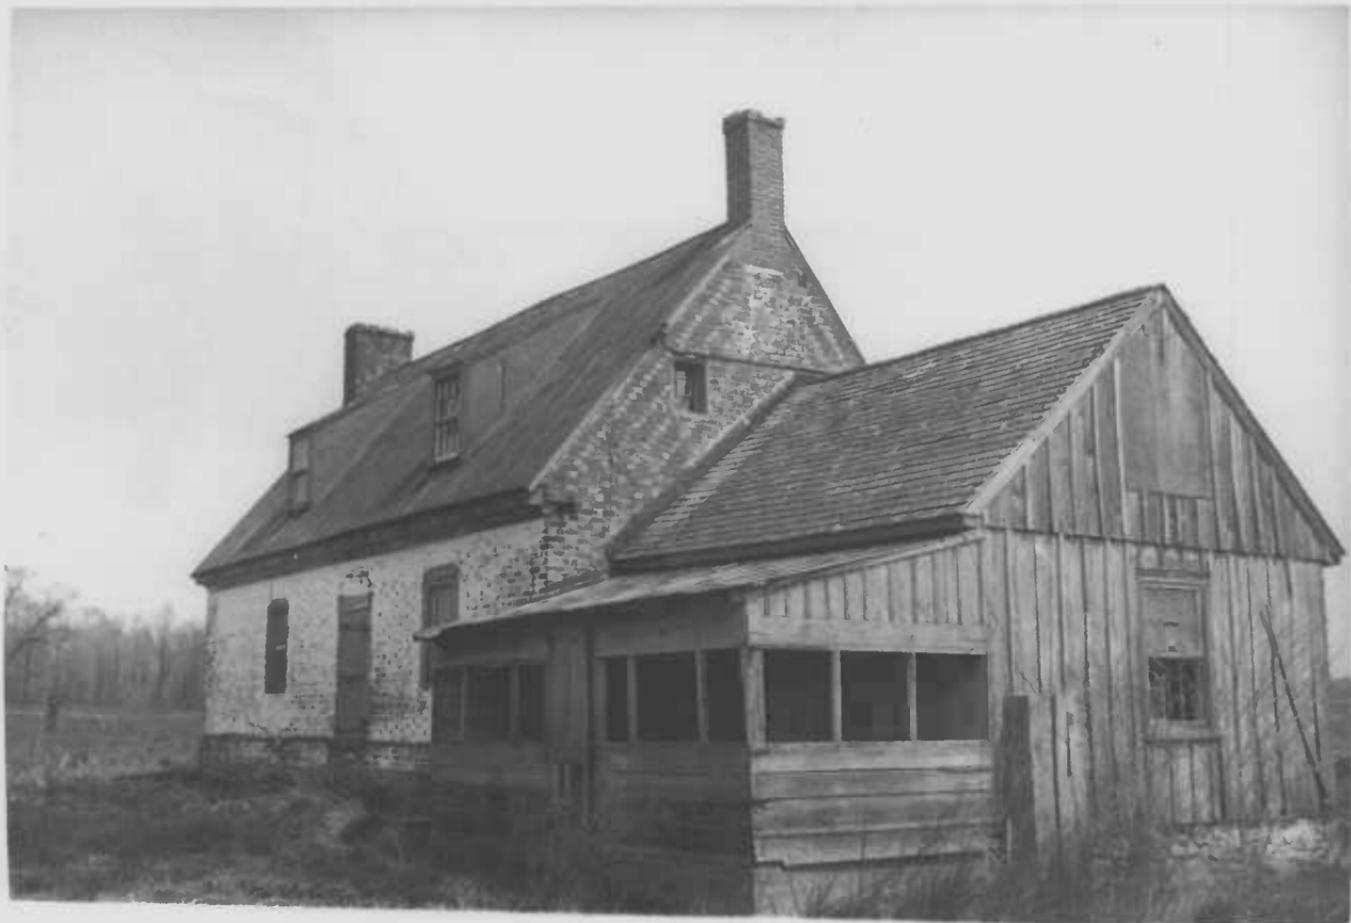
QA-18

Bishopton
Church Hill vicinity
James W. Valliant, 1973
View from Southwest
