QA-42
Charles Vonville Farm
Sudlersville vicinity
Private

INVENTORY FORM FOR STATE HISTORIC SITES SURVEY

Charles Vonville Farm

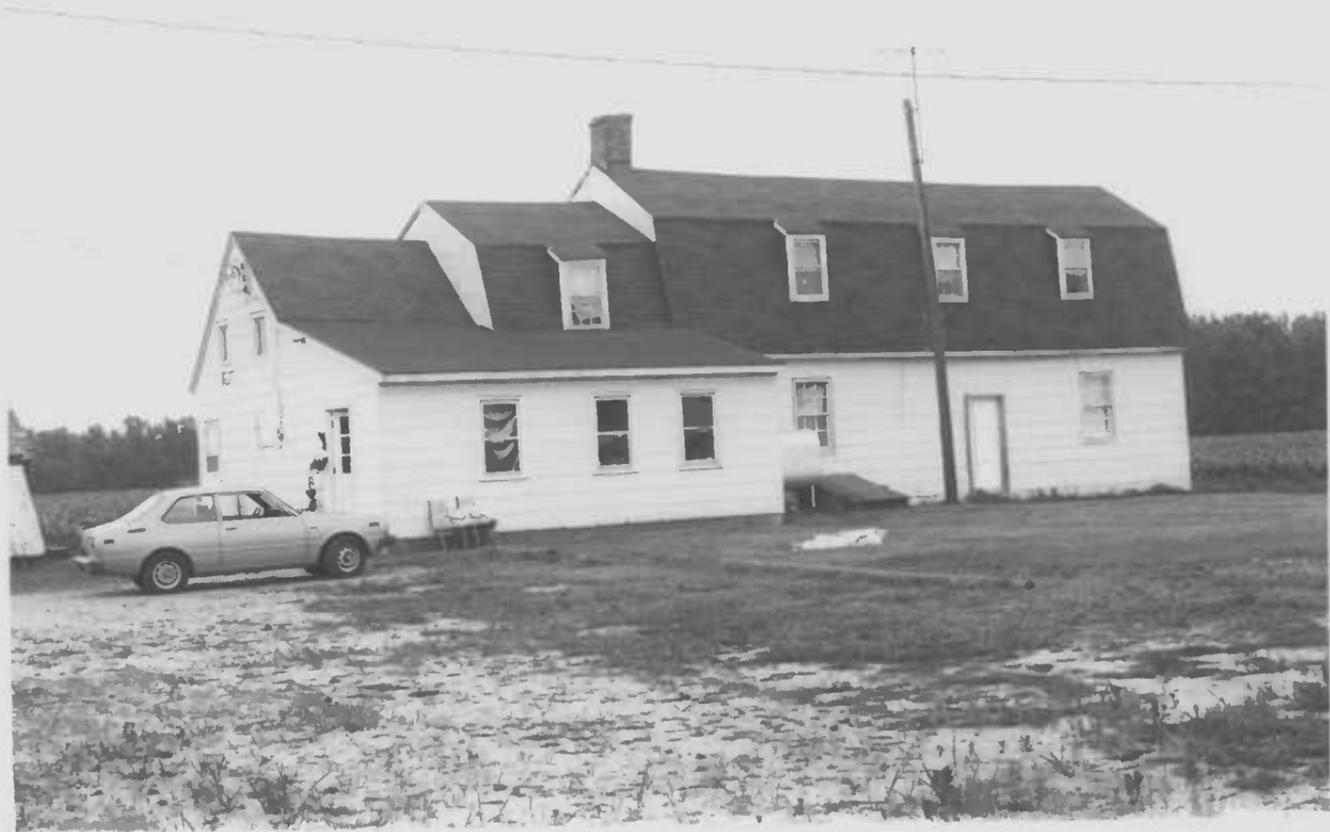
QA-42

On the rear or north facade, there is a single door without transom offset to right of center, and one 6/6 window to east and west on the first floor. Three 6/6 shed roof dormers are ranged across the second story. A bulkhead cellar entrance is located under the east window. The foundation, siding, cornice and roof all match the front facade. The door on this facade is an unusual three-panel example with flattened Greek ogee panel molds.

Charles Vonville Farm
Sudlersville vicinity
Orlando Ridout V 1981
Rear facade from north

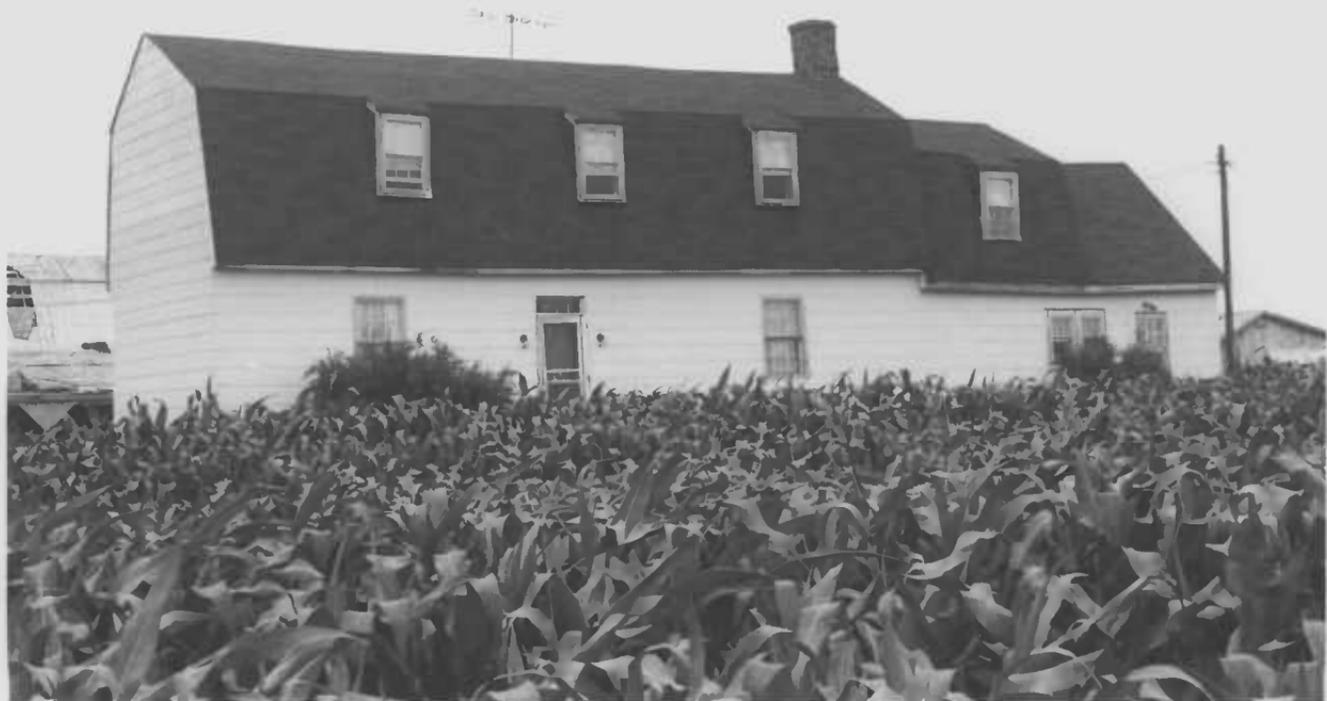
QA-42

The principal facade of the main house faces south to the road. The door is offset to left of center with a four-light transom above, one 6/6 to the west and another 6/6 to the east. There are three 6/6 shed roof dormers on the second floor. These are symmetrically placed on the roof, in contrast to the asymmetry of the first floor openings.

The building rests on a continuous foundation of concrete block and is covered with asbestos siding, a plain box cornice and asphalt shingle roofing.

Charles Vonville Farm
Sudlersville vicinity
Orlando Ridout V 1981
Front facade from south
