QA-57  
Cohey Farm  
Church Hill  
Private

INVENTORY FORM FOR STATE HISTORIC SITES SURVEY

Allen and Charles Cohey farm

COHEY FARM  
CHURCH HILL, MARYLAND

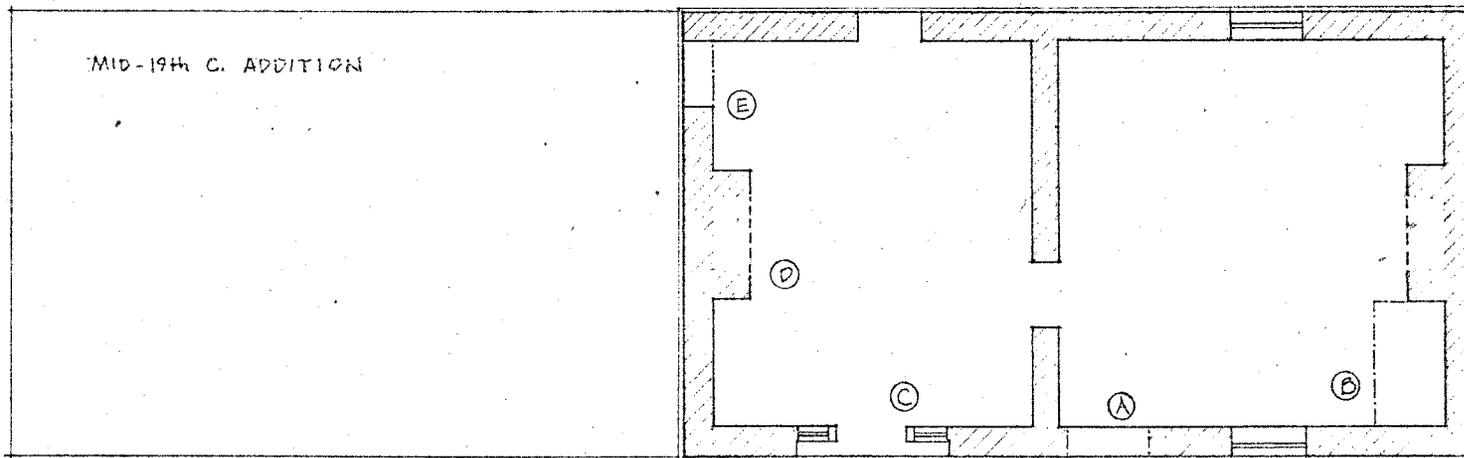
- A LOCATION OF ORIGINAL EXTERIOR DOOR.
- B LOCATION OF ORIGINAL STAIR.
- C MID-19th C. EXTERIOR DOOR.
- D ORIGINAL FIREPLACE CONCEALED BY  
MID-19th C. STAIR (NOT SHOWN).
- E CONNECTING DOOR CUT IN FOR ADDITION.
