QA-81  
Plain Dealing  
Centreville vicinity  
Private

INVENTORY FORM FOR STATE HISTORIC SITES SURVEY

Plain Dealing

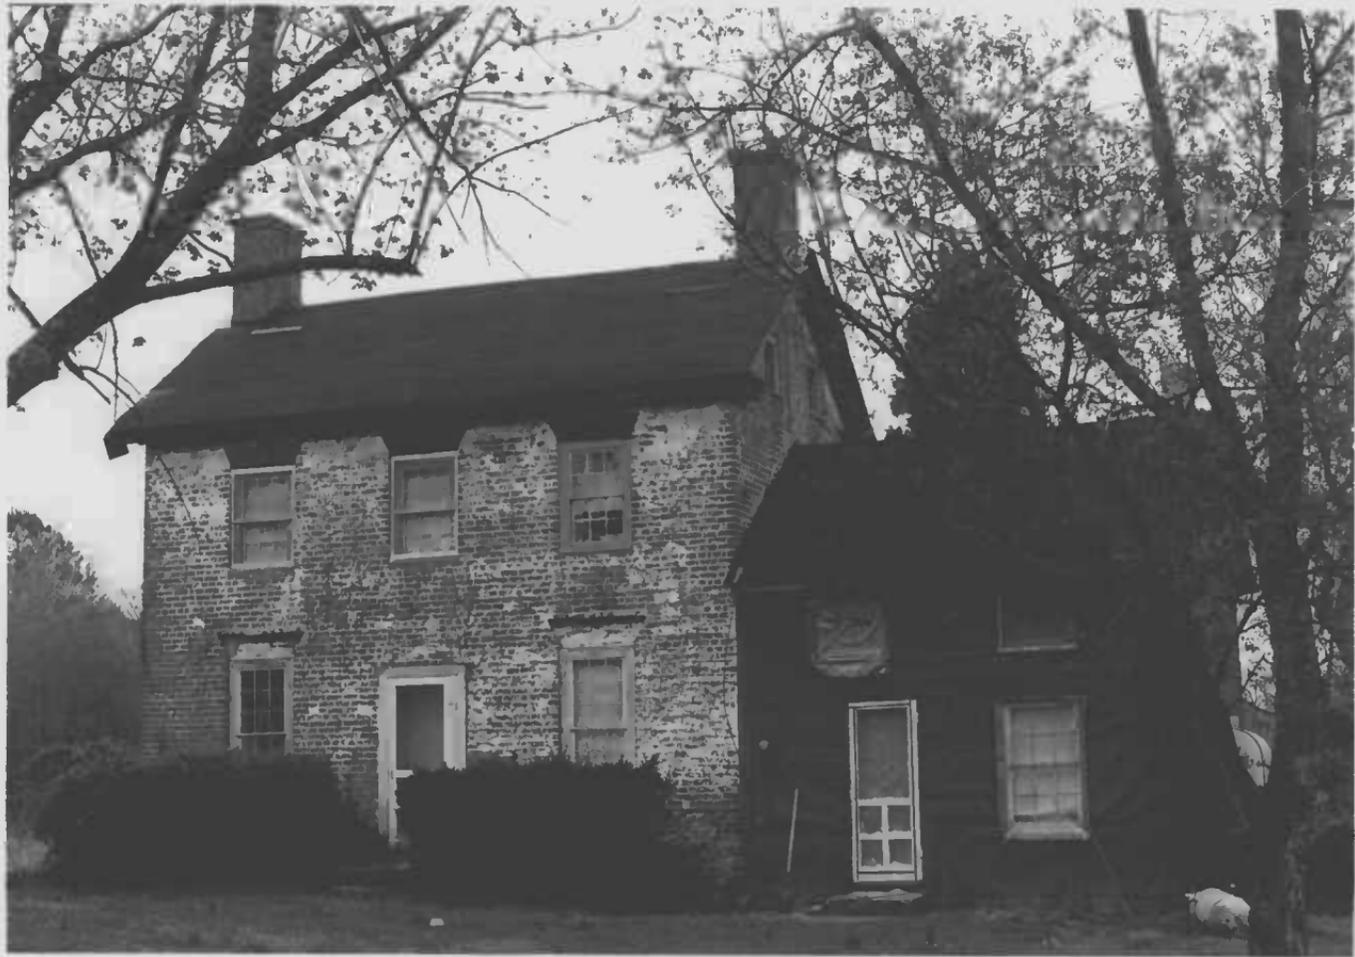
QA-81

The rear or north facade is similar to the front facade, with a center door flanked by 9/6 windows and three 6/6 windows on the second floor. The brickwork is three-course bond above a plain watertable. The wood lintels are also gone from the openings on this facade.

Plain Dealing  
Centreville vicinity  
Orlando Ridout V 1980  
North facade

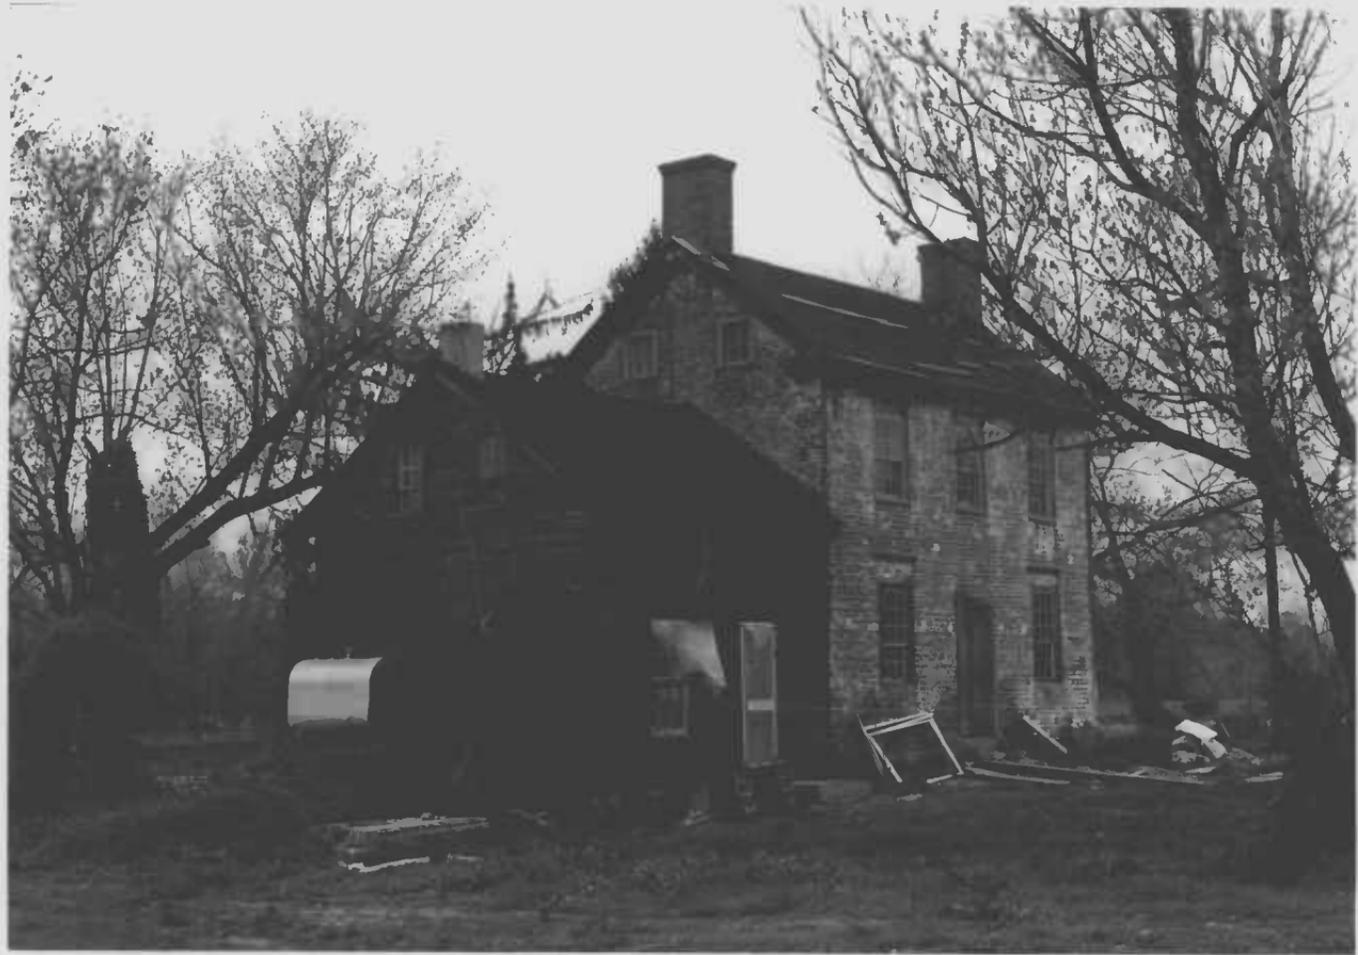
QA-81

Plain Dealing  
Centreville vicinity  
Orlando Ridout V 1980  
View from Southwest

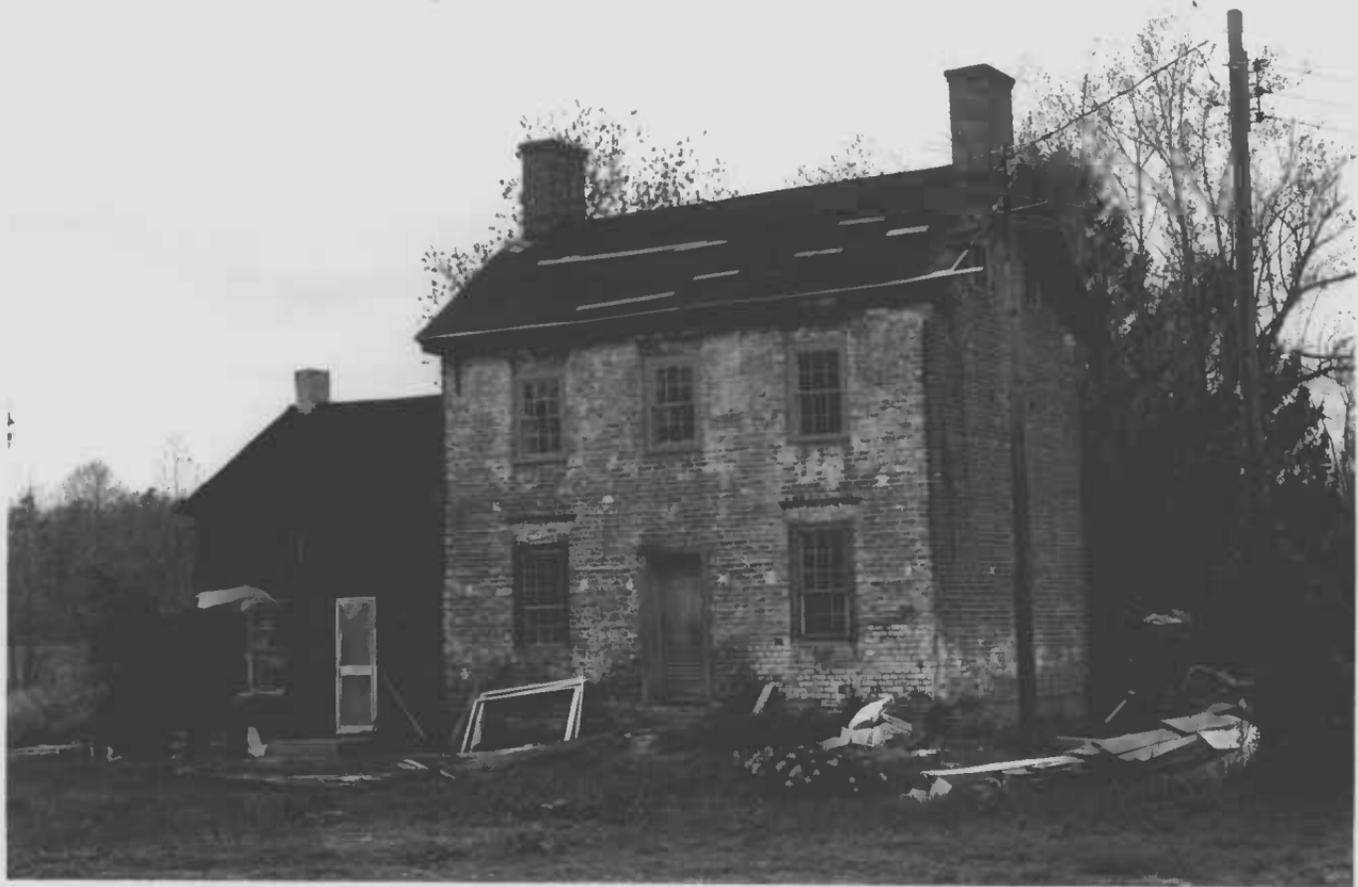
QA-81

The front facade of the original house faces south. The center door is flanked by one 9/6 window on each side; there are three 6/6 windows on the second floor. The jambs and soffit of the doorway are paneled with mid-19th century fielded panels, the 6-panel door appears to be original. Each opening was originally embellished with splayed wood lintels (presumably rusticated), but these are now gone, leaving shallow splayed recesses. The facade brickwork is laid in five-course bond above a plain watertable and three-course bond foundation. The eaves are finished

Plain Dealing  
Centreville vicinity  
Orlando Ridout V 1980  
South facade
