QA-94
Paul Ward Farm
Ruthsburg vicinity
Private

circa 1815-1830

INVENTORY FORM FOR STATE HISTORIC SITES SURVEY

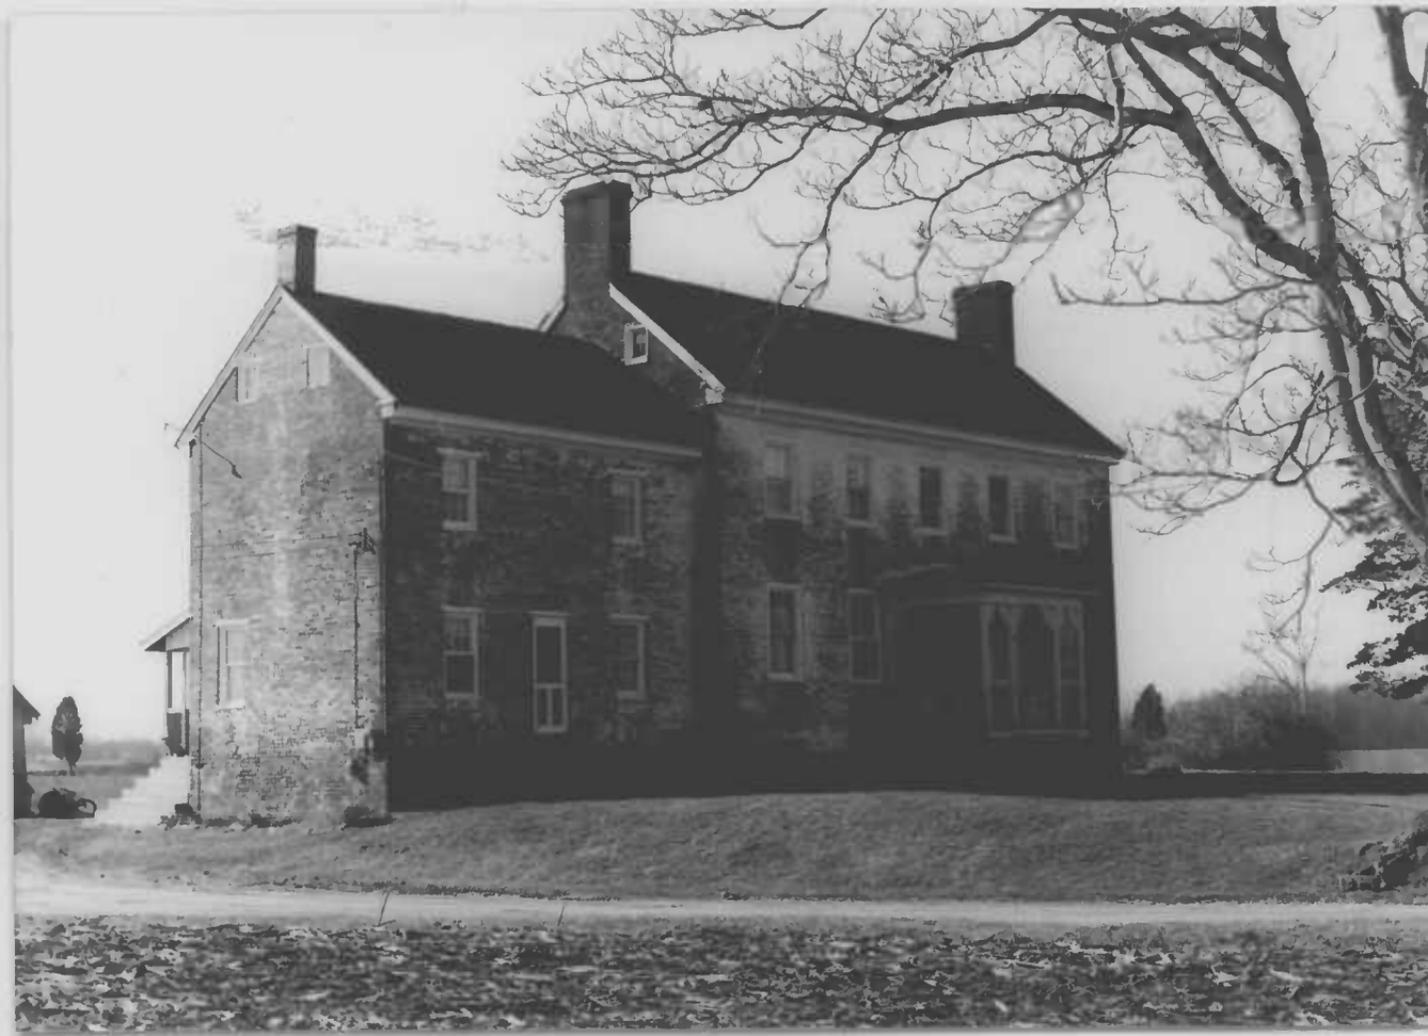
QA-94 Paul Ward Farm
Ruthsbury vicinity Md.
Orlando Ridout V, 1978 (MHT)
Front facade, camera facing SW

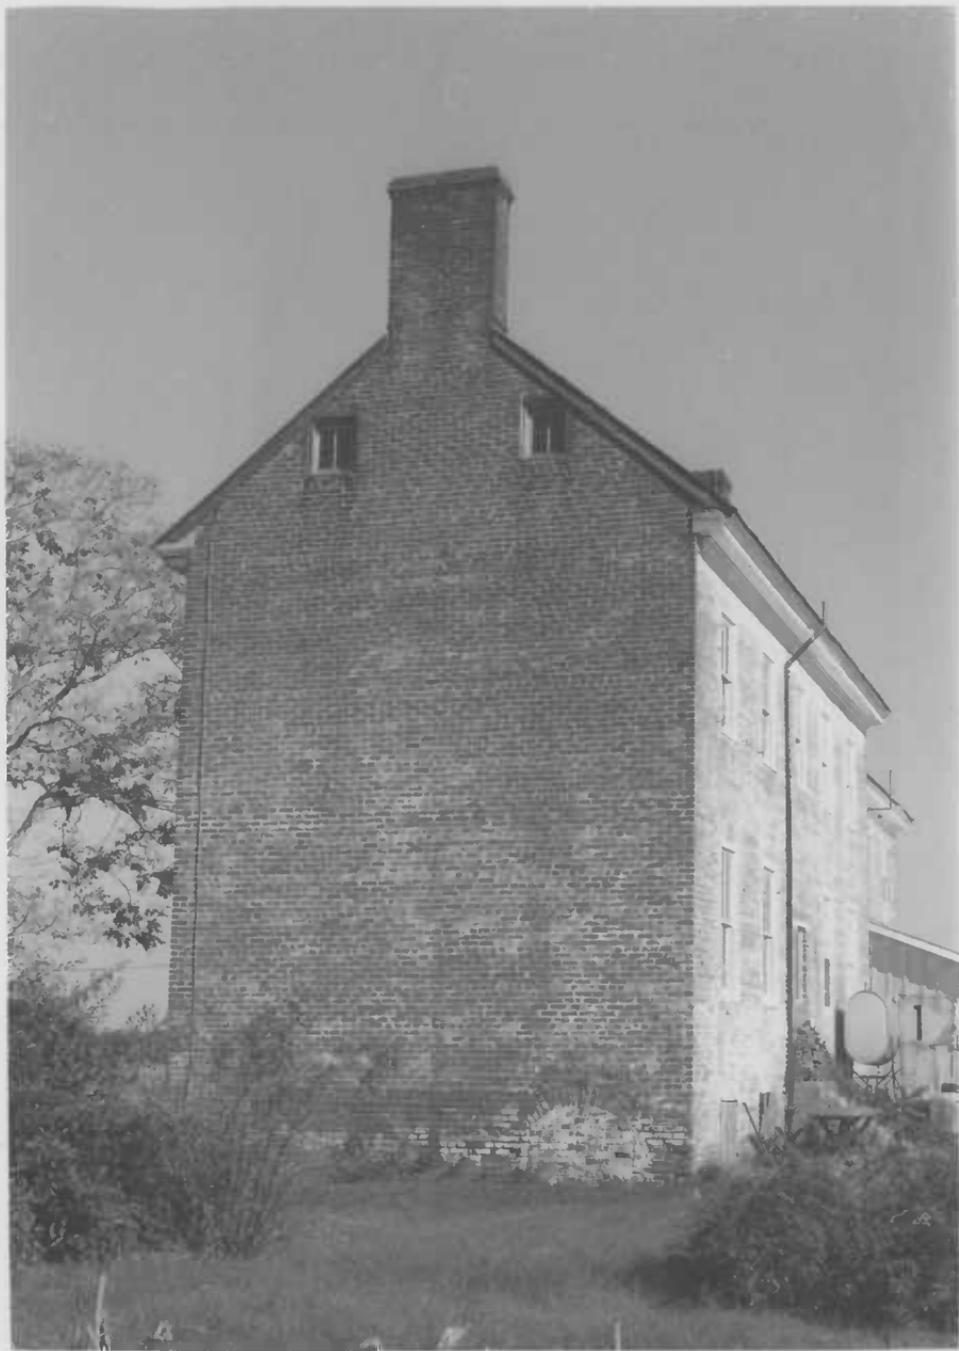
On the west gable, a blocked-up bulkhead cellar entrance with a segmental arched lintel is located in the southeast corner, and a pair of four-light windows flank the chimney in the upper gable.

QA-94 Paul Ward Farm
Ruthsburg vicinity, Md.
Orlando Ridout V, 1978 (MHT)
West Gable, camera facing East
