QA-147

Centreville Furniture Store

INVENTORY FORM FOR STATE HISTORIC SITES SURVEY

121 North Commerce Street

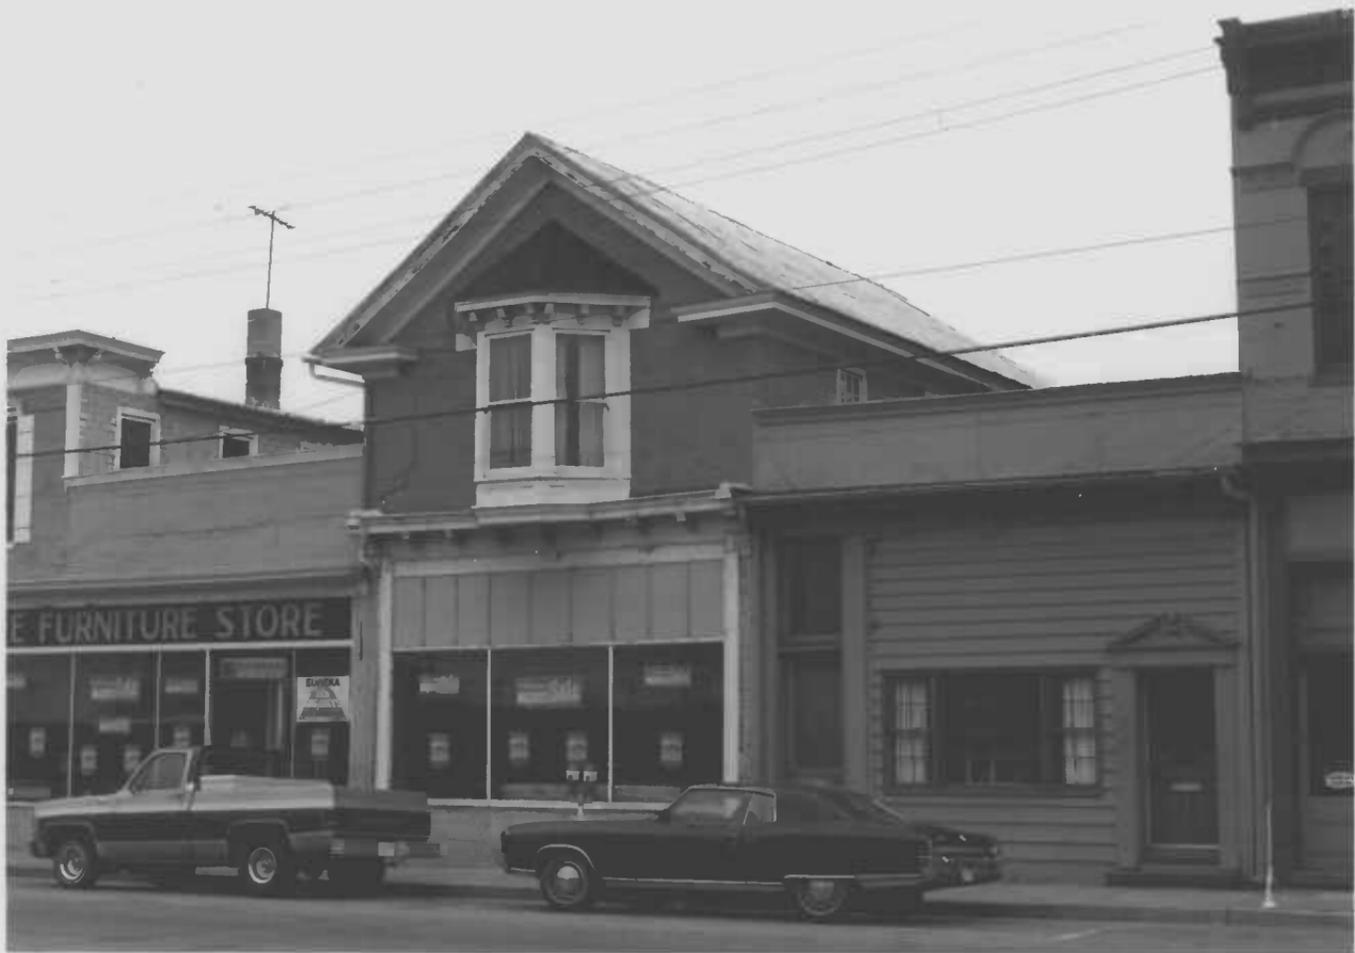
QA-147

The west gable of the main building, facing Commerce Street and the Court House, serves as the front facade. The first story of the street gable has been opened up to accommodate a large, three-part plate glass store front framed with

flat pilasters and a Victorian cornice. On the second story, two original windows have been bricked up and a semi-octagonal Victorian bay window inserted. A flush brick chimney that originally was centered on the gable has been removed, and the gable eaves are trimmed with a post-Civil War box cornice that returns at the corners. The surviving original brickwork on the second floor is laid in Flemish bond, and the original window openings have splayed jack arches. A two-course belt course crosses the gable at the second floor eave level.

Centreville Furniture Store
Centreville, Maryland
Orlando Ridout V 1980
Front gable wall, from west

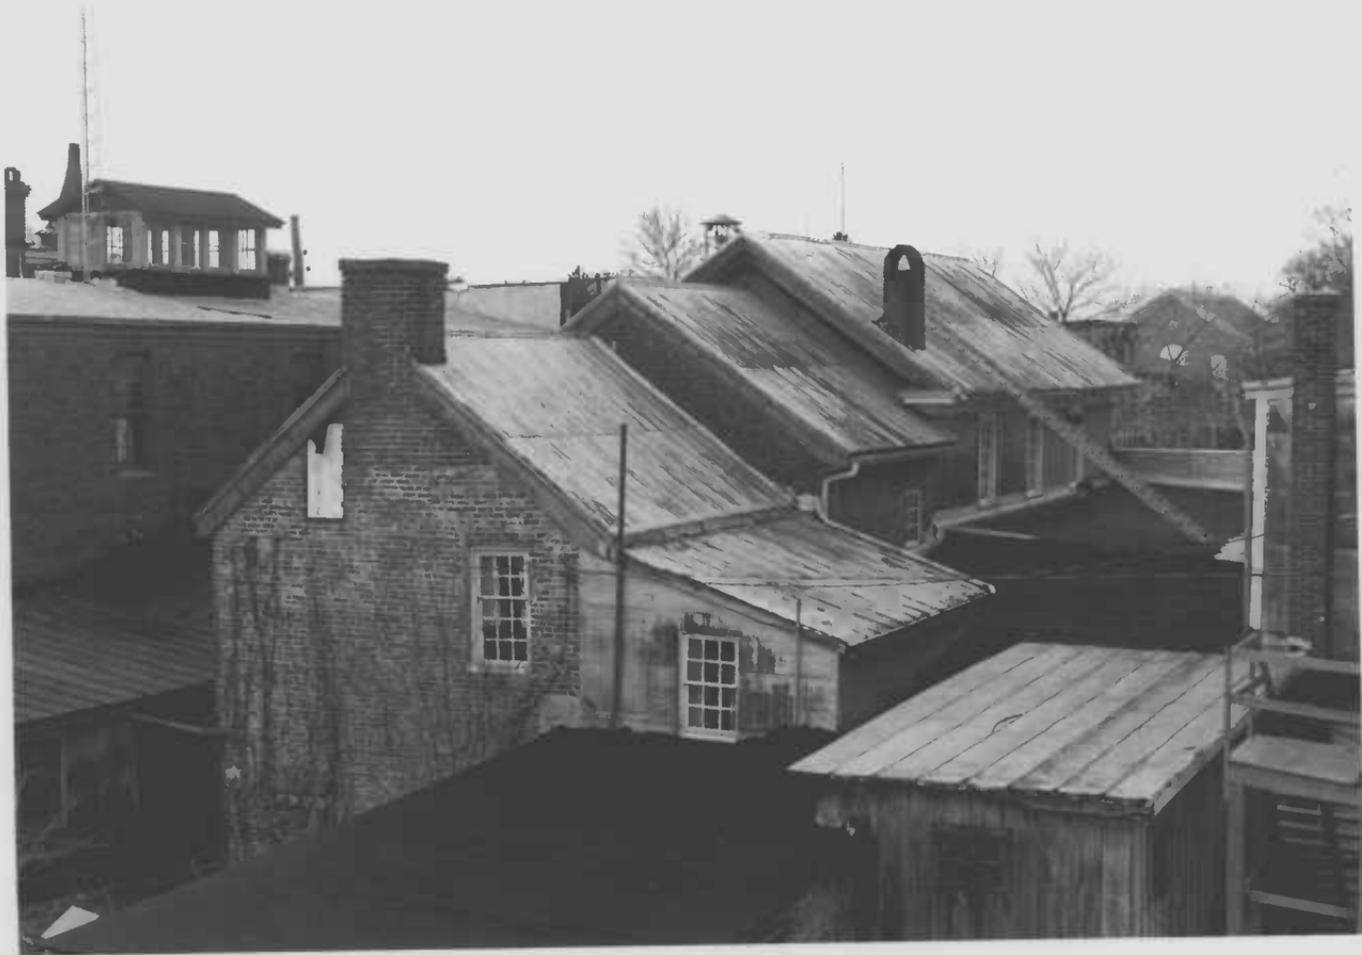
The smaller wing to the rear of the dwelling is also of brick. The south wall is laid in Flemish bond, the east gable in five-course common bond. Two large openings on the first floor of the south wall have been blocked up; two 6/6 windows survive on the second floor. On the east gable, a door in the north bay of the first story has been bricked up. Above the door, there is a 6/9 window, and to the left of center in the upper gable a 4/4 window has been blocked. The gable eaves are fitted with replaced rakeboards. On the south facade the eaves are finished with a box cornice.

QA-147 Centreville Furniture Store
 Centreville, Maryland
 Orlando Ridout V 1980
 Rear view from East
