QA-191A

Poplar Grove Quarter
Burrisville vicinity
Private

INVENTORY FORM FOR STATE HISTORIC SITES SURVEY

Poplar Grove Quarter, Brampton

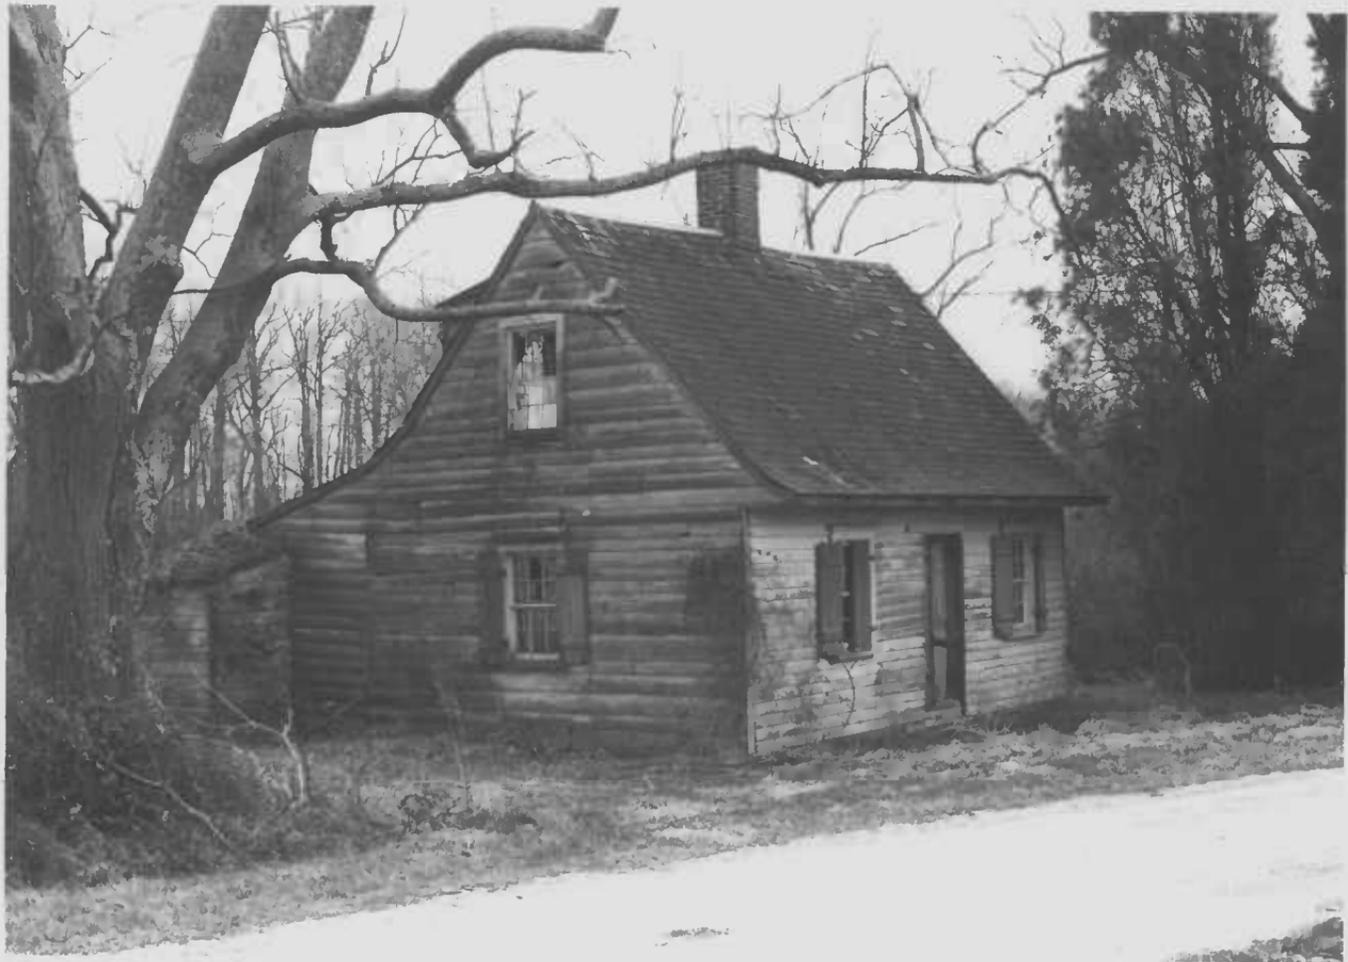
QA-191A Poplar Grove Quarter
Centreville vicinity
Orlando Ridout V 1981
View from Northeast

The building known as the Quarter is of frame construction, one-and-one-half stories high, three bays wide, and one room deep, with a small brick chimney centered on the ridge of the pitched gable roof. The building has been extensively altered over the years, and all that survives of the original structure is the timber frame.

The front facade faces north to the driveway, with a center door flanked by 6/6 windows on the first floor and no openings on the roof. The horizontal weatherboards are 20th century, and the picturesque bell-curve eave to the roof is a 20th

The east gable wall is pierced by single 6/6 windows centered on the first and second floor, and is covered with plain horizontal weatherboards secured with machine nails.
