QA-232
Sudlersville Bank
Sudlersville

1913

INVENTORY FORM FOR STATE HISTORIC SITES SURVEY

Sudlersville Bank

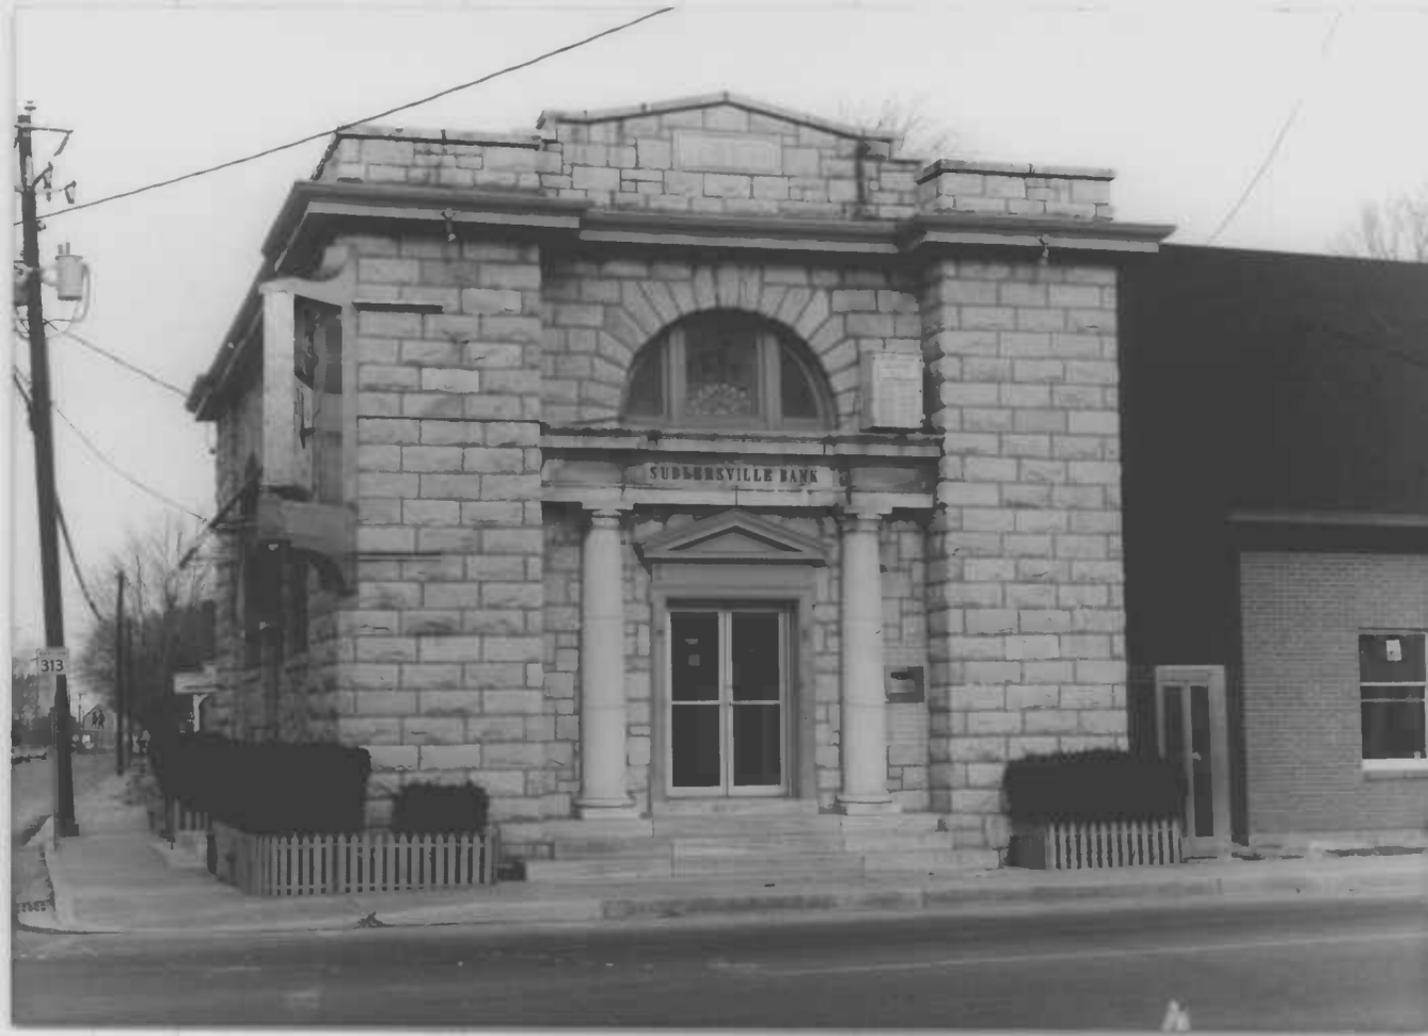
Q4-232

The old bank faces south, across Route 300, but because of the corner site, there is a prominent secondary entrance on the west facade, facing Route 313. The building is constructed of dressed ashlar with the faces of the blocks left rough. The wall surfaces are relieved by dividing each wall into three units, with the corners expressed by breaking forward, and the center section of the wall recessed. Horizontal unity is increased by a plain water table near ground level and a bold cornice about 18 inches below the top of the building. The top of the walls are terminated by a flat stone drip cap.

facade, and is accentuated by an ornate crossetted surround surmounted by a pediment and flanked by a handsome pair of engaged stone columns which in turn support a carefully dressed stone cornice. This cornice is located directly above the door pediment, and only extends across the recessed entrance area. Above the stone cornice is a large semi-circular leaded glass window with a dressed stone extrados. The window is divided into three parts by vertical mullions, and the leaded glass forms a radiating fan of clear glass accentuated by a very simple band of colored glass. Directly above this window is the bold wood cornice that encircles the building. In the center of the upper wall, above the main cornice, is a rectangular datestone, on which the date "1913" is inscribed.
