QA - 372  
Church Hill Store and House  
Church Hill  
Private

INVENTORY FORM FOR STATE HISTORIC SITES SURVEY

Church Hill Store and House

Michael O. Bourne, Historic Sites Surveyor

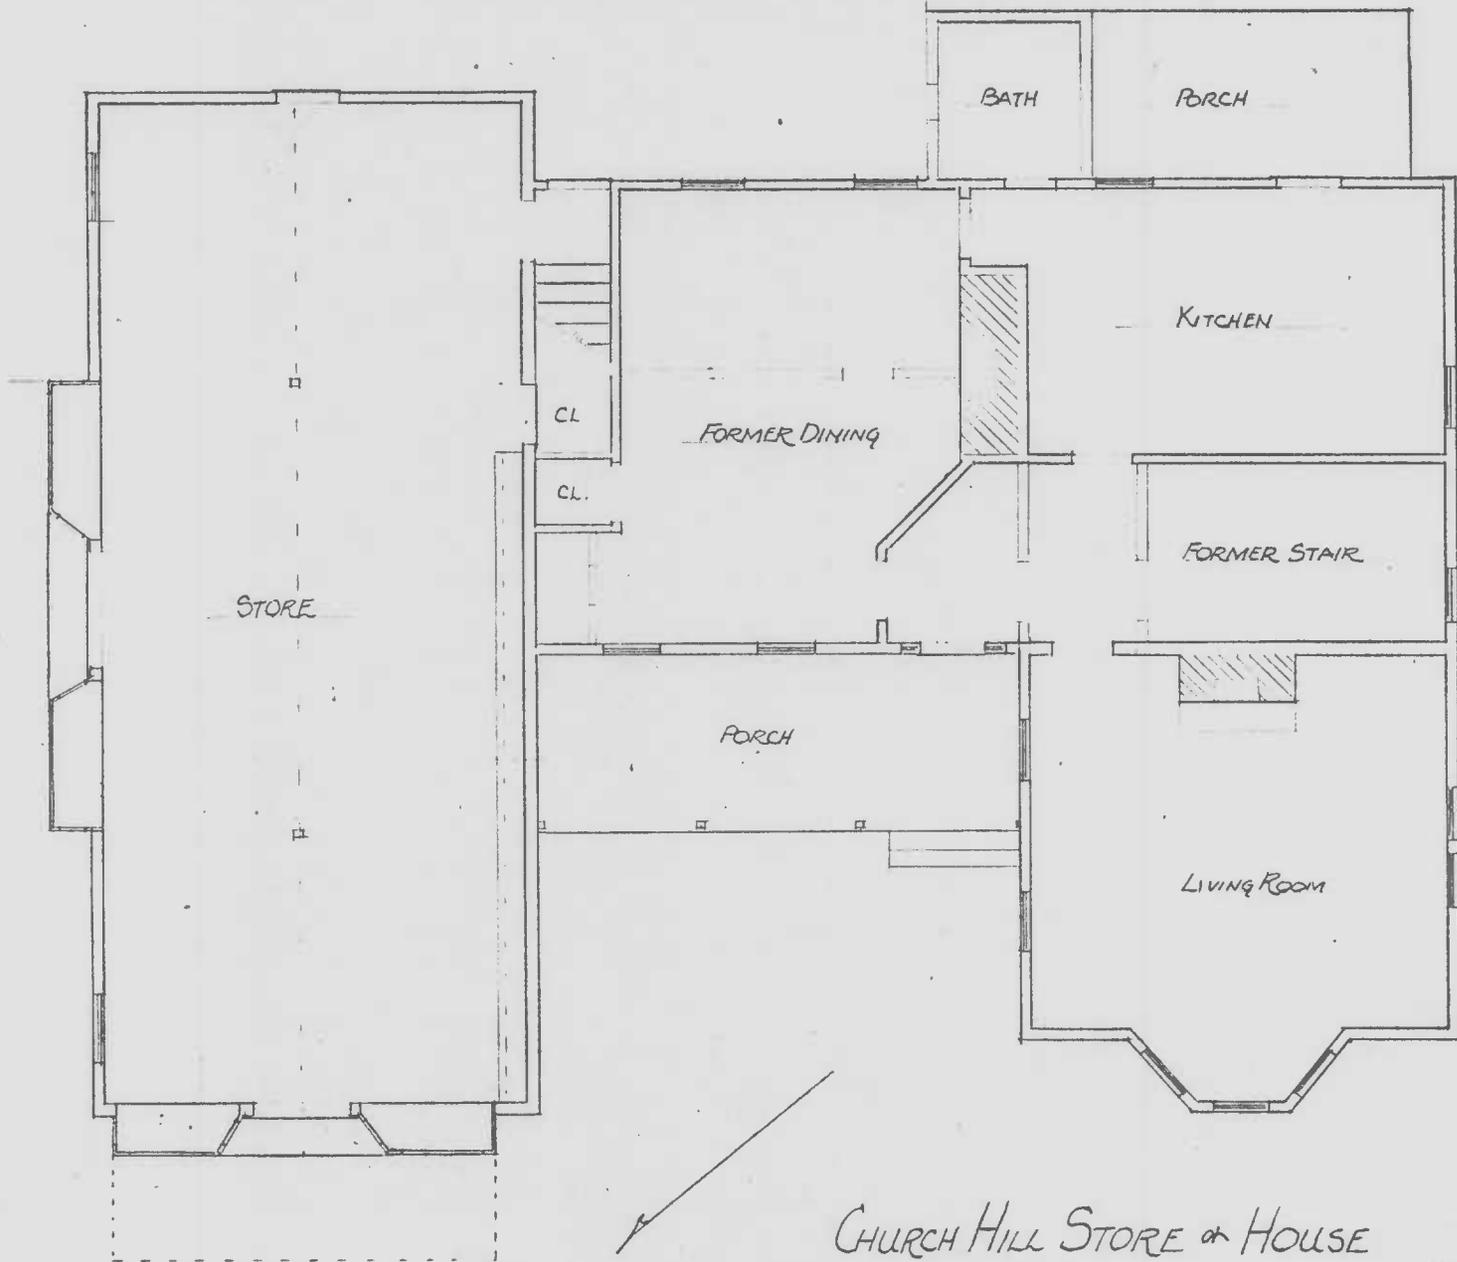
FIRST FLOOR PLAN - SCALE - 1/8" = 1'-0"

The plan of the house is now cut up into apartments, but the original plan consisted of an entry and stair hall with dining room off the entry and kitchen and living room off the stair hall. Since the stair was removed when the building was made into apartments, the only remaining element of distinction is the mantel in the living room. It is a buffet-type mantel with turned supports holding the principal shelf. Above the shelf are two other tiers of shelves with beveled mirrors behind each section. The cornice has carved floral detail within interlocking

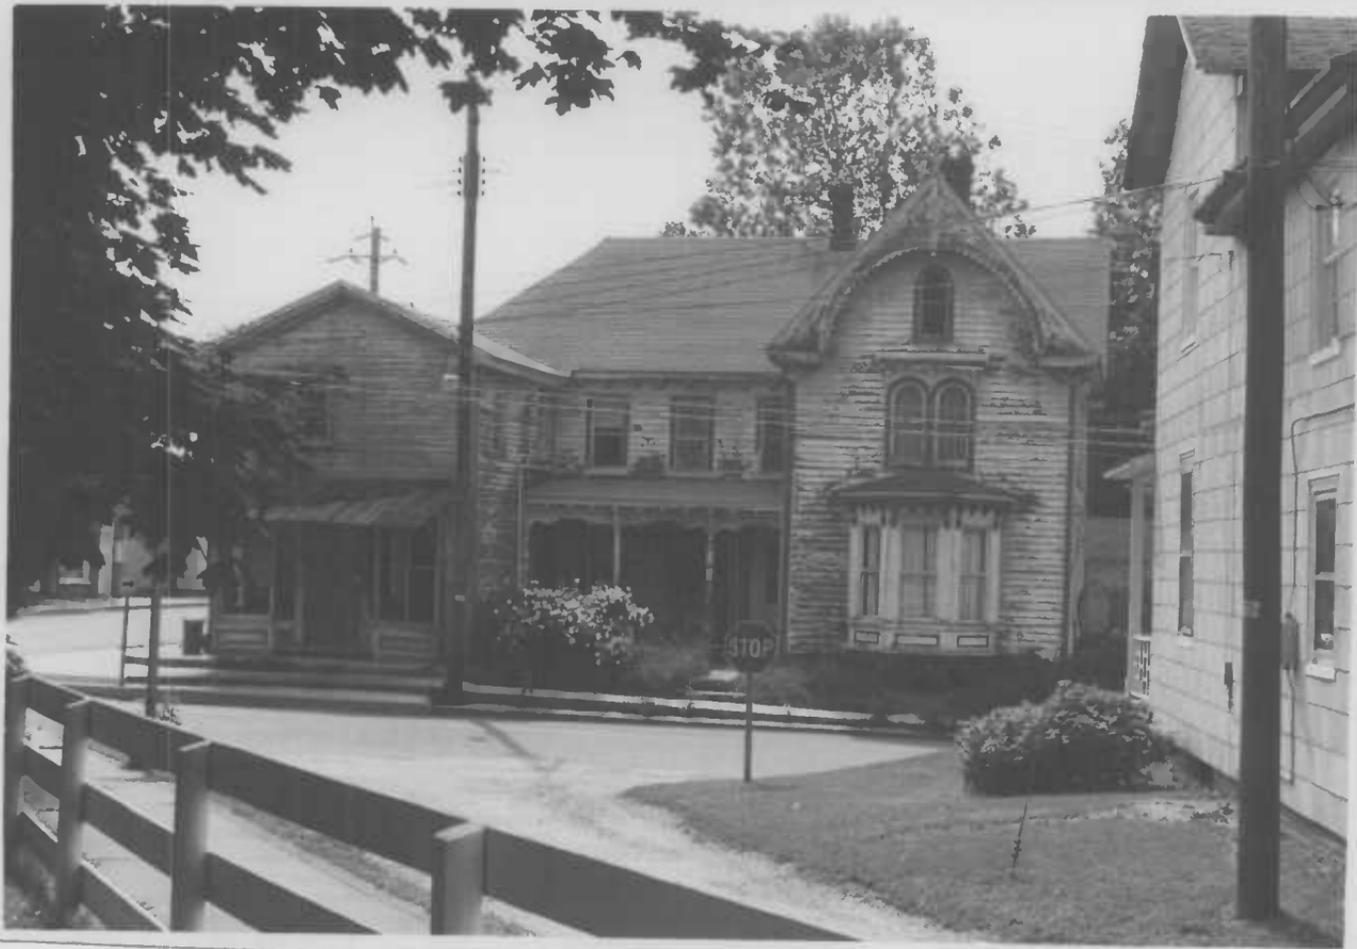
QA-372 House and Store  
Church Hill  
West

The northwest facade has only a store window on the first story which is identical to the other window in every detail, only narrower. The original awning has chamfered structural members and exposed beaded dado or decking. Between the cornice and the diagonal pipe support is a row of the same type squiggly scallop as found on the northeast windows. There is one window, off-center, on the second story.

Part of the southwest side, about 15', has beaded weatherboard over its first story. Its foundation is taller than the other part of the store and is exposed inside, behind the shelves. These weatherboards are fastened with cut nails.

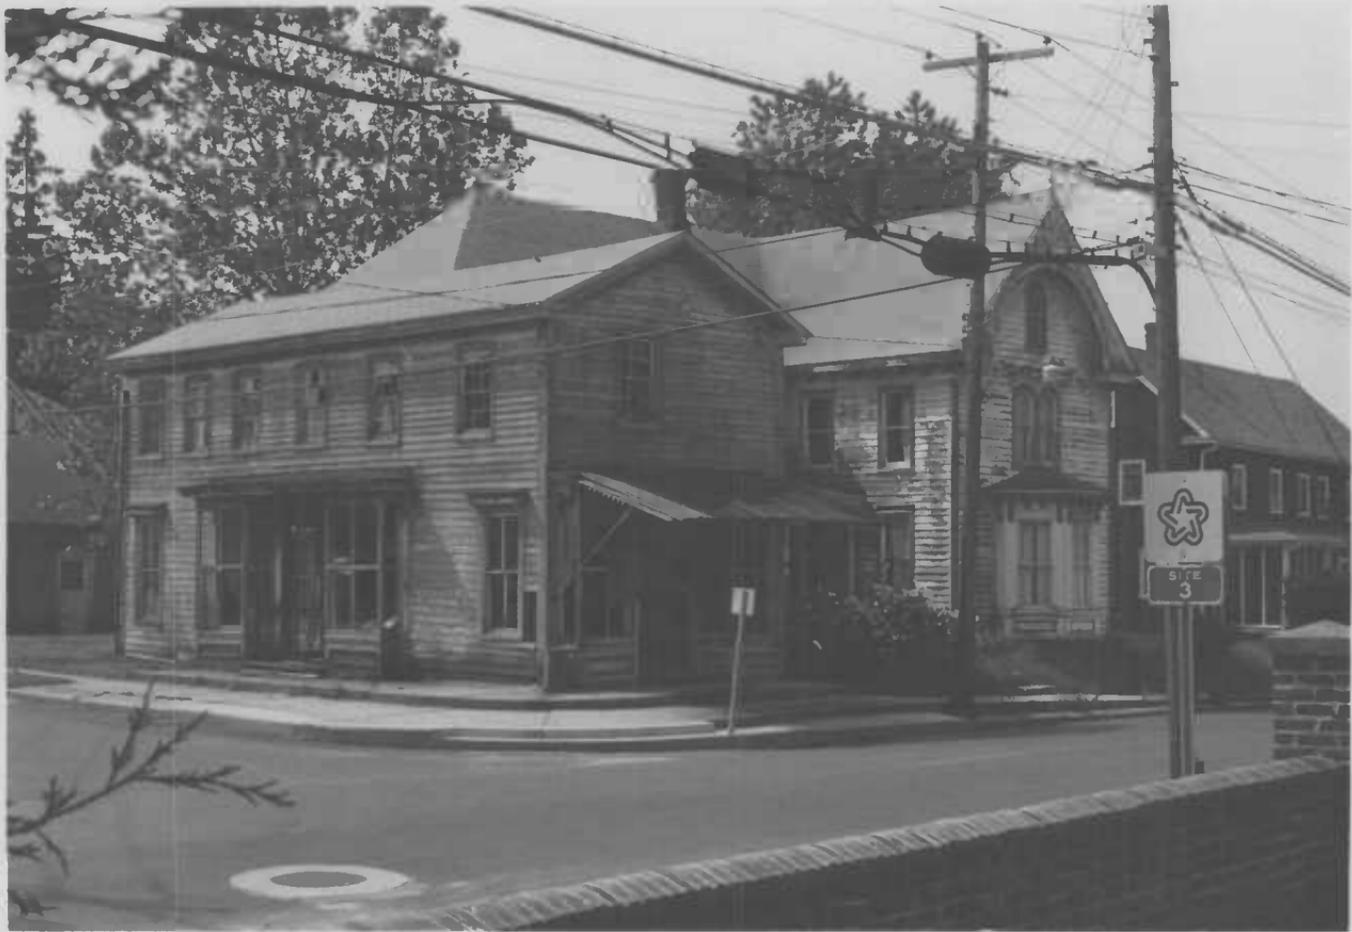
QA-372 House and Store  
Church Hill  
Northwest

The north facade has a wide store window with central entrance and two flanking windows. The store window has 4 large panes on the front and two panes where it projects from the plane of the building. Beneath the windows are panels surrounded by bold bolection molding. The same panels are at the bottoms of the double doors. The doors have two glass panes each and there is a two pane transom above. In the soffit above the doors is a panel. Flanking each window is a large bracket beneath the projecting cornice. The crown molding is broken where the wood awning originally hung. (The original awning exists on the northwest facade). Flanking the store front are two windows with overhanging cornices supported on two brackets. A squiggly scallop design hangs from the cornice. Both windows have 2/2 sash.
