**MARYLAND HISTORICAL TRUST
DETERMINATION OF ELIGIBILITY FORM**

Property Name: Hemsley's Fortune Inventory Number: QA-377

INVENTORY FORM FOR STATE HISTORIC SITES SURVEY

Hemsley's Fortune

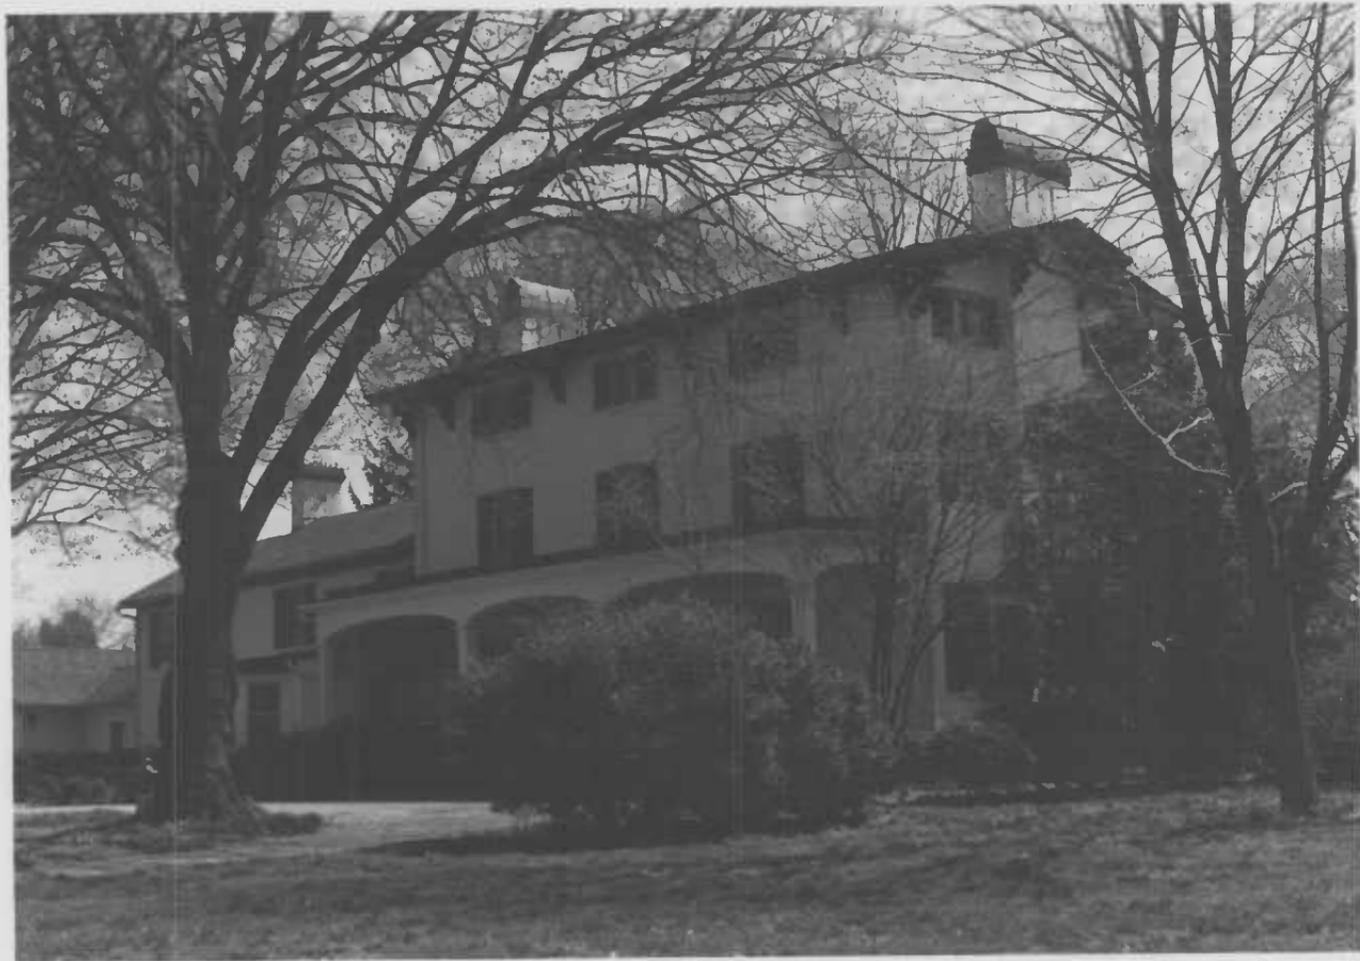
QA-377

Hemsley's Fortune
Queenstown vicinity
Orlando Ridout V 1980
Northwest facade

The northwest facade is similar to the front facade, but the brickwork on the first floor is English bond to the left of the center door and three-course bond to the right of the door. On the second and third floor it is laid in five-course bond. The entrance door is not as elaborate as the door on the southeast facade, otherwise the fenestration is identical. The contrasting brickwork on the first floor is puzzling, but is probably evidence of a major repair, or could be further evidence of a mid-19th century fire.

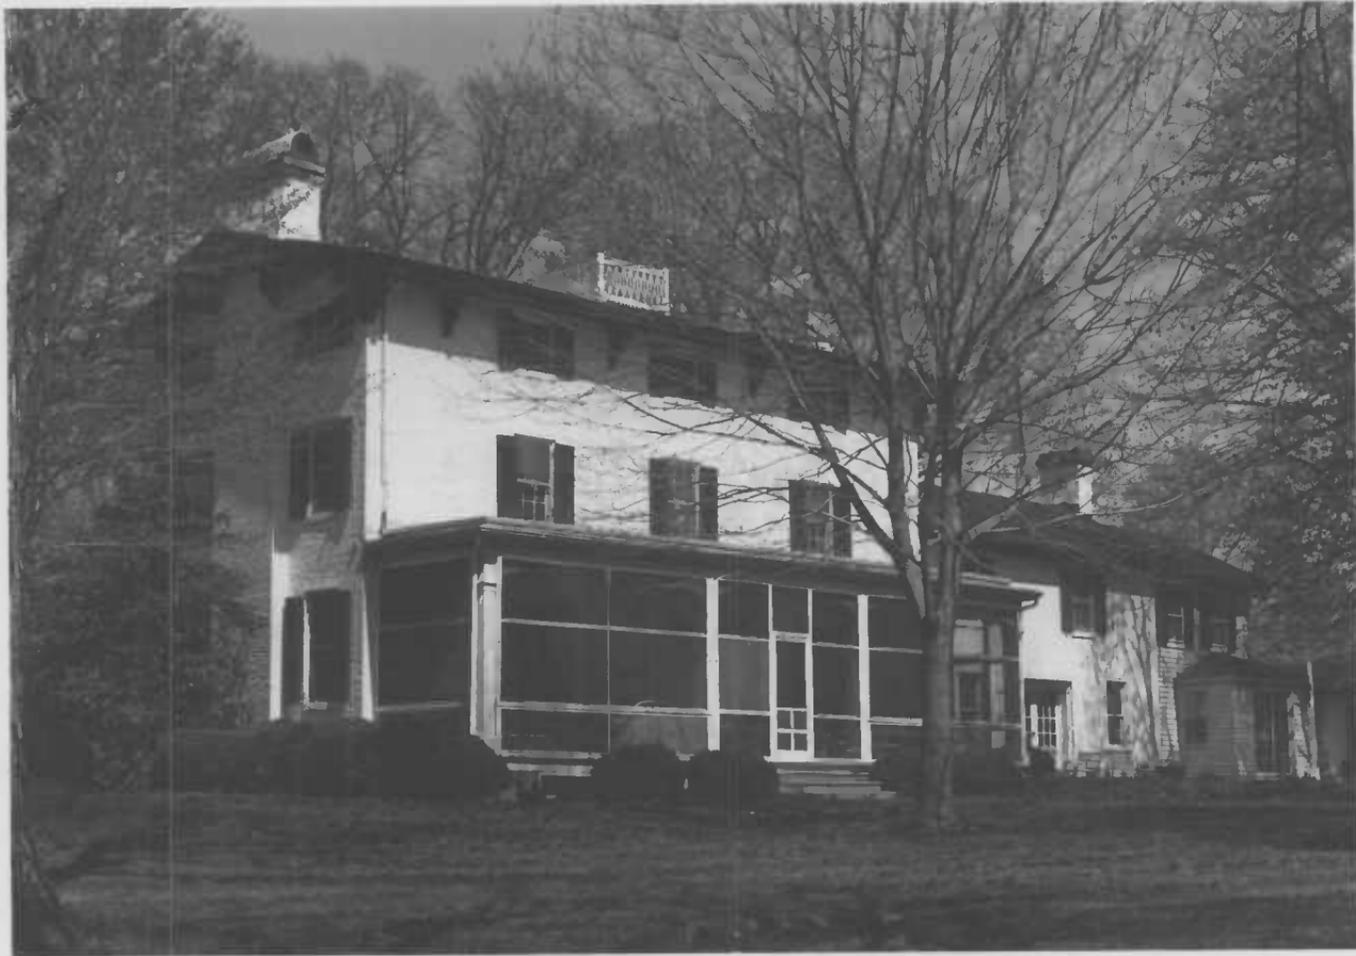
QA-377

Southeast facade

Despite the extent of later alterations, a close examination of the building reveals considerable detail of interest. The southeast facade was evidently the principal facade, with glazed header Flemish bond above a plain water table. The central entrance is now fitted with an elaborate mid-19th century surround, a paneled door, sidelights and a transom. The door is flanked by a single six-over-six window on each side. Oddly enough, these window openings do not have any visible form of arched or reinforced lintel. The second and third stories are laid in five-course bond using smoother, 19th century brick. There are three six-over-six windows on the second floor, and three smaller windows fitted with paired two-light casements on the third floor. The low-pitched gable roof is set off with a heavy bracketed

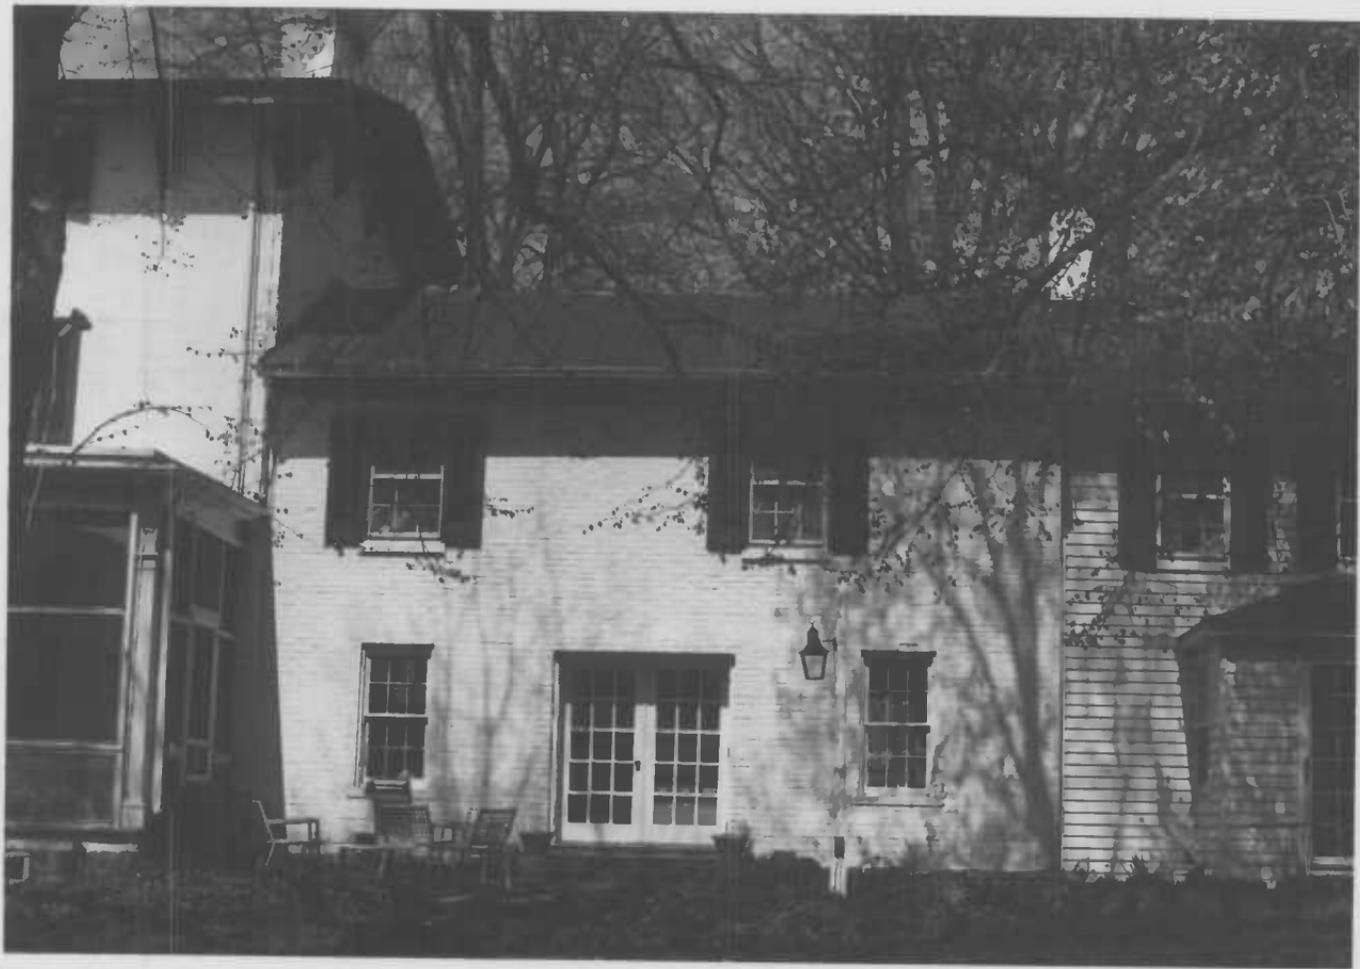
QA-377

Hemsley's Fortune
Queenstown vicinity
Orlando Ridout V 1980
Southeast facade of early
section

The southeast facade is laid in glazed header Flemish bond above a plain watertable. The first floor openings have all been altered, and now consist of double glass doors in the center bay flanked by six-over-six windows. It is unclear when these windows were installed, but the openings have been

reworked. On the second floor, there are two asymmetrically placed six-over-six windows which do not show evidence of alterations. The northeast gable of the wing is almost entirely covered by a frame addition. The southwest bay of the northwest or rear facade is also covered on the first floor by a modern addition. The exposed portion of the facade is laid in three-course bond on the first floor, with Flemish bond on the second floor. The first floor openings have been altered on this facade as well, and now include a center door with a single six-over-six window to the left. Evidence of an earlier door opening is visible to the left of the existing door, and the window opening has been reworked. There are two six-over-six windows on the second floor, placed asymmetrically as on the front facade. The eaves are finished on both facades with a box cornice, and the roof is covered with asphalt shingles.
