INVENTORY FORM FOR STATE HISTORIC SITES SURVEY

Turner Farm

Crouse Farm

Crouse Mill Road at the head waters of Tuckahoe Creek
(Tuckahoe State Park)

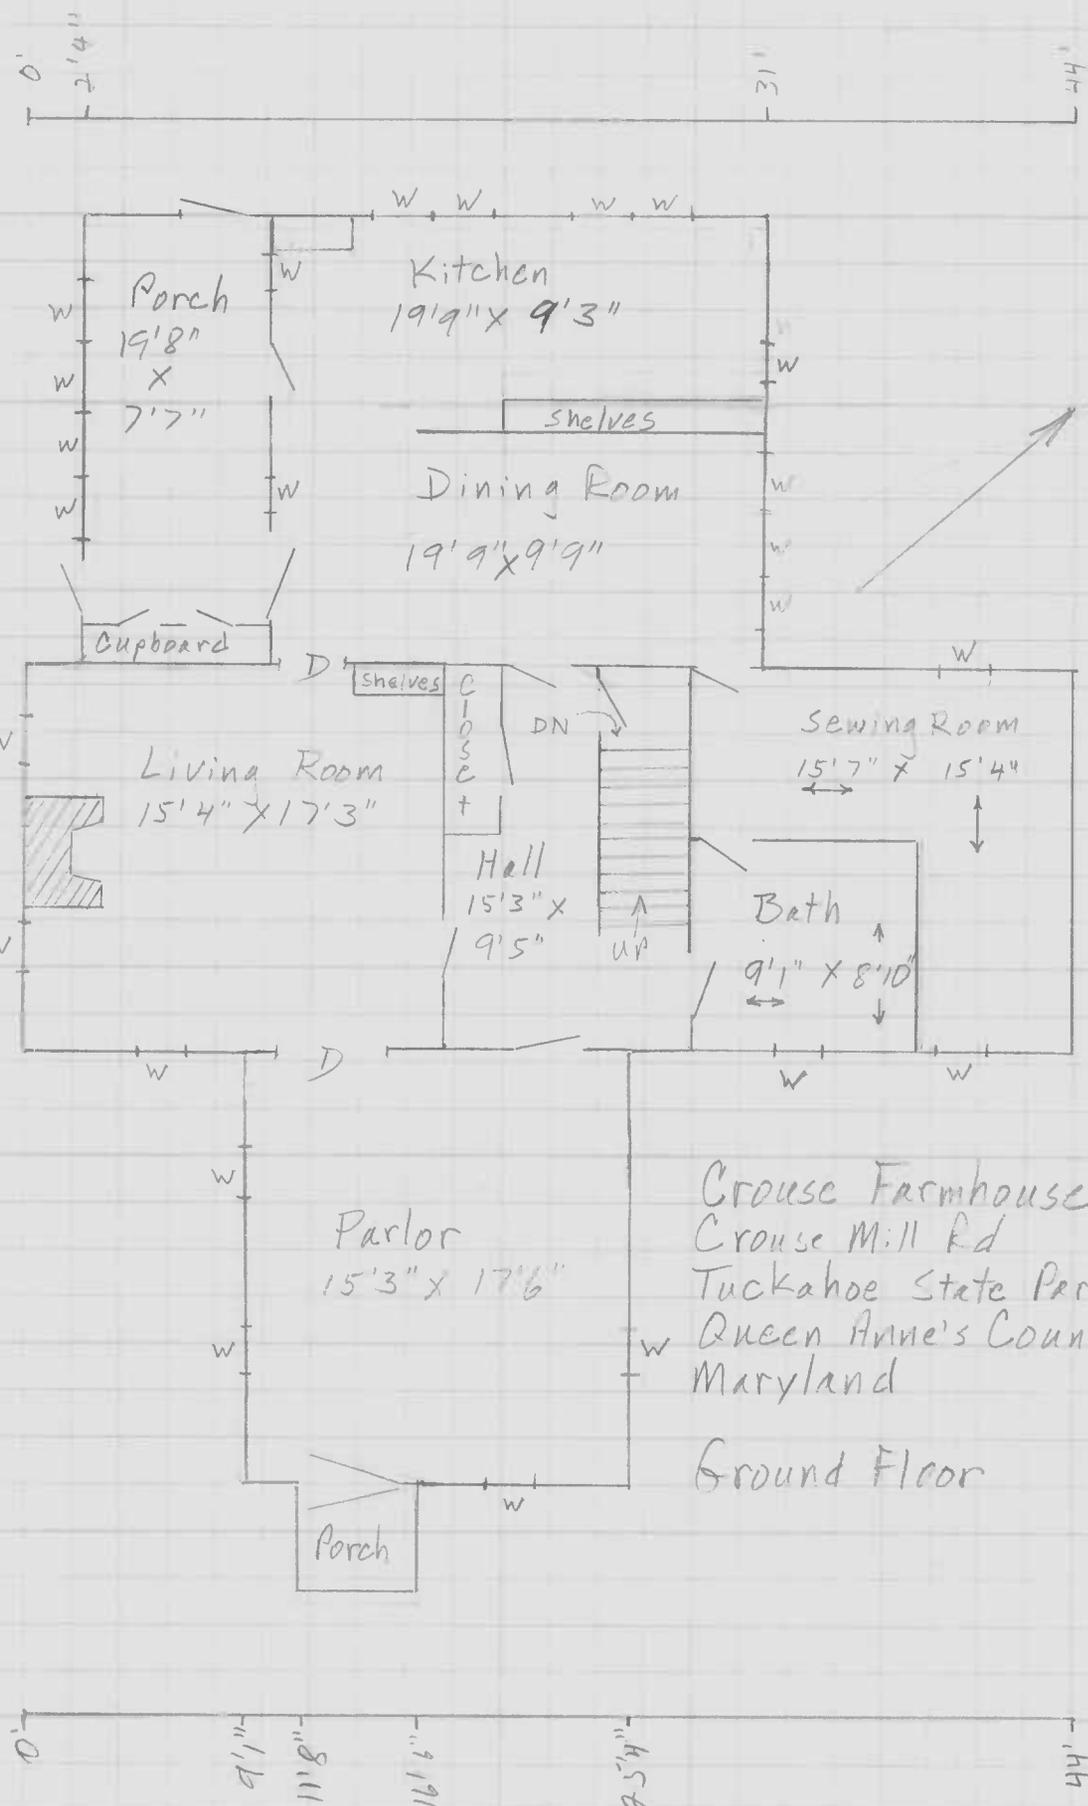
Dairy is 10'3" x 10'0"
(10'3" x 10'3")

Wash House is 20'1" x 12'2"

Crouse Farmhouse (QA-380)
Crouse Mill Rd
Tuckahoe State Park
Queen Anne's County
Maryland
Ground Floor

Exterior Scale: 1/8" = 1'

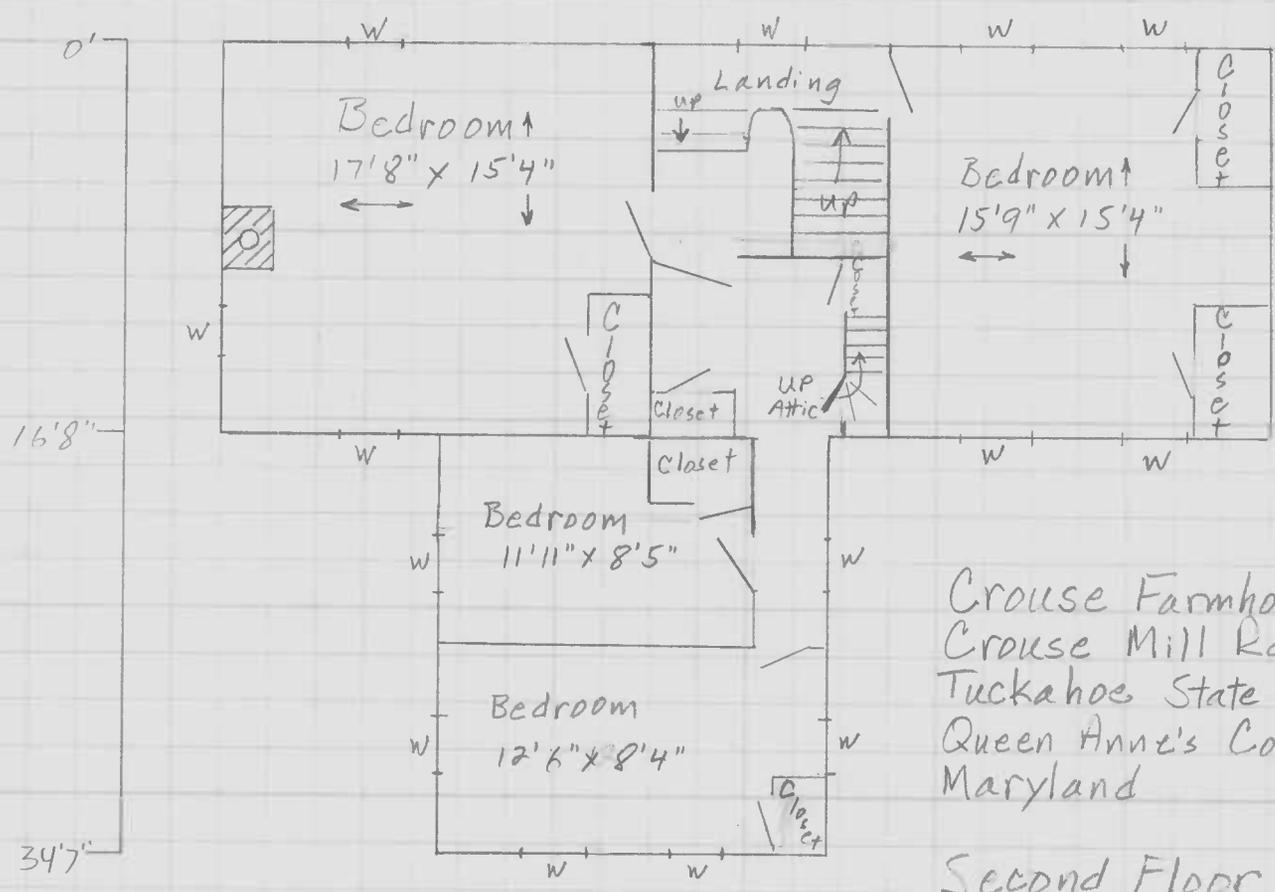
Second Floor

Crouse Farmhouse
Crouse Mill Rd.
Tuckahoe State Park
Queen Anne's County
Maryland

Exterior Scale : 1/8" = 1'

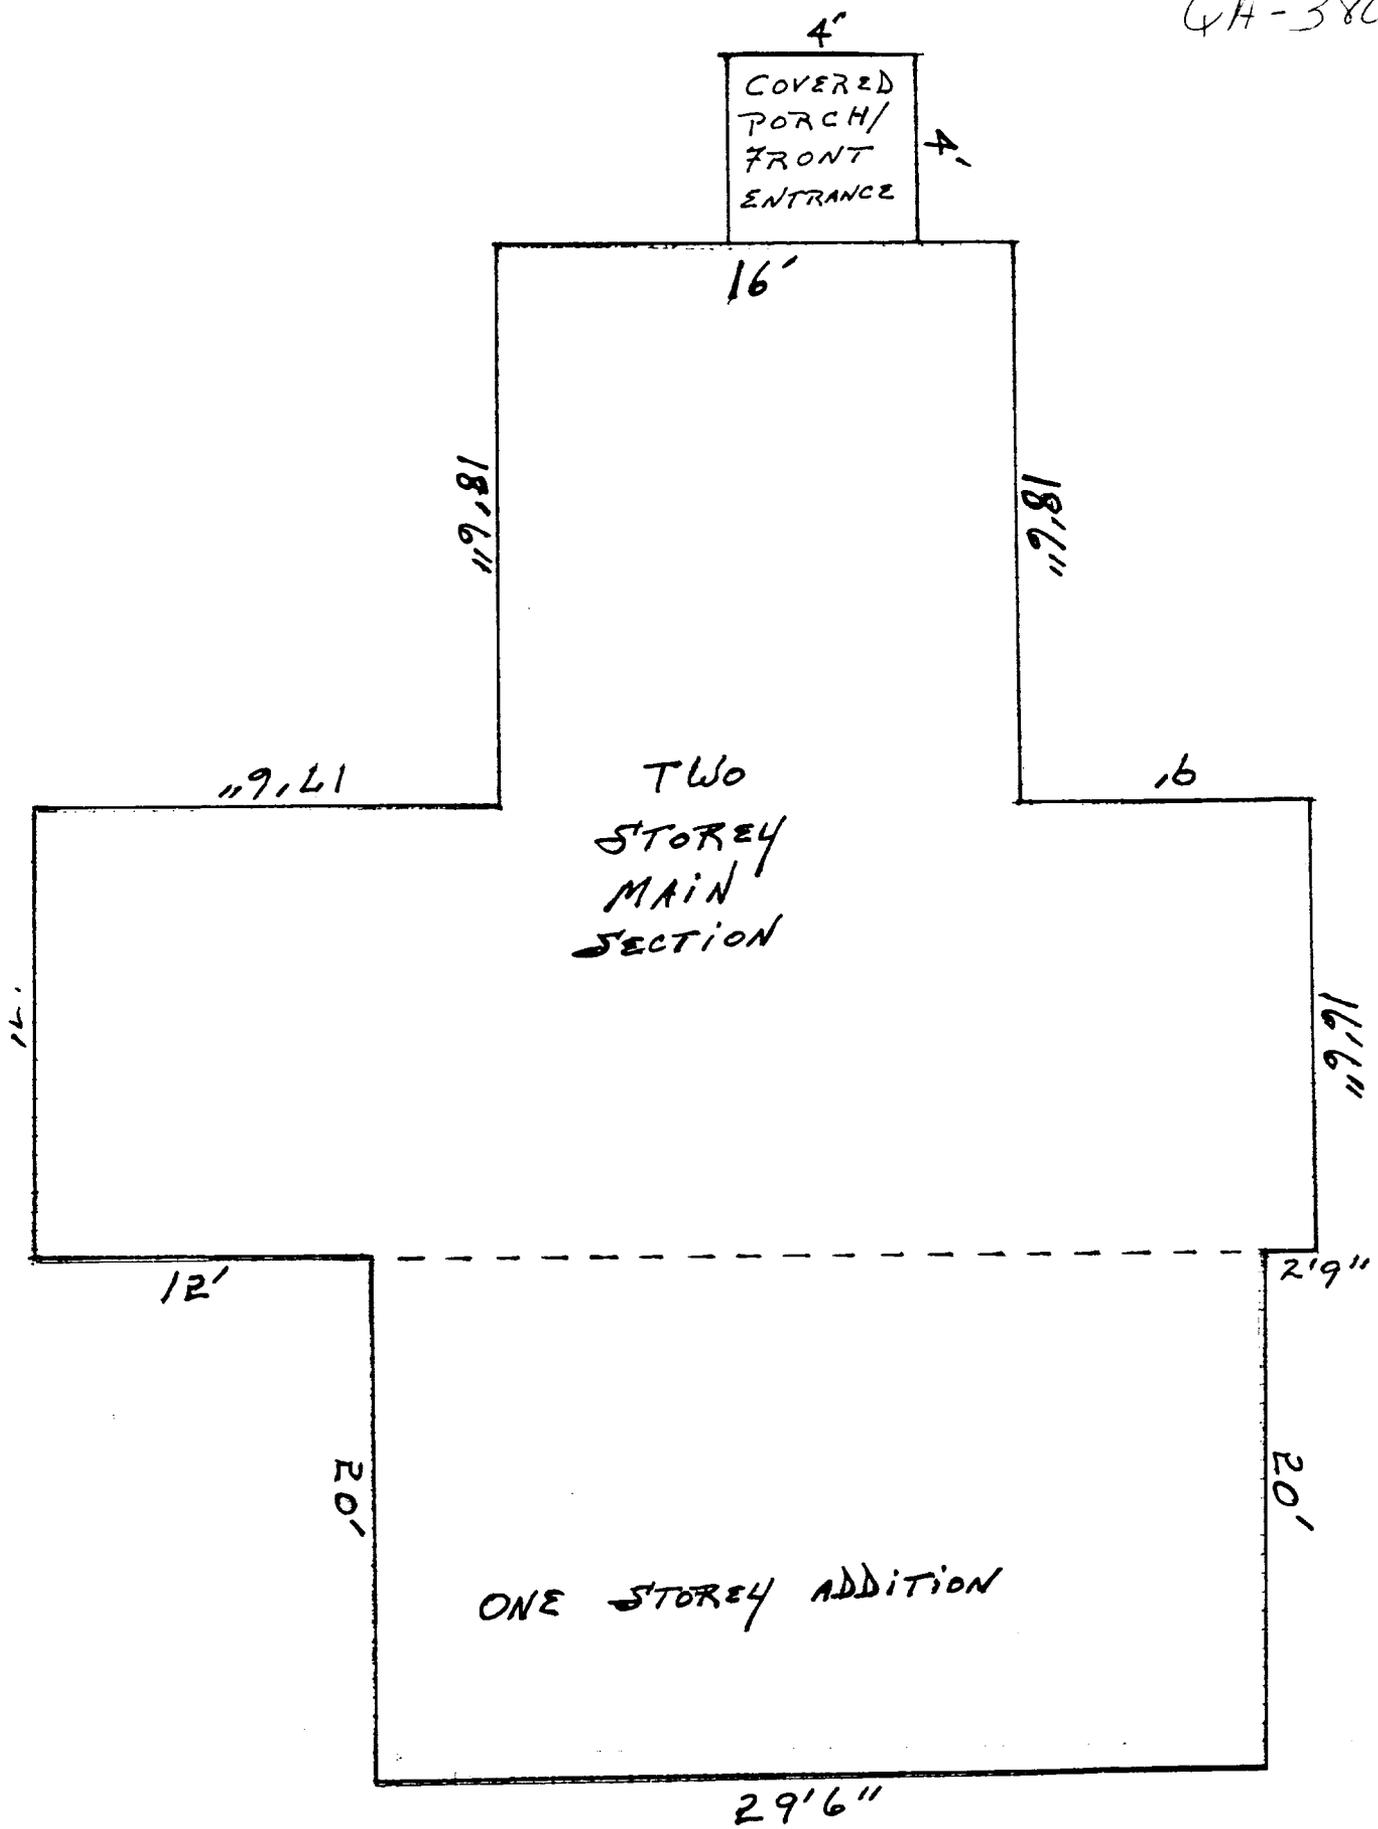
EXTERIOR
 CROUSE FARM HOUSE, TUCKAHOE STATE PARK
 QUEEN ANNE'S COUNTY

SECOND FLOOR INTERIOR

CROUSE FARM HOUSE, TUCKAHOE STATE PARK, QUEEN ANNE'S COUNTY

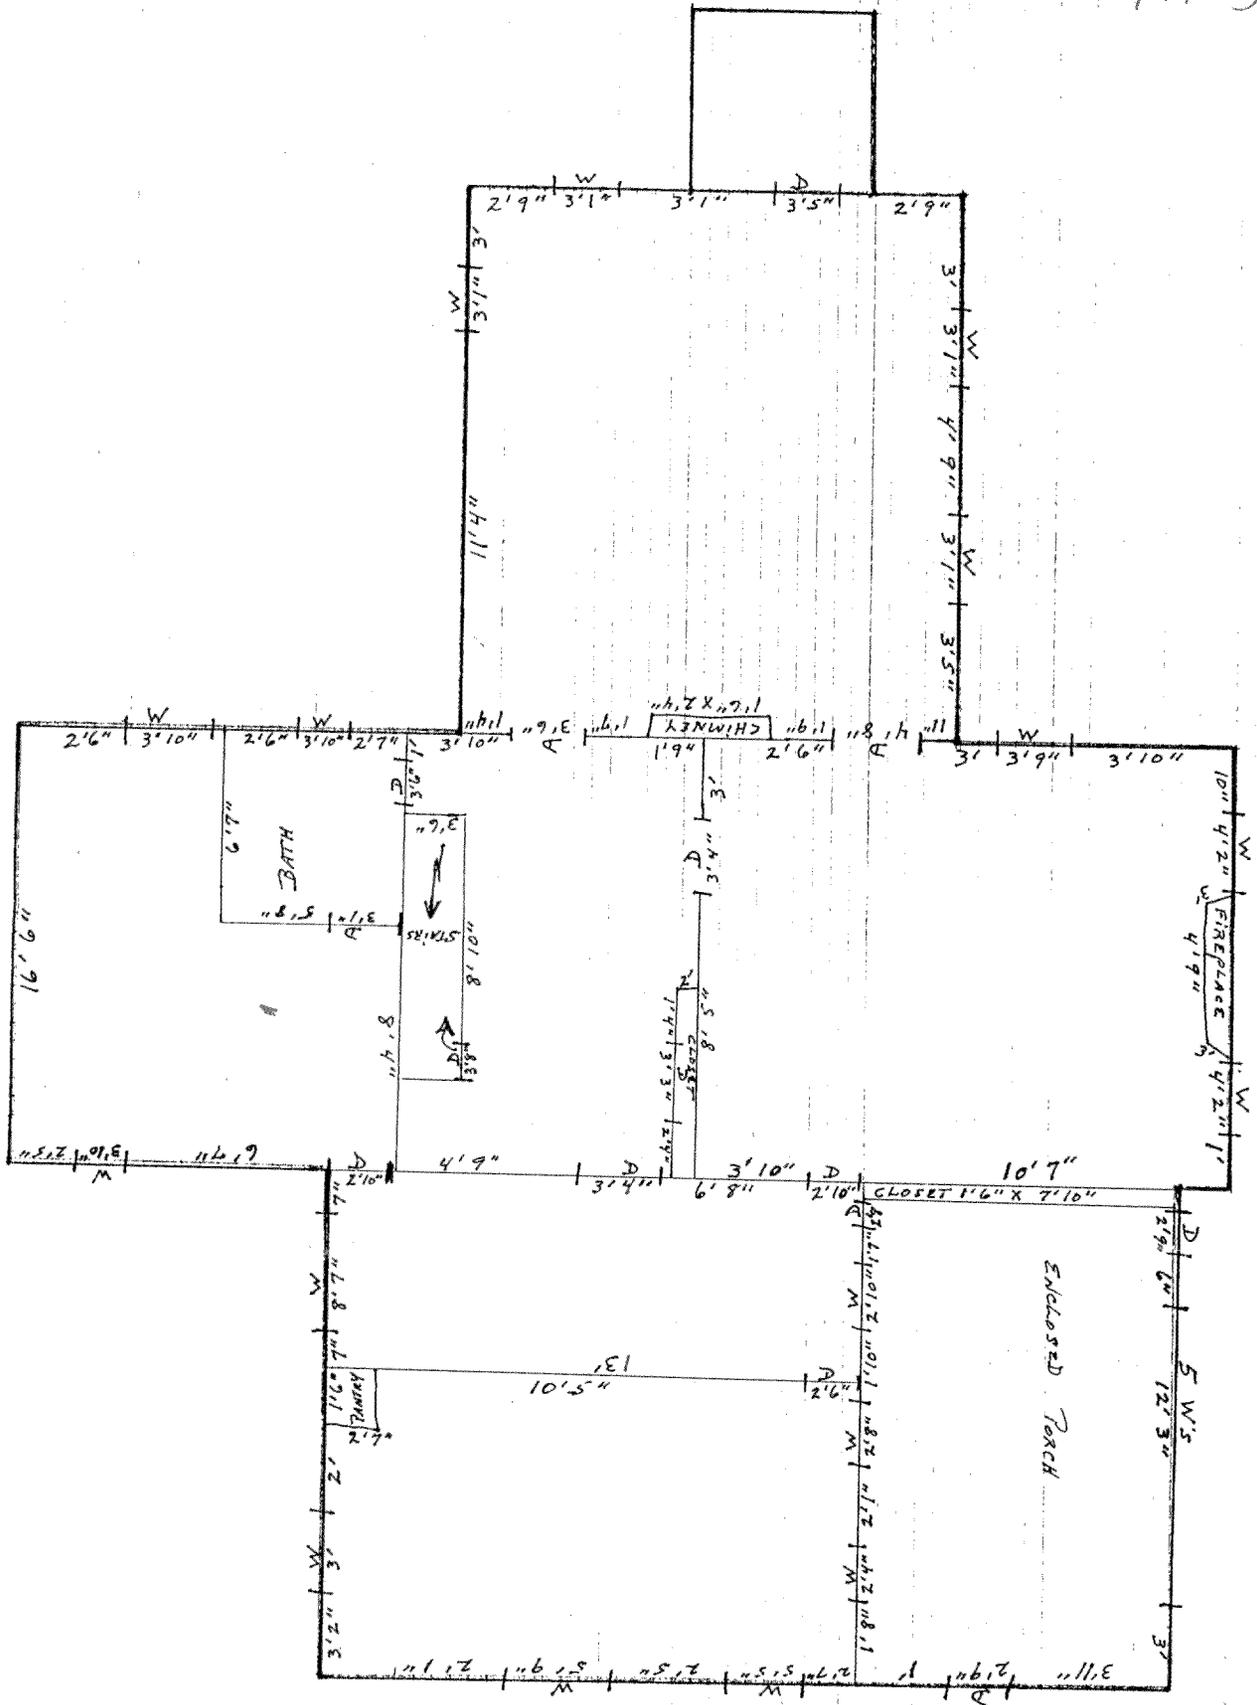
FIRST FLOOR INTERIOR
CROUSE FARM HOUSE, TUCKAHOE STATE PARK, QUEEN ANNE'S COUNTY
