QA-400
White House Farm
Queenstown vicinity
Private

circa 1820-40, 1890

INVENTORY FORM FOR STATE HISTORIC SITES SURVEY

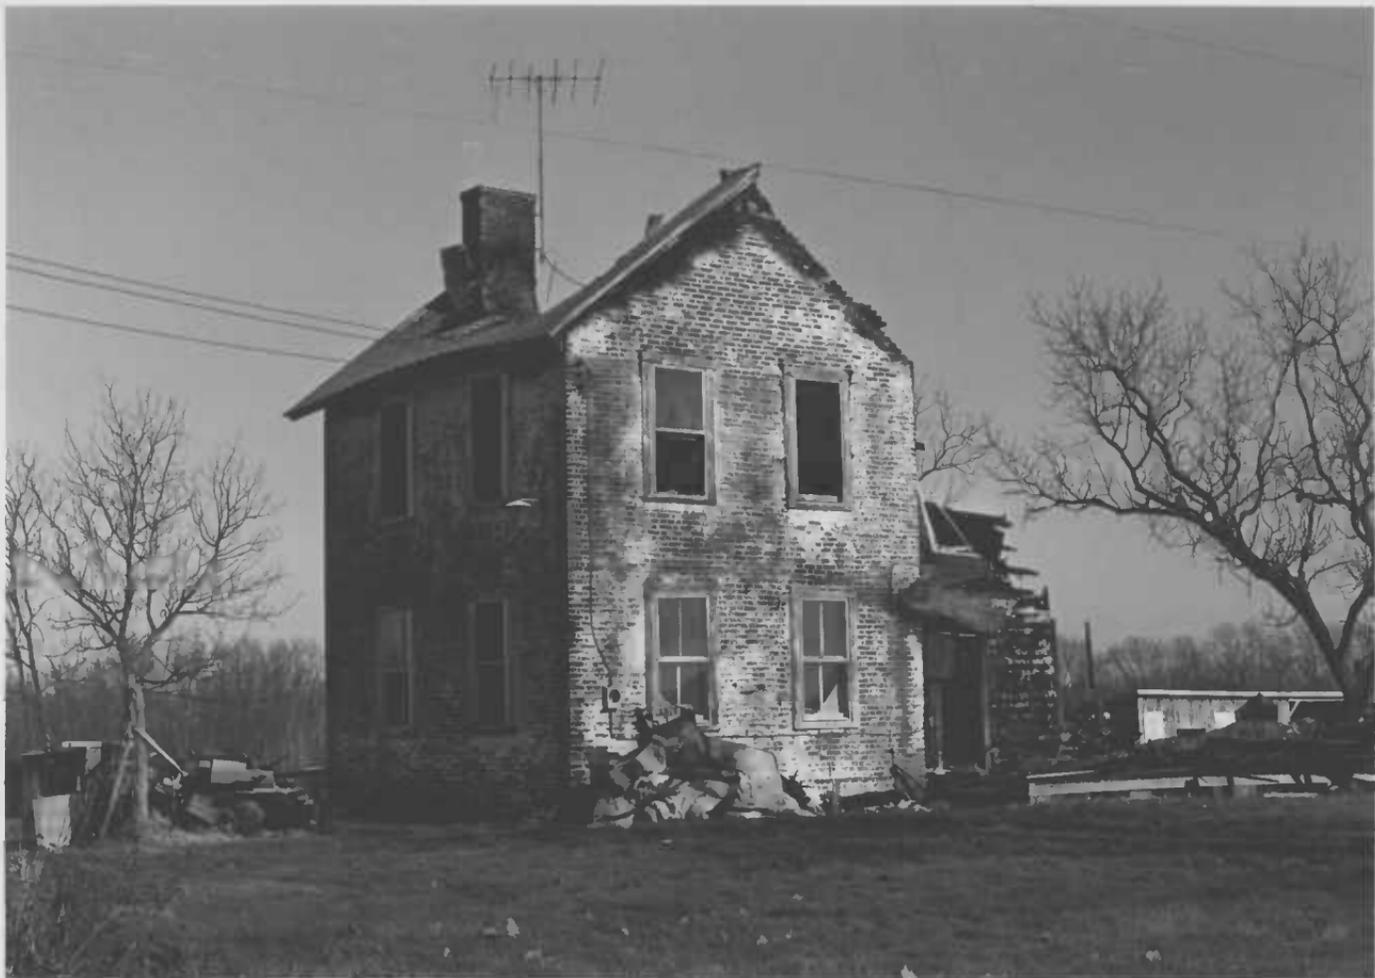
QA-400

The brick dwelling is two stories high with a pitched gable roof. The west facade, facing the road, is laid in Flemish bond above a plain watertable and a five-course bond foundation. There are two large 2/2 windows on each floor. The south gable is laid in Flemish bond above a plain watertable and a five-course bond foundation. The upper gable is laid in common bond and does

not match the lower work, suggesting it was rebuilt following the fire in 1890. There are two 2/2 windows on each floor. The north gable is five-course bond above a plain watertable and five-course foundation. A blocked opening to the right of the flush gable chimney was probably an original exterior door. The east facade was partially covered by the frame wing, and this portion of the brickwork is laid in common bond with rough unfinished jointwork, indicating that it was never intended to be exposed. The exterior walls of the pre-1890 frame structure can be determined from this unfinished finish, and the racking of a two story brick hyphen or similar structure can be seen under the rubble of the fire. The exposed brickwork on this wall is laid in five-course bond with no watertable. The exterior walls were at one time whitewashed and where the whitewash was protected by the frame wing, the outline of the cornice of the earlier structure can still be seen. The only openings in this wall are a single door on the first floor and two doors on the second floor. All three served as interior doors leading to the frame wing.

White House Farm
Queenstown vicinity
Orlando Ridout V 1979
View from Southwest

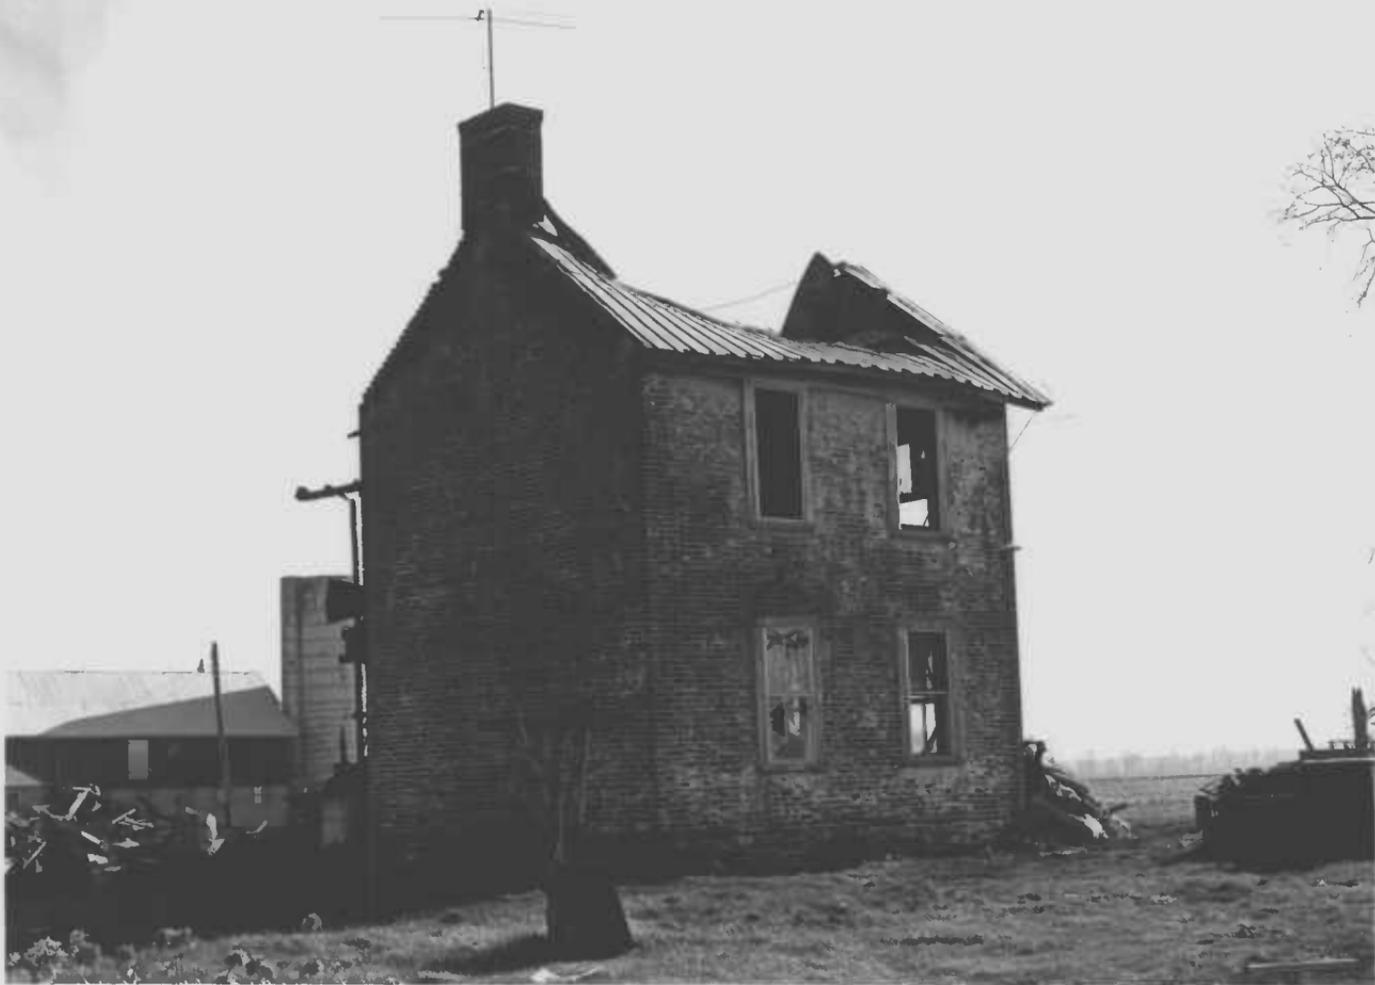
QA-400 White House Farm
Queenstown vicinity
Orlando Ridout V 1979
View from Northwest

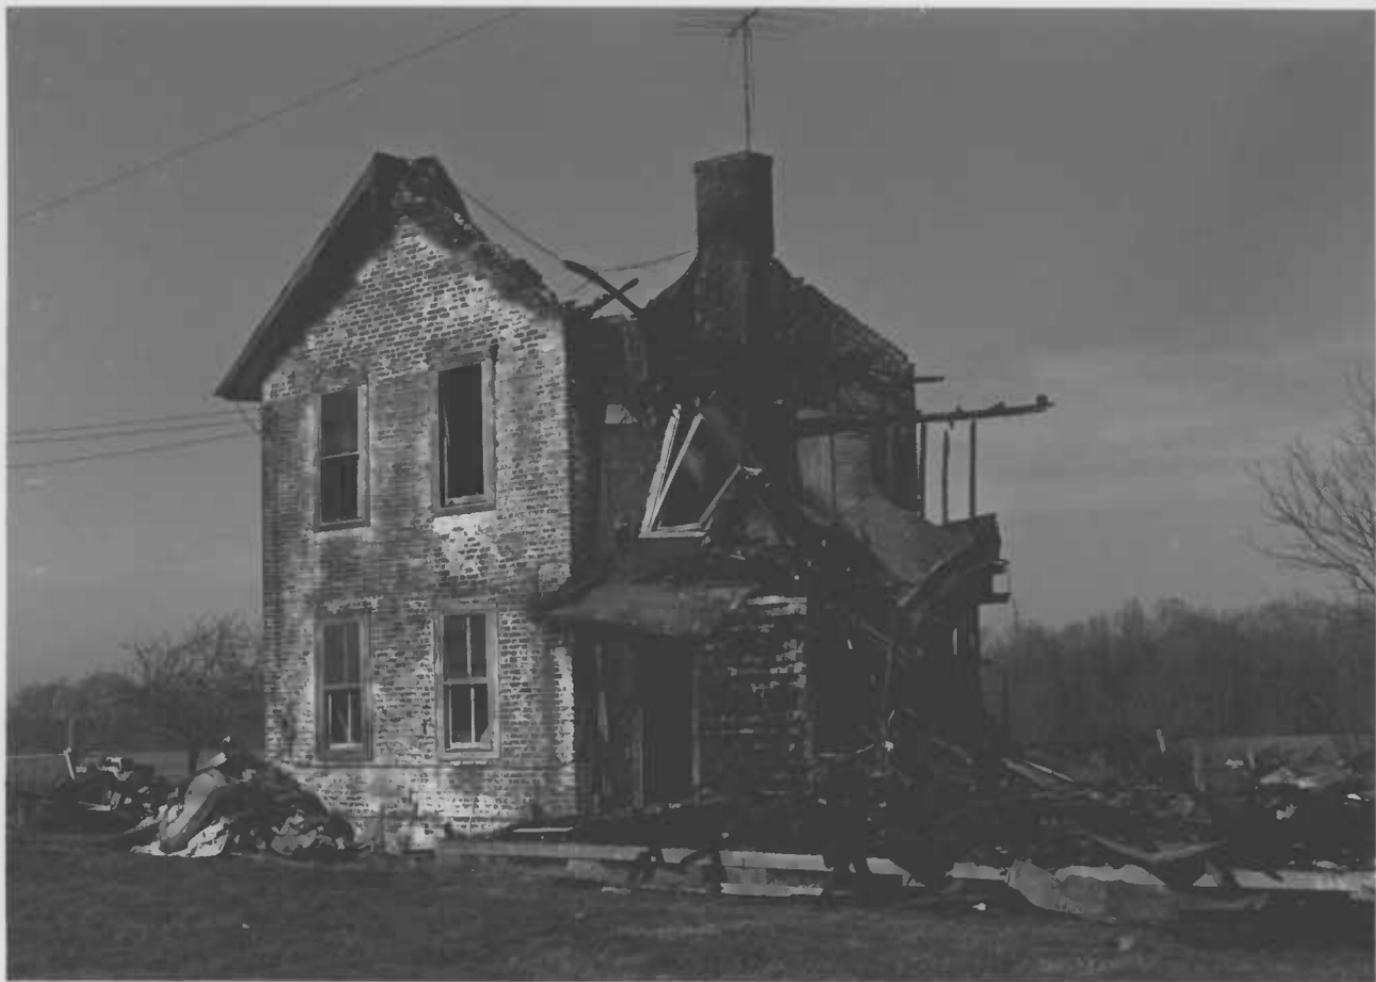
QA-400

The history of White House Farm has been troubled by two major fires, the first circa 1890 and the second more recently, in October 1979. Based on an examination of the site following the second fire and aided by oral tradition recounted by the present owner, it would appear that the cellar foundation is all that remains of the earliest building. This was a frame dwelling of uncertain date, but probably dating to the early 19th century. It was enlarged later in the 19th century, perhaps circa 1820-1840 by a two story brick hyphen and wing. In 1890, the first fire destroyed the early frame house and brick hyphen, and gutted the two story brick wing. Following the fire, the brick section was renovated and a new two story frame addition was built on the ruins of the destroyed section. The recent fire destroyed this 1890 wing and damaged the brick building.

White House Farm
Queenstown vicinity
Orlando Ridout V 1979
View from Southeast after
fire

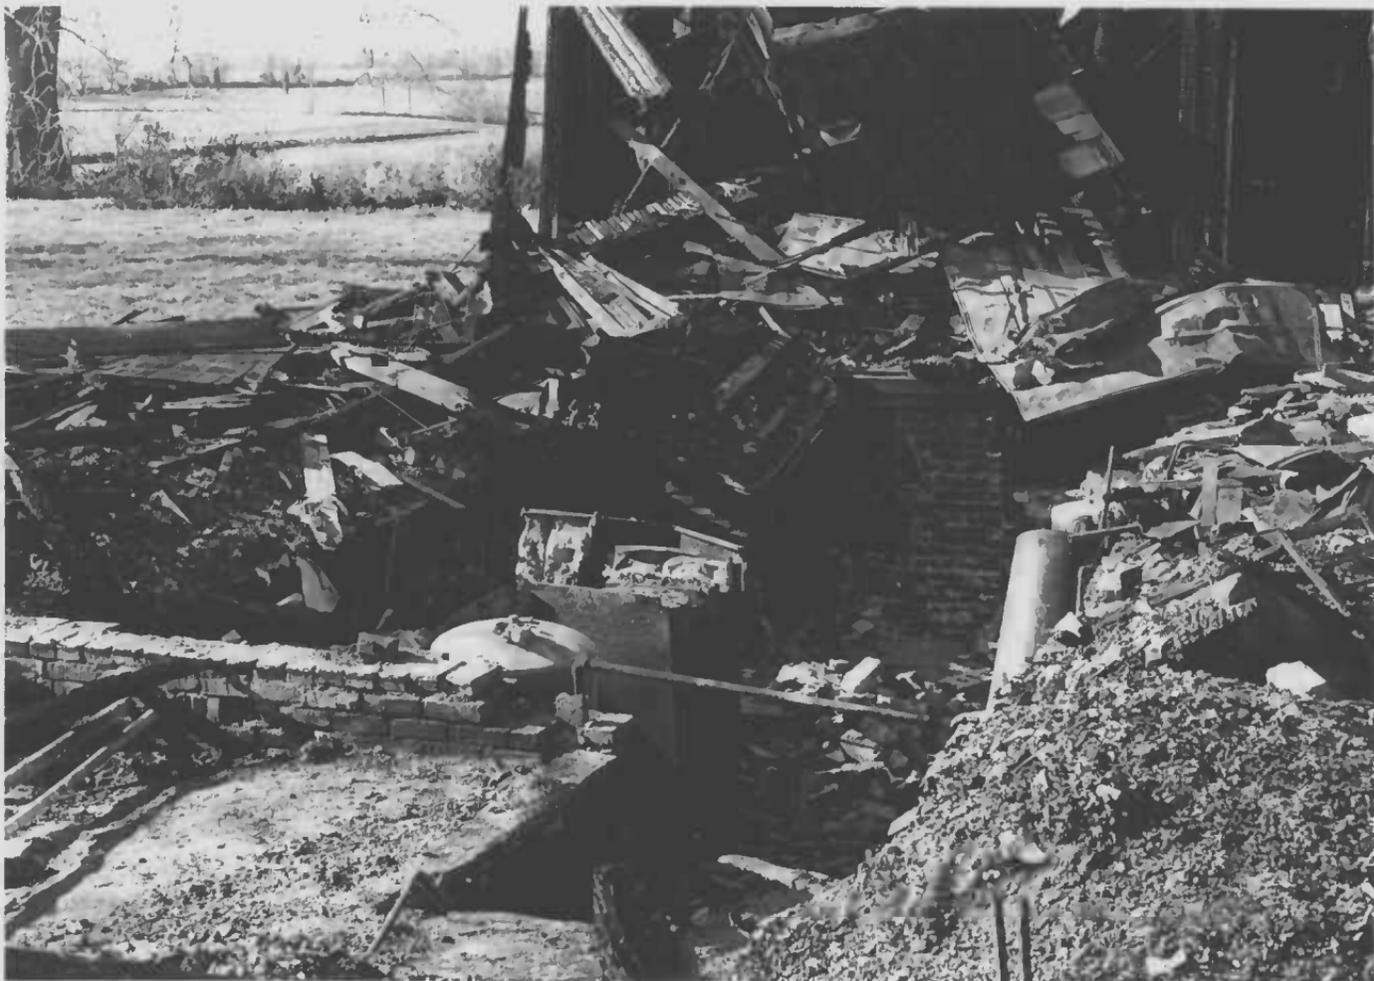
QA-400

A brick cellar lies to the east of the brick house, partially buried by the rubble of the fire. It measures 11 feet by 20 feet (inside dimensions), and is laid in three-course bond. An arched brick chimney base at the west end of the cellar was not reused in the 1890 wing. Brick foundations at ground level run from the west end of the cellar toward the standing brick section. Mrs. Dukes reports that another massive foundation runs parallel to the south wall of the cellar, discovered when she attempted to plant shrubs in front of her porch.

White House Farm
Queenstown vicinity
Orlando Ridout V 1979
Early foundation under
rubble of wing
