QA-432
Clark Nicholson Farm
Centreville vicinity
Private

INVENTORY FORM FOR STATE HISTORIC SITES SURVEY

Clark Nicholson Farm

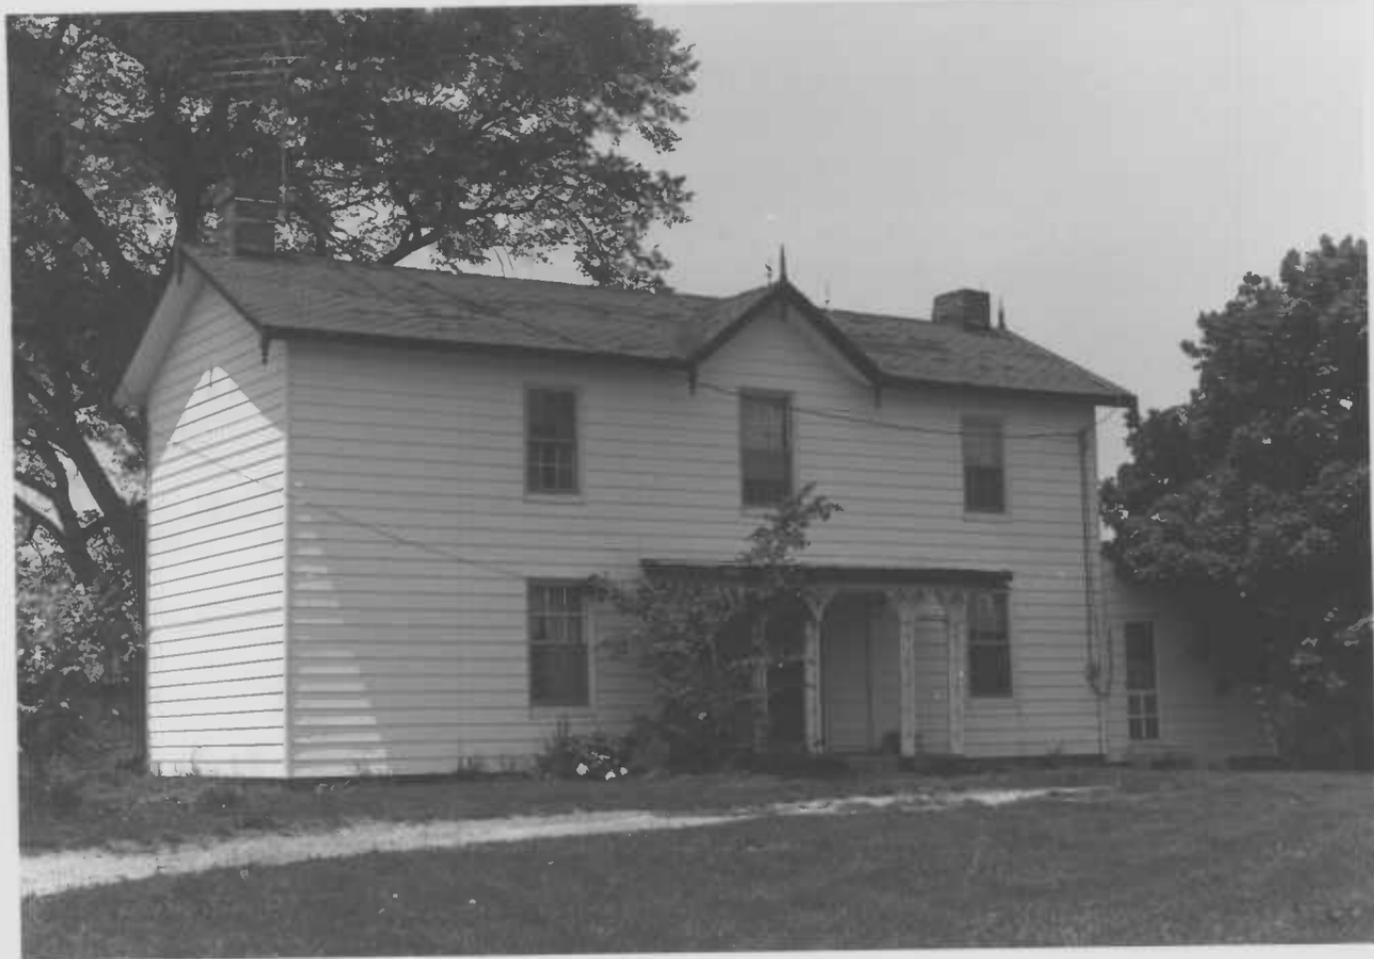
QA-432 Clark Nicholson Farm
Centreville vicinity
Orlando Ridout V 1980
Front facade

The front facade of the enlarged house faces east, toward Tanyard Road. The entrance is in the center bay, flanked by a 6/6 window on each side. There are three 6/6 windows on the second floor; a cross gable is centered on this facade. A small shamrock shaped ventilation window in the center of the cross gable has been blocked from outside but remains visible from the attic. The front door is set off by sidelights and a transom, and is protected by a small entrance porch with ornately scrolled support posts and arched Gothic spandrels. The building rests on a stuccoed foundation and is covered with vinyl siding and an asphalt shingle roof. The eaves oversail and are boxed in, with turned drops at each corner of the building and at the base of the cross gable.

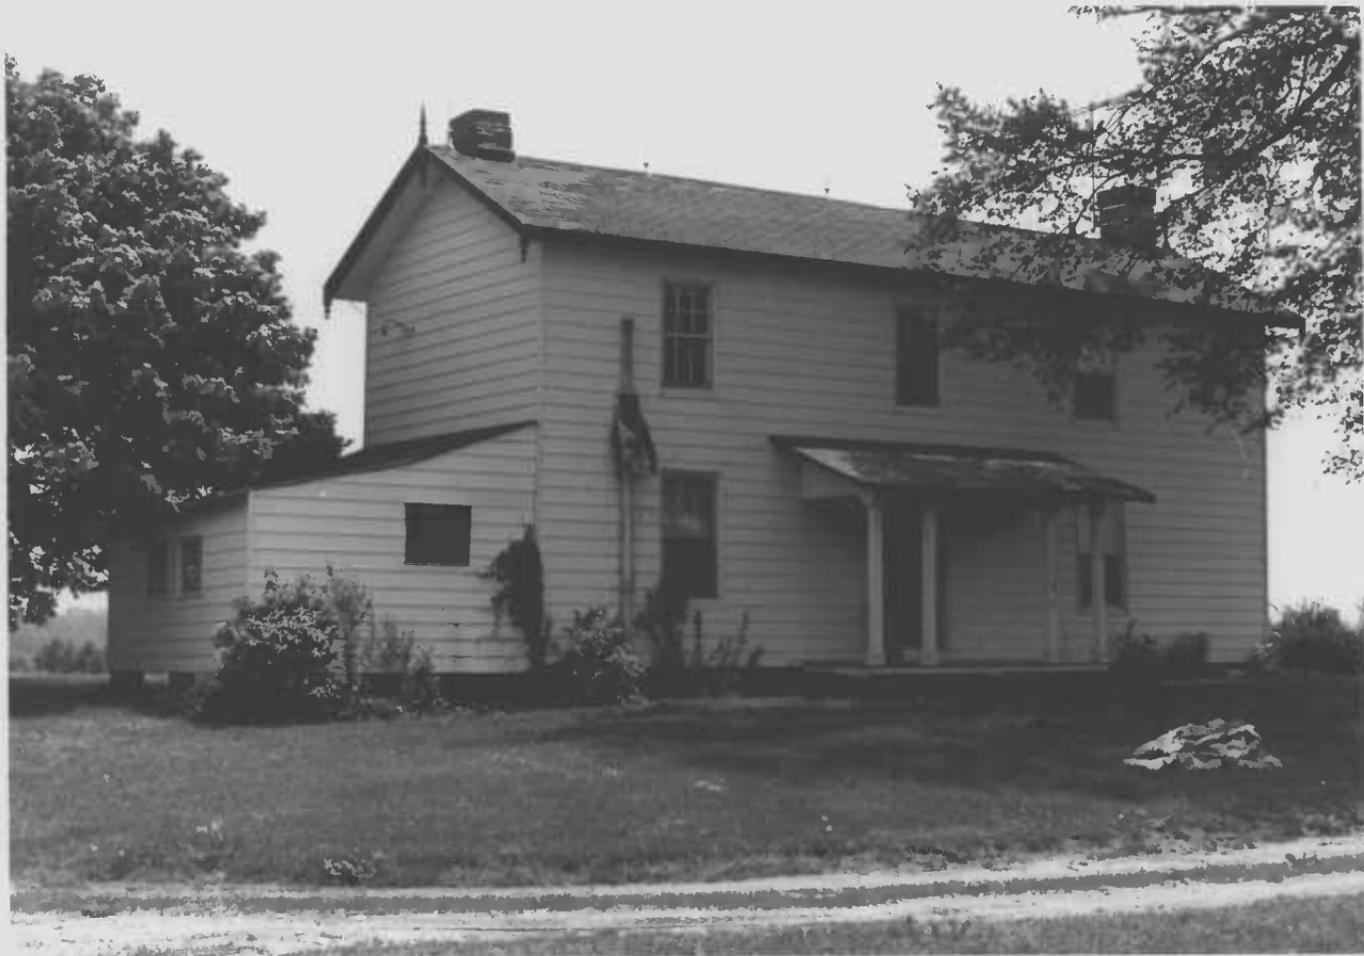
Clark Nicholson Farm
Centreville vicinity
Orlando Ridout V 1980
Rear facade

The rear facade is similar to the front facade, with a center door flanked by 6/6 windows on the first floor and three 6/6 windows on the second story. The door has a four-light transom but no sidelights. The small porch over the door on this facade is relatively plain, without decorative posts or spandrels.

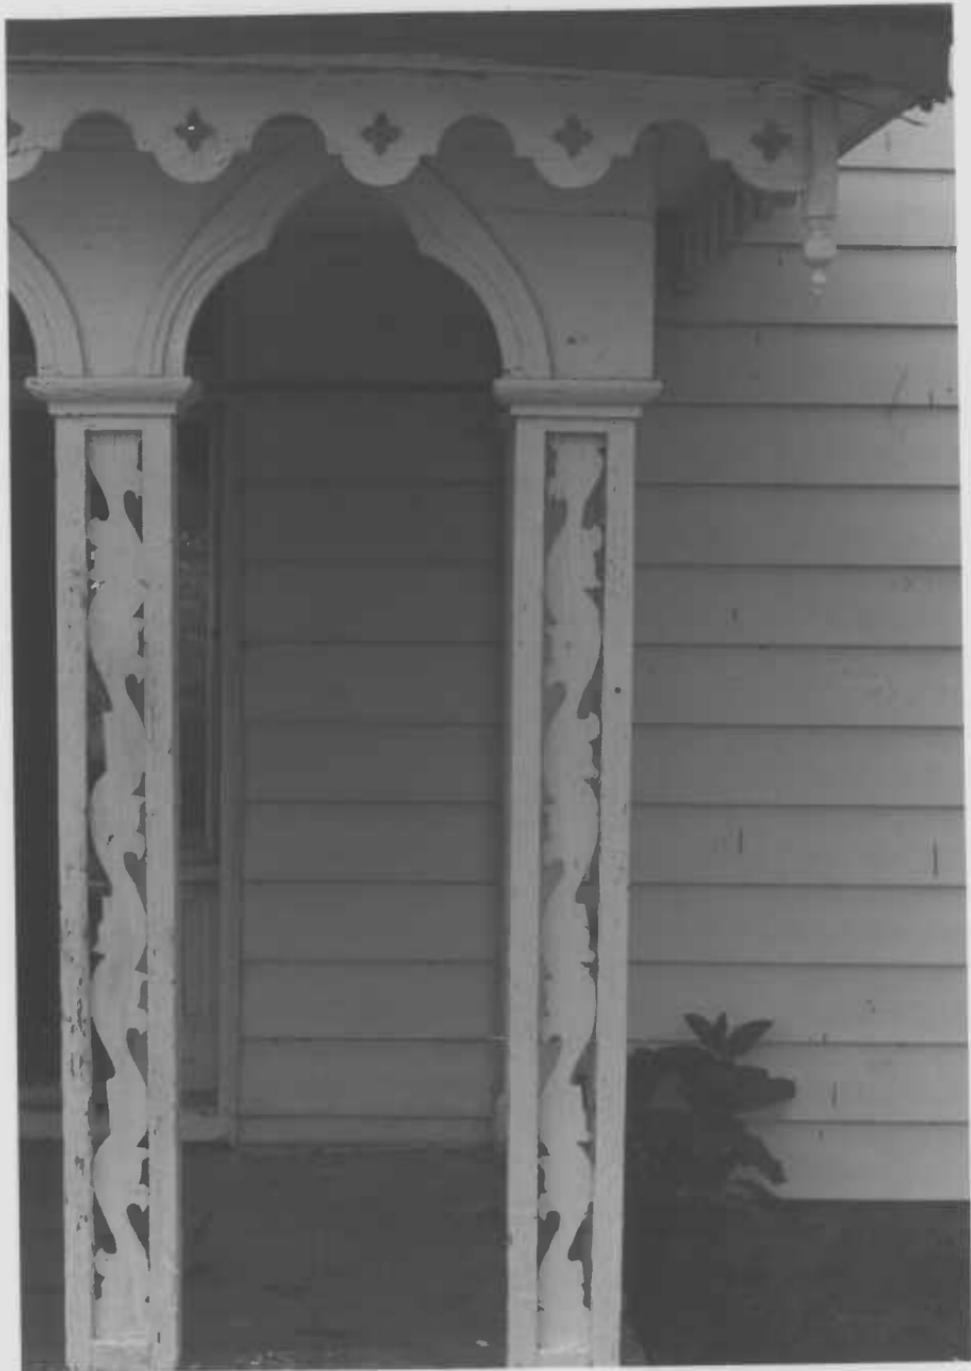
Clark Nicholson Farm
Centreville vicinity
Orlando Ridout V 1980
Detail of Porch
