MARYLAND HISTORICAL TRUST  
DETERMINATION OF ELIGIBILITY FORM

Property Name: Bordlington Inventory Number: QA-95  
Address: 200 Bordlington Farm Lane Historic district:  yes  no  
City: Centreville Zip Code: 21617 County: Queen Annes  
USGS Quadrangle(s): Centreville  
Property Owner: Robert Willis Adams et al. Tax Account ID Number: 008924  
Tax Map Parcel Number(s): 3 Tax Map Number: 53  
Project: Planning Studies for US 301 at MD 304 Agency: Maryland State Highway Administration  
Agency Prepared By: Maryland State Highway Administration  
Preparer's Name: Stephanie Foell Date Prepared: 08/10/2005  
Documentation is presented in: Maryland Inventory of Historic Properties Form QA-95  
Preparer's Eligibility Recommendation:  Eligibility recommended  Eligibility not recommended  
Criteria:  A  B  C  D Considerations:  A  B  C  D  E  F  G  
*Complete if the property is a contributing or non-contributing resource to a NR district/property:*  
Name of the District/Property: \_\_\_\_\_

QA-95  
Bordlington  
Centreville vicinity  
Private

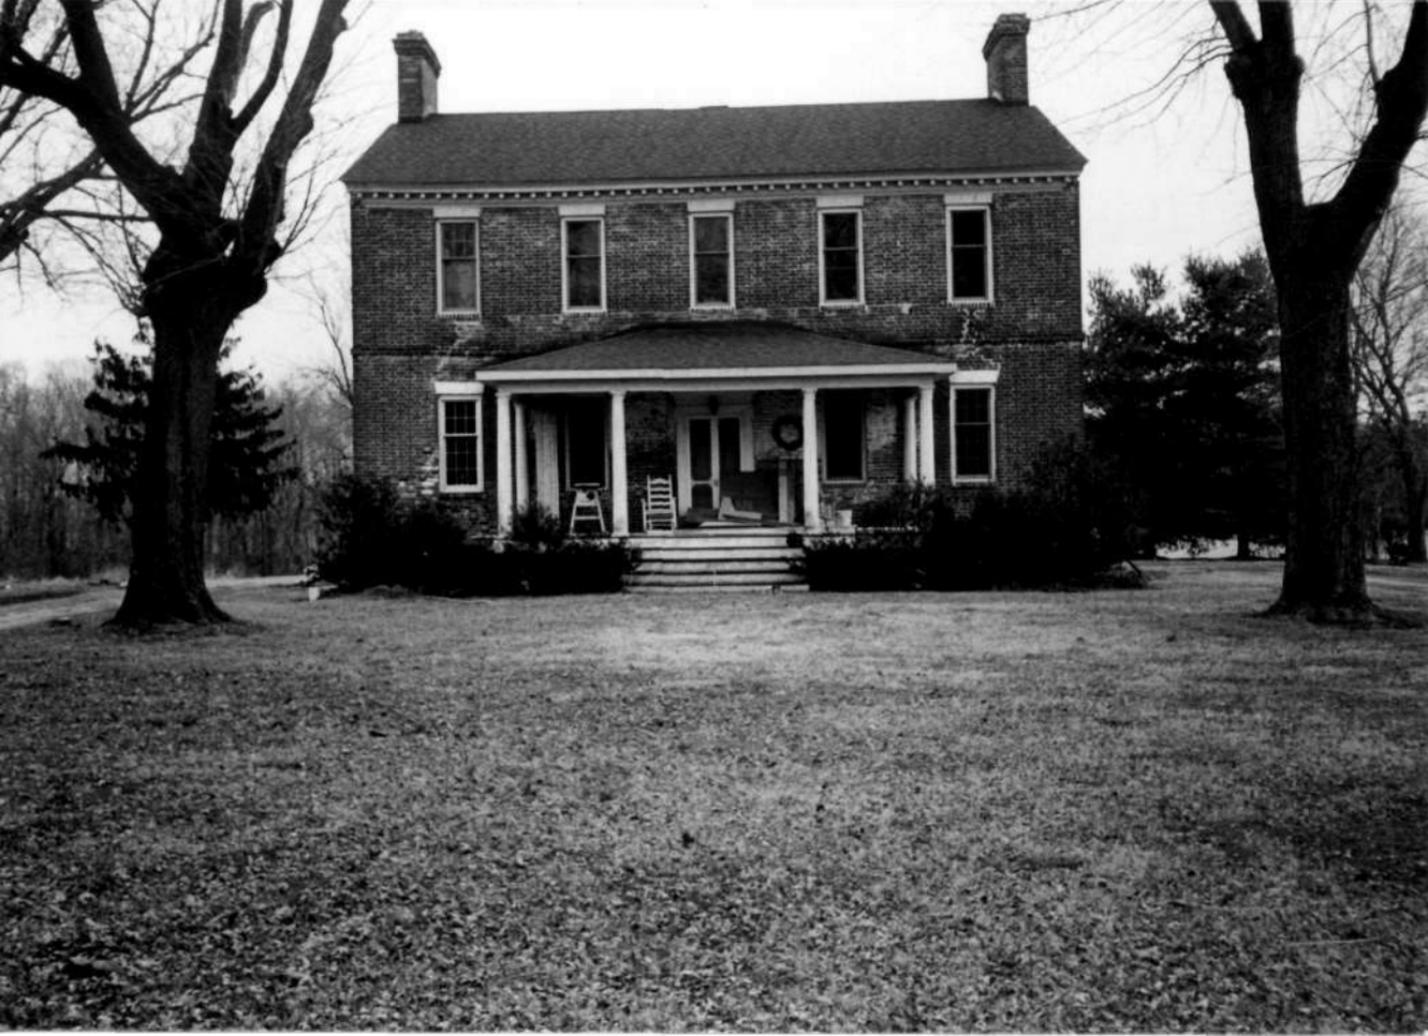
1/4

Facade of residence (east elevation)

The principal facade faces east, overlooking the wooded streambed below. The entrance is located in the center bay with two nine-over-nine windows on either side. Three-light cellar windows are located below each first floor window. The second floor windows are nine-over-nine. All first and second floor openings have flat brick jack arches, while the cellar windows have segmental arches. The two north bays of this facade have been covered by a one-story kitchen addition, and the front door is protected by a screen porch. The original modillion block cornice remains intact.

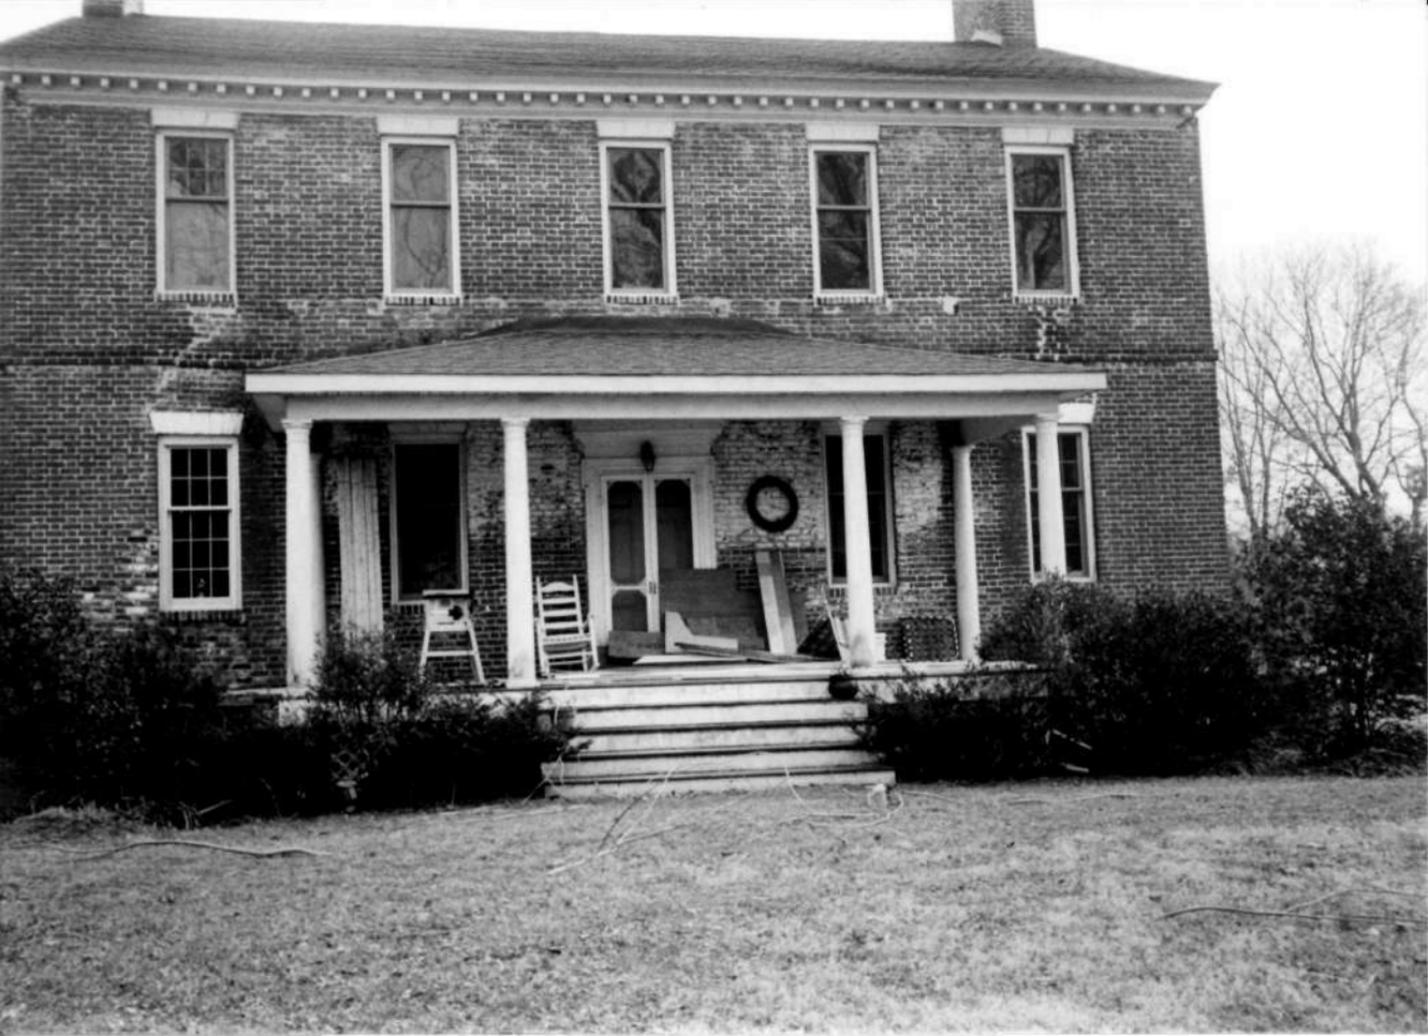
2/4

Facade; east elevation porch

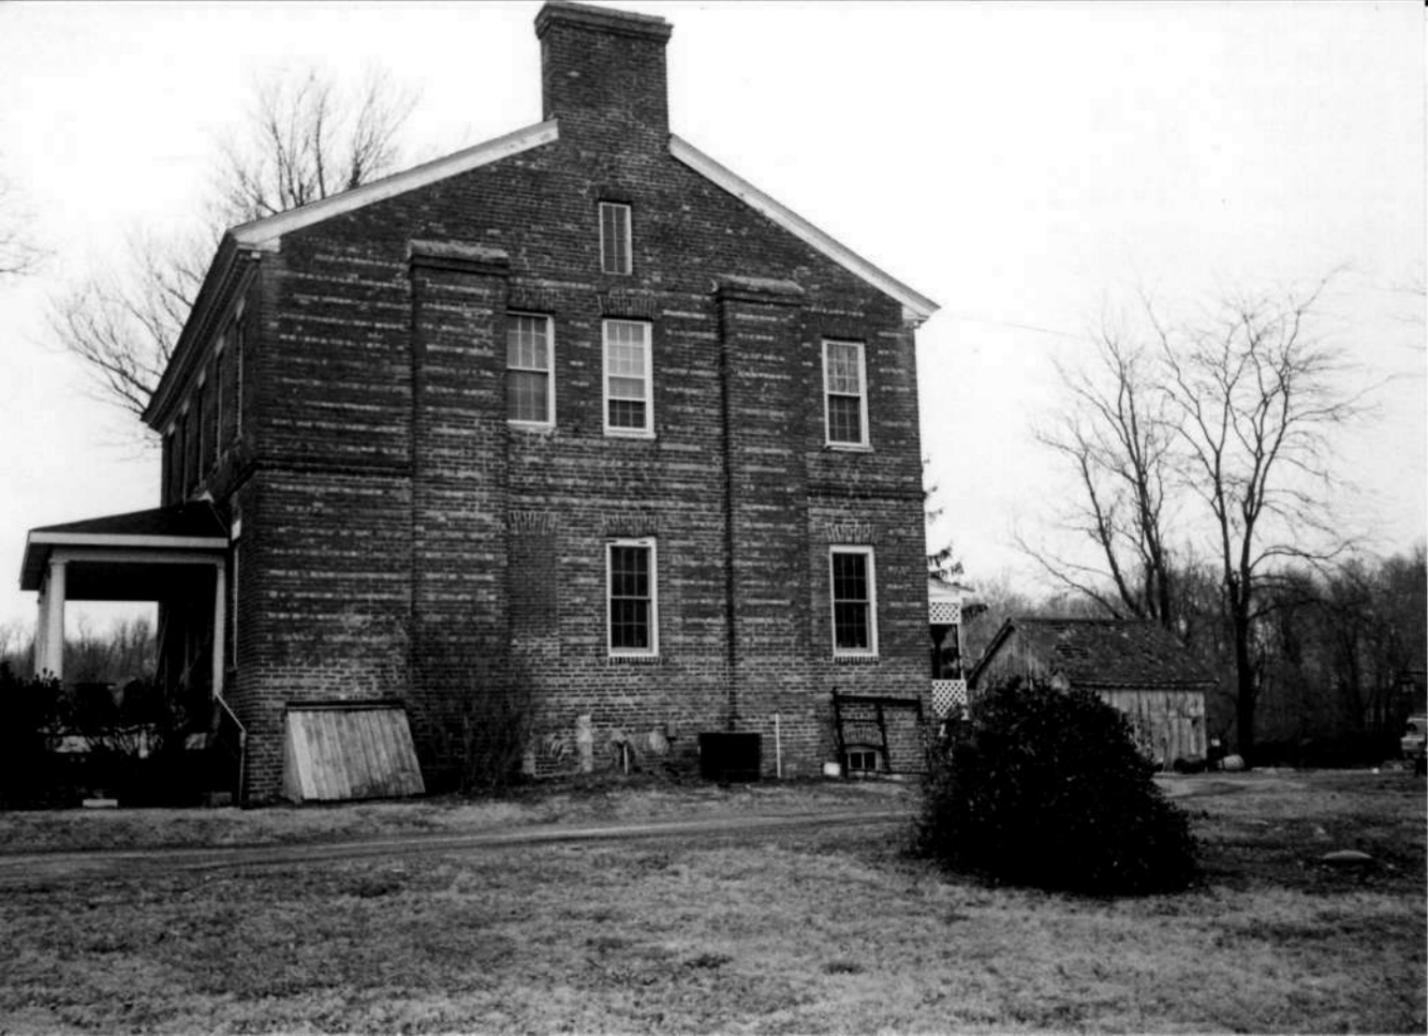
3/4

North elevation

The north gable is dominated by the paired chimneys. The fenestration is not symmetrical, with a single nine-over-nine window to the left of the east chimney and two nine-over-nine windows between the chimneys on each floor. There are no openings to the right of the west chimney. There are three three-light windows, directly below the first floor windows, and a single four-over-four window is located in the center of the upper gable. The rakeboards are tapered and have a molded lower edge and a crown mold along

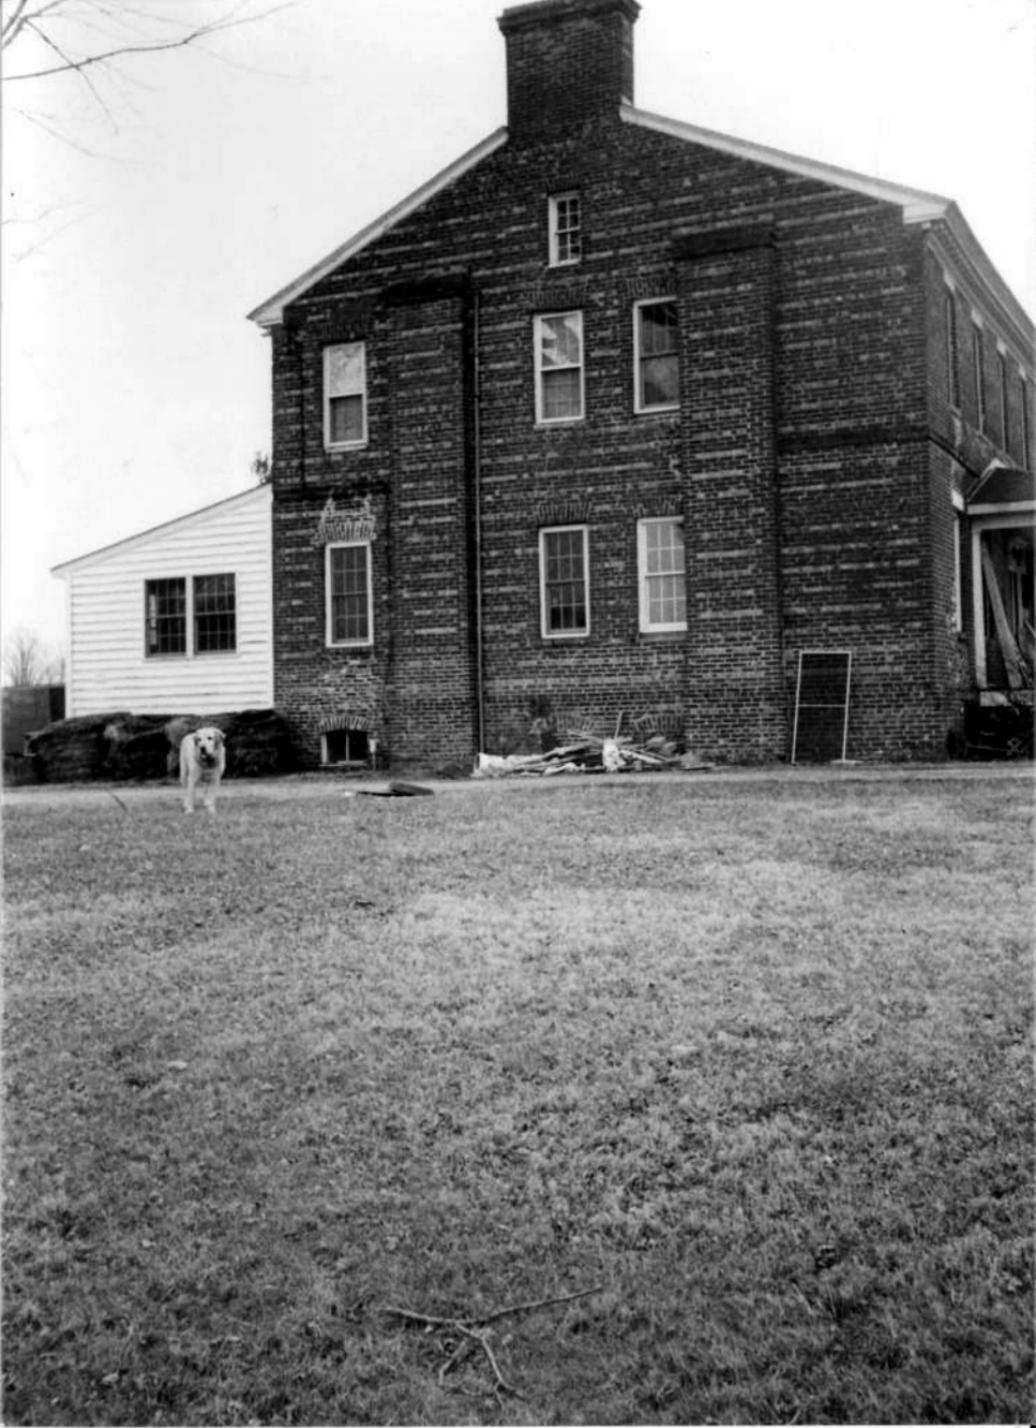
4/4

South elevation

The south gable is similar to the north gable, with several minor differences. There is a bulkhead entrance to the cellar at the west end of the south gable, and the four-over-four sash in the gable window has been replaced with a new six-light casement. The rakeboards have also been replaced.
