MARYLAND HISTORICAL TRUST  
DETERMINATION OF ELIGIBILITY FORM

Property Name: Spring Garden Farm Inventory Number: QA-105  
Address: 210 Spring Garden Farm Lane Historic district:  yes  no  
City: Centreville Zip Code: 21617 County: Queen Annes  
USGS Quadrangle(s): Centreville  
Property Owner: Margaret Quimby and Eleanor H. Price Tax Account ID Number: 011100  
Tax Map Parcel Number(s): 7 Tax Map Number: 45  
Project: Planning Studies for US 301 at MD 304 Agency: Maryland State Highway Administration  
Agency Prepared By: Maryland State Highway Administration  
Preparer's Name: Stephanie Foell Date Prepared: 08/10/2005  
Documentation is presented in: Maryland Inventory of Historic Properties Form QA-105  
Preparer's Eligibility Recommendation:  Eligibility recommended  Eligibility not recommended  
Criteria:  A  B  C  D Considerations:  A  B  C  D  E  F  G  
*Complete if the property is a contributing or non-contributing resource to a NR district/property:*

Spring Garden Farm (QA-105)

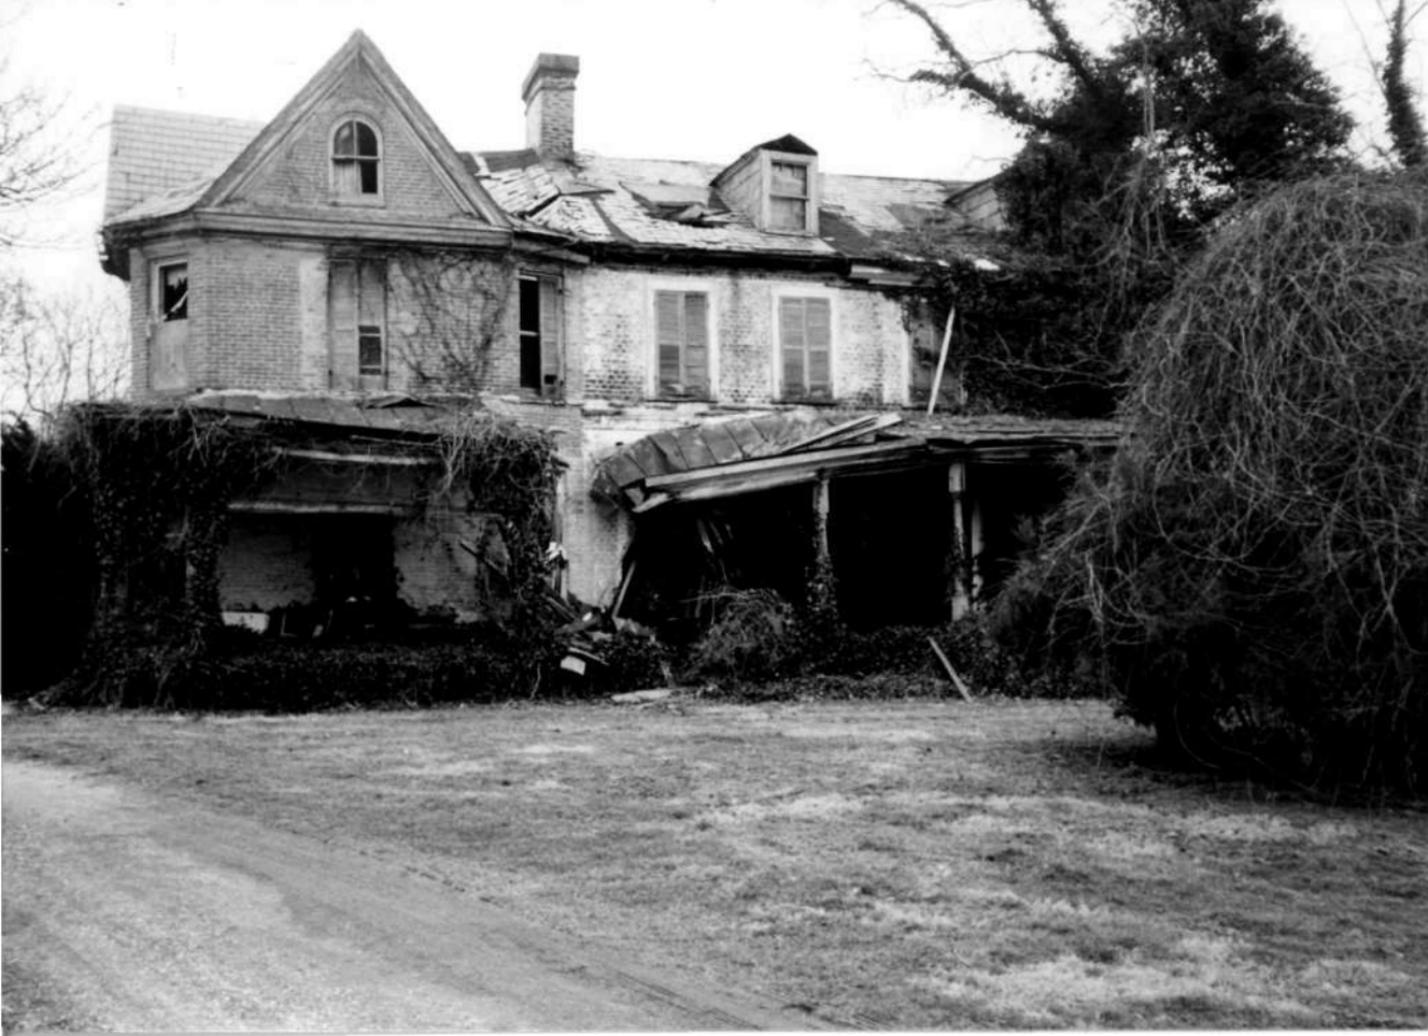
1/2

The residence consists of a circa 1790 brick house that was altered with Queen Anne and Gothic additions approximately 100 years after its initial construction. Clad in brick that was at one time painted white, the façade of the house features a front-facing gable atop an octagonal portion of the building. A round-arch window is located in the articulated gable. The entrance is obscured by the collapsing porch.

Facade

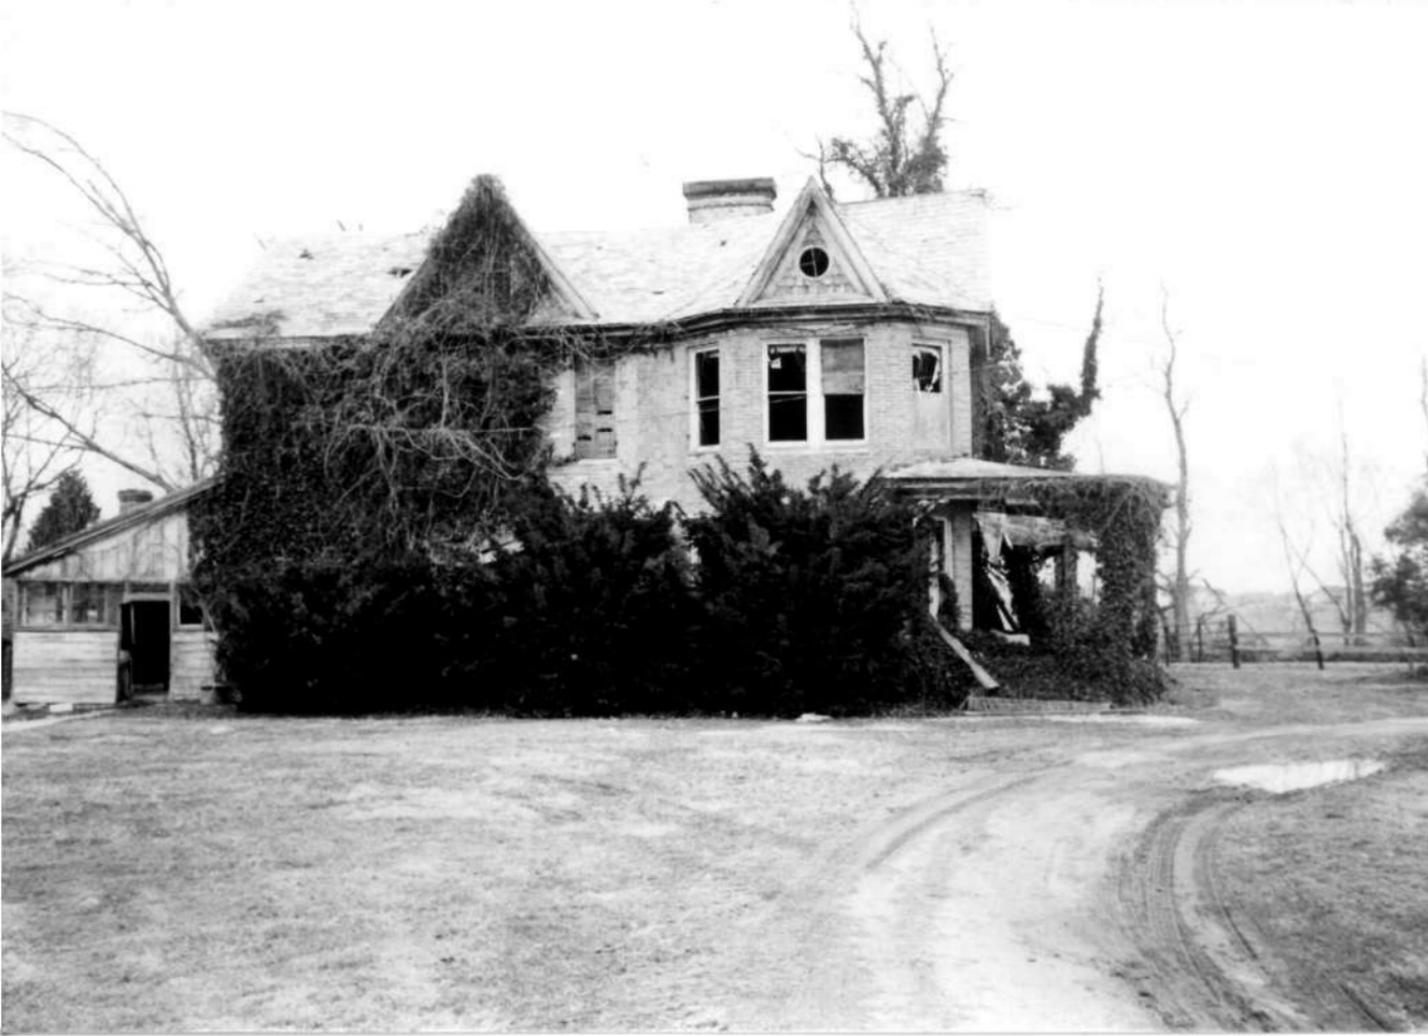
2/2

A side-gable wing extends from the octagonal portion of the building. The wing contains a single-story porch topped with a standing-seam metal roof that is currently collapsing. The porch supports, which are failing, consist of turned balusters. Fenestration beneath the porch has been obscured by the partial collapse. Window openings on the second level are tall and narrow and are missing the glass, but some are covered with louvered shutters. Gable dormers whose sides are clad in wood shingles sit atop the roof, which is covered with asbestos shingles.

side elevation
