QA-139
Tucker House
Centreville

INVENTORY FORM FOR STATE HISTORIC SITES SURVEY

Tucker House

124 South Commerce Street

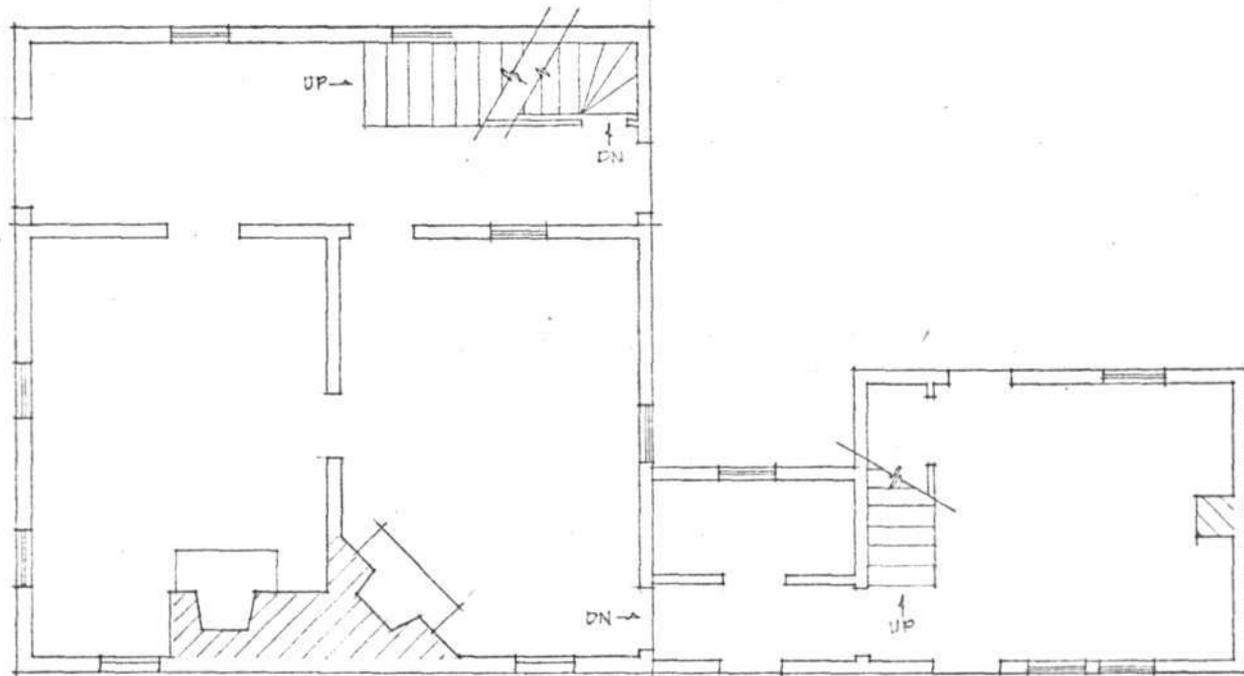
QA-139

TUCKER HOUSE
CENTREVILLE, MARYLAND SEPT. 25, 1978.

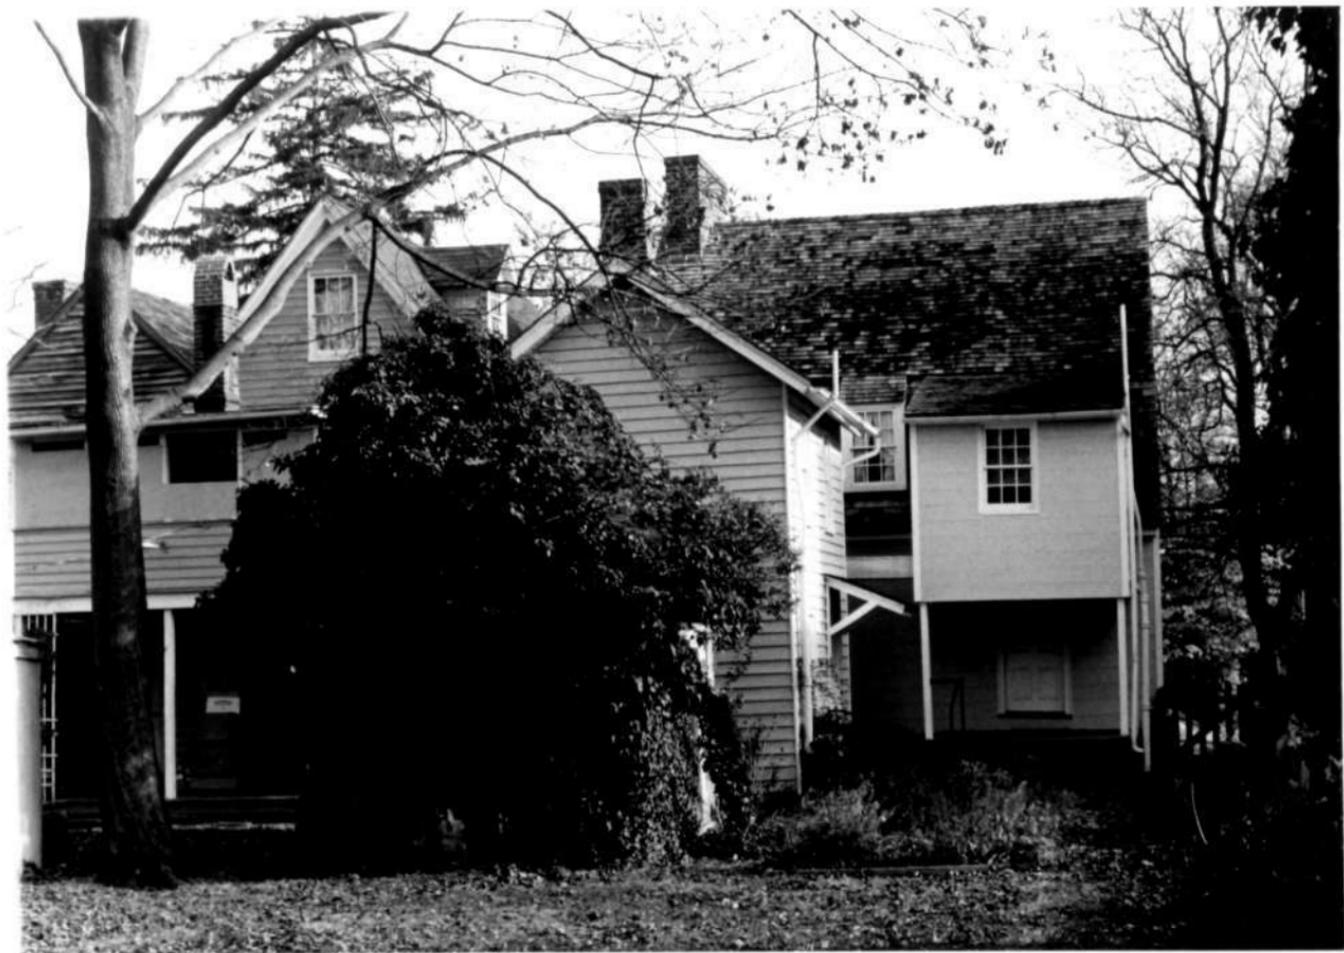
QA-139 Tucker House
124 South Commerce Street
Centreville, Md
Orlando Ridout V , 1978 (MHT)
Rear Elevation, Cameral Facing SE

The north end of the rear facade is covered by the rear addition, leaving a nine-over-six window in the center bay and a six-panel exterior door in the south bay. On the second floor, there are six-over-six shed roof dormers in the center and north bay, but the south bay is covered by the bathroom addition. A bulkhead entrance to the cellar is located in the center of this facade.

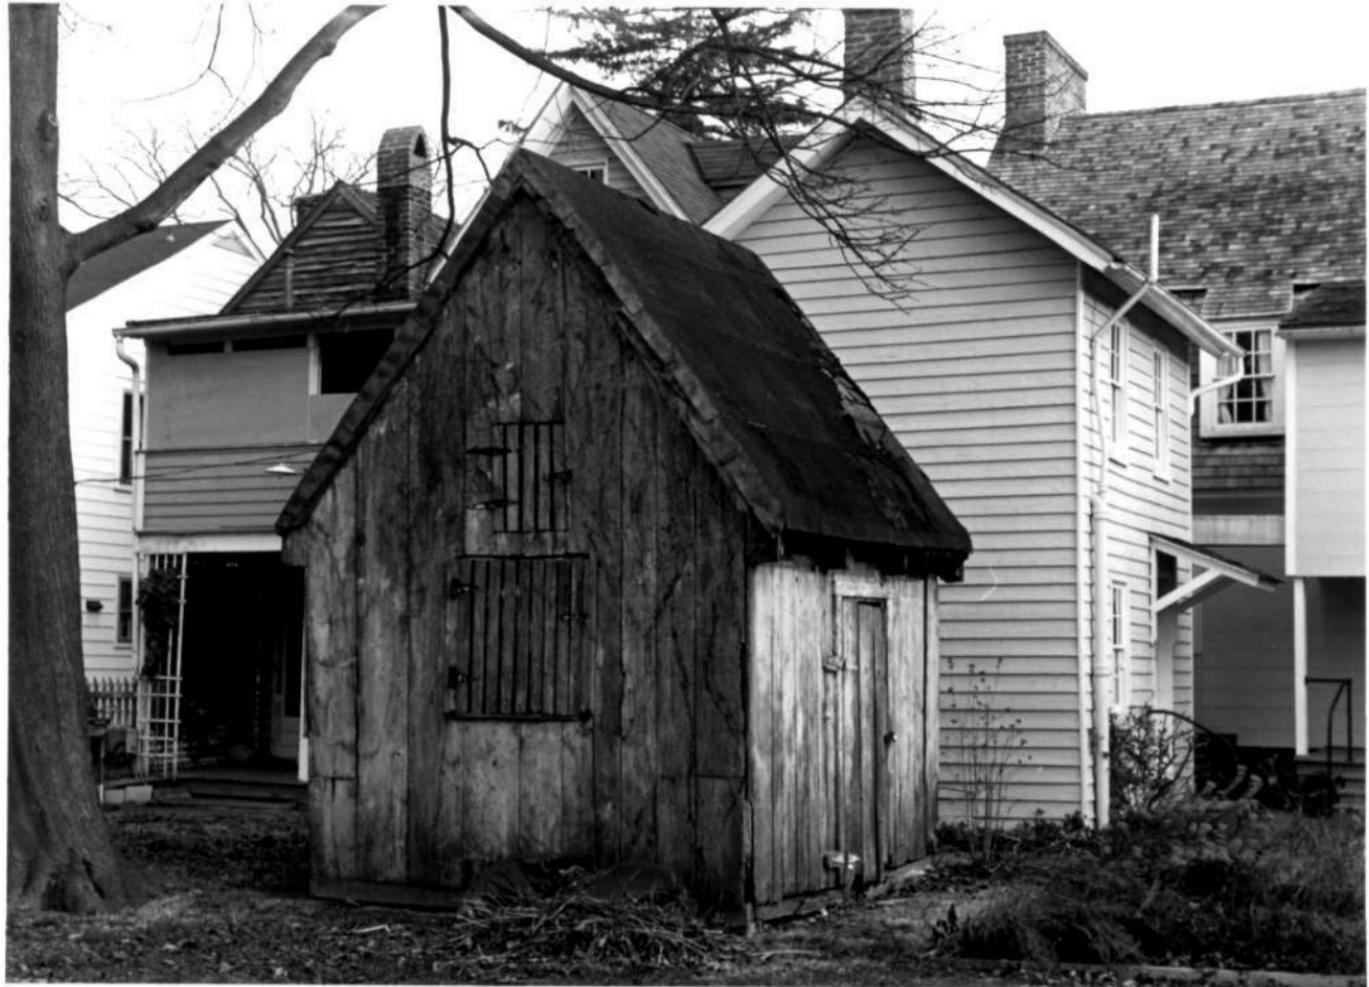
QA-139 Tuckee House
post and plank meathouse
OAV 1979

Meat house: Directly to the rear of Tucker House there is a post-and-plank meat house. It is 10 feet wide and 12 feet long, with a steeply pitched gable roof. The exterior is covered with vertical board siding secured with machine nails. The door is located in the center of the west facade, and there are window openings in the center of the west wall as well as in the upper

The interior has been partitioned into two storage areas, but otherwise remains almost entirely original. The log planks are hewn and pit-sawn, $2\frac{1}{2}$ -3 inches thick and 7 to 9 inches wide, and are widely spaced with no evidence of chinking. These are secured to hewn corner posts with a pegged mortise-and-tenon joint. There are no intermediate posts, but part of the original door jamb remains in place. This indicates that the door was originally only 4'-3" high and 3'-8" wide, but has been enlarged.

The roof framing consists of common rafter pairs set at a pitch of 53 degrees and supported by a flat false plate resting on hewn and pit-sawn ceiling joists. The rafter pairs are secured at the ridge with a pegged mortise-and-tenon joint, and the gable rafters are reinforced with a series of collar beams. There are two collar beams remaining in each gable, with evidence of a third that was located directly above the gable top plate. These were let into the exterior face of the gable rafters with half-lap joints, and the lowest collar was pegged, while the two surviving
