INVENTORY FORM FOR STATE HISTORIC SITES SURVEY

Madison Brown House

111 South Liberty St.

QA-242

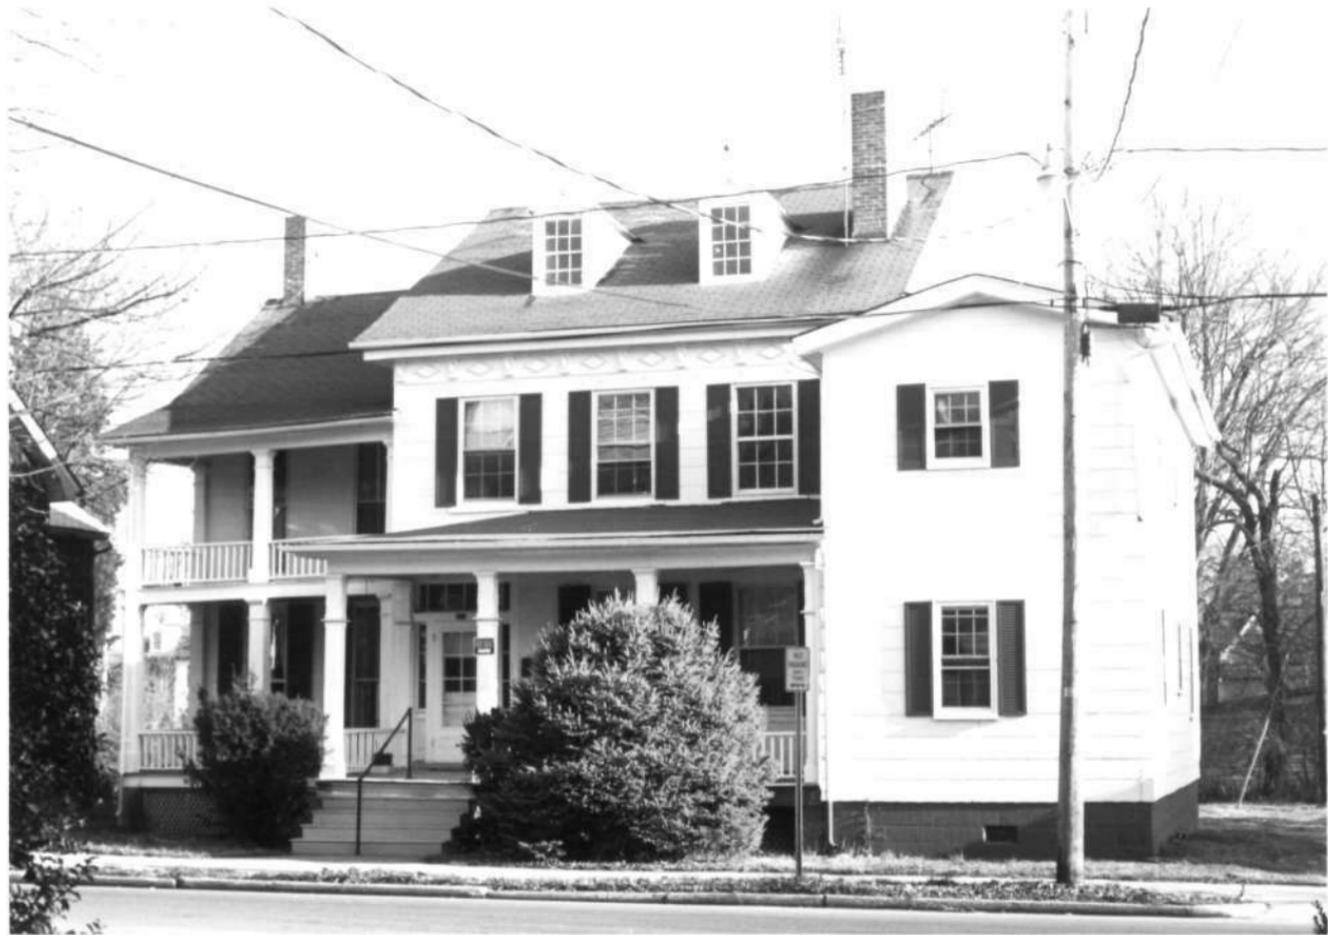
The front facade of the original house faces west to Liberty Street. The entrance door is in the north bay, framed with sidelights and a transom. There are two 6/6 windows to the south of the door, three 6/6 windows on the second story, and two pitched roof 6/6 dormer windows

on the third story. The house rests on a continuous brick foundation and is covered with asbestos shingle siding over earlier bevel edge siding; the roof is covered with asphalt shingles. The window and door openings are framed with simple architrave trim and peaked wood lintel pieces. The eaves are boxed in and the frieze board is decorated with alternating square and diamond pattern applied blocks. A one story porch with simple, late Victorian posts extends across the front facade.

QA-242 111 South Liberty Street
Centreville, Maryland
Orlando Ridout V 1981
West (front) facade

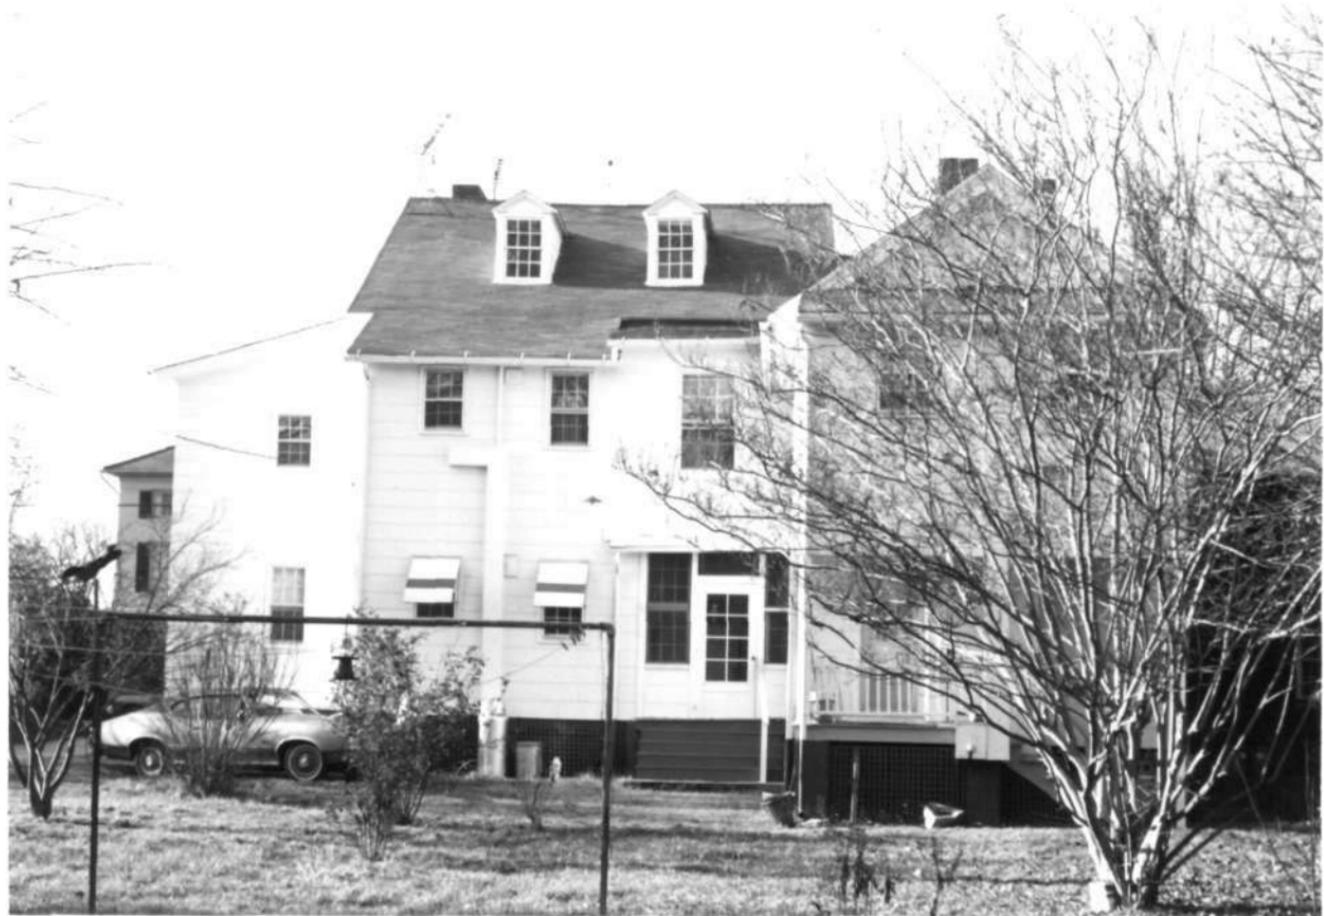
The north and south gable walls are almost entirely concealed by later additions. The gable eaves remain exposed on the north wall; they are boxed in and return at the gables. The first two stories of the rear facade ^{are} almost concealed by a later addition, leaving the two 6/6 pitched roof dormers intact on the third story.

QA-242 111 South Liberty Street
Centreville, Maryland
Orlando Ridout V 1981
Rear facade from East
